Maritime archaeological analysis of two historic shipwrecks located during the MH370 aircraft search

Ross Anderson

April 2018

Report No. 322—-Department of Maritime Archaeology Western Australian Museum

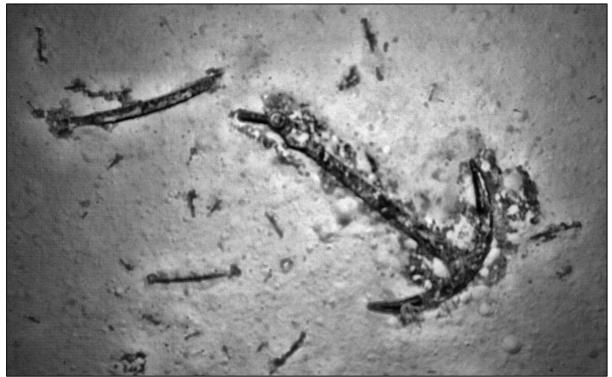
Anchor 1 is a large, Admiralty-type best bower anchor, with an iron folding stock lying detached nearby, an iron shackle, with stud link chain visible attached to the shackle.

Figure 13 Anchor 1, Admiralty type anchor with detached folding iron stock (Fugro/ATSB).

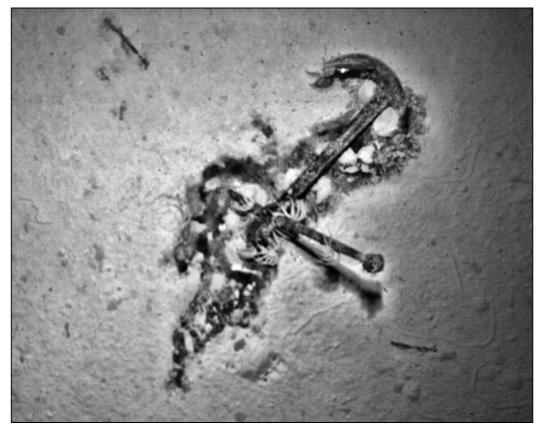
Anchor 2 is another large Admiralty-type, iron stocked anchor with stud link chain attached (Figure 14). The stock appears to be a folding type that has been rigged. As the stock is rigged for deployment, this is identified as the sheet anchor.

Figure 14 Anchor 2, Admiralty type anchor with iron stock (Fugro/ATSB).

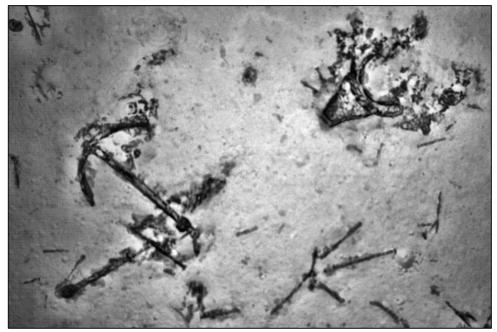
Anchor 3 is an Admiralty-type bower or kedge anchor of lighter size and construction to a best bower and sheet anchor, with a folding iron stock (Figure 15). A ring or shackle is visible though it is not clear if there is chain cable attached. A possible apron knee lying nearby may be an indication that part of the stempost, or sternpost is lying nearby.

Figure 15 Anchor 3 stream or kedge anchor with folding stock, possible apron knee at top right (Fugro/ATSB).

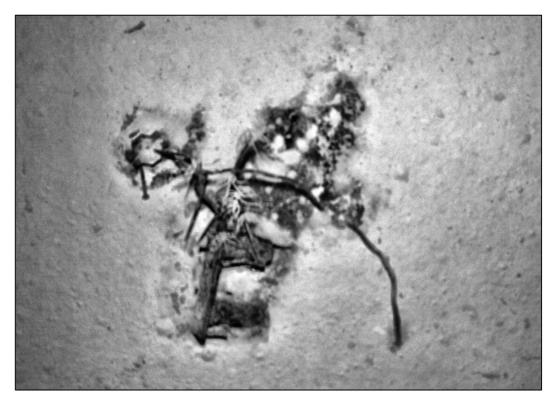
Figure 17 Windlass on IOS-001 site. A hexagonal-shaped bolted fitting is also apparent which may be for the pawl bitt that has deteriorated (Fugro/ATSB).

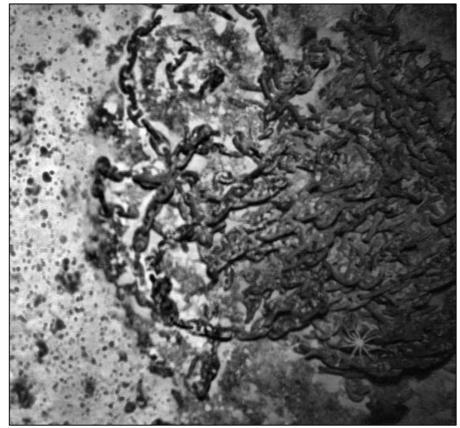
A mound of stud link chain cable lies 245m east from Anchor 2 (Figure 19). Chain mounds are typically found on late 19th century shipwrecks, with stud link chain used on merchant ships from as early as 1815 (Curryer 1999: 100). Chain mounds are a good indication of the bow/ forepeak of the vessel where chain cables for the anchors were stored below deck. That the chain mound is intact is a strong indication that the lower fore part of the vessel also sank intact in this area. The gauge of stud link chain is a more reliable method of estimating a shipwreck's tonnage than anchor size. However the small, sub-inch, differences in gauge are not considered to be reliable in this case, without the ability to take precise, manual measurements from original surfaces. As the anchors—normally stowed above deck in the bow area—and the majority of other structural parts of the vessel lie between 145 and 245m west of the chain mound, this is further evidence that the vessel did not sink to the bottom intact, and appears to have suffered some catastrophic event.

Figure 19 Detail of chain mound with stud links visible (Fugro/ATSB).

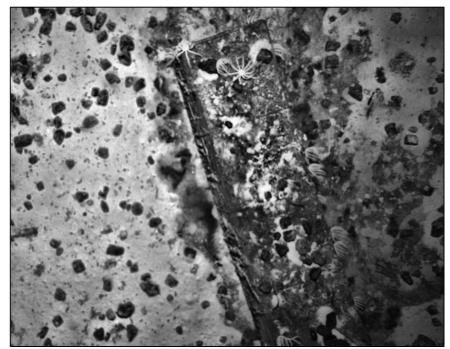
A large rectangular metal object of 6m length is the largest feature on the site (Figure 6, Figure 22), and is identified as a ship's iron water tank. Metal tanks were increasingly fitted to ships from around 1811 to store water, as well as perishable goods such as bread (Pearson 1992: 25). Remains of a similar large rectangular tank have been identified on the wreck of the 858 ton wooden barque *Stefano*, wrecked in 1875 near Point Cloates, Western Australia (Figure 23).

Figure 22 Rectangular iron water tank on IOS-001 site, with coal scattered around (Fugro/ATSB).

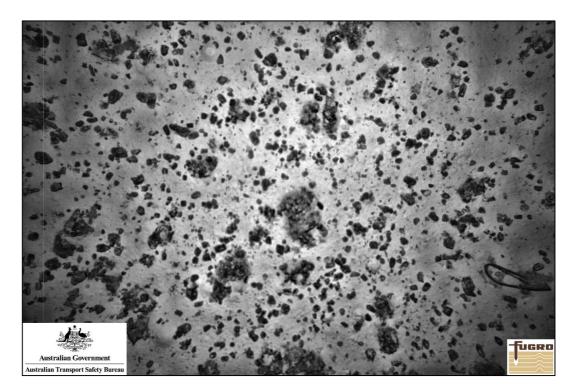
A large amount of coal is widely scattered over a 340 x 270m area of seabed, the extensive quantity indicating it is remains of the vessel's cargo.

Figure 25 Scattered remains of coal cargo on IOS-001 site (Fugro/ATSB).

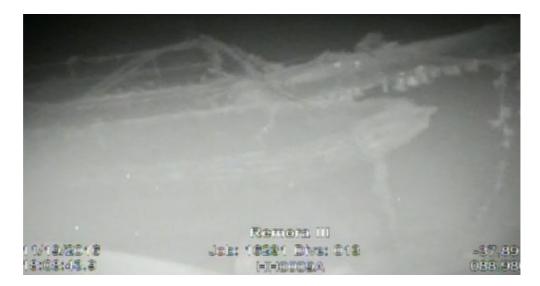
Figure 37 Starboard side of bow buried in seabed, with intact deck railings, clipper bow, beak-head and bowsprit (ATSB)

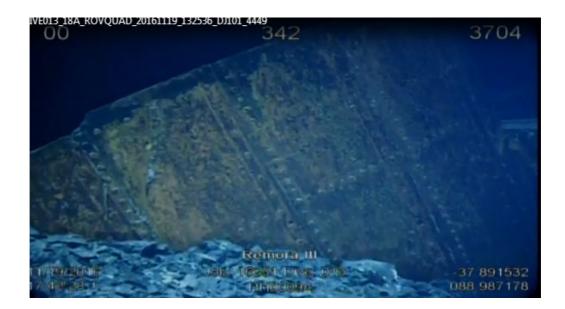
Figure 41 Iron hull plating showing riveted iron frames and hull plating, with remains of coal cargo visible in foreground (ATSB)

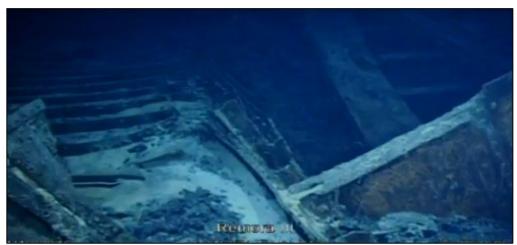
Figure 42 Hull buried in seabed, collapsed outer hull plating (left), collapsed deck (top right) and a bulkhead in the foreground (ATSB)

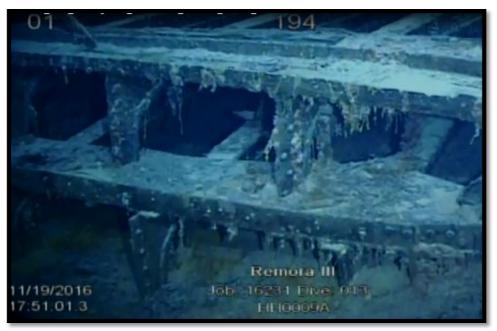
In the amidships area of the vessel the deck beams and stringers have collapsed almost exactly on top of each other, with the thinner hull plating entirely corroded away and missing (Figure 43).

Figure 43 Two decks collapsed on top of each other, with hull plating missing (ATSB)

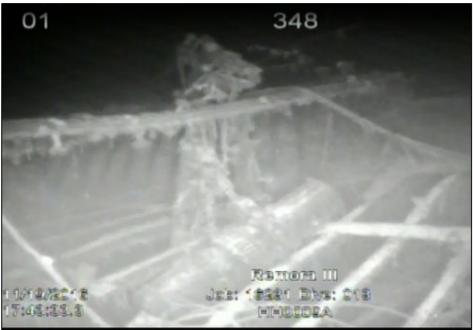
Figure 44 Collapsed iron windlass with chain connected to iron capstan on forecastle deck (ATSB)

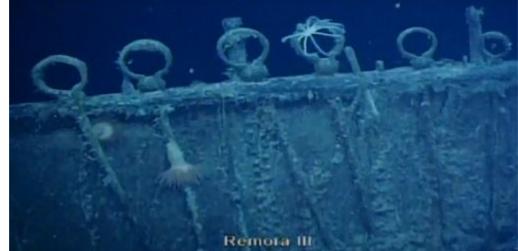
Figure 47 Intact hull with iron rigging chainplates for shrouds, with wooden deadeyes missing. A spider crab and anemone are visible (ATSB)

All timber has completely disappeared including timber deck planking and deadeyes (wooden pulley blocks usually made of *lignum vitae* and having a higher resistance to biological degradation) from the chain-plates (hull-mounted supports for the standing rigging/ shrouds) (. While much intact hull plating appears to be sound, in

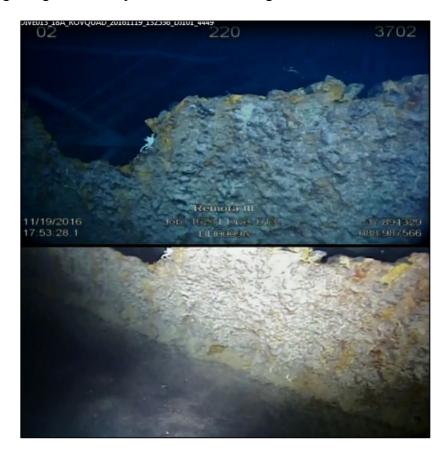
one area the hull plating shows evidence of ragged edges and extensive surface corrosion products, which may be an indication of heat or fire damage (Figure 48). This phenomenon has been observed on the HMAS *Sydney II* shipwreck relating to fires as a result of battle damage (McCarthy 2016: 209; Anderson & Bigourdan in McCarthy 2016: 316), and is relevant to discussion as to the possible cause of wrecking being a fire or explosion in the coal cargo.

Figure 48 Hull plating surfaces showing extensive corrosion products, possibly related to heat/ fire damage (ATSB)
