First port in the Northwest
A maritime archaeological survey of Cossack
25-30 June 2012

Report—Department of Maritime Archaeology,
Western Australian Museum— No. 297

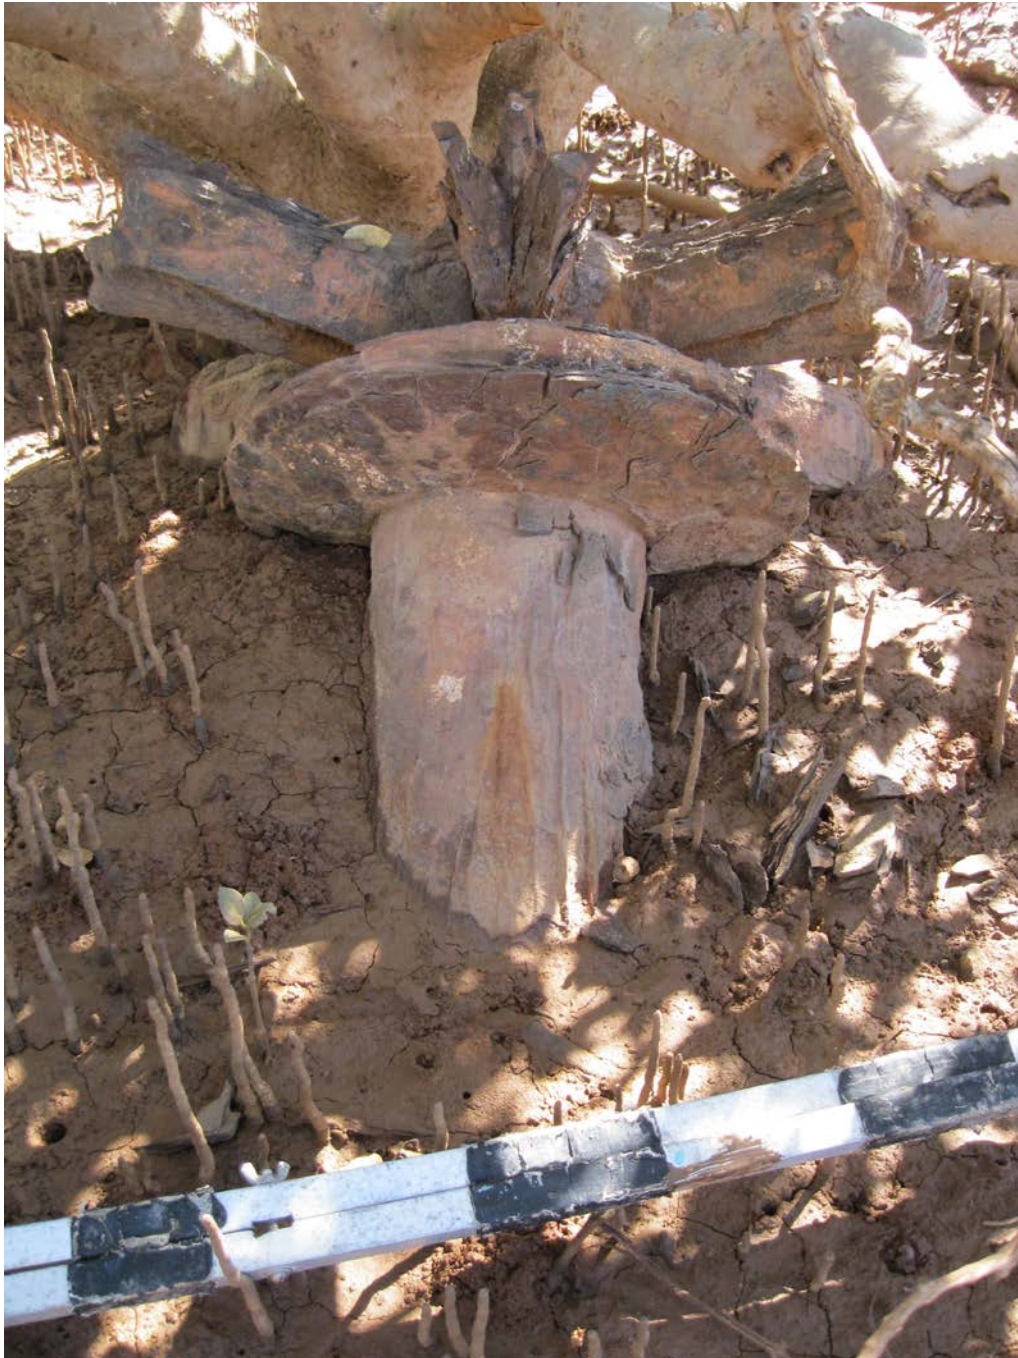
Figure 14. Corroded remains of windlass (Feature CK45) at Upper Landing.

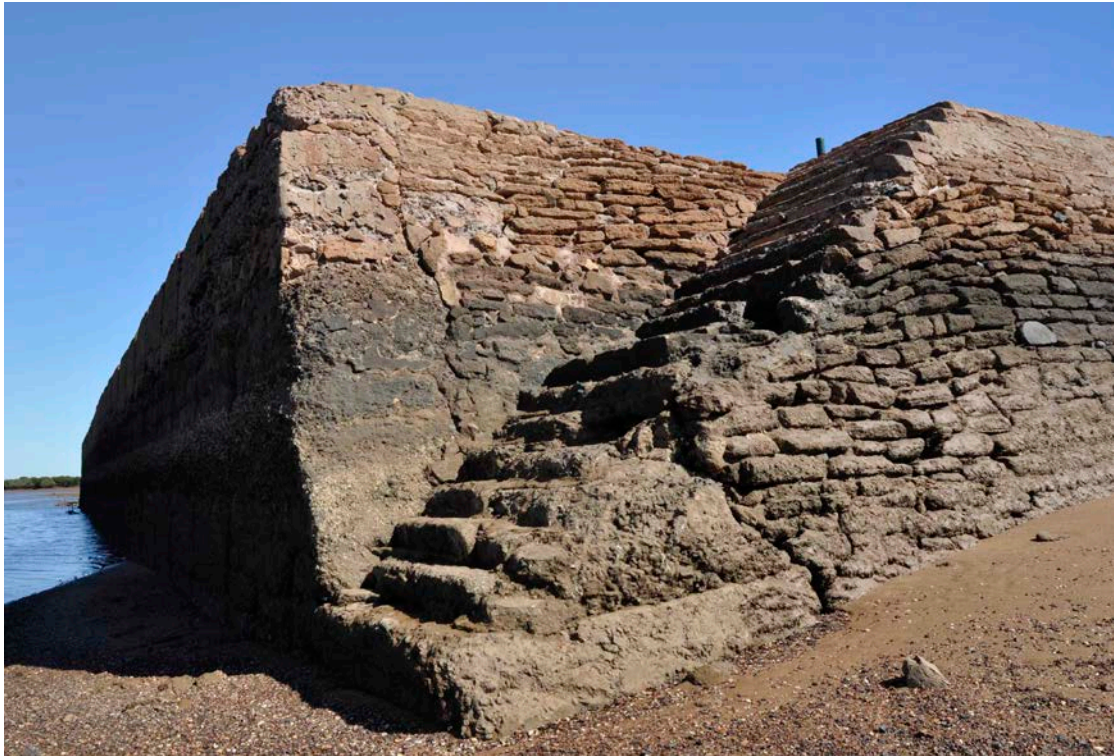
Figure 18. Steps on northern side of Cossack quay at low tide in 2012.

parts are eroded, and a large structural crack is evident (Figure 18). A modern metal pontoon jetty has been added to the south wall of the quay for use by small boats. An iron stock harness most likely dating to the late 19th/ early 20th century is found abandoned in the mangroves on the southern side of the quay. A boat-based photographic survey to record the condition of the stone quay wall was undertaken.

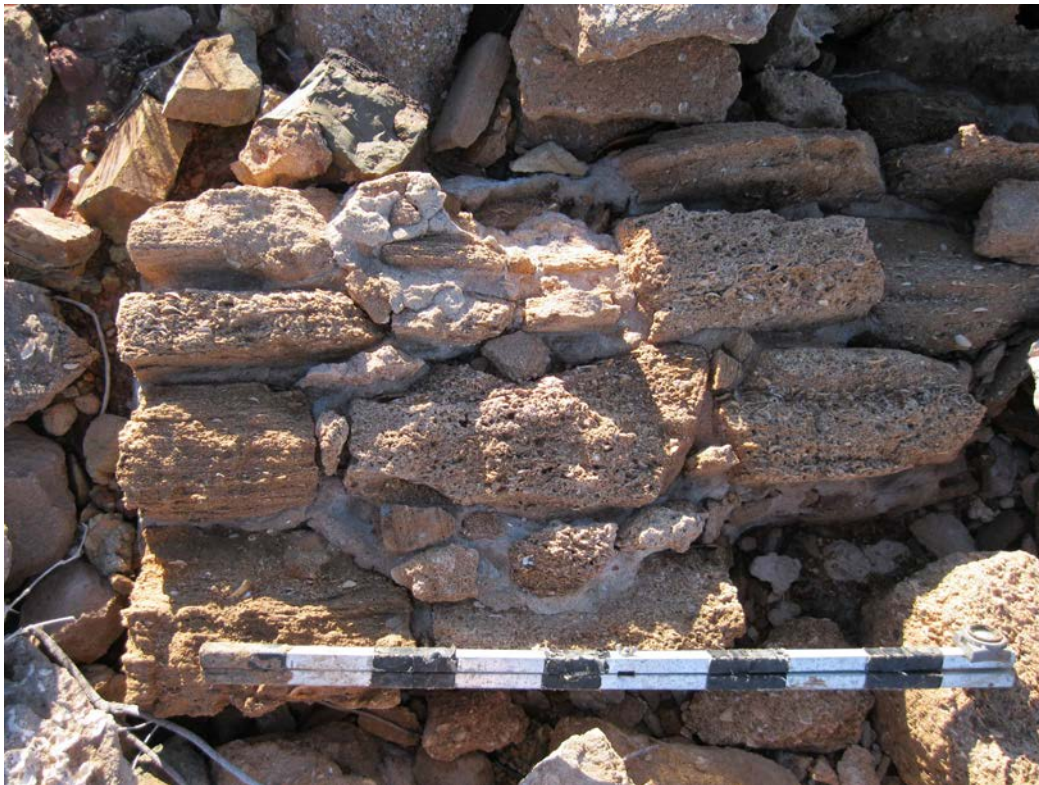
Figure 20. Mortar repair on Cossack dry stone retaining wall/ seawall.

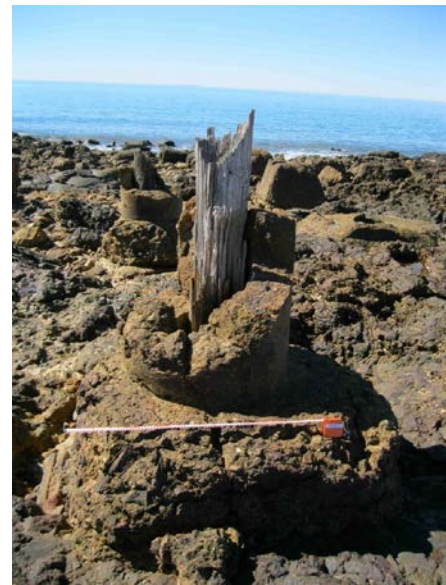
Figure 26. Point Samson jetty piles in inter-tidal zone, June 2012.

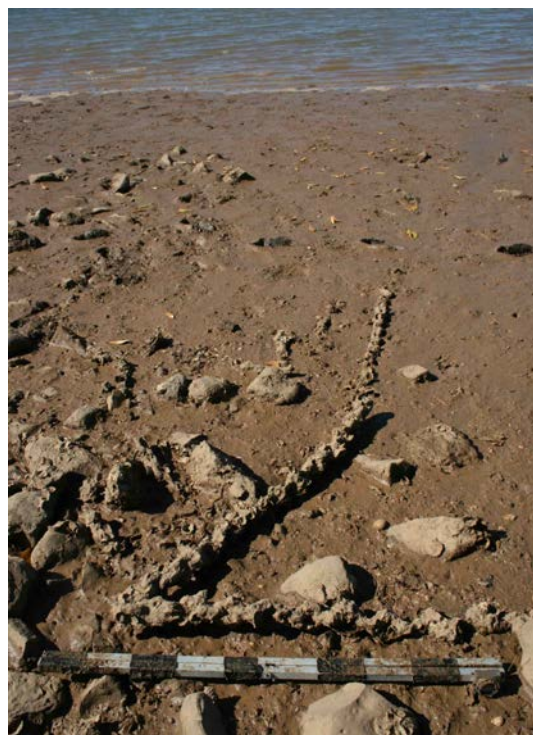
Figure 29. Corroded mooring chains are evident along the length of Butcher Inlet foreshore.

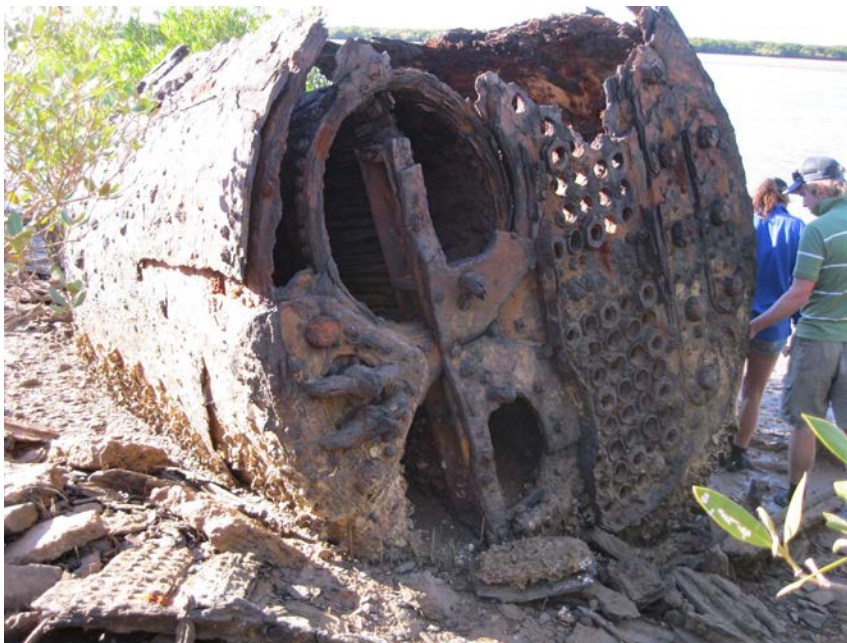
Figure 52. SS *Silver Star*'s corroded boiler rolled onto its port side showing two furnaces, collapsed furnace doors and boiler tubes.

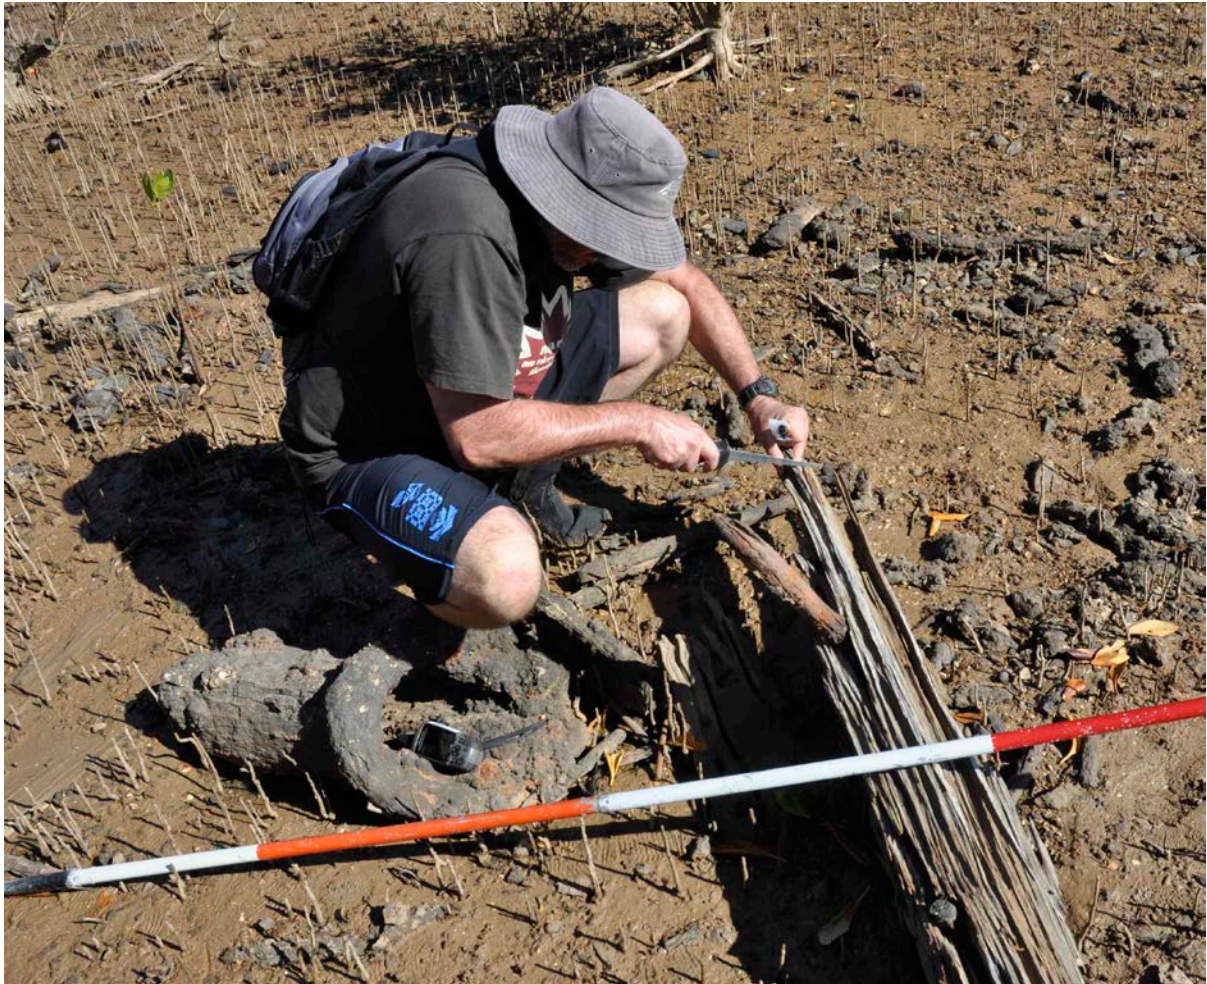
Figure 71. Cutting a timber sample from the keel of a large wooden lighter Cossack UNID 4. Note large iron hawse pipe indicating the bow area, and scattered pieces of corroded chain moorings.
