Pakington whaling station inspection, Port Gregory

12 June 2018

Report—Department of Maritime Archaeology,

Western Australian Museum—No. 328

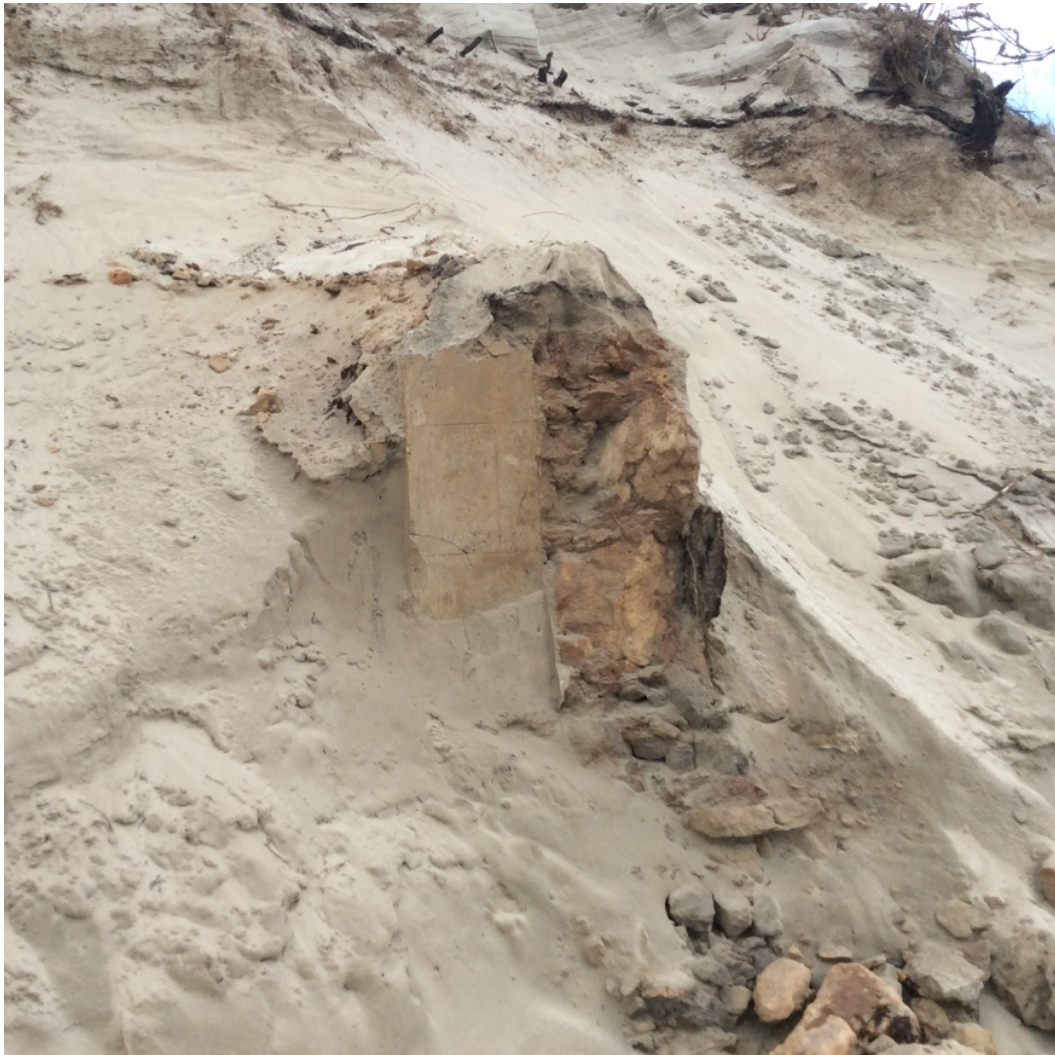
Figure 1 Stone wall exposed in foredune following storms in May 2018. Note render with tuck-pointing on front edge (Greg Horsman)

Comparison of photographs taken prior to, and during this inspection clearly show that there has been further significant erosion in the intervening two week period. Figure 1 shows rendering on the front edge of Wall A which was intact when initially exposed, but has subsequently collapsed. Given that the fore-dune has eroded significantly further since 28 May 2018, and is steep and continuing to collapse with more wall structure exposed, the structure and any associated artefacts are currently at risk from further damage/ collapse due to storm erosion.

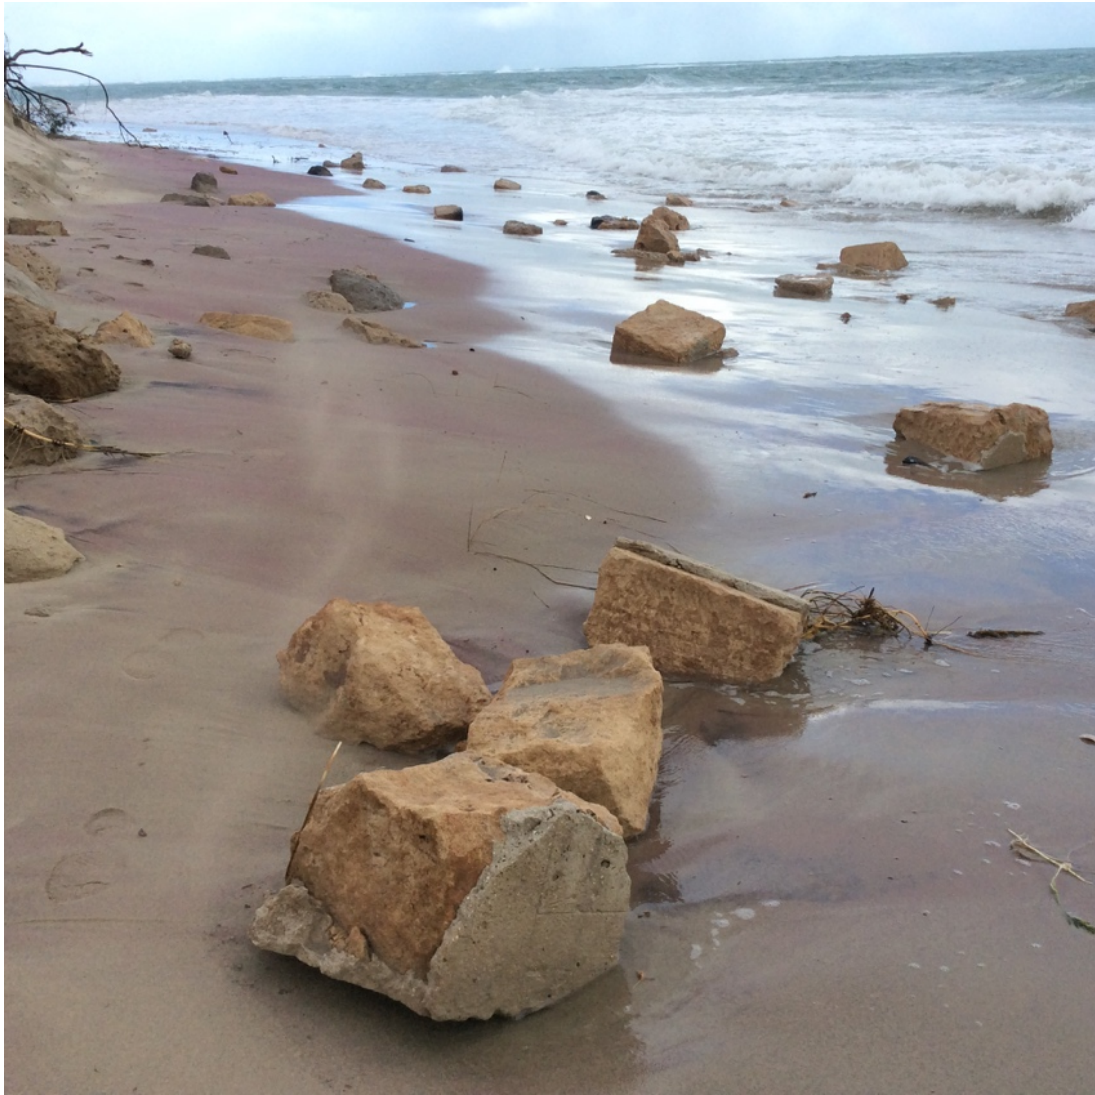
Figure 2 Dressed stone building blocks with render eroded from foredune, and lying exposed and scattered on beach in May 2018 (Greg Horsman)

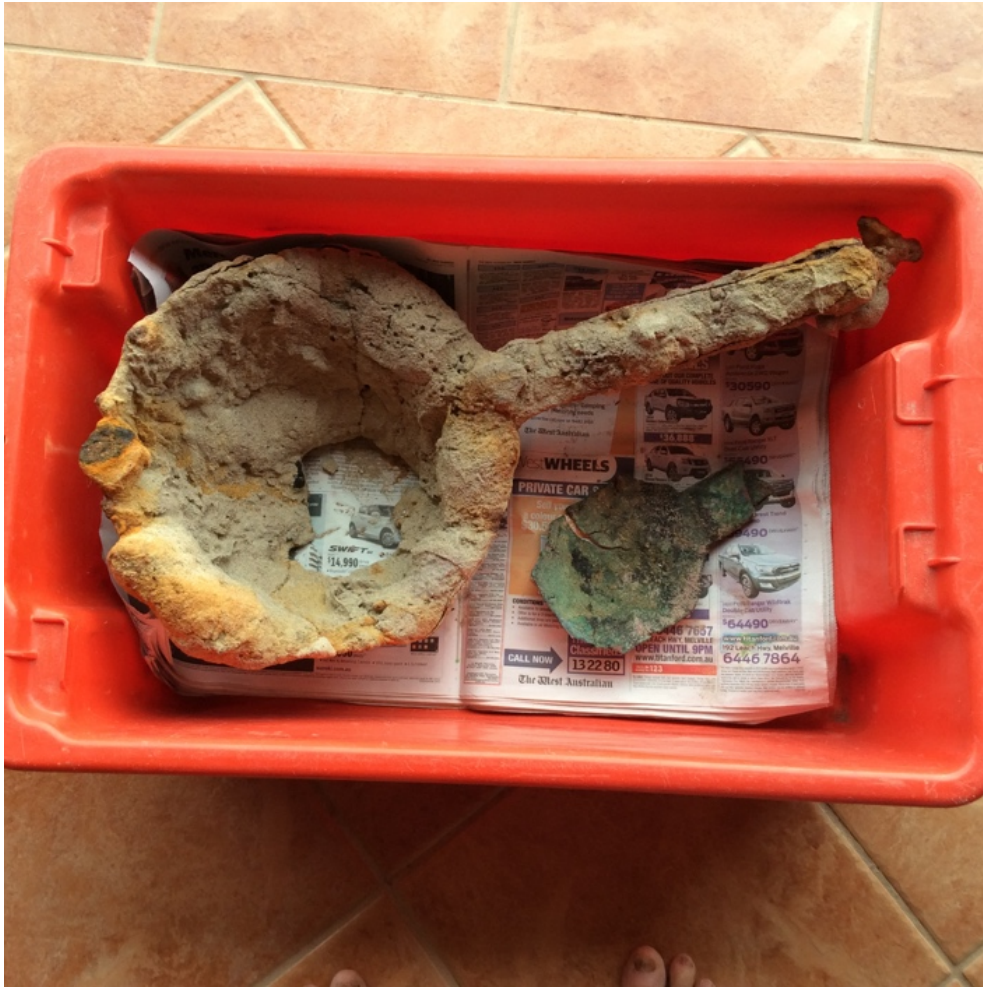
Figure 3 Concreted iron whale oil ladle and copper 'scrap' ladle recovered in May 2018 (Greg Horsman)

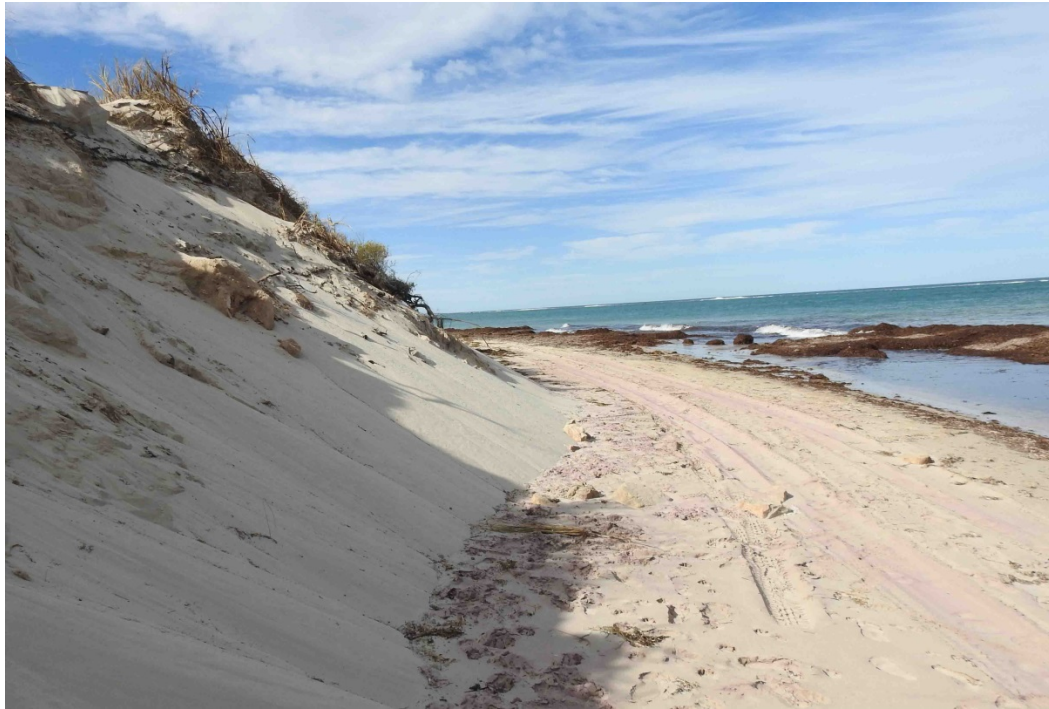
Figure 4 Location of wall in fore-dune and eroded stone blocks on beach reburied by collapsing dune sand cover on 30 May 2018, view south (Howard Gray/ WA Museum)

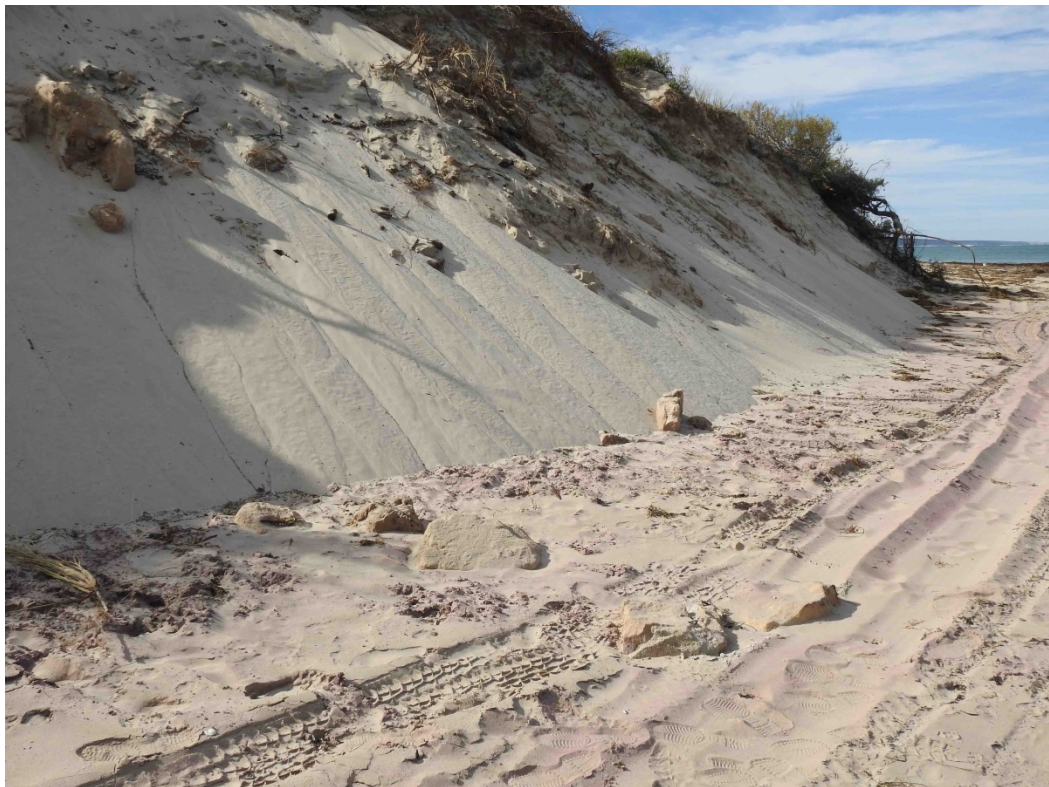
Figure 5 Location of wall in fore-dune and eroded stone blocks on beach reburied by collapsing dune sand cover on 30 May 2018, view south-east (Howard Gray/ WA Museum)

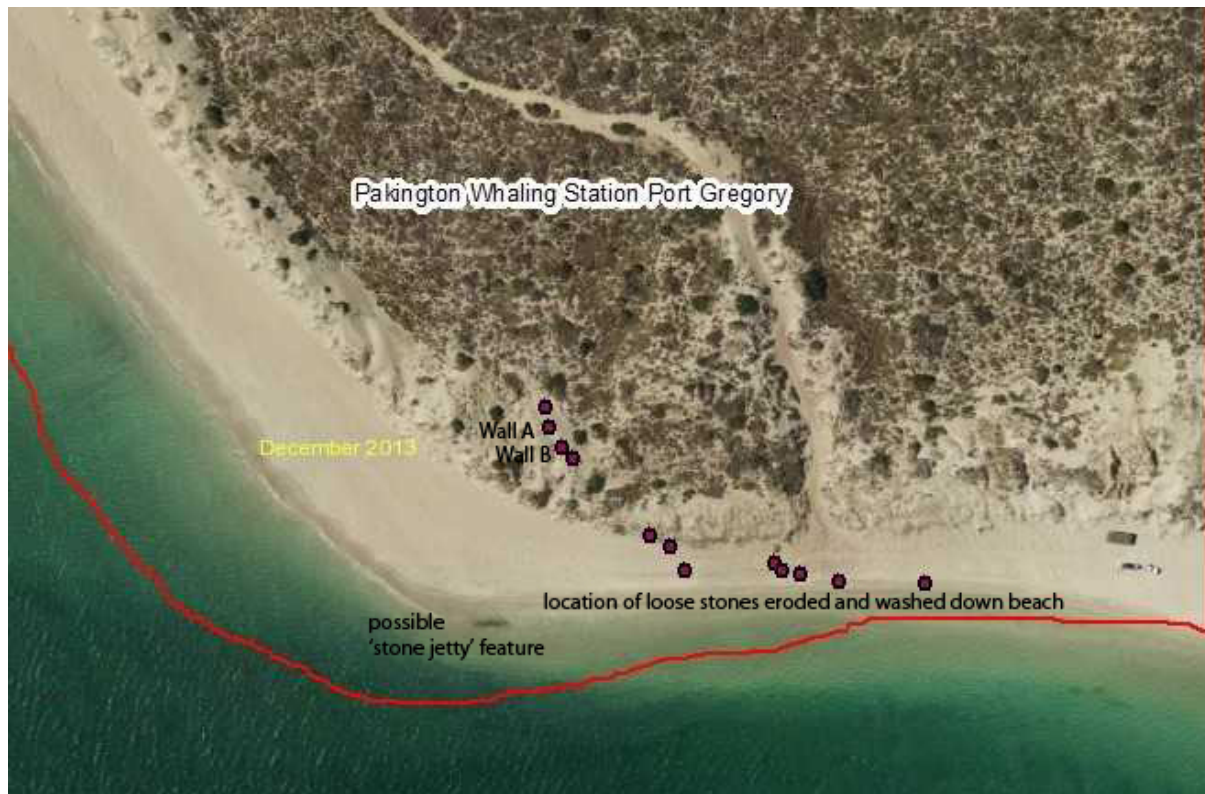
Figure 6 GIS map showing Pakington whaling station features recorded on 12 June 2018 overlaid onto December 2013 aerial photograph, indicating the extent of dune erosion where Walls A and B are currently exposed. The possible 'stone jetty' feature on the beach is now approximately 20-30m offshore (WA Museum)

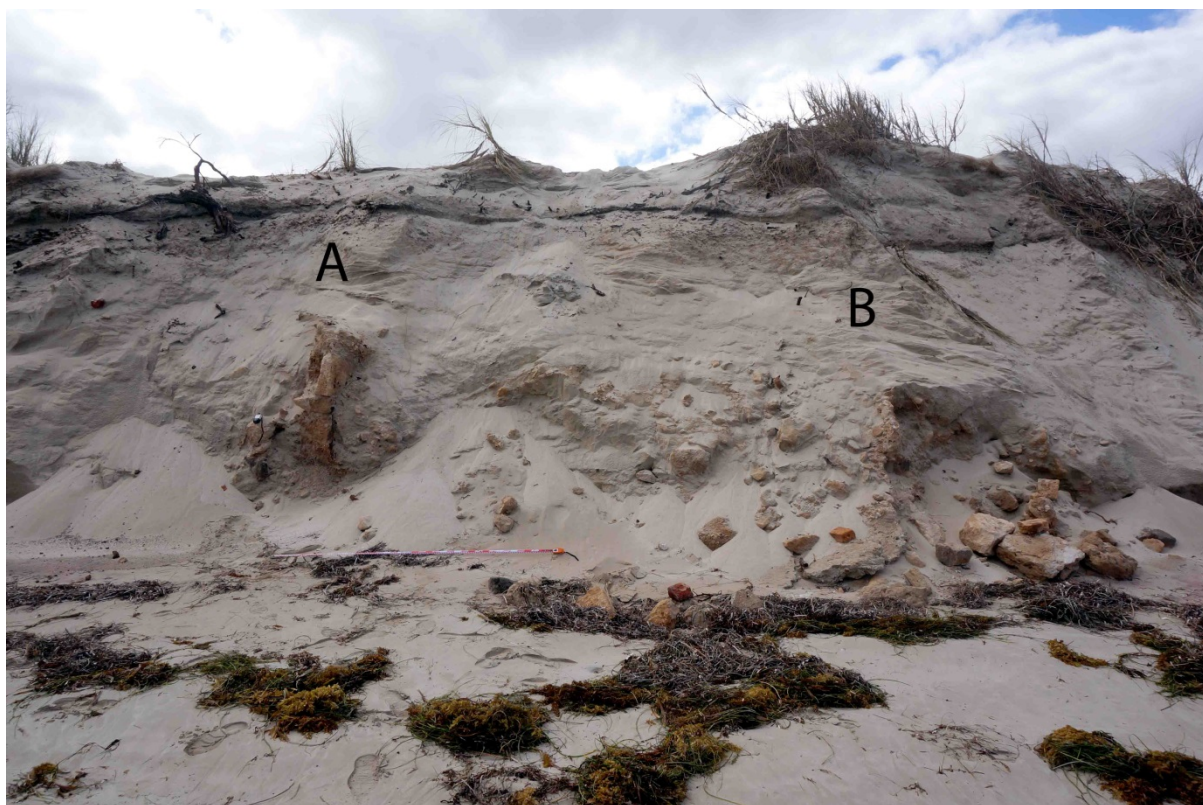
Wall A is the northernmost section consisting of partial remains of an intact standing stone wall constructed of cemented dressed limestone, handmade bricks (or fragments of) and rubble 1.76m in height above the high water mark (HWM). The wall is broken/ collapsed at the top, with dimensions of 40cm thickness at the top section and original thickness of 76cm (indicated by render on both sides) across at the lower section.

Figure 7 View east showing walls A and B, scale 2 metres (Ross Anderson/ WA Museum)

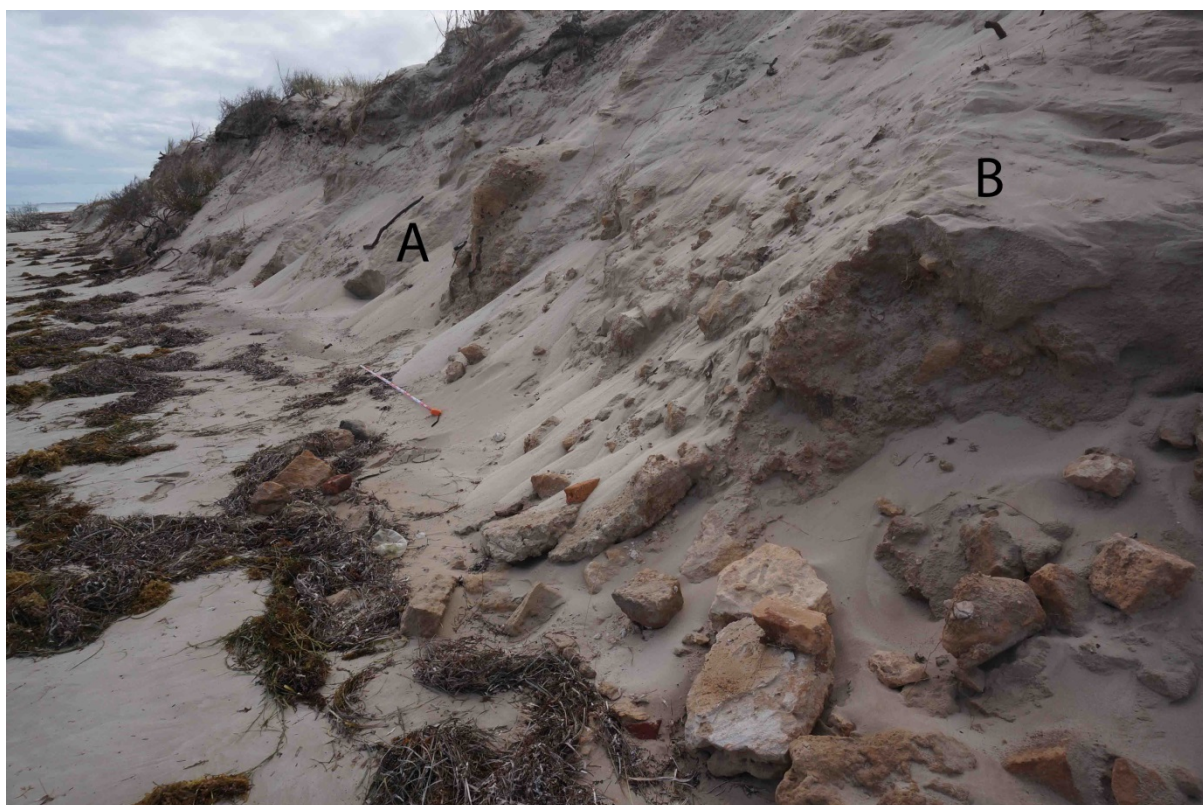
Figure 8 View north showing walls A and B, scale 2 metres (Ross Anderson/ WA Museum)

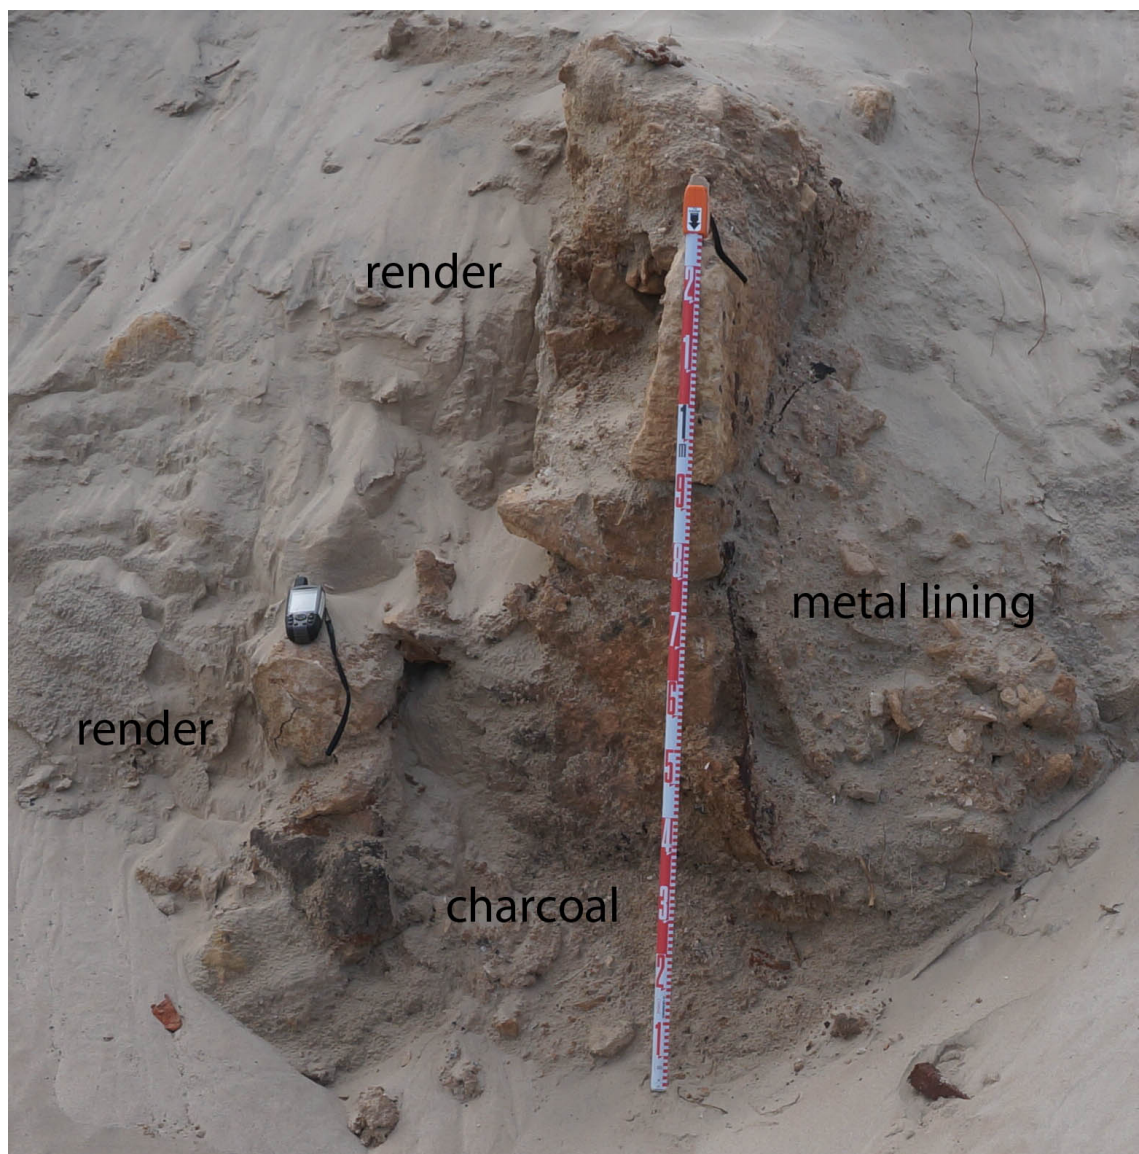
The wall is thinner at its top section, and is rendered and tuck-pointed on the northern side. The thicker, lower part of the wall is also rendered and tuck-pointed. The southern side of wall A has a thin metal (iron) plate lining/ jacket or covering (Figure 9, Figure 10). Alternatively it may be the remains of a metal oil cooling tank. A piece of hoop iron was sitting loose on top of the wall. A loose thin piece of metal with a corner, possibly remains of a tin or else related to the iron lining was sitting loose next to the metal lining of the wall. Charcoal was visible in a section at the base of wall A about 40cm above HWM (Figure 9).

Figure 9 Detail of wall A construction, view east, scale 1.25 metres (Ross Anderson/ WA Museum)

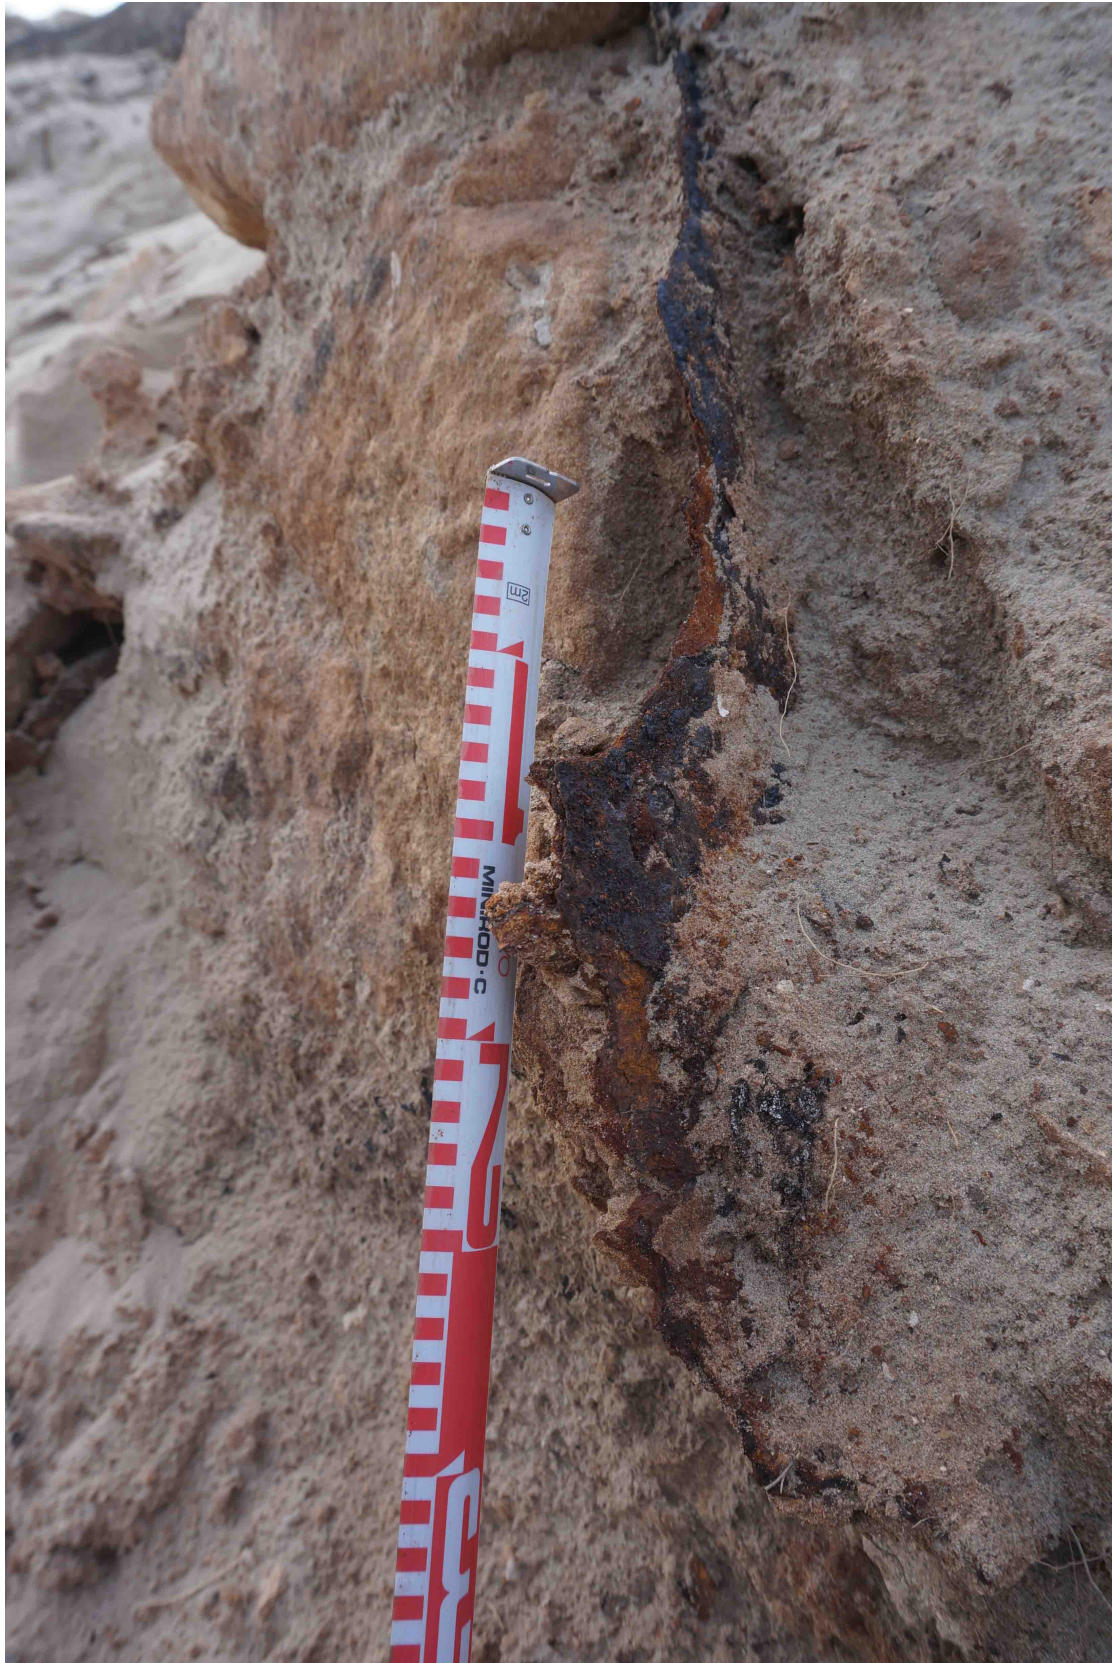
Figure 10 Detail of metal lining on south side of wall A, view north (Ross Anderson/ WA Museum)

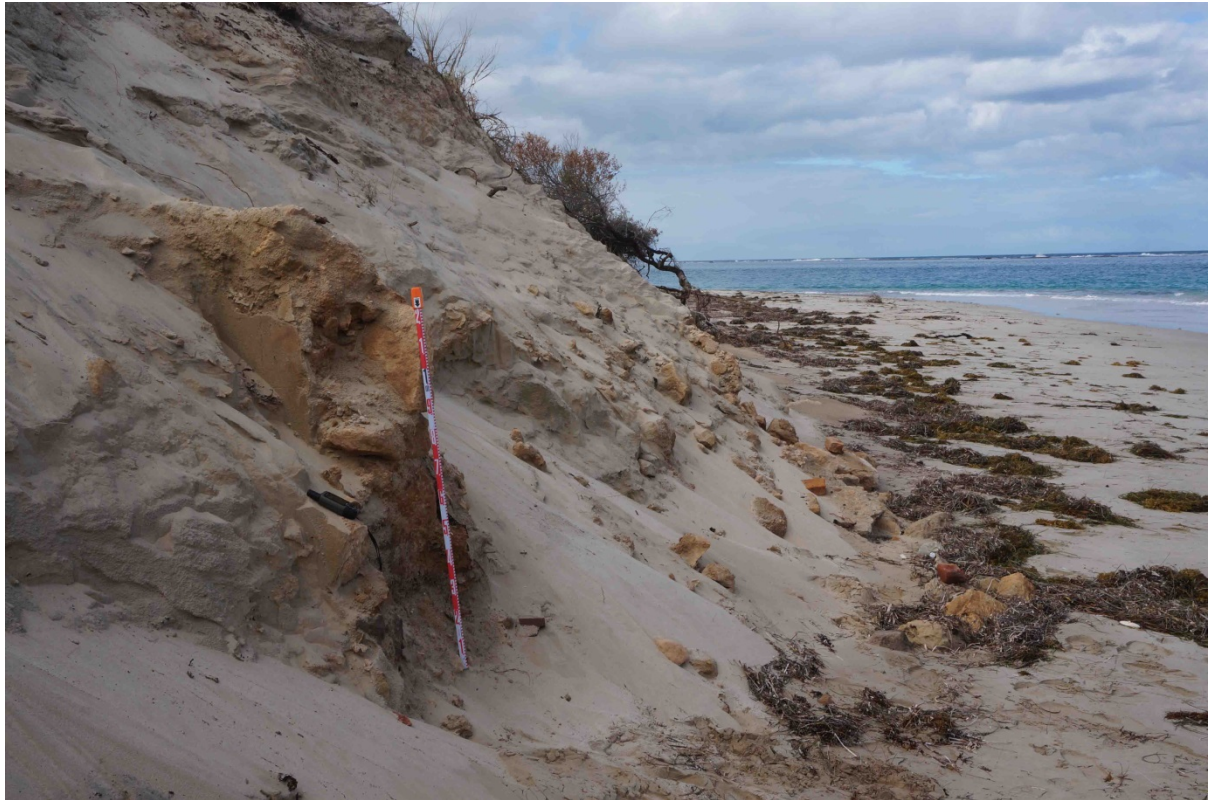
Figure 11 Wall A view south, scale length 1.2 m (Ross Anderson/ WA Museum)

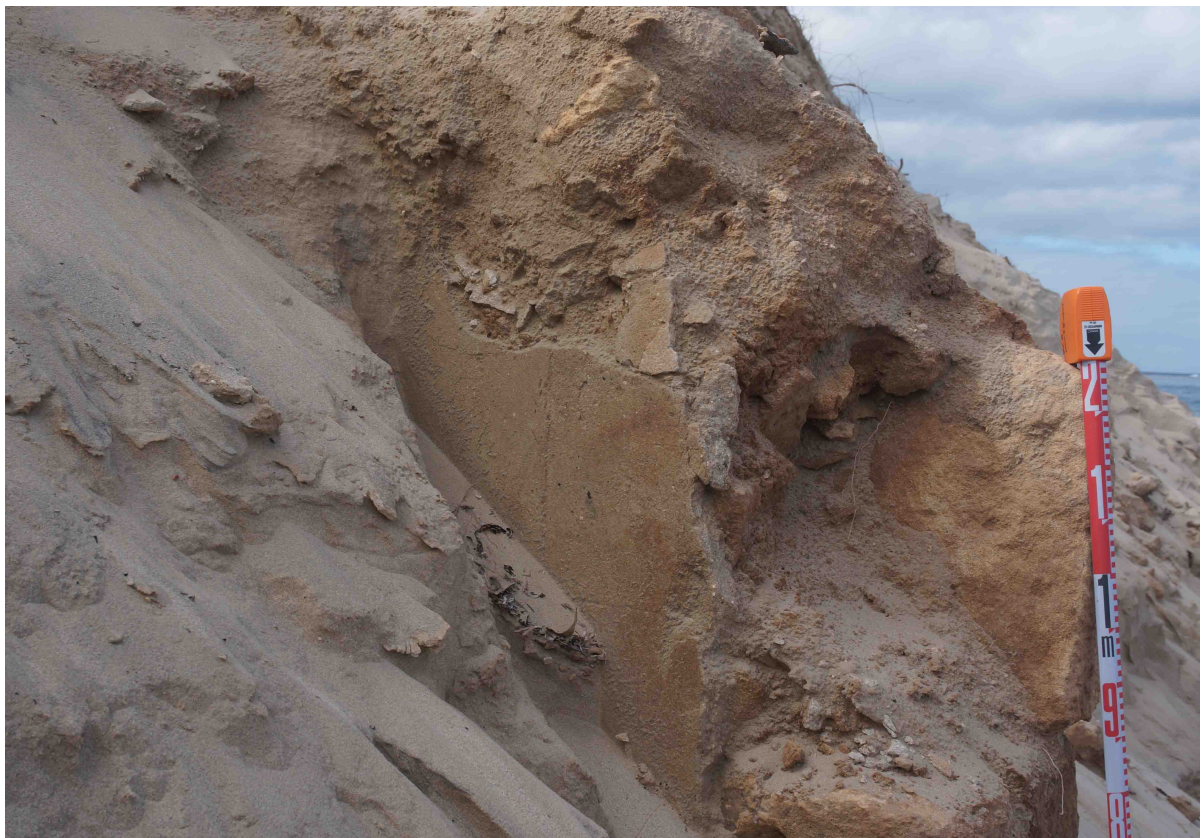
Figure 12 Detail of rendering and tuck-pointing on wall A northern side, view south (Ross Anderson/ WA Museum)

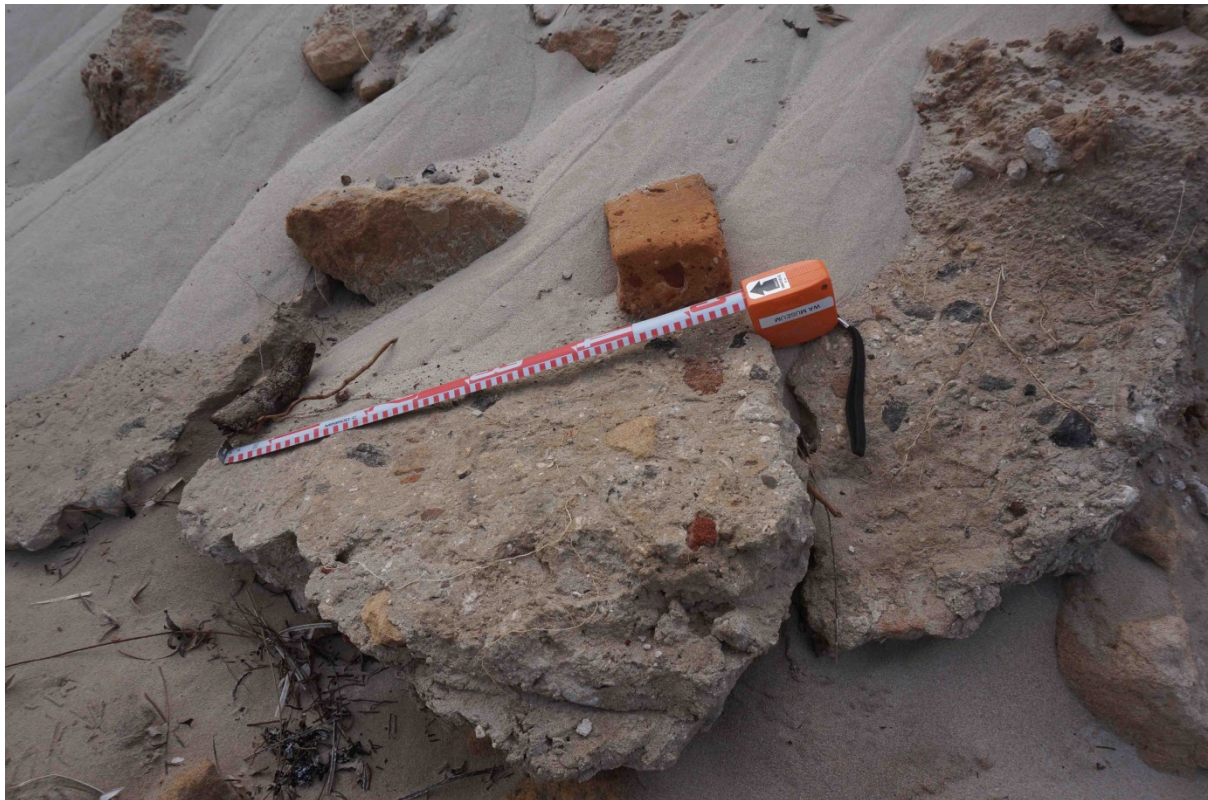
Figure 13 Collapsed cement floor and hand-made brick (Ross Anderson/ WA Museum)

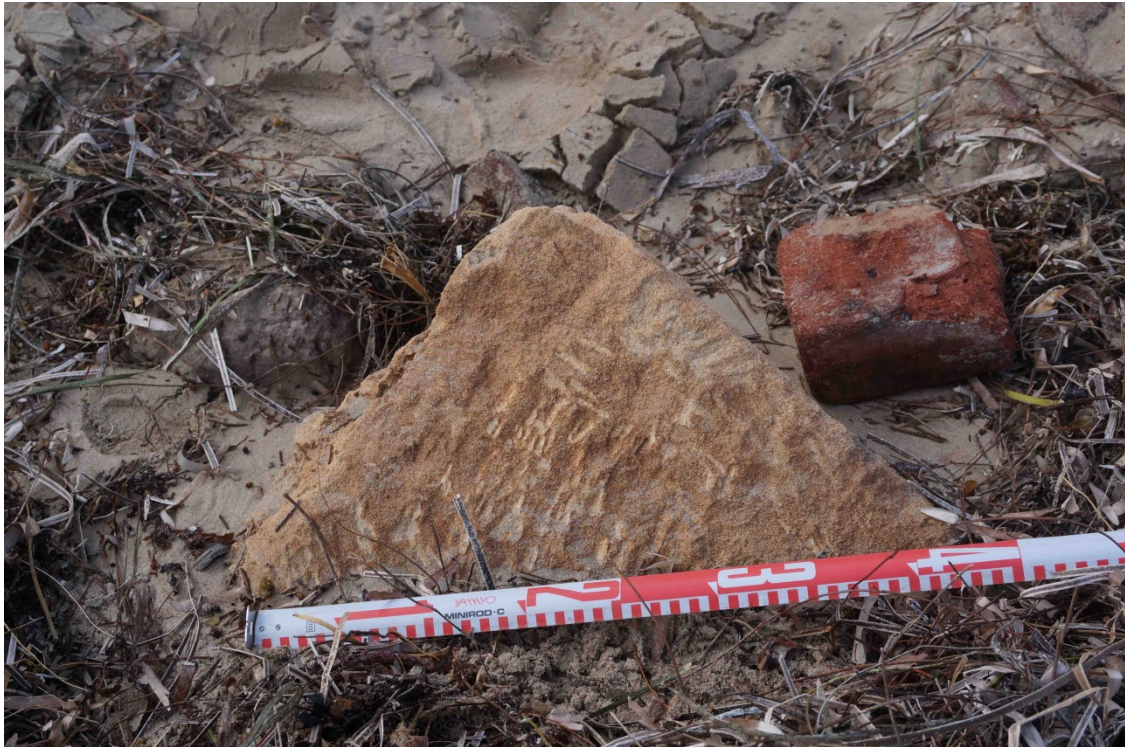
Figure 14 Dressed stone with broken hand-made brick in area of rubble collapse (Ross Anderson/ WA Museum)

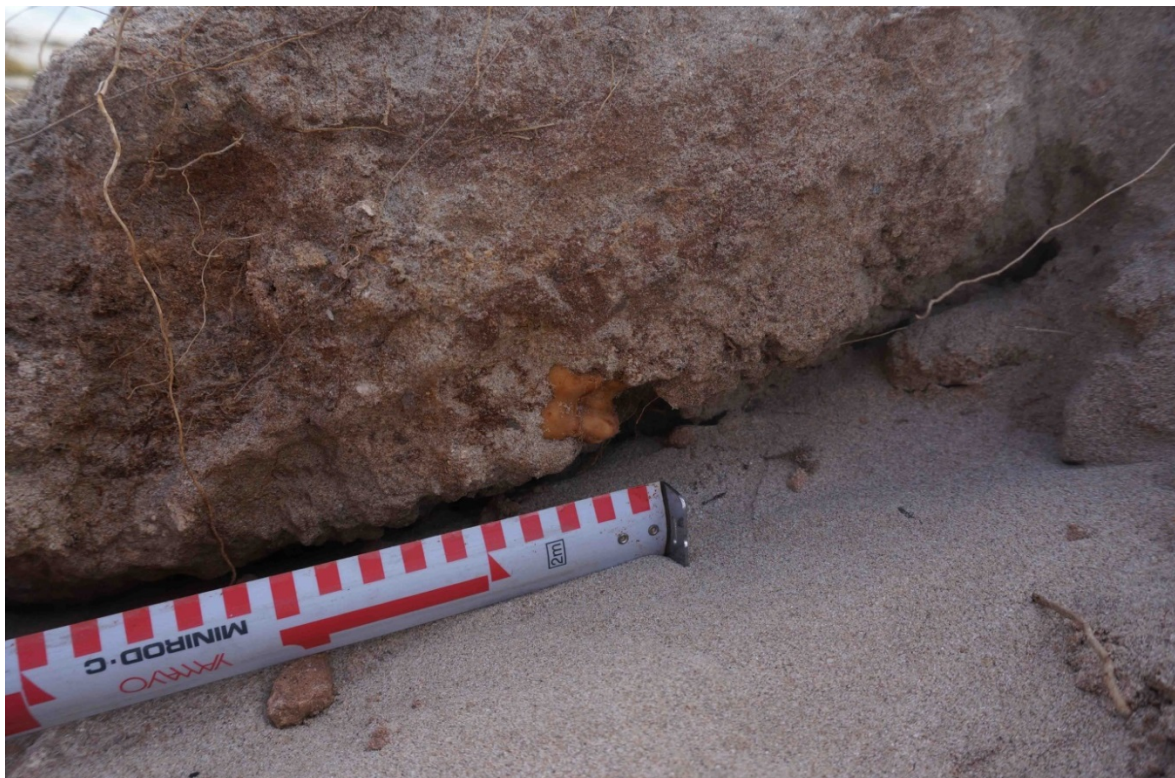
Figure 15 Bone embedded in base of cement floor (Ross Anderson/ WA Museum)

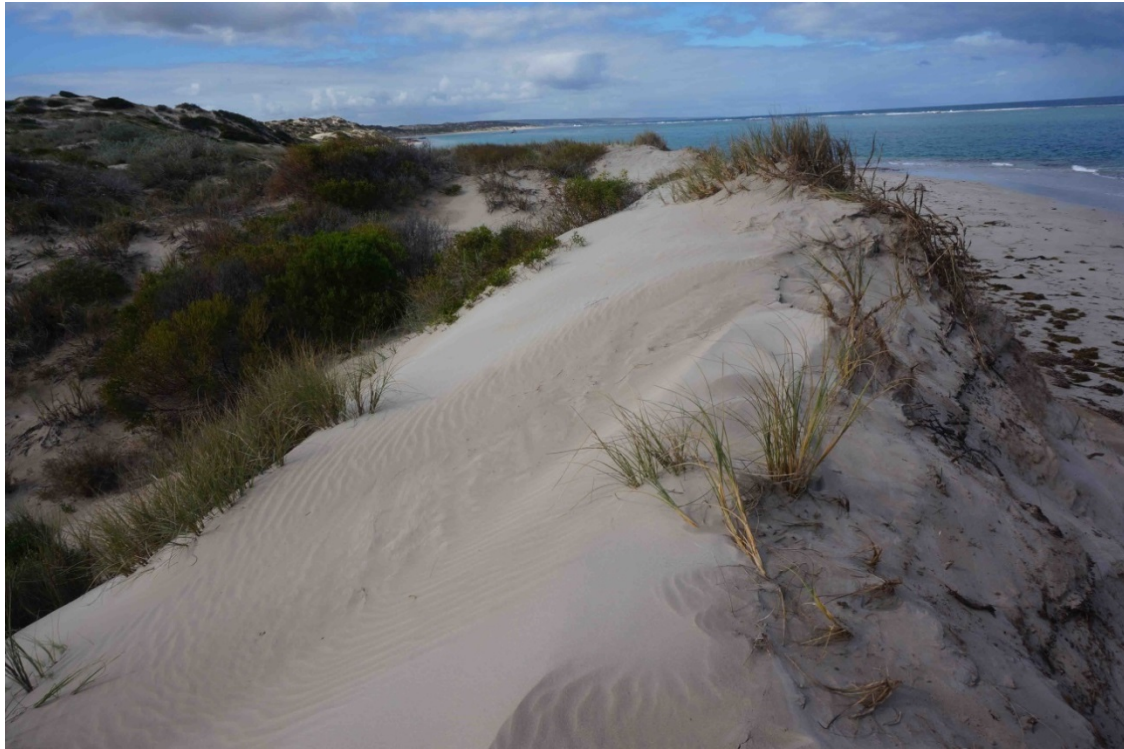
The fore-dune is currently a steeply-fronted and slope-backed parabolic dune (Figure 17). The top and rear of the dune were inspected for any further signs of structure or artefacts, with none seen.

Figure 17 View of top and rear of foredune in area of structure (Ross Anderson/ WA Museum)

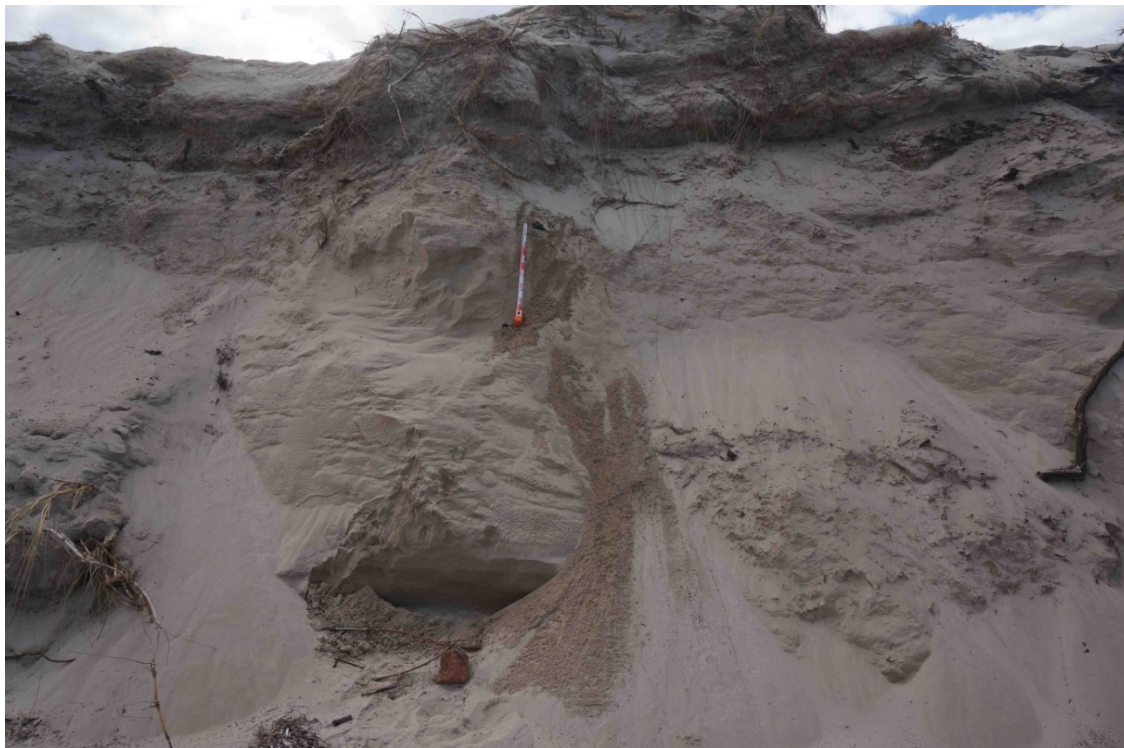
Of interest were two broken handmade bricks observed eroding out of the dune both at a height of 2.0m above HWM—higher than the exposed, visible wall structures—4.8m north of wall A (Figure 18). One brick with evidence of burning was recovered as a sample (Figure 20). If the bricks are from an upper part of the structure since collapsed, they could be possible evidence for a fire which reportedly destroyed Captain Sanford's try-works in the 1858 season (*The Perth Gazette and Western Australian Journal*, 13/8/1858: 2).

Figure 18 Top of scale located next to burnt brick eroding out of top of collapsing sand dune (Ross Anderson/ WA Museum)

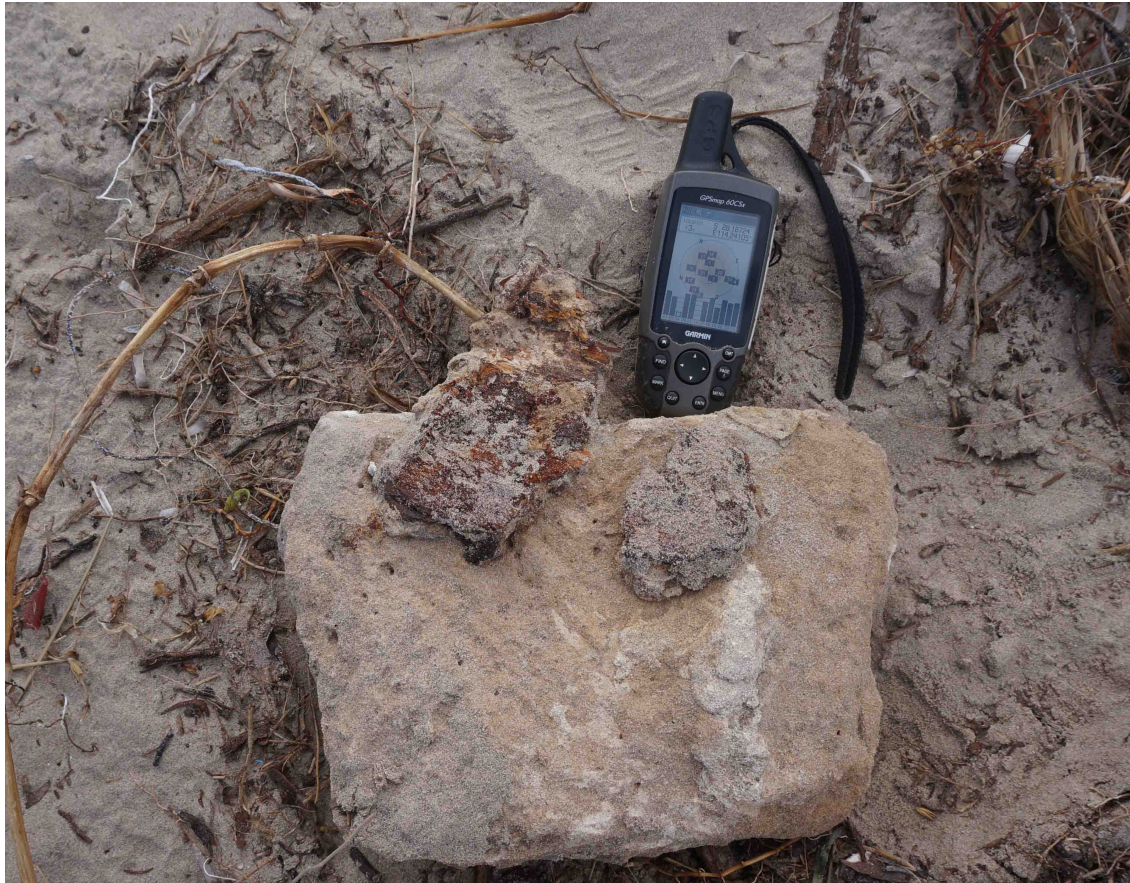
A number of large, loose stones including dressed stones—all limestone—are scattered southwards down the beach between the walls and south of the 4WD track. One dressed stone had iron/ concretion attached (Figure 19). These appear to have originally been part of the structure that were eroded and redeposited southwards as the result of the recent storm events.

Figure 19 Dressed stone with iron concretion attached lying on beach south of structure (Ross Anderson/ WA Museum)

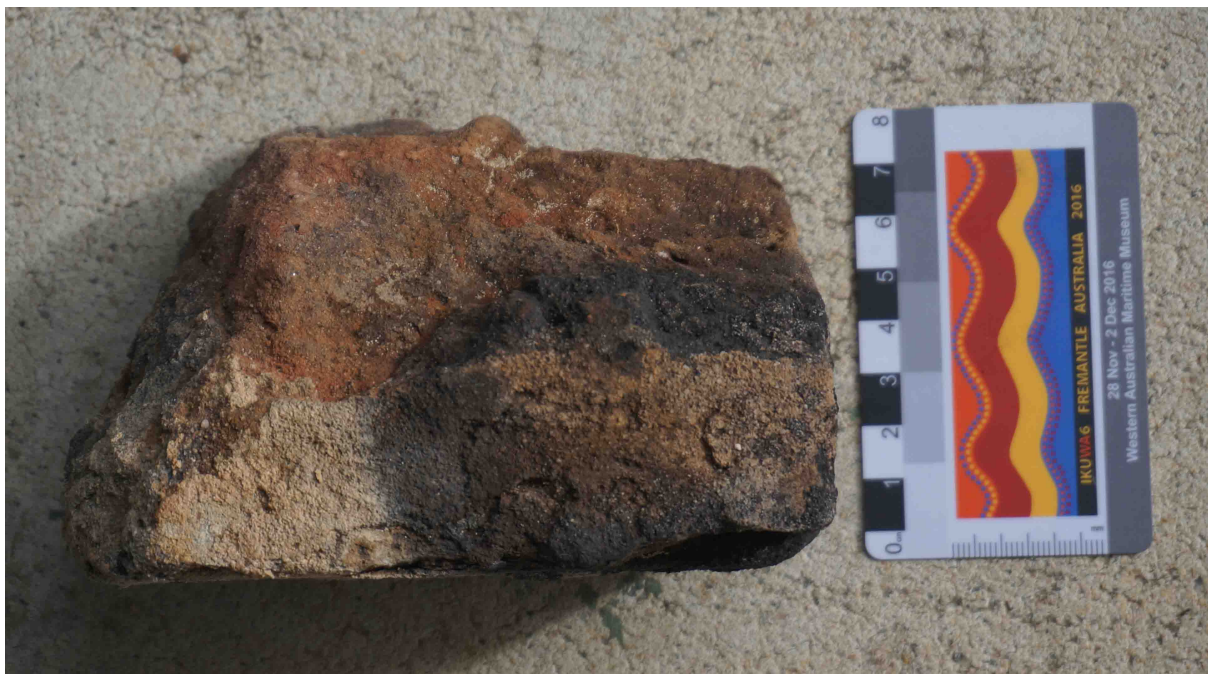
Figure 20 Burnt brick sample (Ross Anderson/ WA Museum)

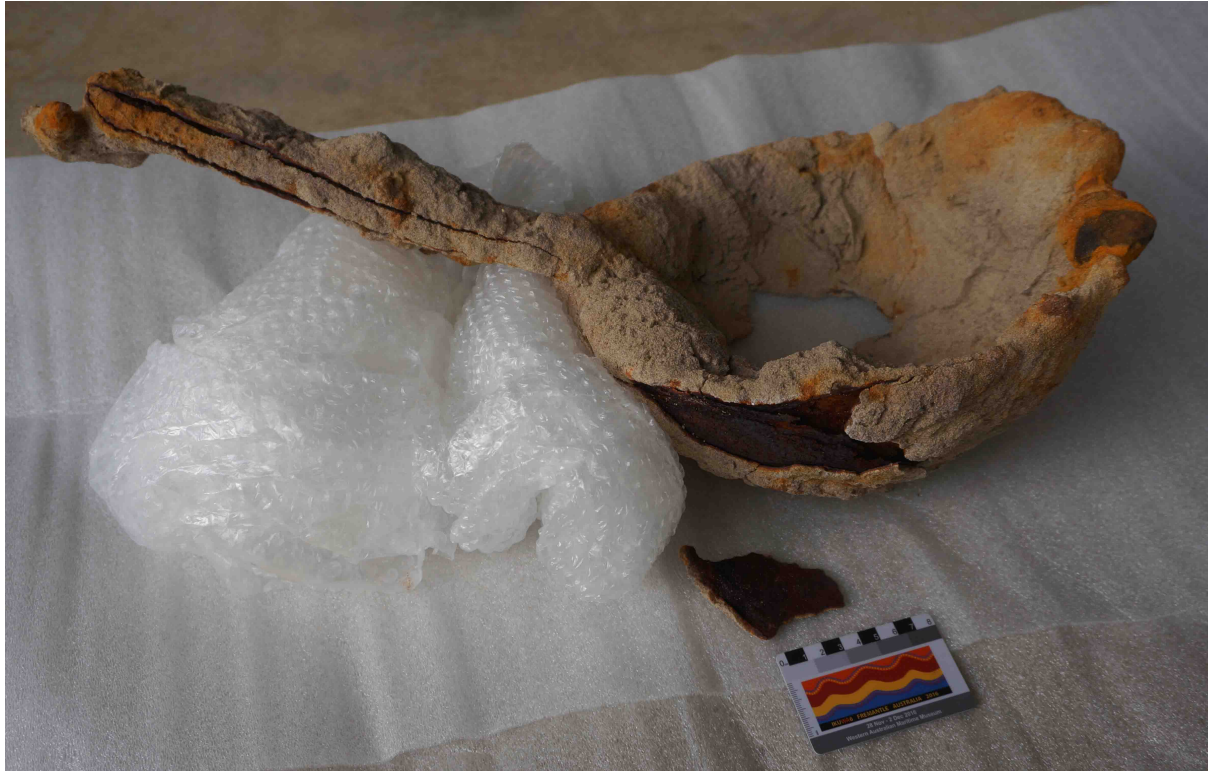
were a large 30cm diameter concreted iron whale oil ladle in a fragile condition, and a smaller 13cm by 13cm ladle made of worked copper sheet, such as would be used for removing scrap blubber from a try-pot during the trying out process. The large iron oil ladle appeared to have been a mass manufactured item, while the smaller ladle appears to have been simply made using materials to hand i.e. copper sheet.

Figure 21 Large 30cm diameter concreted iron whale oil ladle (Ross Anderson/ WA Museum)

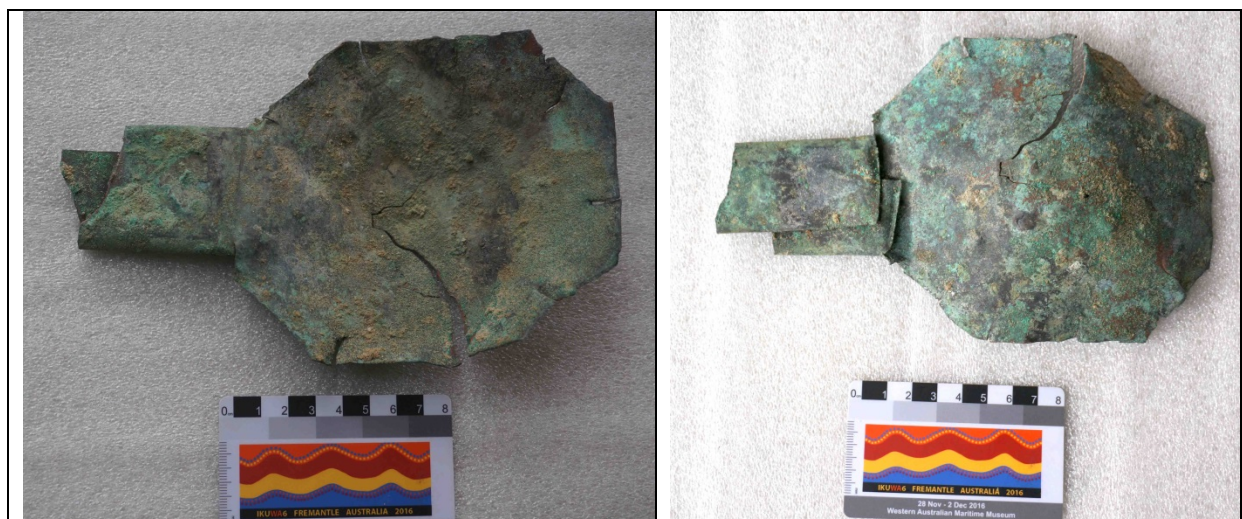
Figure 22 Top and reverse sides of scrap ladle manufactured from copper sheet
