Flat Rock Unidentified site inspection and artefact analysis

**Report—Department of Maritime Archaeology,
Western Australian Museum—No. 294**

November 2015

Ross Anderson

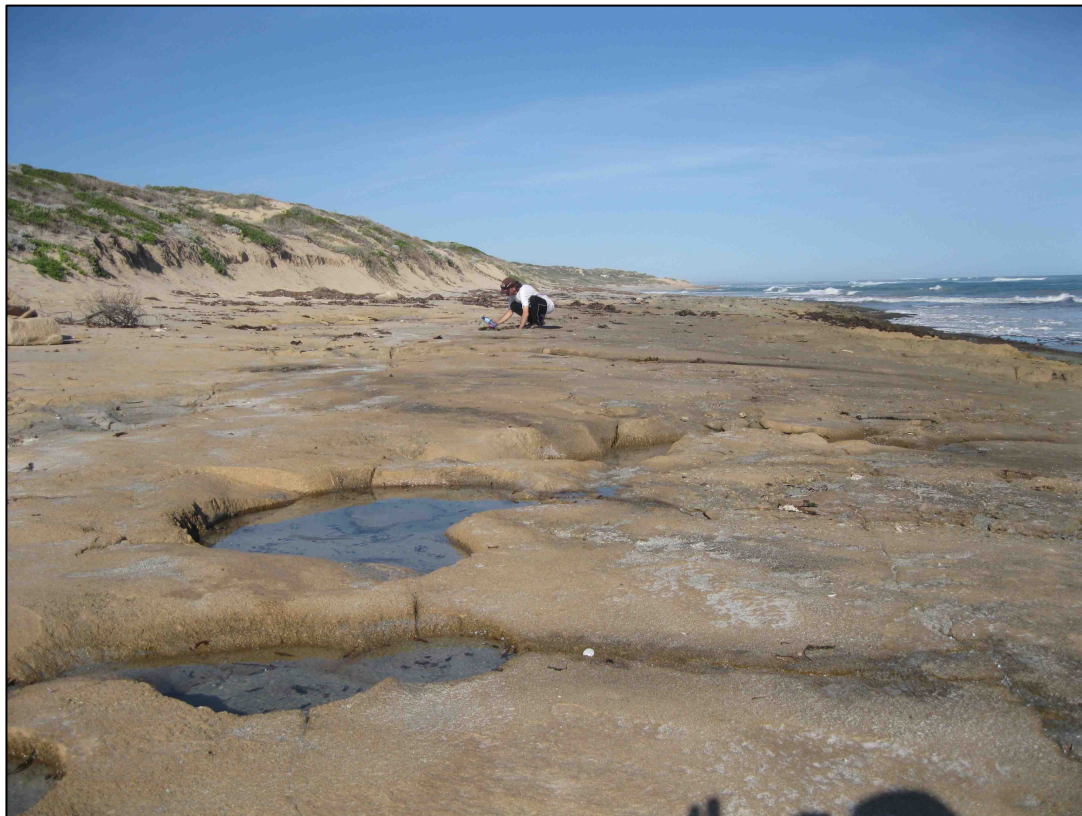
Figure 3 Limestone beach platform north of car park at Flat Rock showing rock holes, view south (R. Anderson/ WA Museum)

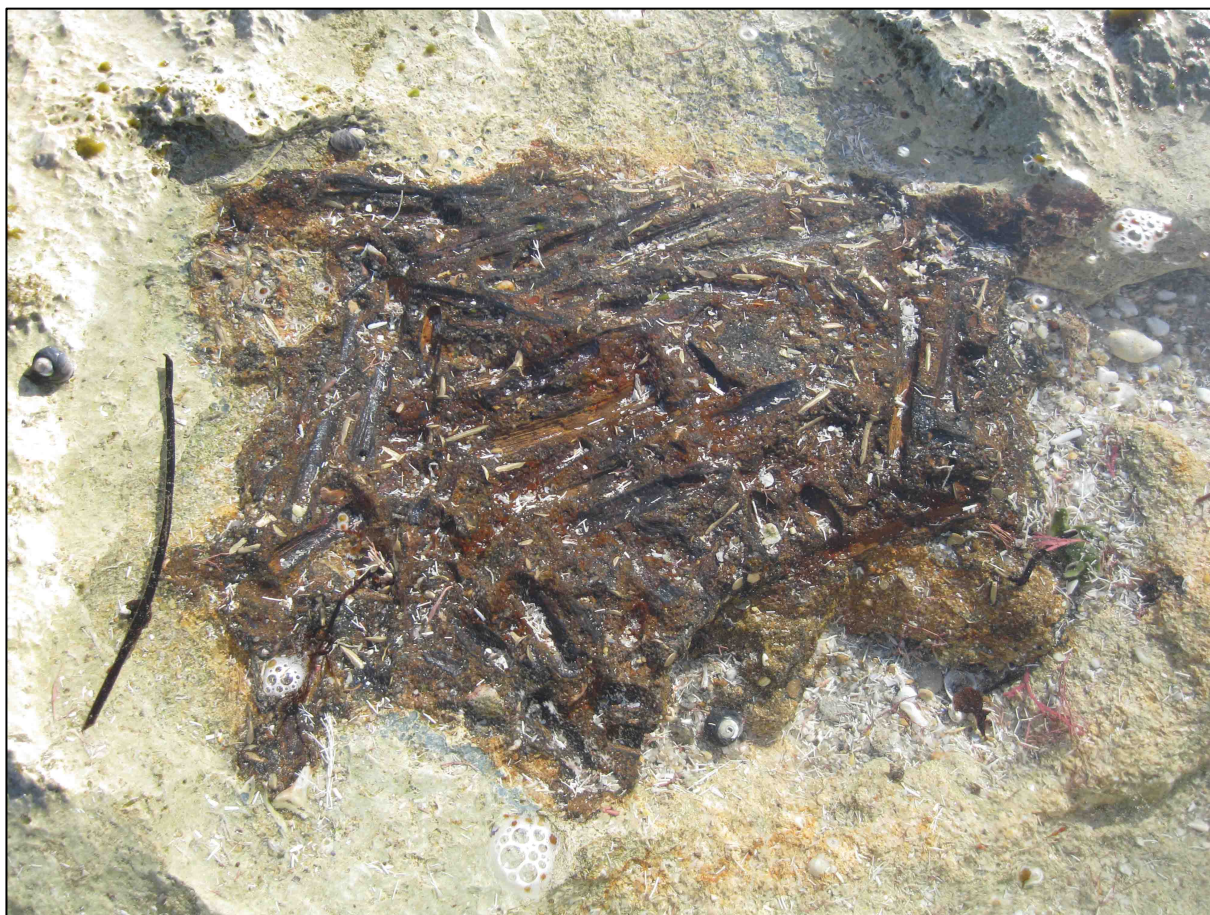
Figure 4 Mass of iron fastenings concreted together in a rock hole in the inter-tidal zone (R. Anderson/ WA Museum)

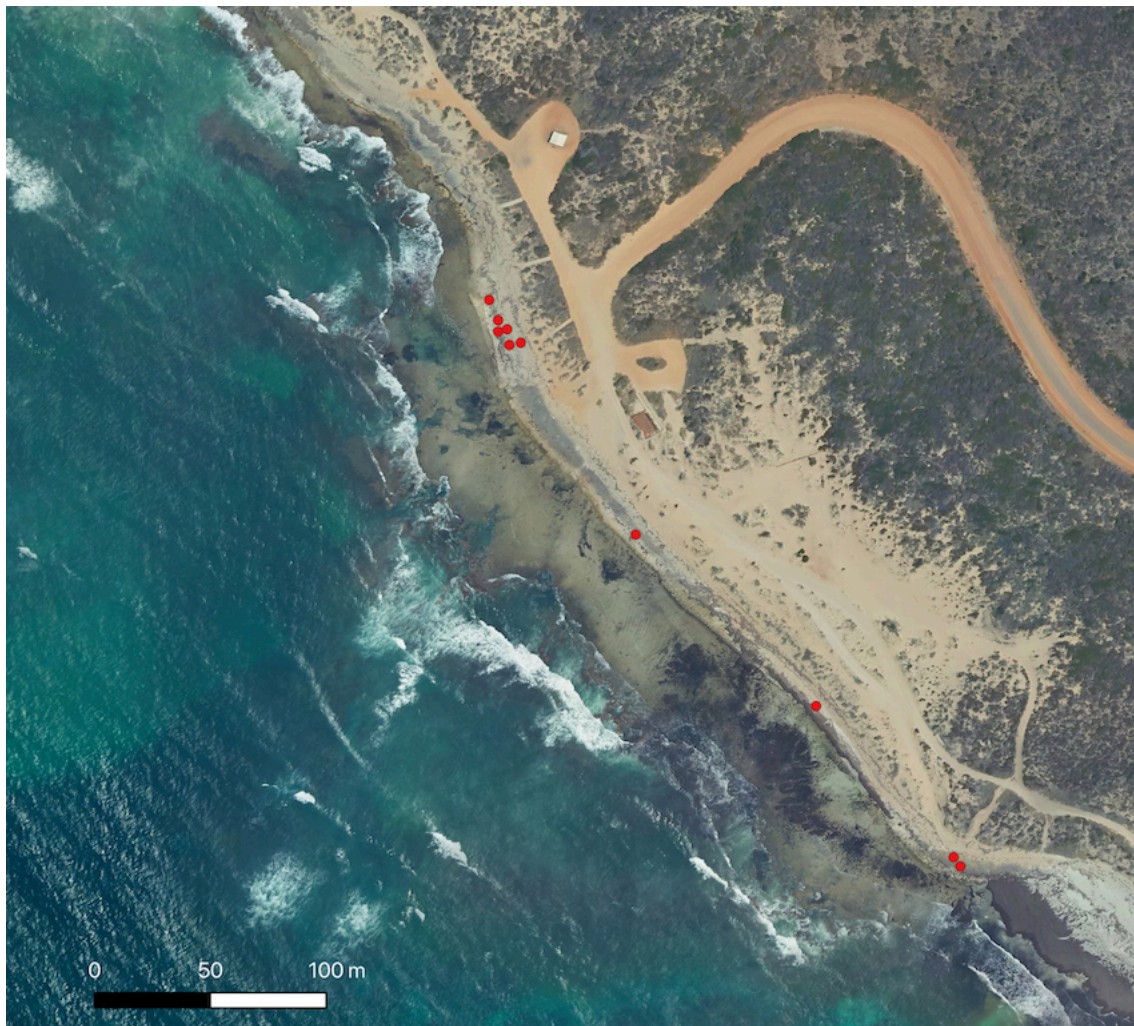
Figure 5 GIS site plan of Flat Rock Unidentified site showing car park area, reef and location of artefacts and features marked (points marked in red) (see Appendix A)

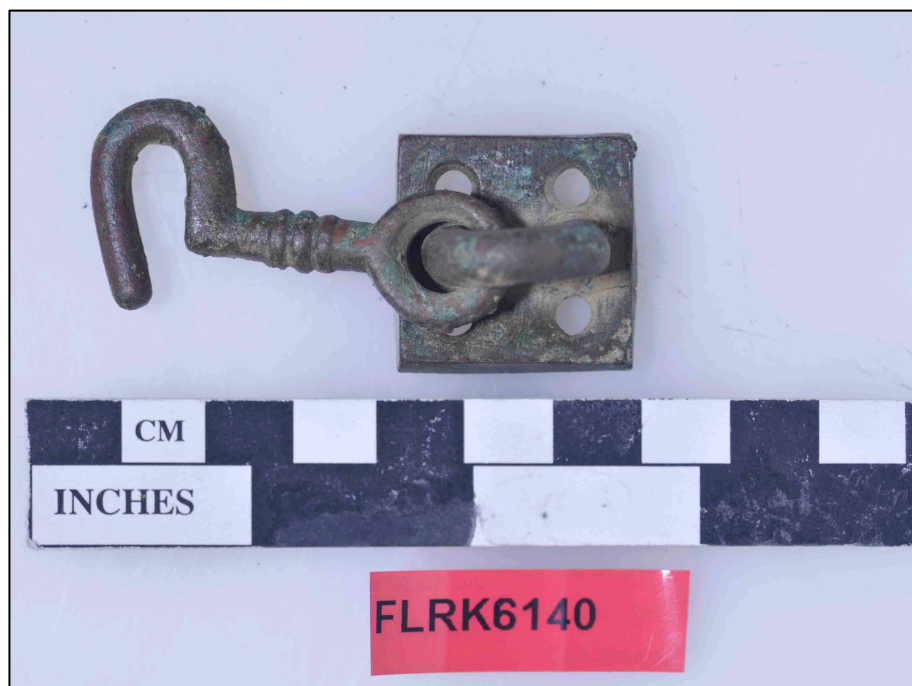
Figure 6 Copper alloy decorated hook latch, possibly related to ship's cabin furniture or fittings (R. Anderson/ WA Museum)

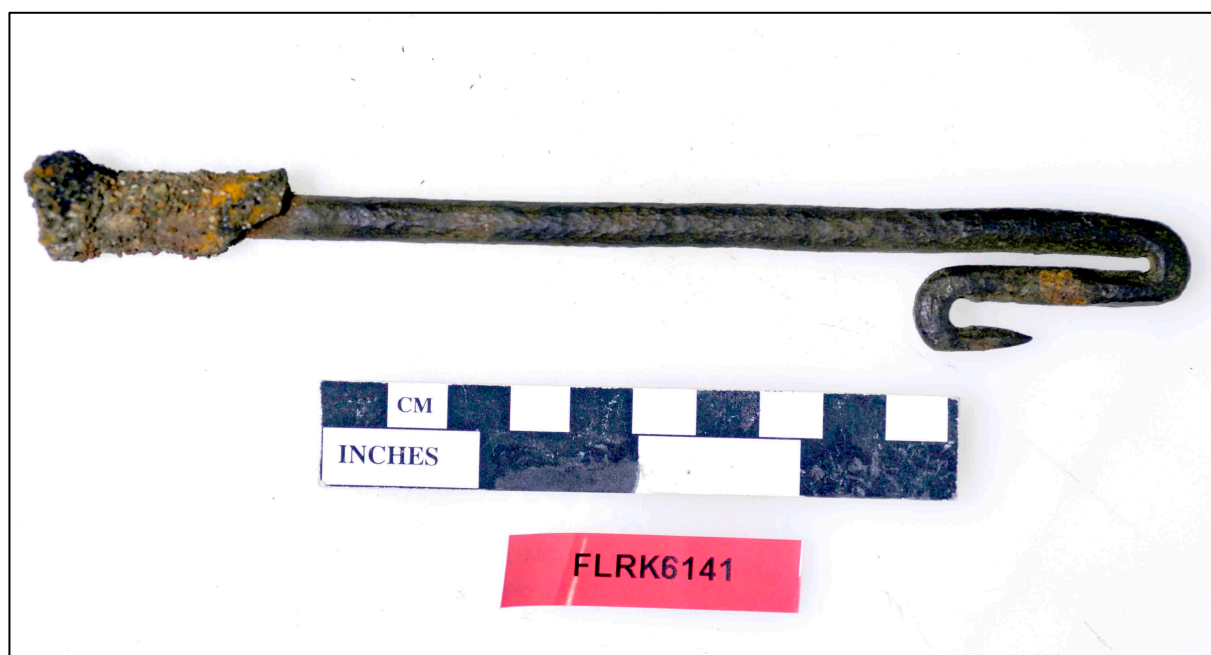
Figure 7 Sailmaker's tool (R. Anderson/ WA Museum)

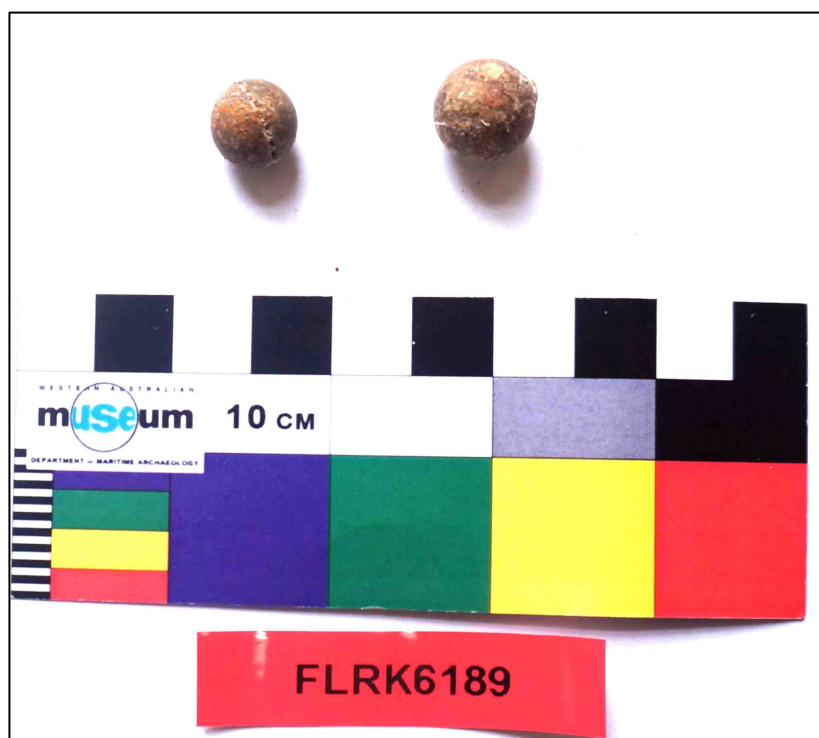
Figure 8 Musket balls (FLRK6189) (R. Anderson/ WA Museum)

The presence of musket balls is some evidence for an earlier to mid 19th century date. Muskets were used until the widespread use of breech-loading rifles in the mid-19th century. 'Black glass' (in fact dark green glass made by adding iron slag to the glass) was used to manufacture British-made bottles until the 1870s (Jeanne Harris 2010: 12). None of the glass or metal artefacts has any makers' marks or other identifying features to enable more precise identification of place of manufacture to assist with origin or dating. The presence of small artefacts such as the hook latch and sailmaker's tool are an indication that a substantial enough portion of wreckage able to contain some artefacts such as furniture or cabin fittings and personal belongings was cast on the shore.

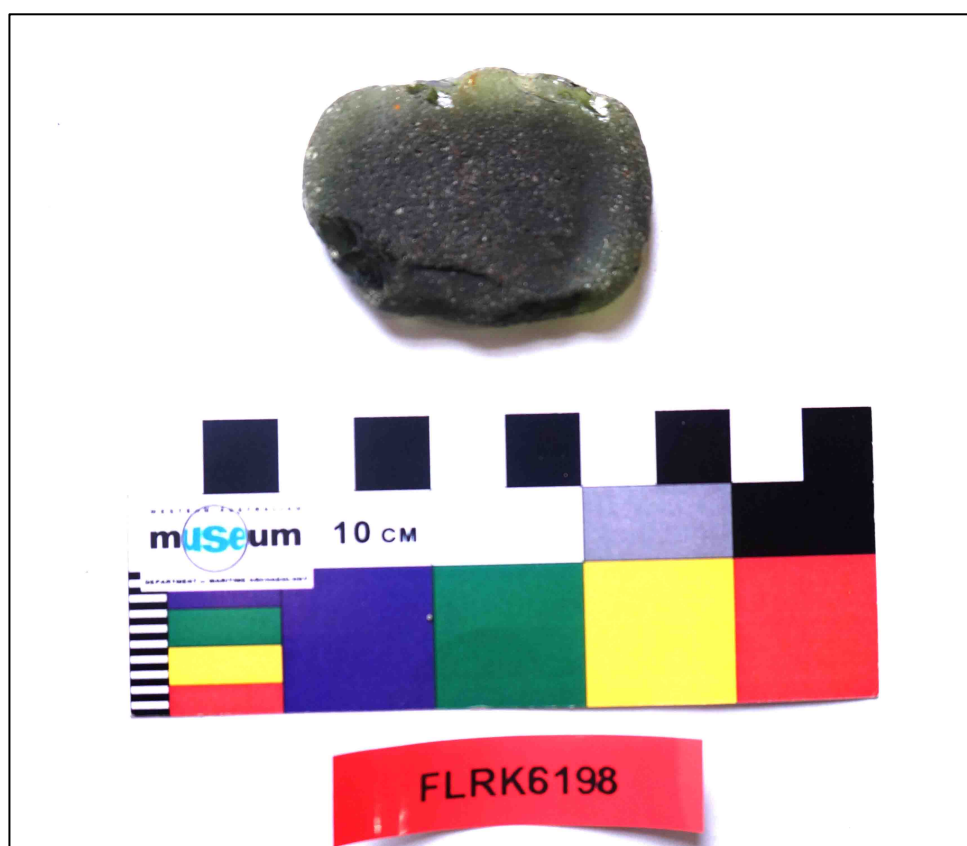
Figure 9 Fragment of green glass bottle base (R. Anderson/ WA Museum)

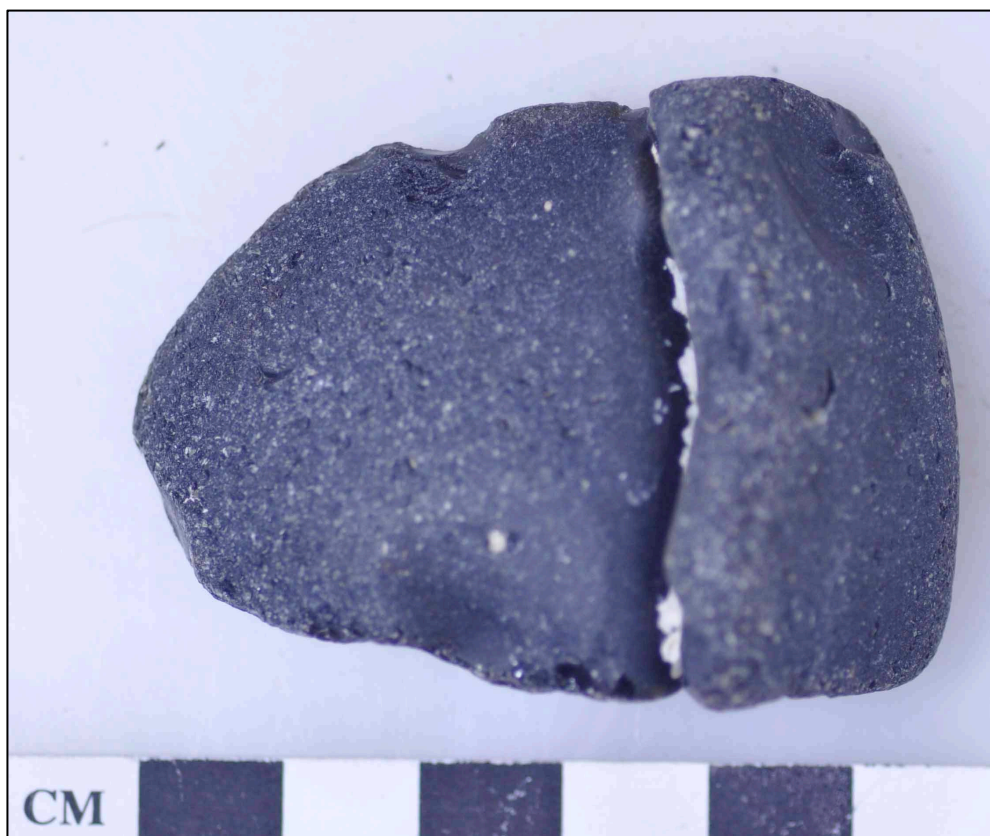
Figure 10 Green glass bottle base FLRK6175 recovered during site inspection south of Flat Rock car park (R. Anderson/ WA Museum)

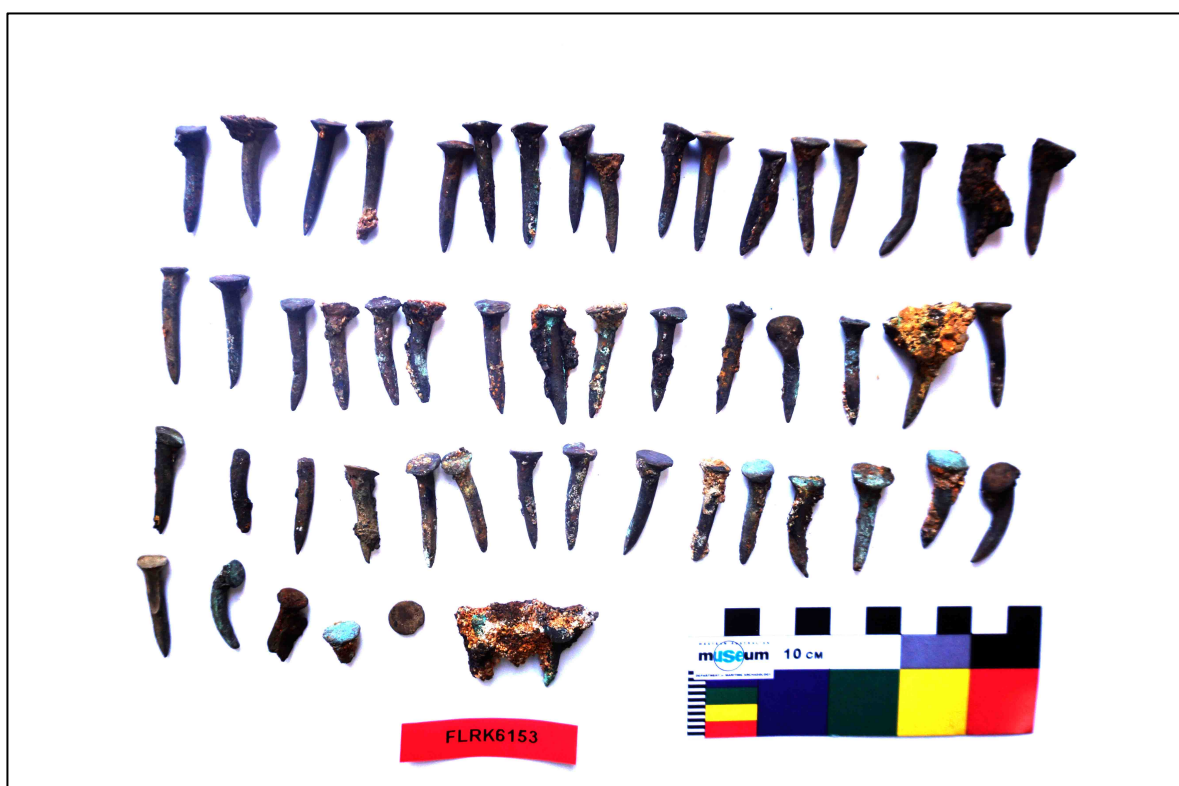
Figure 11 Copper alloy sheathing tacks (FLRK6153) (R. Anderson/ WA Museum)

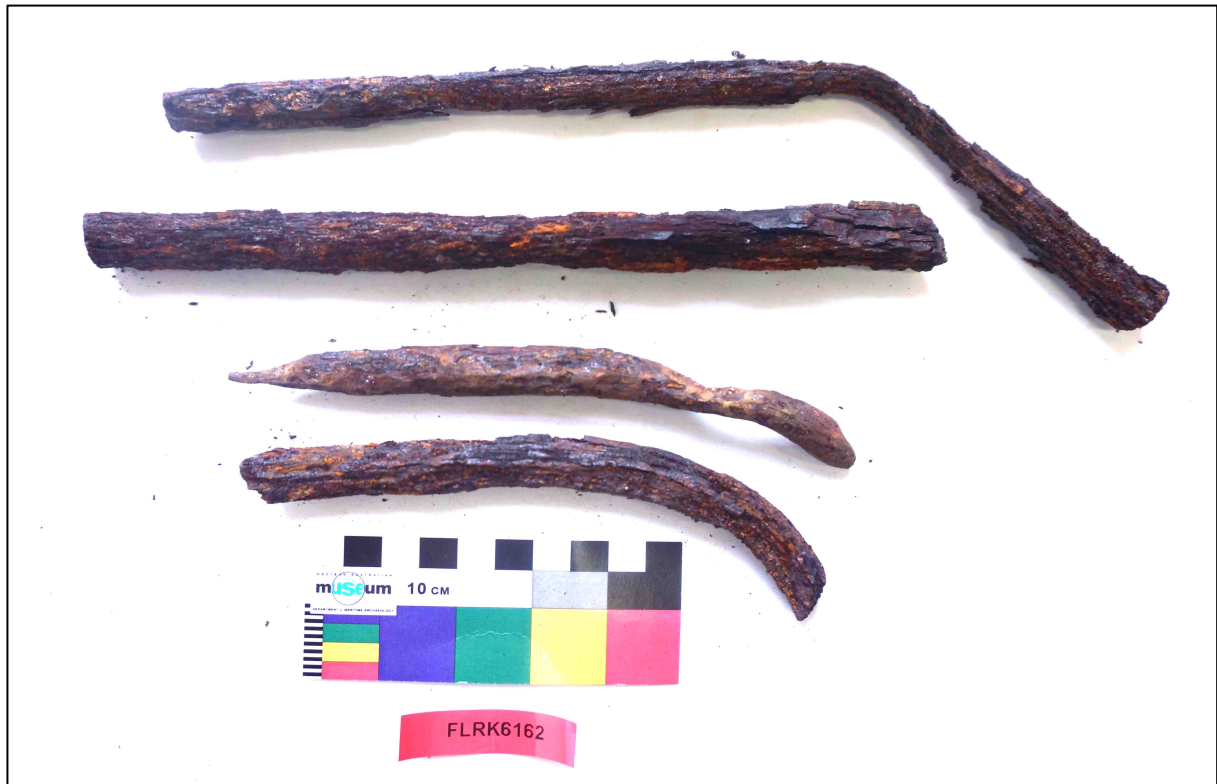
Figure 12 Range of ferrous fastenings (FLRK6162) (R. Anderson/ WA Museum)

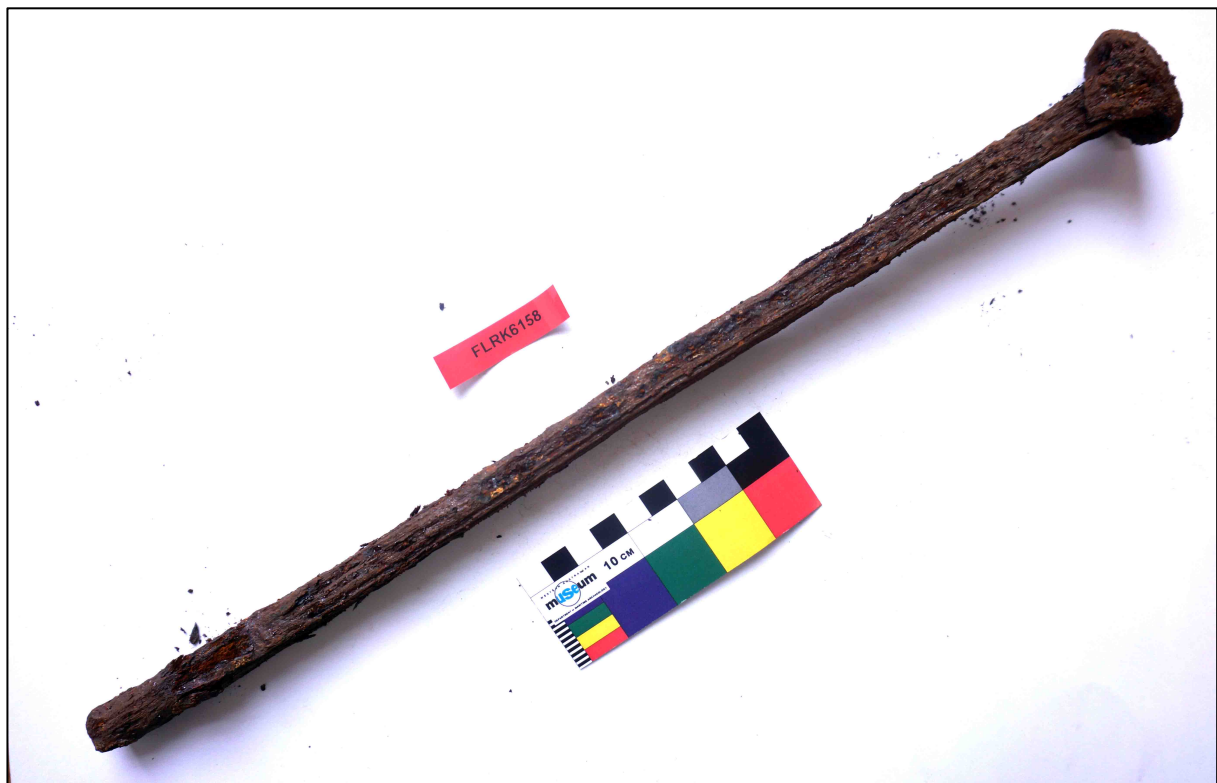
Figure 13 Large iron round headed, square section bolt (R. Anderson/ WA Museum)

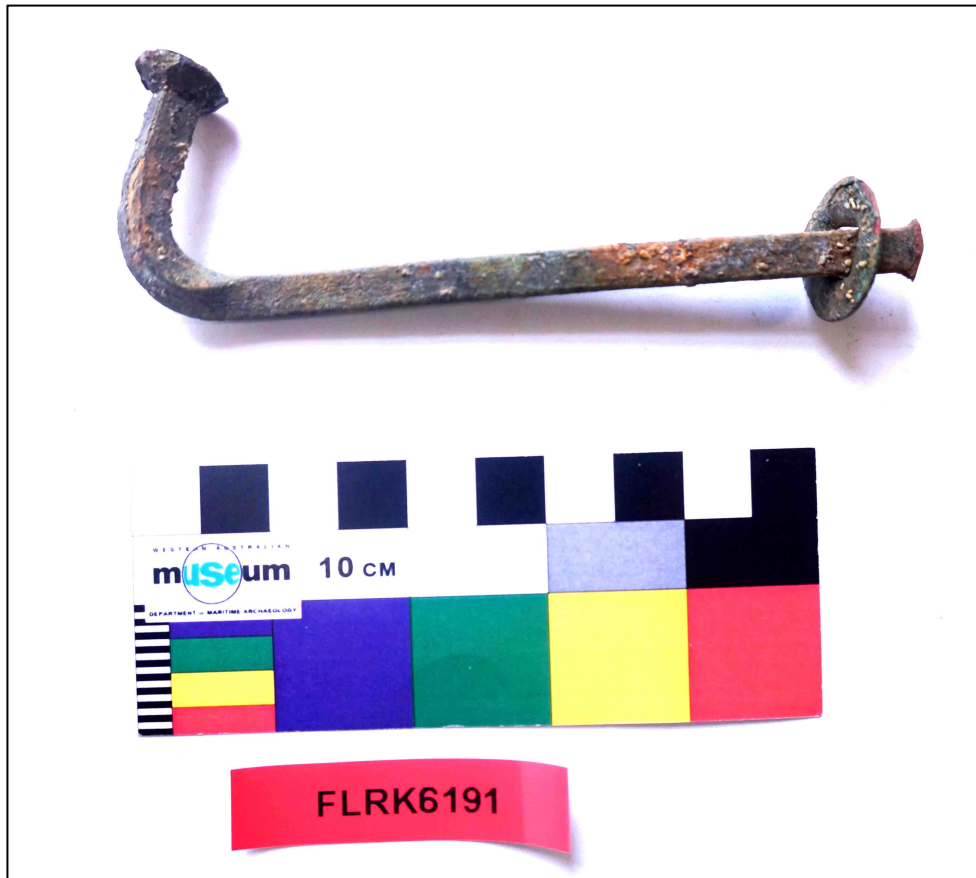
Figure 14 Copper alloy square section clench nail with washer (R. Anderson/ WA Museum)

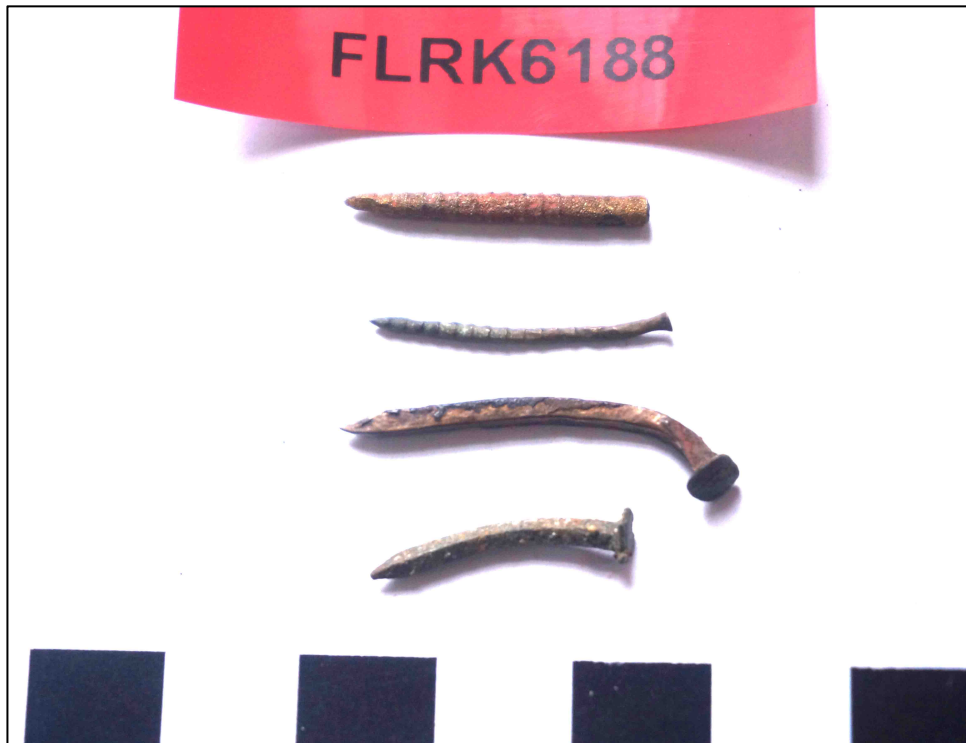
Figure 15 Four different types of small copper alloy nails, square section and cylindrical section with ragging (FLRK 6188) (R. Anderson/ WA Museum)

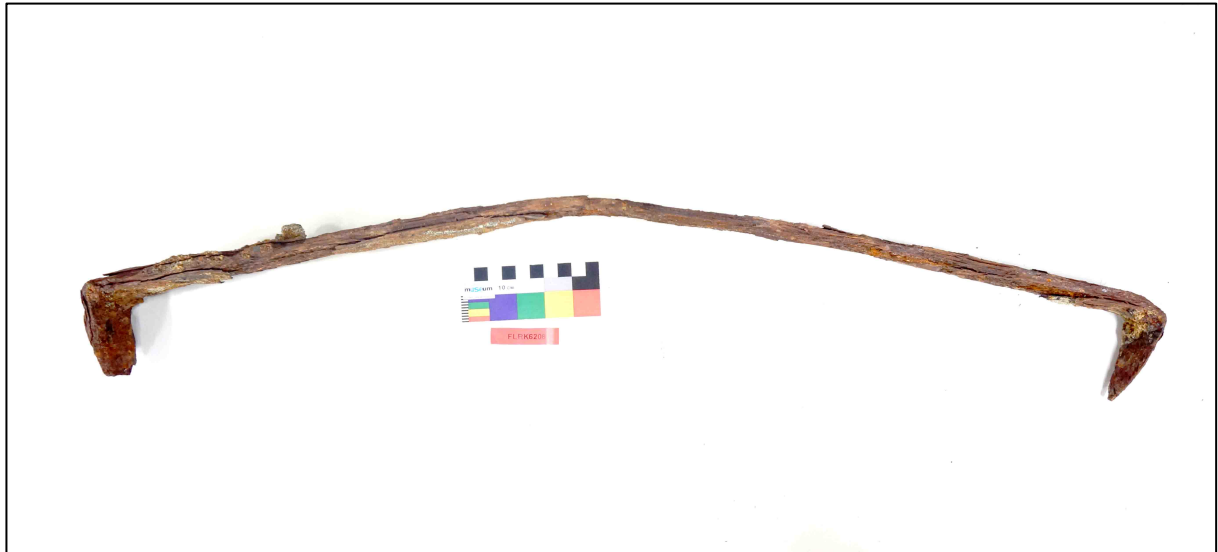
Figure 16 Corroded remains of a ferrous staple, possibly ship-related (R. Anderson/ WA Museum)

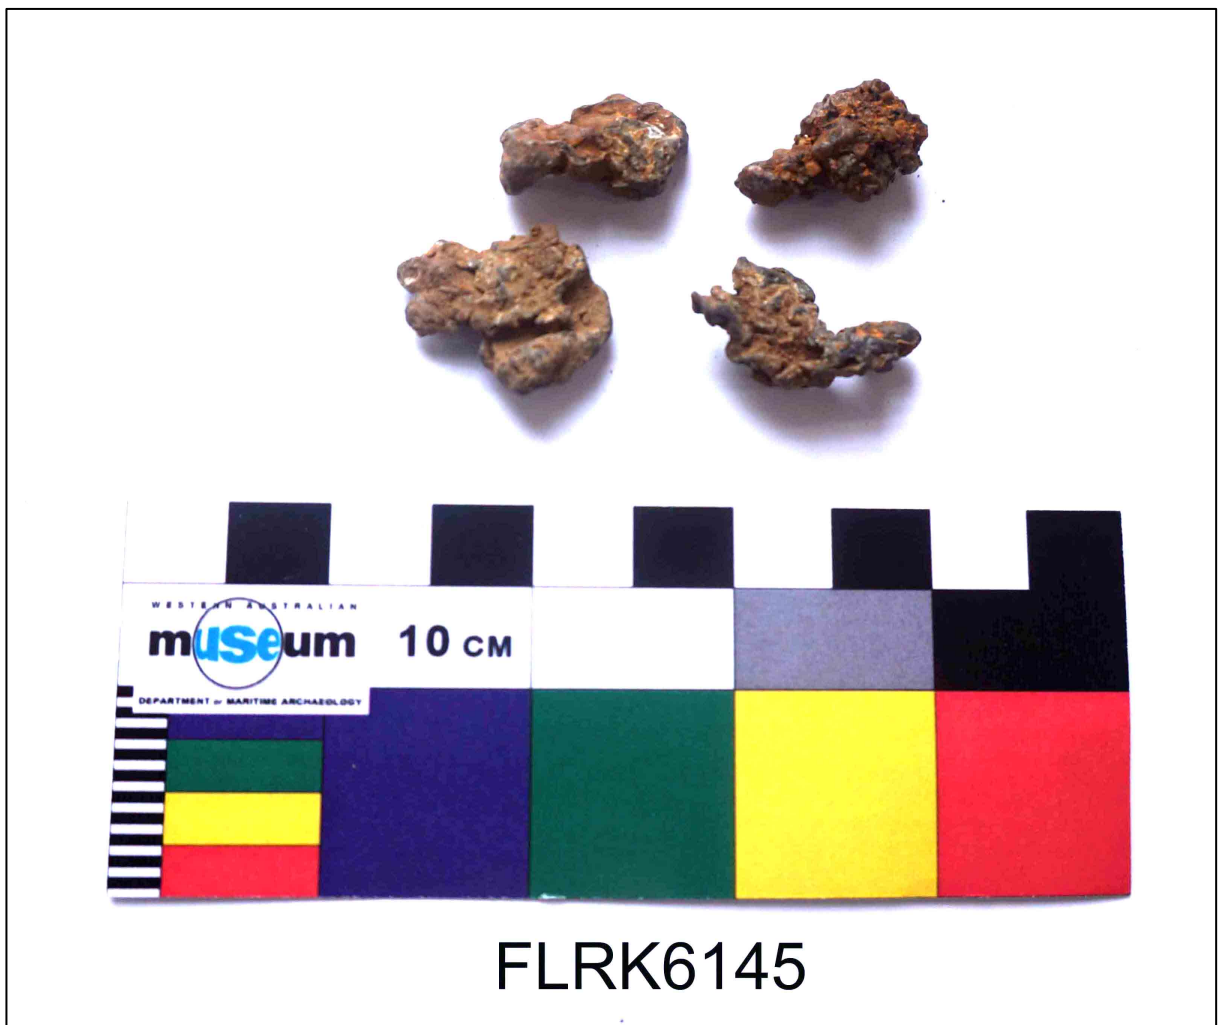
Figure 17 Fragments of molten lead (FLRK6145) (R. Anderson/ WA Museum)

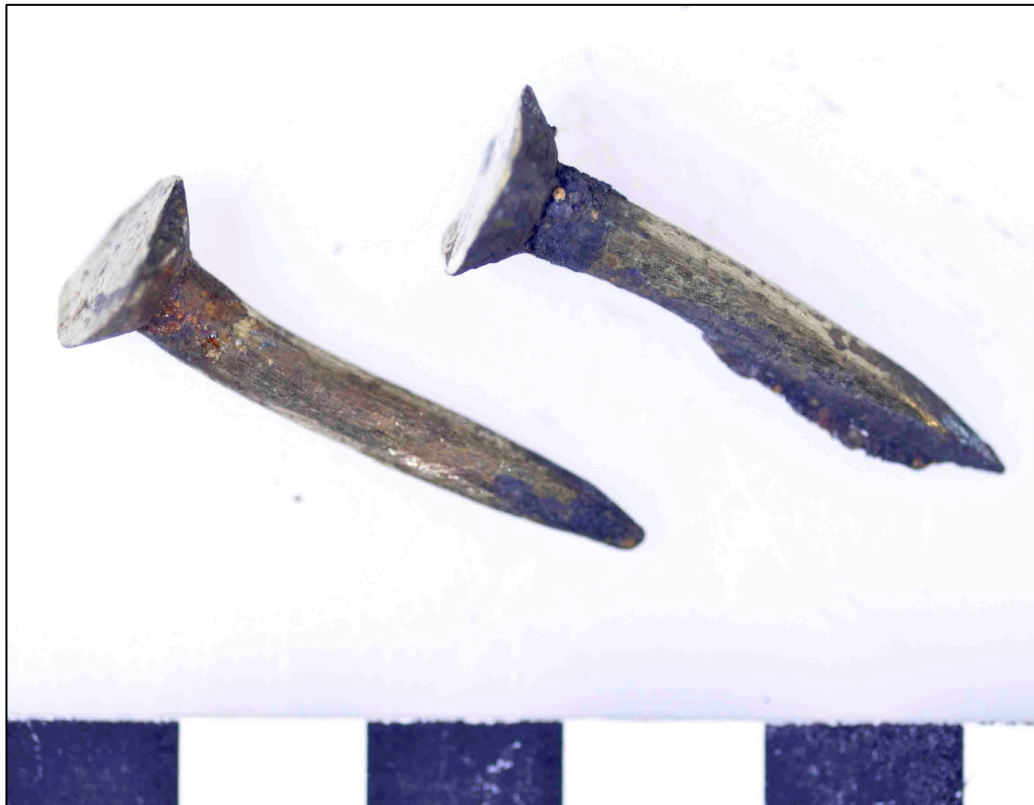
Figure 18 Cleaned sheathing tack samples FLRK6146-1 and FLRK6146-2 (R. Anderson/ WA Museum)

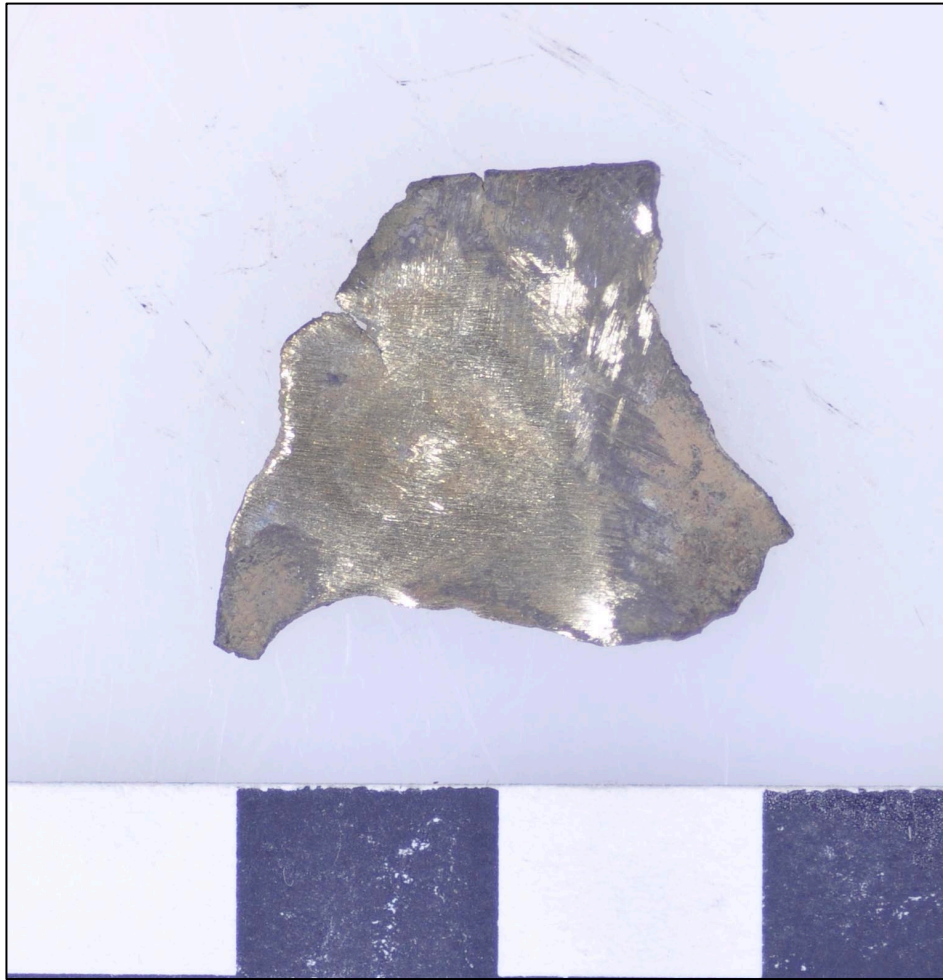
Figure 19 Cleaned sample of copper alloy sheathing FLRK 6146 (R. Anderson/ WA Museum)

The fragment of copper alloy sheathing FLRK6146 had a zinc content of 34.29%, which dates it to being constructed sometime after 1832 when Muntz lodged his patent for zinc-copper composition metal sheathing. Iron fastenings sampled are determined to be from the same batch of wrought iron, and consistent with use in 19th century sailing ships (Dr Ian MacLeod, Appendix C). Artefacts of molten lead and evidence of carburised iron as a result of burning and quenching (*ibid*) may be an indication that fastenings associated with timber wreckage remains on the beach were at one stage burnt. This material could have been burnt prior to the wreckage washing up, or as a post-depositional process such as the salvage practice of burning wreck timbers to recover metal fittings. Quenching could have occurred either at sea, or on the land with a high tide/ storm/ waves.

Sample FLRK 6146_fragment Cu alloy sheathing is typical of a duplex brass (greater than 32.5% zinc or zinc equivalence) which dates it to being after the Muntz patents were taken out following the realisation that additional zinc makes the alloy less prone to cracking on hot rolling which was used to achieve the desired gauge. However the problem for long-term materials performance on an historic shipwreck is that the zinc-rich beta phase is preferentially corroded and so such samples typically require twice as long to desalinate as single phase brasses.
