Frontispiece: Aerial photograph of the excavation of the Elvie (photo P.Baker).

## ABSTRACT

The remains of at least three vessels are known to lie within Frenchman Bay, Albany. This bay, therefore, played a significant role in the history of the port of Albany. From previous Western Australian Maritime Museum surveys of these wrecks, and local knowledge, the identities of two of the vessels have been confirmed, with continuing debate over the number and identification of vessels lying along Vancouver Beach.

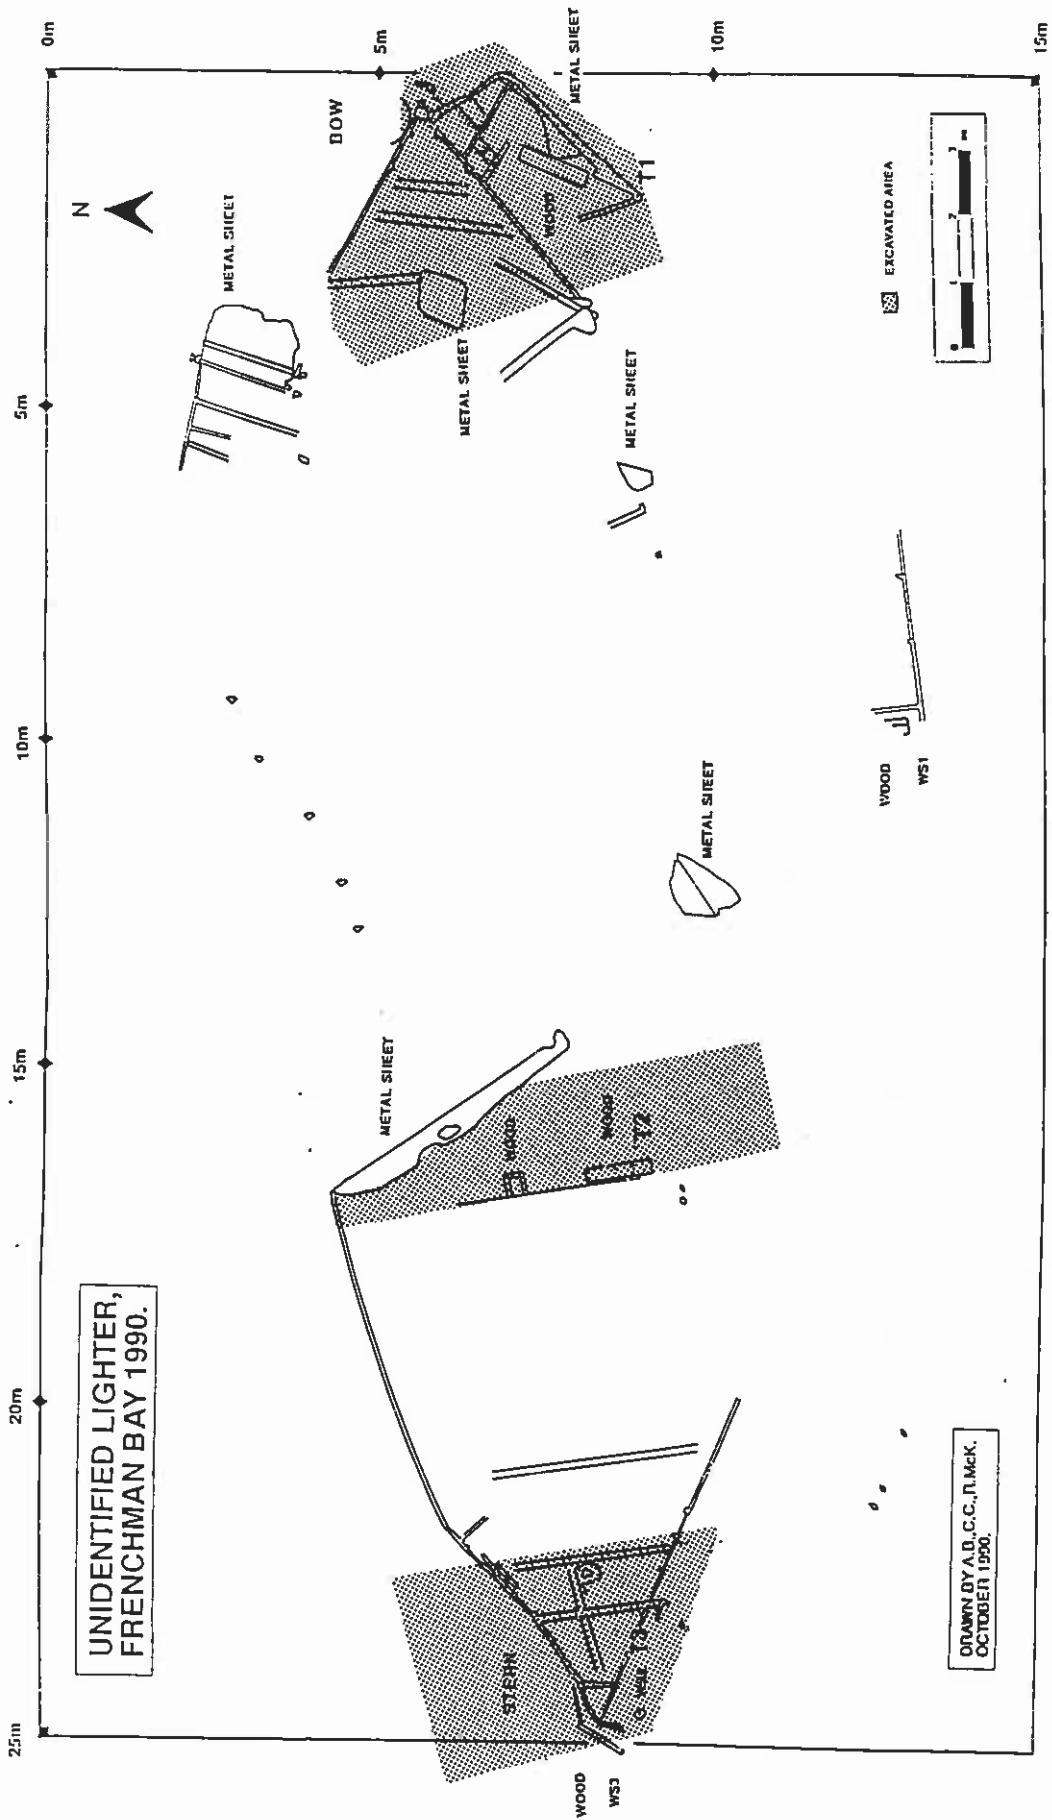
Figure 4.2: Unidentified Lighter, Frenchman Bay; site plan

The vessel was of iron hull construction with iron ribbing, and wooden planking in at least one section (refer Plate 4.7). Early indications, such as the right angular projections of the joins in the stern section as opposed to acute, suggested that the vessel was probably a barge or lighter.

The condition of the vessel has greatly deteriorated from the time of stranding. The age of the wreck, its location in shallow water and in the surf zone (according to L. Douglas (1990:personal communication) the wreck was once on the beach but is now underwater, as the shape of the beach has changed (Appendix C)), as well as the fact that it was most likely a prefabricated vessel, have all contributed towards its present condition.

Its method of construction may have contributed to its deterioration as parts of the hull and ribbing have broken away in sections. The differing alignments of the various parts of the vessel supports this hypothesis. The hull has broken up while buried and the separate sections have moved about independently with the shifting sands. The deck beams have collapsed as would be expected according to Riley's Waterline Theory (Riley 1985: 191).

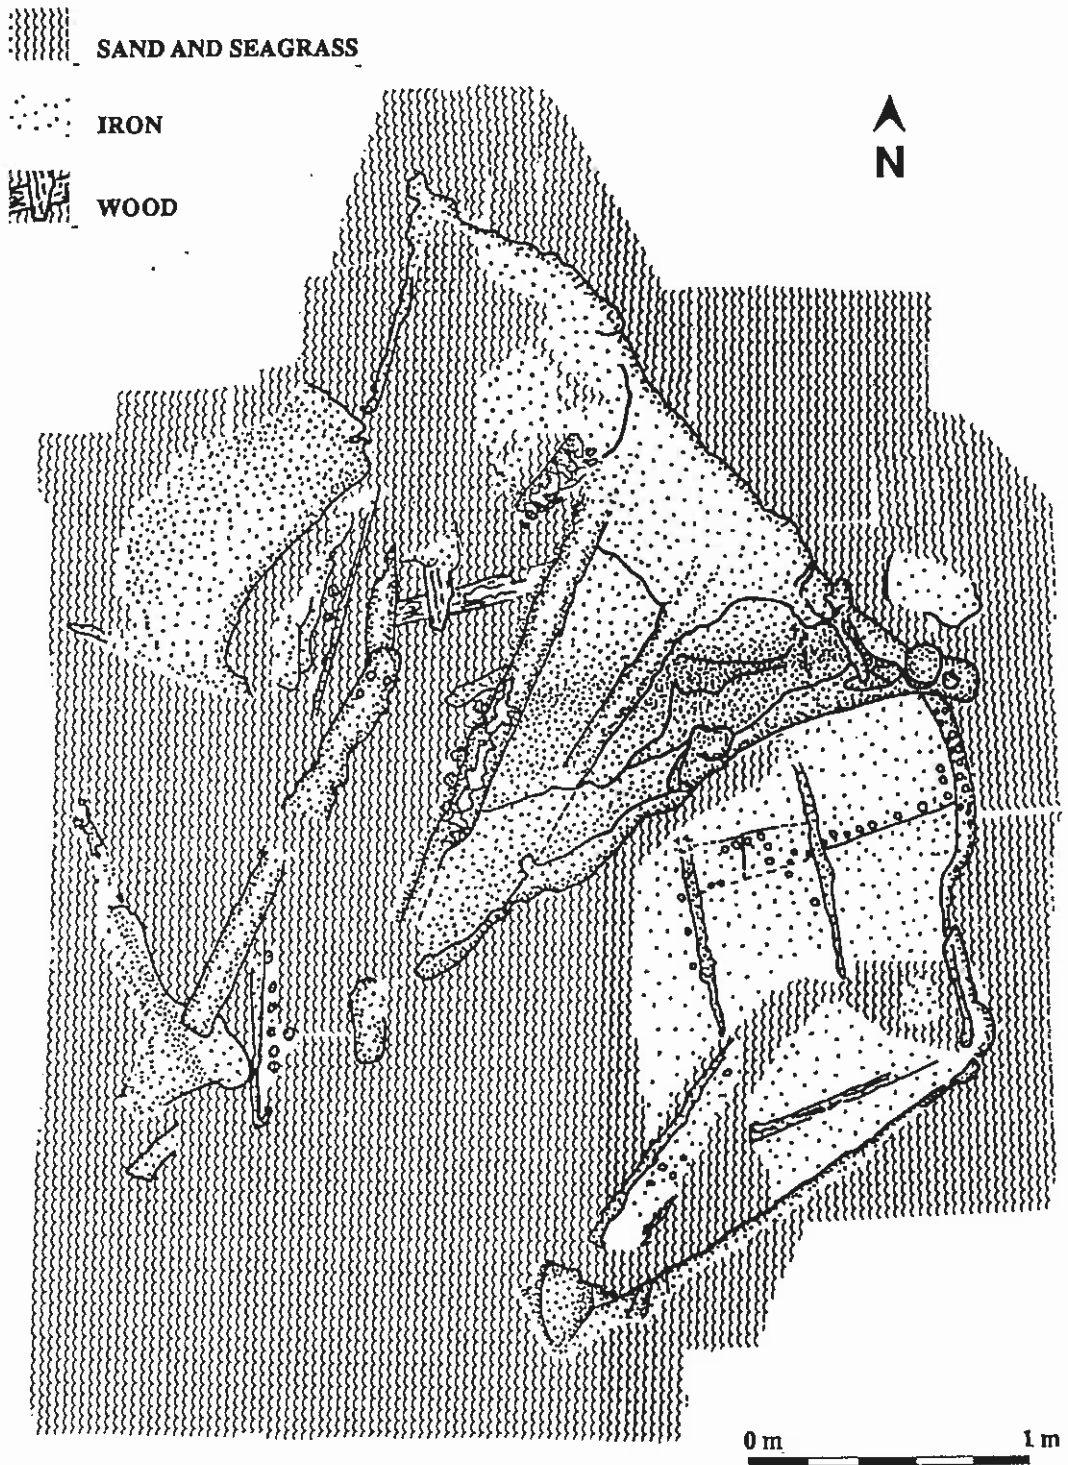
Figure 4.5: Detail of bow section taken from photomosaic of the Unidentified Lighter.

A section of overlapping iron plates joined to each other by iron bolts lies on its side partially underneath the bow (Figure 4.5). A strip of iron 8 cm wide and a row of bolts spaced 2 cm apart form the rim of the iron plates. These bolts measure 2.5 cm by 3.5 cm wide and are raised above the rim to a height of 1 cm. An additional row of bolts with the same dimensions ran perpendicular to the rim. This section of plating may not have formed part of the hull as there is no evidence of ribbing., whereas northwest of the bow, a section of hull with ribbing still attached is evident (Figure 4.2). This iron plating is approximately 4 cm thick, whereas the thickness of the remaining hull plates at the bow is 1.5 cm. The difference in thickness of the relative pieces of iron plating suggest the above is not part of the hull. The section of iron plating may be associated with the iron feature immediately south (Plate 4.5 and Figure 4.5).

The violence that the wreck has been subjected to can be seen in the bow section. The upper part of the hull and the fore decking has broken off and now lies beneath the bow. The deck beam closest to the stern has broken through the starboard side. As the keelson was not reached during excavation, it was not possible to determine if this was still intact.

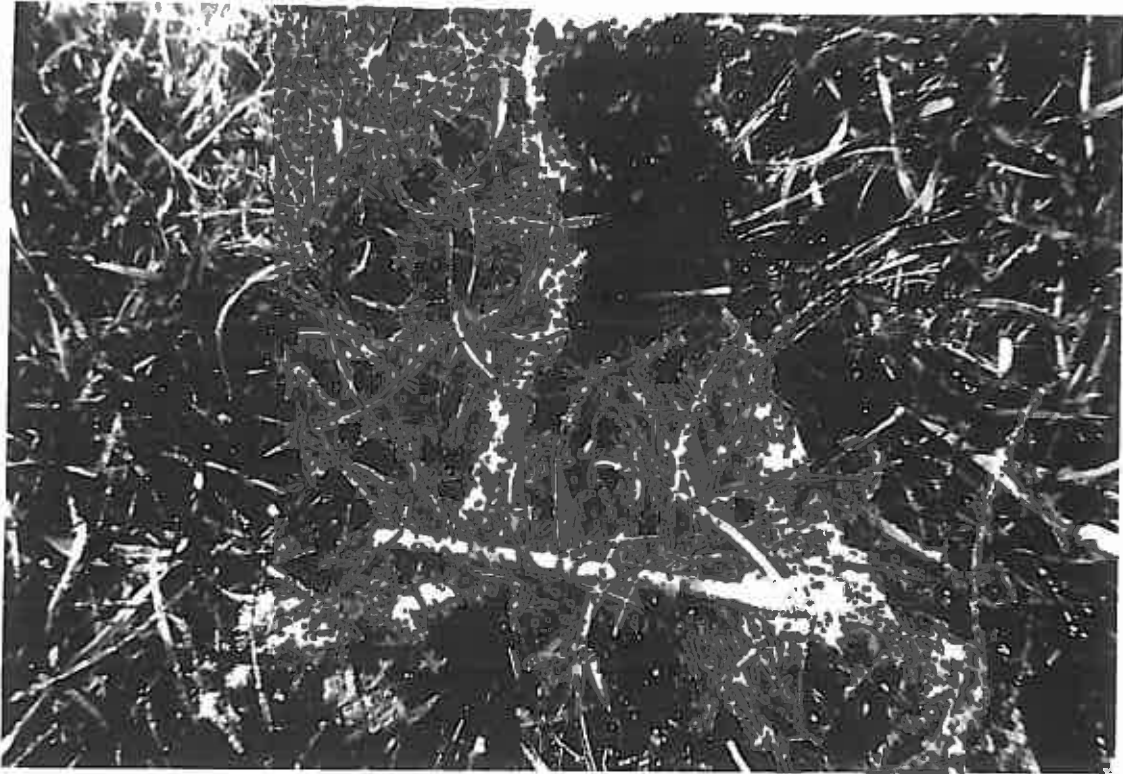
Plate 4.3: Stempost, Unidentified Lighter.

The section of wreckage in the northeast area of the site initially caused some confusion as to whether the bow or the stern of the vessel was located in this area. This section of the wreck is referred to as the 'stern' in the day journal and plans drawn while in Albany. This assumption is based on the feature seen in Plate 4.3 (Figure 4.6), initially considered to be the stern post. A metal protrusion on the 'post' was assumed to be the gudgeon.

During the excavation of this area of the site (TR1, Figure 4.2) particular attention was paid to this feature. It was hoped that by following the post down the keel would be located. Excavation in this area was abandoned after approximately 80 cm of sediment was removed with no sign of the keel. 120 cm of the post was revealed, which was enough to provide a satisfactory profile drawing (Figure 4.6). Approximately 40 cm below the 'gudgeon' the diameter of the post increases. If this was indeed the stern, the rudder would have had to have been less than 40 cm long. Furthermore, it would be expected that the stern of a craft of this type would have a hard angle with the rudder ending at the chine (McKenna 1990: personal communication). This holds true when looking at plans of barges and lighters constructed by Denny and Co. (Plates 4.4a and b).

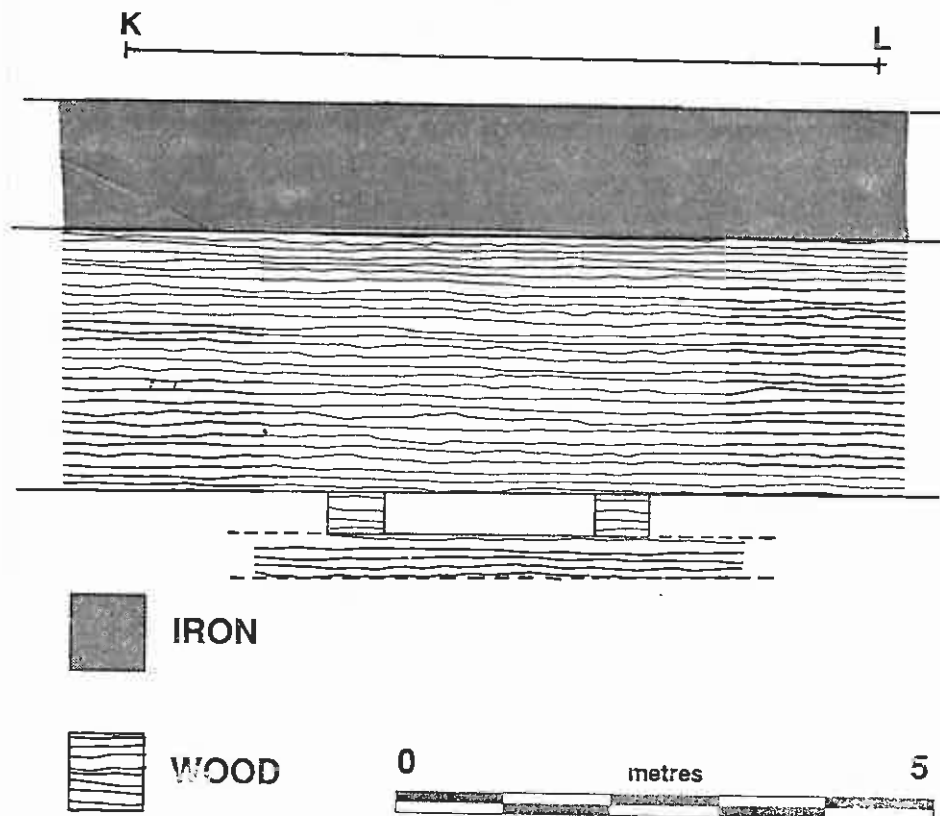
Figure 4.9: Profile of K-L, across the mid-section of the vessel

This trench revealed (Figure 4.9) part of a “box girder” on the keelson, defined by timbers running parallel to the vessel’s centreline. Hollow compartments separated by wood would have been positioned either side of the box girder. The box girder and the compartments on either side would have given the vessel additional buoyancy. Directly above these, a 24 cm thick wooden beam extended across the vessel. This trench, therefore, revealed details of the below deck construction of the lighter.

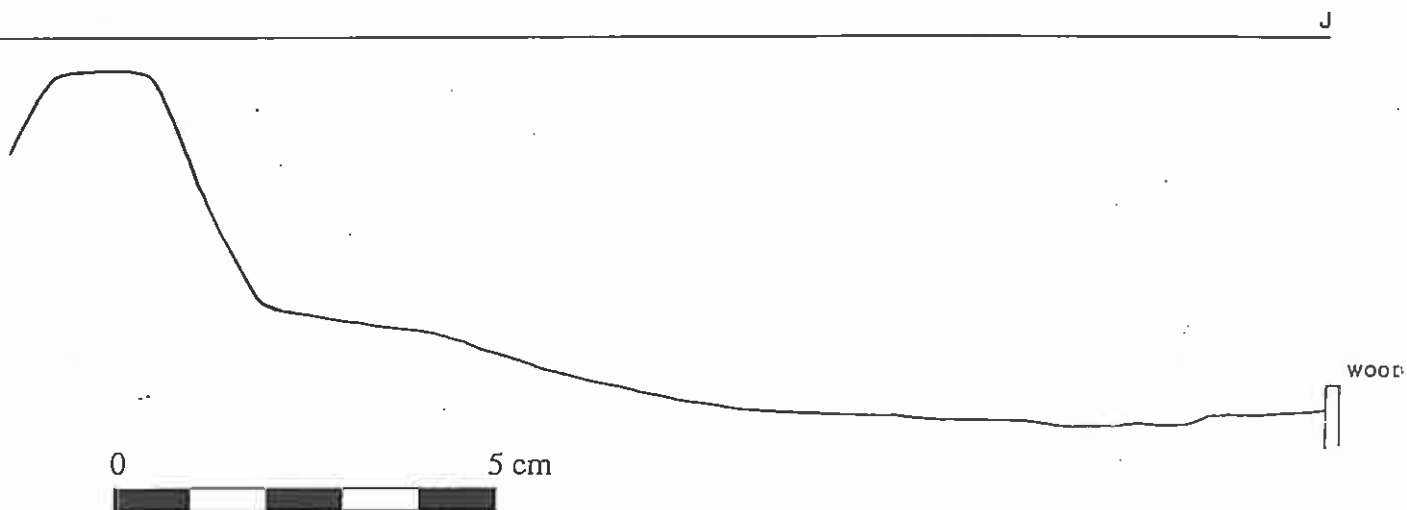
Figure 4.10: Profile I - J, stern section, Unidentified Lighter.

A wooden 'bulwark' is visible in Figure 4.2 (seen in profile in Figure 4.10), from which a wood sample was taken (WS-2, Figure 4.2). If the assumption that this is the stern is correct, it would appear that the Unidentified Lighter is a double-ended vessel. The lighter would have been built of a design similar to that of a whaling boat (McKenna 1990:personal communication). However, according to Mr. L. Douglas (1990:personal communication), who remembers seeing the vessel on the beach during the First World War, it was not double ended but possessed a counter stern which by then had almost disappeared (Appendix C). If this is the case, what was uncovered in the excavation is the stern below the water line (refer Riley's Waterline Theory), the counter stern having totally disappeared. The stern of the Unidentified Lighter may have been similar to that of the barge in Plate 4.4b.

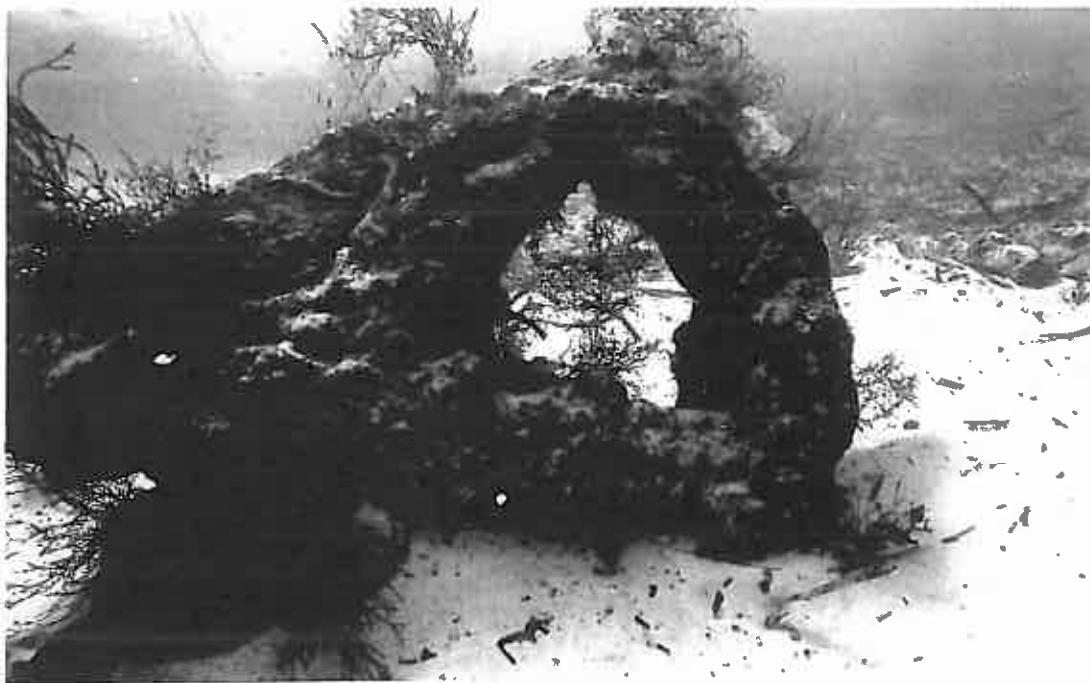
Plate 4.9: Unidentified iron object, 2.3 m west of the stern.

A substantial iron beam and/or post (14 x 6 cm) stands vertical approximately 0.5 m south of the stern (Plate 4.9). It was initially thought to be the stern post of the vessel but subsequent excavation revealed that it is not connected to the wreck. This may be part of the remains of the jetty.

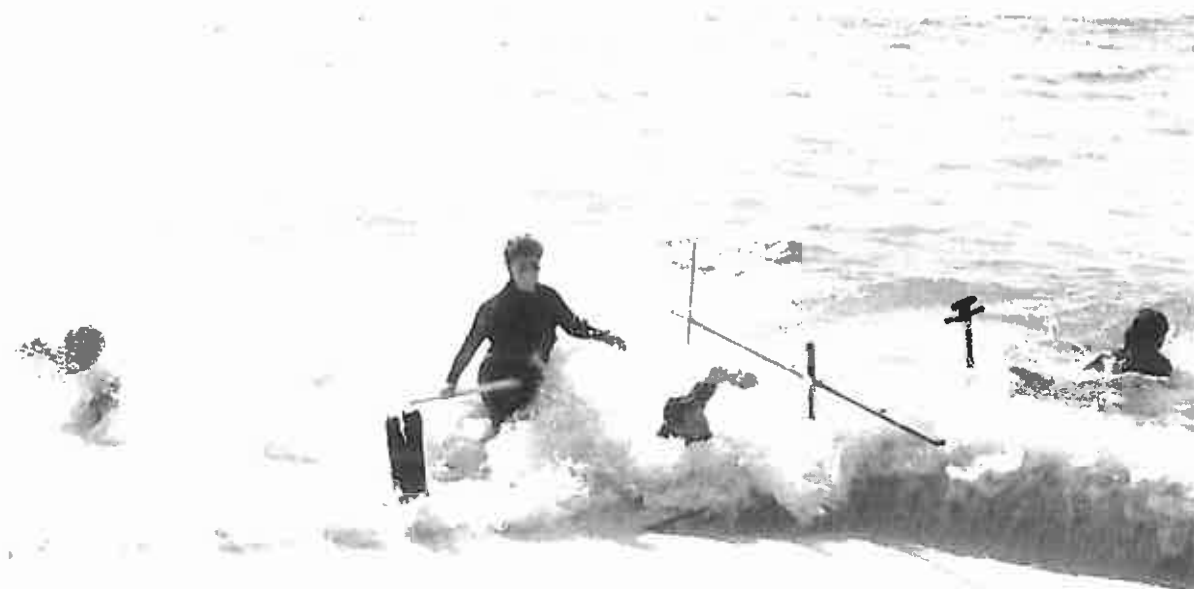
The form of the aft portion of the vessel was unable to be determined with any degree of certainty. This was a direct result of the constant surge of the tide, which made recording measurements on stations 7 to 9 very difficult. (Plate 5.6) The datum had to be lowered, as the depth of the vessel beneath the surface was greater than the depth of the probe. Consequently, as will be seen in 5.6.1, stations 7 to 9 could not be used in a reconstruction of the vessel's form.

Plate 5.6: Attempting to take profiles in the aft section of the *Elvie*.

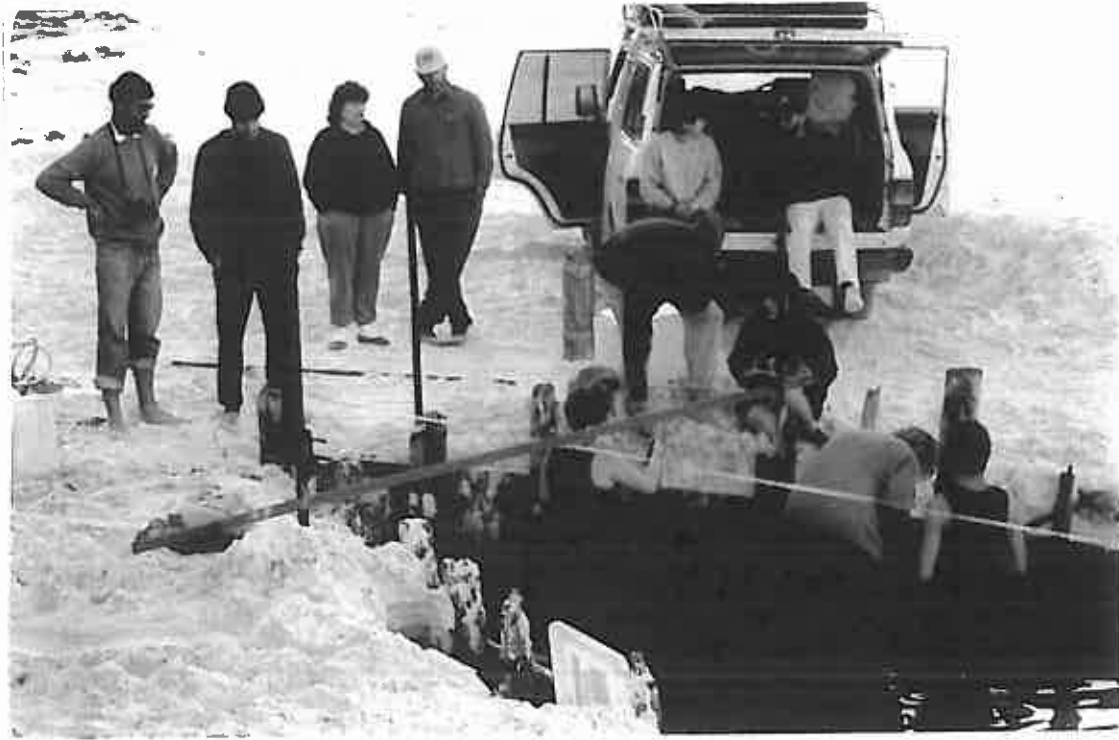
Plate 5.10: View of *Elvie*, showing the extent of preservation of the vessel on both the port and starboard sides.

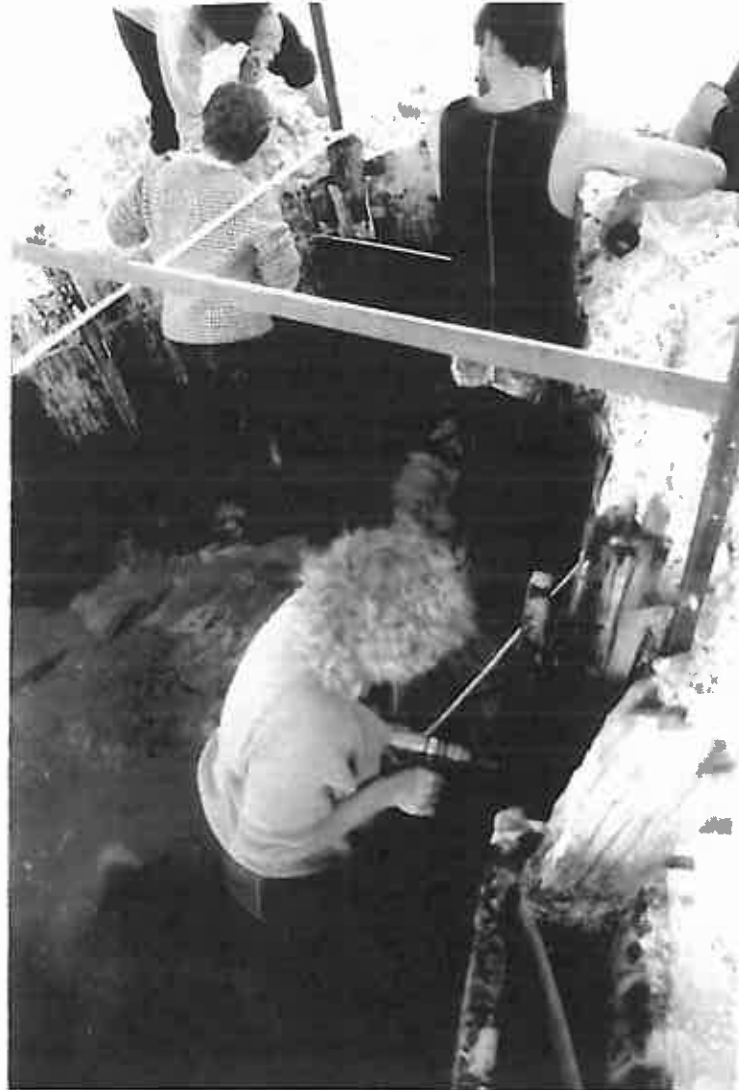
Plate 5.11: Location of wood samples.

Identification of ship's timbers as Jarrah (*Euc marginata*) (Plate 5.11) suggests the vessel was not shipped to Albany from Norway on board a Whaling vessel. Instead she was most likely built locally.

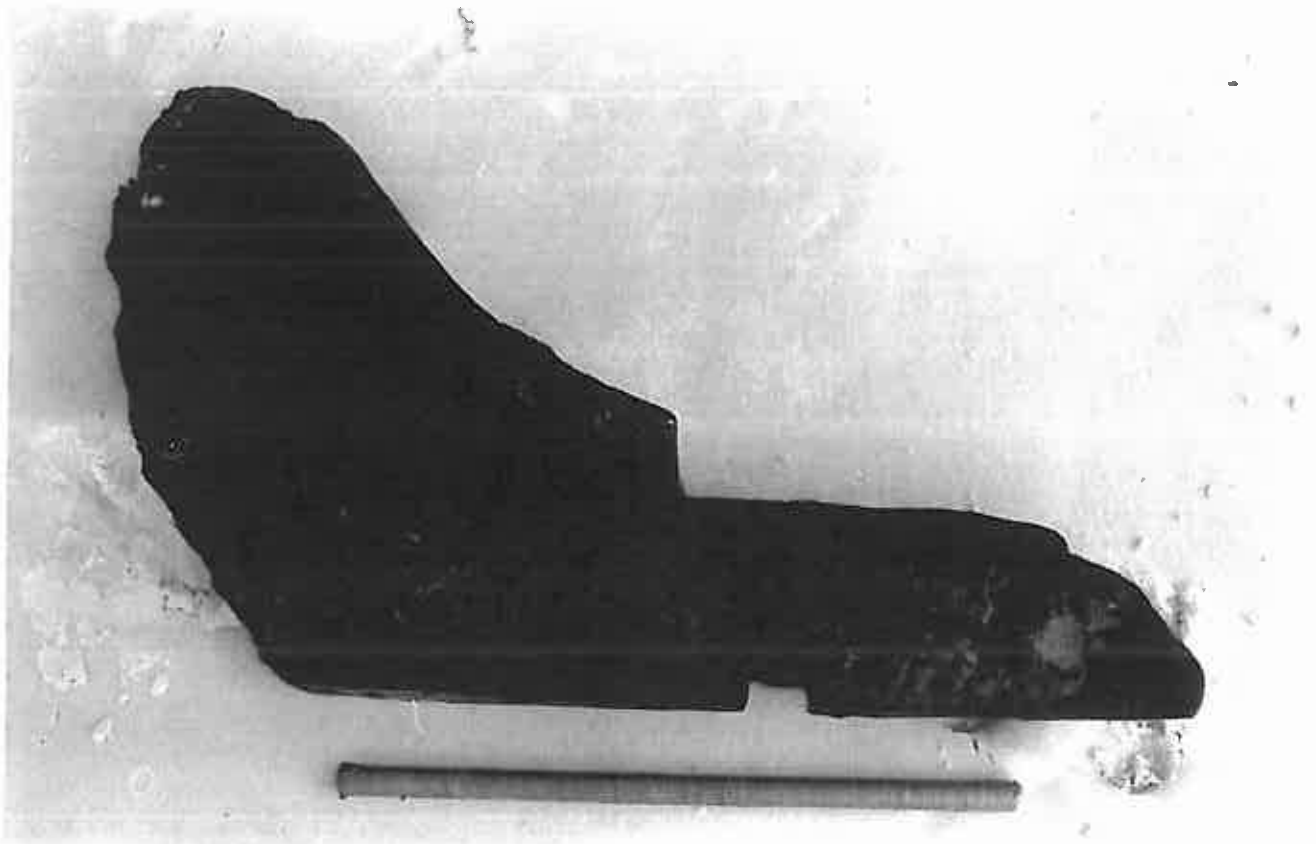
Apart from the bolts investigated by the Conservation Department, Western Australian Maritime Museum, only one other artefact associated with the Elvie was found during excavations by the backhoe (Plate 5.13). The knee measures 48.5 cm at its widest point and is 84.5 cm long. Maximim width is 5 cm.

Figure 5.13: Knee uncovered during backhoe excavations .
