JERVOISE BAY PROJECT REPORT

A survey of the shipwrecks Abemama and SS Alacrity

Report - Department of Maritime Archaeology, Western Australian Maritime Museum, No. 127.

June 1997

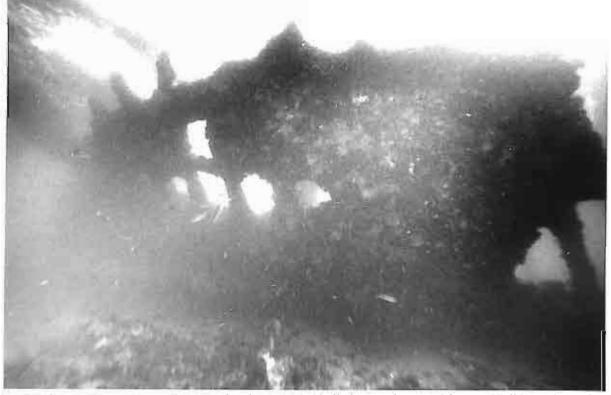
The vessel dimensions are approximately 44 x 10 metres, lying on a north south axis, bow to the north. The wreckage is heavily concreted and densely covered with sessile marine organisms. The sternpost(?) of the *Alacrity* is visible from the shore with a section of the stern breaking the surface at low tide. Most of the hull around the turn of the bilge has collapsed. Hull structure at the stern and midships projects approximately two metres above the sea bed. The average height of the adjoining hull structure is approximately one metre. Due to the dredging operations for the construction of the oil rig *Ocean Endeavour*, and subsequent cyclonic activity, the shoreline has undergone some comprehensive changes. The wreck which was originally beached now lies 50 metres from the shore in a maximum depth of 3.5 metres for example. The bow and stern remain in an upright position and several major bulkheads are in place supporting the frames and other parts of the vessel's structure.

Figure 7. Alacrity, port counter at the stern showing corroded hull plates and exposed frames. Visible on the starboard side is the propeller shaft "A" frame and starboard propeller shaft. Photo No. 5151/31: P. Baker, WAMM.

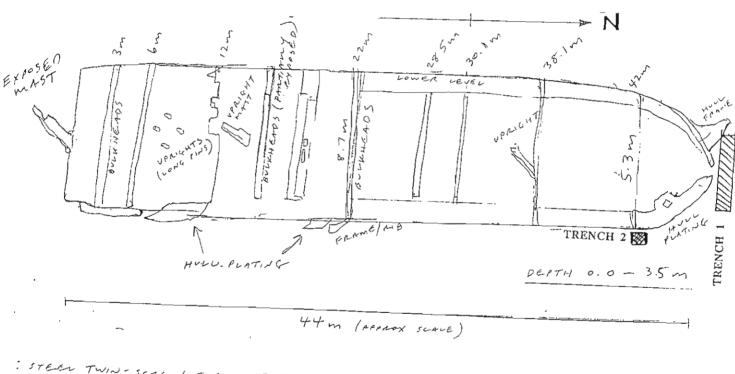
The depth of excavation of Trench 1 at the *Alacrity* was approximately 0.5 metres. The excavation revealed that wreckage lies buried for a distance of approximately one metre from the northernmost extremity of the bow and consists of iron ribs and hull plating. Dredging midships was not considered necessary as only a thin layer of sediment, approximately two centimetres deep, lay over the hull remains, consisting of iron frames and hull plating. The excavation at the bow revealed an intrusion of lighter coloured sand into the darker sediment which suggests some mobility of sand at this location in the recent past. This may be attributed to sand scouring which occurs in medium to heavy seas.

The wreckage in Trench 2 was buried 1.5m below the seabed. The detritus primarily consists of small pieces of ironwork, ranging in size from 2 cm to 20 cm in diameter, possibly corroded bulkheads or hull plating. In this area of the wreck most of the hull beyond the turn of the bilge has collapsed.

Figure 17. Field sketch plan of SS Alacrity showing the position of the test trenches. S. Souter, WAMM 1997.

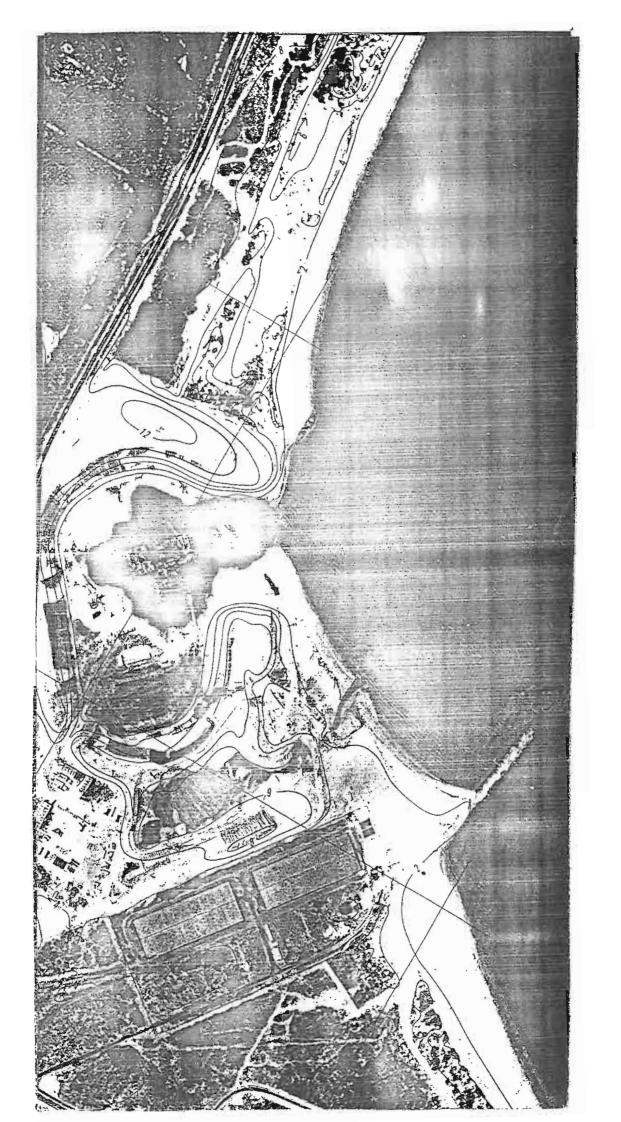
JERVOISE BAY 1975 Figure 21.

Explanation of Overlays
Figures 21, Jervoise Bay, 1975, showing the shore line immediately before and after the opening of the Ocean Endeavour pond. Note the erosion of sand on the port side of the *Alacrity*.

Jervouse Bay, 1959 and 1975, showing the shore line immediately before and after the opening of the Ocean Endeavour pond.

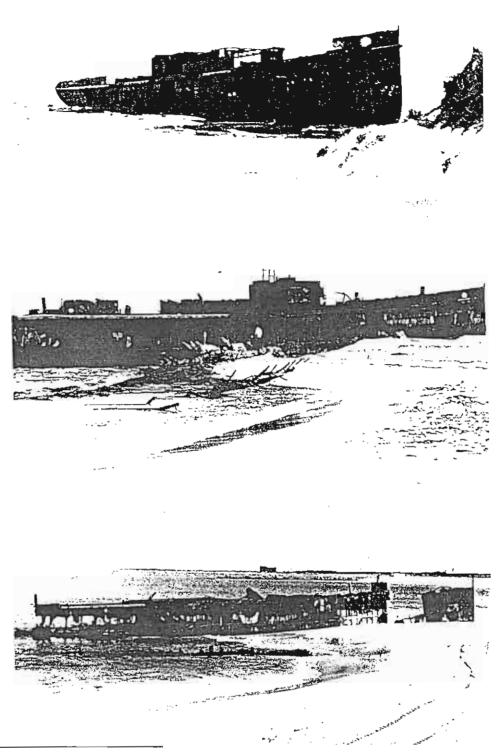
¹It is useful to note at this juncture that wrecks can move, even after many years. The evidence appears above in the case of the *Abemama*.

Figure 23. The iron-hulled SS Alacrity in the process of disintergration over a period of about twenty years up to around 1975. The Abemama can be seen inshore on the aft quarter of Alacrity. The uncovering of the two sites is due to dredging nearby. Note the varying angles of the Abemama hull to the Alacrity.

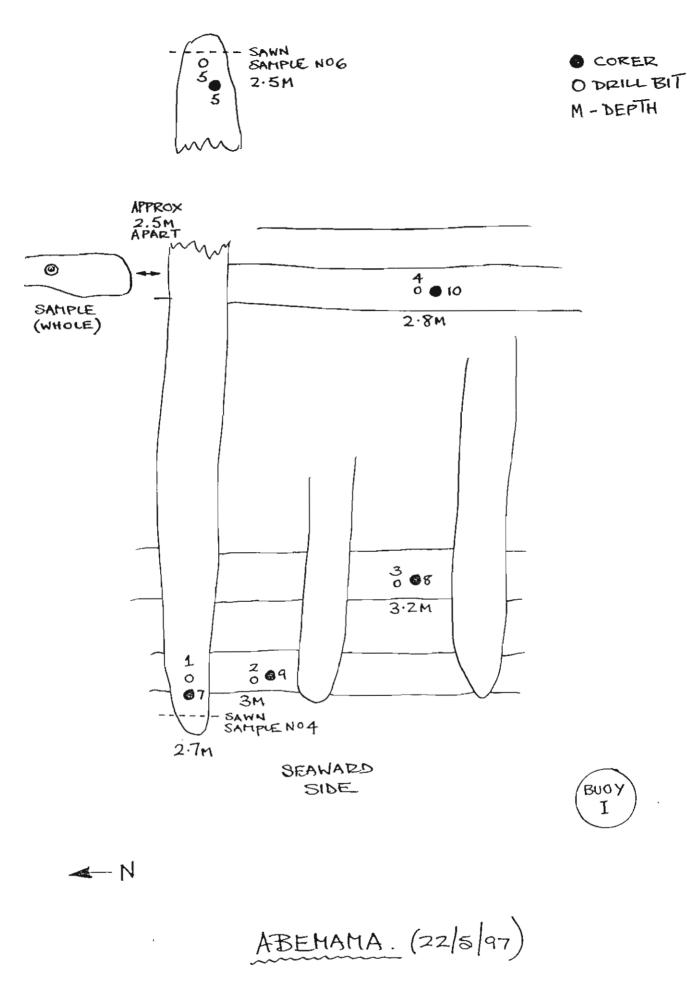
Figure 5. Position of pH profiles and wood sampling on the Abenama site [Carpenter 1997].

The outer hull planking measured in position 3 (Figure 5) was the most degraded of the timbers measured. The pH values of the outer planking (3) were higher than those measured for other timbers and the pH decreased only slightly as the core depth increased. The minimum pH value measured for outer planking (3) at a depth of 5cm was 7.06. This indicates that this timber is generally more degraded than the other measured timbers. After this minimum, the depth into the wood continued to

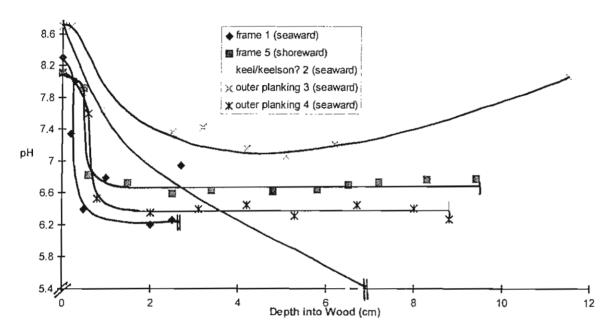
Figure 6. pH profiles of selected timbers measured on the Abemama site.

From observing the pH profiles of these aerobic timbers, in general, the pH of the surface wood is high then as the depth into the timbers increases there is a sharp and rapid decrease in pH. The higher pH measured on the wood surface, slightly more acidic than sea water, is indicative of the pH being controlled by the buffering capacity of the sea water. More importantly, this maximum pH denotes the area of greatest deterioration. As wood degrades in a marine environment by physical and biological means, its polysaccharide content is reduced and spaces created within the wood structure are then filled with alkaline sea water. This initially occurs in the outer more exposed areas of the timber. Hence, the normally acidic nature of the wood becomes progressively more alkaline with increasing degradation due to the inward diffusion of sea water. The pH then rapidly decreases as the depth increases into the wood core indicating a gradual decrease in the extent of degradation. The pH will reach a minimum denoting the area of least deterioration where the wood is less waterlogged. The overall decrease in the pH of the wood core is an indication of the inherent acidity of the wood. The innermost wood is still waterlogged, albeit to a lesser extent than the outer surfaces, therefore the pH will be more alkaline than the standard pH of seasoned, modern, undegraded wood of the same species.

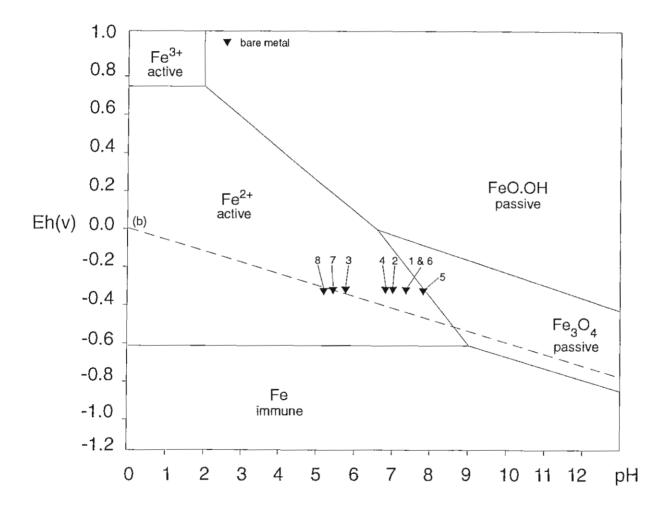
Figure 6. Pourbaix diagram for iron (10⁻⁶M) in aerobic sea water at 25°C indicating the state of iron objects on the *Alacrity* site.

These points on the Pourbaix diagram for iron in aerobic sea water indicate that these iron fittings are actively corroding. The major phase in wrought iron is ferrite with strips of slag incorporated into the structure during the manufacturing process. The corrosion of wrought iron does not leave a coherent
