# ROTTNEST ISLAND: MARITIME CULTURAL HERITAGE ANALYSIS AND MANAGEMENT PLAN-2002

Edited by: Matthew Gainsford

Department of Maritime Archaeology, Western Australian Maritime Museum  
2002 Post Graduate Diploma of Maritime Archaeology

Report—Department of Maritime Archaeology  
Western Australian Maritime Museum No. 190.

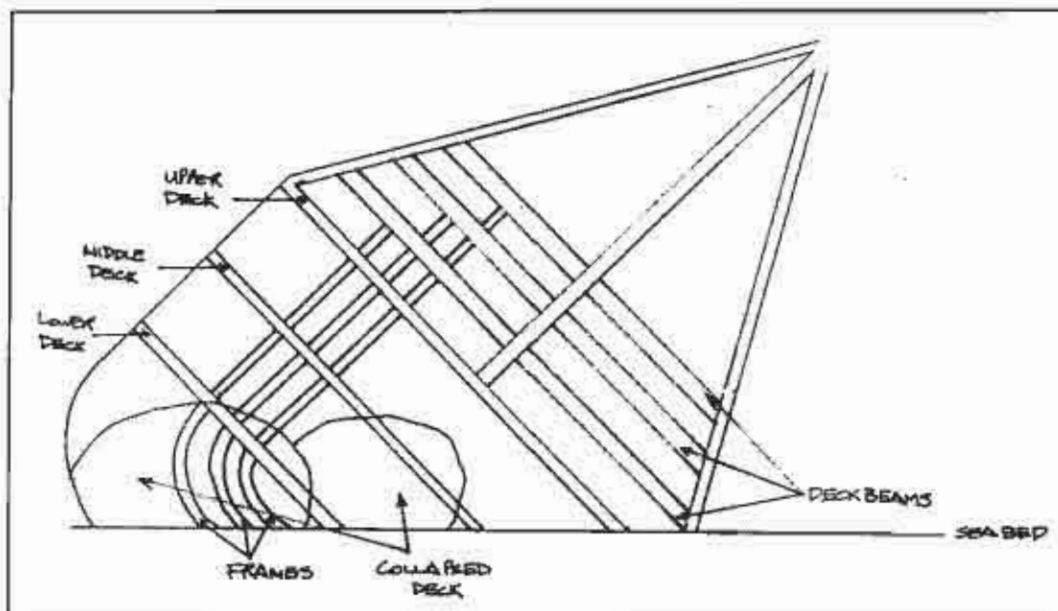
Figure 7. Sketch of the collapsed bow of the Denton Holme (not to scale)

A significant part of the site is scattered with low relief close to and on top of the reef, with the exception of the bow. The majority of the site is concreted to the reef and is indistinguishable from it. The bow is the most susceptible to deterioration from its relief, influenced by the currents and swell. The other sections of the wreck—for example the strakes—would theoretically corrode at a slower rate than the bow due to their decreased exposure to turbulent moving water.

Measurement of corrosion levels of the upper and lower bow and strakes—port and starboard at more than one location—would provide a reliable indication to the rate of deterioration. It would be possible to attach an anode(s) to the bow to restrict corrosion, if indeed. This should be the fastest corroding area of the vessel. Move the plaque—with site plan—to a more suitable area; and clean the second plaque, with the text only. Examine the site and the plaques every few years to determine whether a different management plan needs to be enforced. During this periodical examination of the site, the cleaning of the plaques would help it function properly as an information tool for the public: conducted in conjunction with the annual Maritime Archaeological Association of Western Australia's (MAAWA) plaque cleaning fieldtrip.

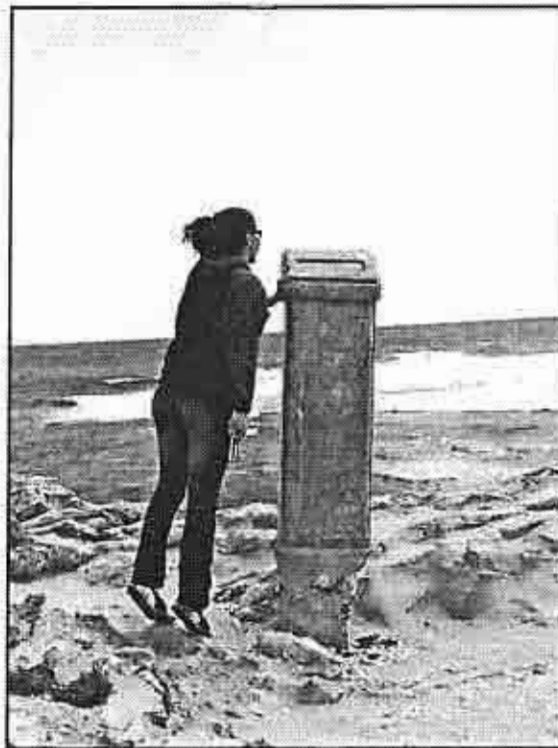
Figure 20. Shows the plaque is too high

The plinth for the *Antira II* is constructed of concrete with a brass plaque attached to its face with the vessels' description etched into its surface. However, the land has eroded away from the plinth and now the steps are visible. This erosion combined with its construction, have resulted in it becoming too tall for a significant selection of readers, especially children. Erosion around the plinth has also caused it to become unstable, with it wobbling side to side.

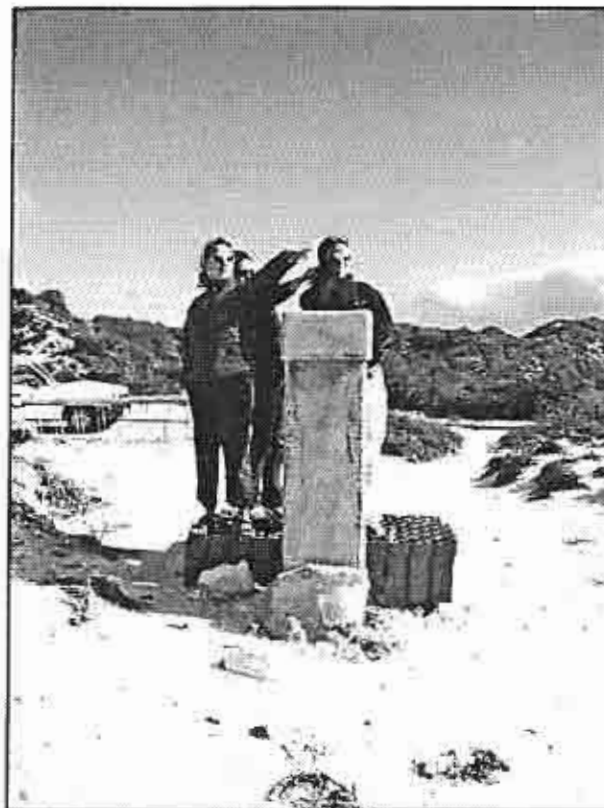
Again, this is an example where the base of a plinth is eroding away and the condition of the plinth could be better. There are stairs so that the public can see the plaque but these are undesirable and need improving. Aside from this, the plinth is in a reasonable condition.

Figure 22. Erosion around the base

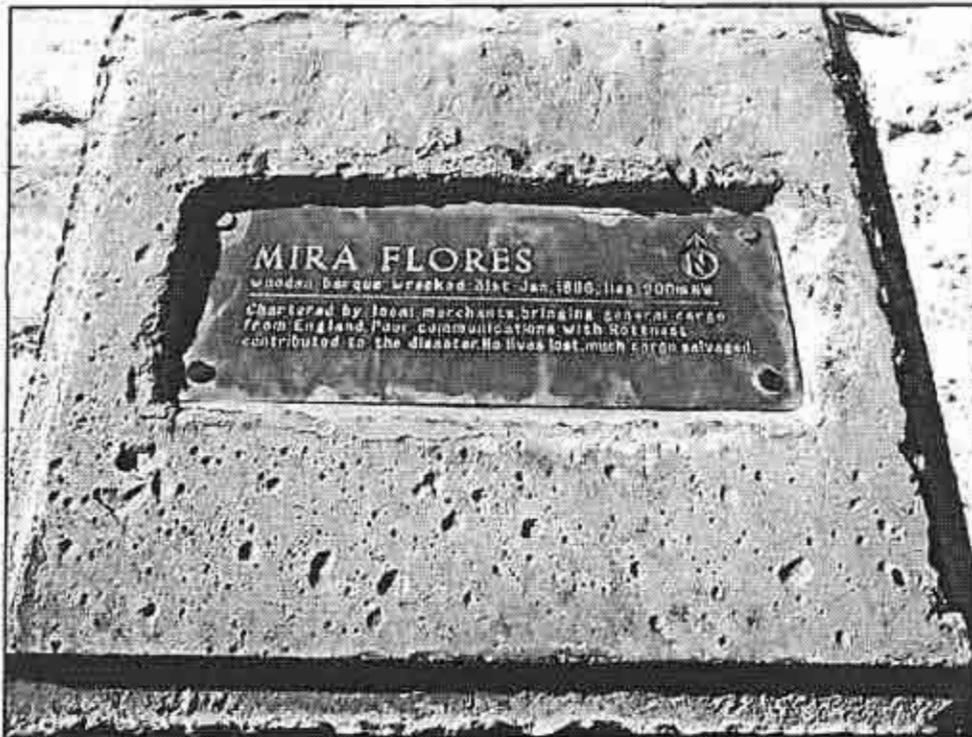
Figure 23. Plaque condition

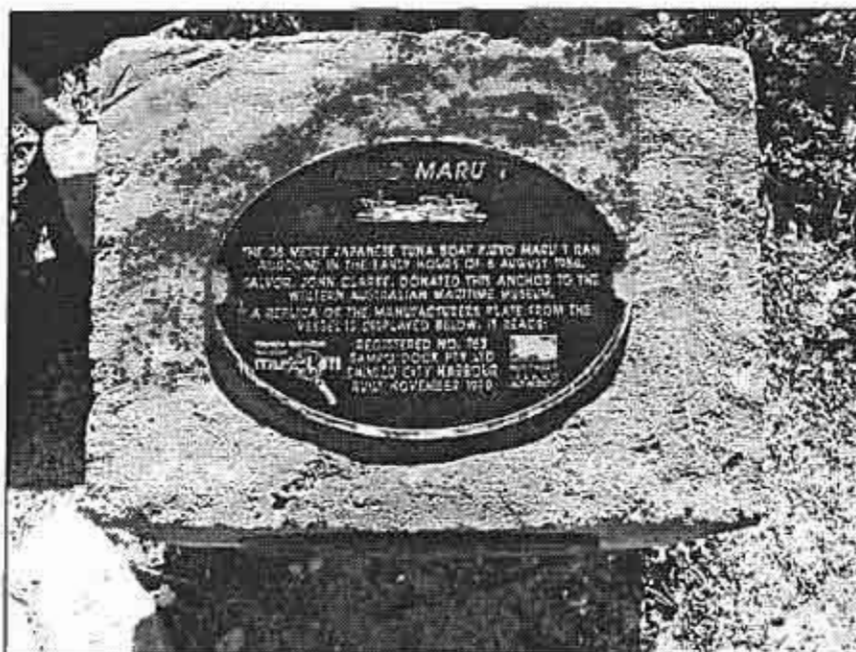
Figure 24. The Kiryo Maru plaque

This plinth is hard to see from the roadside. It is in a position that would make it difficult for the public to interpret in a reasonable fashion and there is a lack of association of the plaque to the site. The position of the plinth does not correspond to where the wreck lies and therefore there should be a better link between these so the public can actually witness the sites exact location.

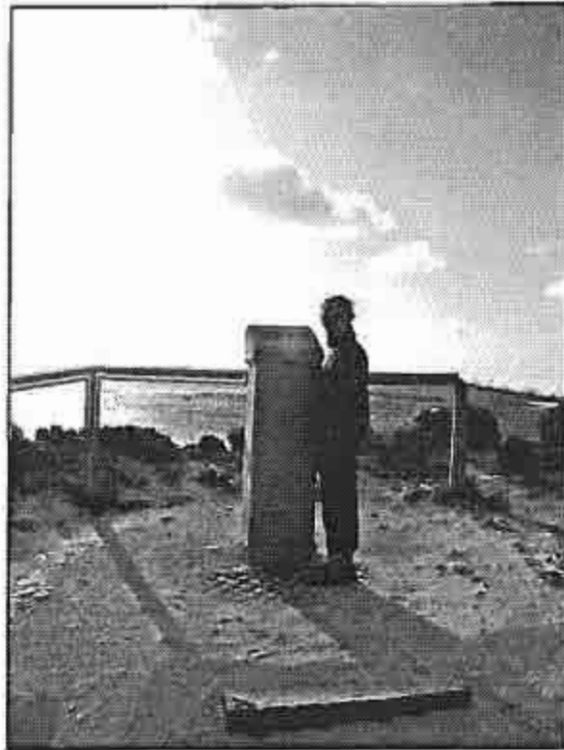
This plinth is at an easier height to reach, read and presents itself to the public in a form that is easier to interpret. The plinth and plaque are also in a better condition and are more aesthetic for the public.

Figure 26. Plinth is a better height

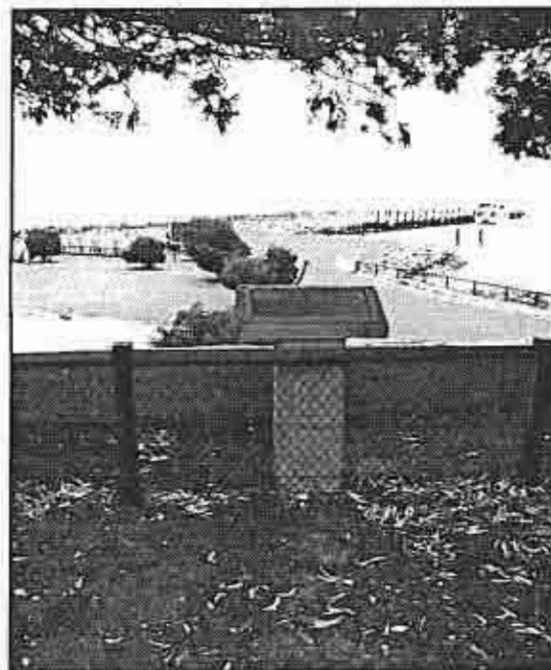
The Transit Reef wrecks—*Macedon*, *Denton Holme*, *Janet*, *Gem* and the *Transit*—are described on the same plinth. The plinth's location makes it difficult for anyone to find easily. To locate it you have to walk across an area covered by trees that obscure it and then contend with a fence that obstructs it. This could be rectified by more adequate signage; a path to the plinth; or removal of the plinth to another area that is easier to locate. The plinth itself however, apart from its location, is at a good reading height. The condition of the plaque and plinth is adequate with some flaking and crumbling. There is also graffiti on its surface. The plinth should be moved to a better location that dissuades people from abusing it.

Figure 28. The plinth is in a difficult location

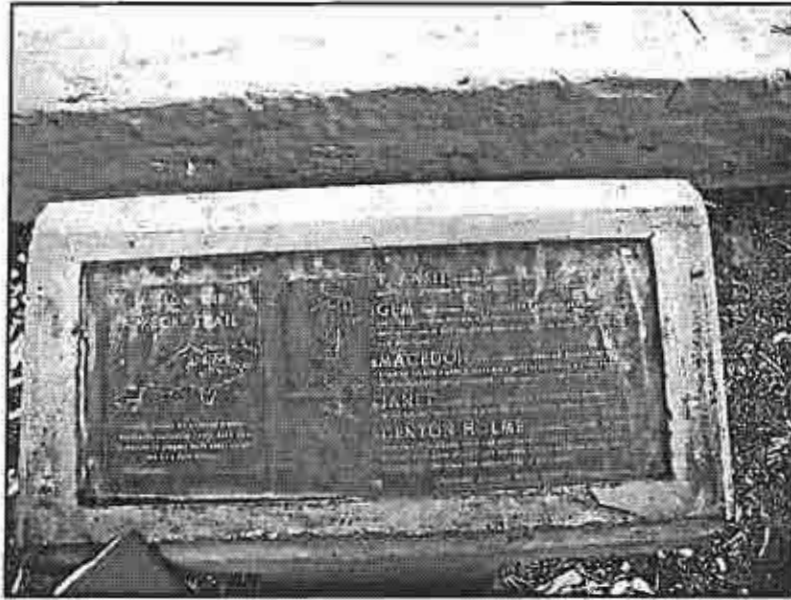
Figure 29. The plinth is also degrading

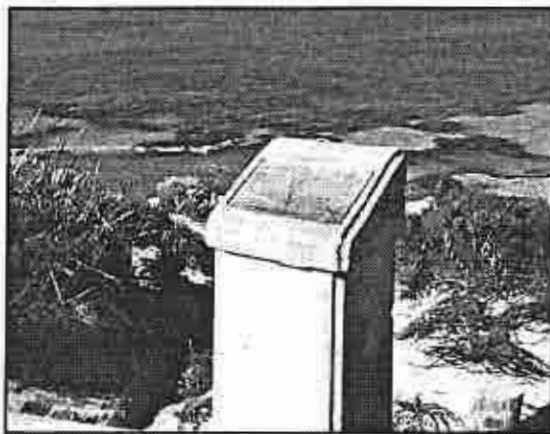
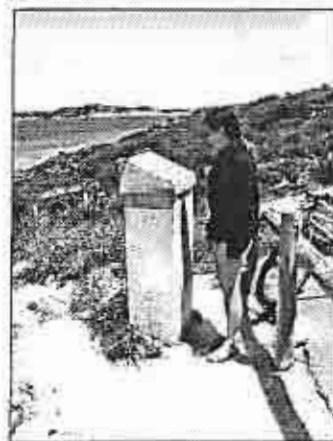
Figure 30. The plinth for the *Lady Elizabeth, Raven and Shark*

There is one plinth for these wrecks that all lie within the same area. The plinth is in a reasonable condition but it is degrading, evidenced from concrete crumbling away from it. The information plaque—like the other plinths—is in a good location, its content read easily and frequently visited by tourists to the island. The height of this plinth is ideal and most of the public should be able to read it easily.

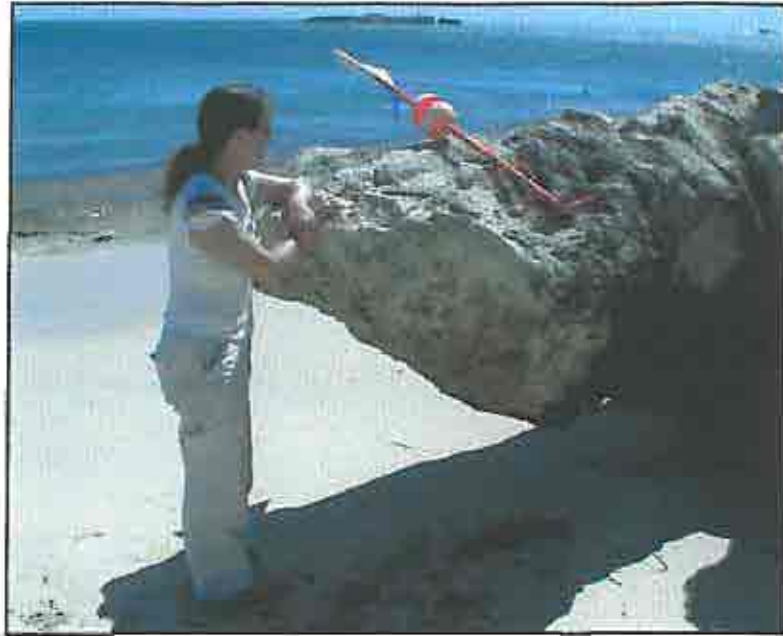
The *Uribes* wreck site has a plaque but no plinth associated with it. The plaque is hard to locate and once located it was small with little information about the site. There are a number of enforceable alterations to make this site more user friendly. A larger plaque on the site is needed; or even some description of plinth so that the public are aware of the wreck site. In addition, the plaque or plinth needs to be in an easily seen location.

Figure 31. The plaque is hard to locate

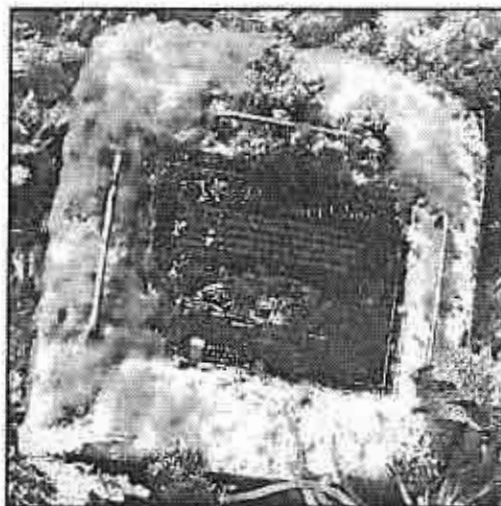
Figure 34. The small plinth on the *Denton Holme* site

There are two plinths associated with the site. One lays just behind the bow that is a small plinth with a plan of the site. The second is located on the starboard side of the bow away from the majority of wreckage. Both seem to be in a reasonable to good condition but the smaller one amongst the wreckage is easily missed.

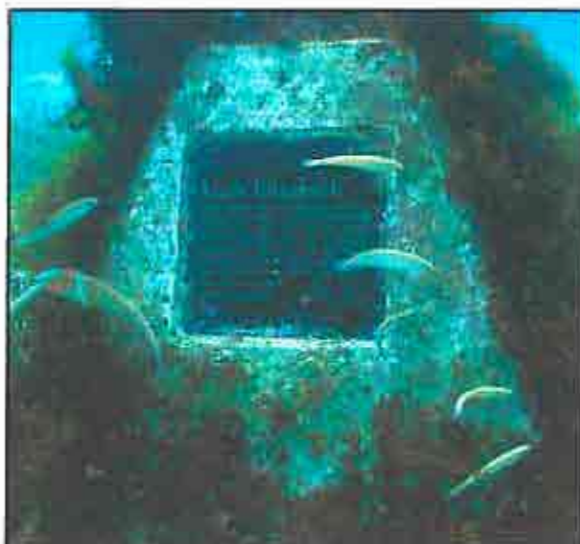
Figure 35. The *Lady Elizabeth* plinth

The plinth on the *Lady Elizabeth* is located towards the bow, about two thirds of the way up the vessel on the starboard side. The plinth is easily spotted and readable. The fact that it lies on the sand to the side of the wreck is its greatest attribute to its location. There is no need for a change in its location or content.

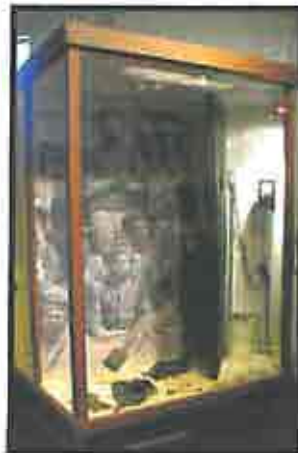
The light levels in this room exceed the maximum and minimum levels for sensitive material by as much as 650 Lux—convict cabinet—; with such high levels of light beaming into these cabinets the objects that are on show are vulnerable to increased deterioration, depending upon the material.

Figure 40. Convicts cabinet, material located in bottom. Light sources both, internal—top right hand corner—and external, reflection in the glass of five lights

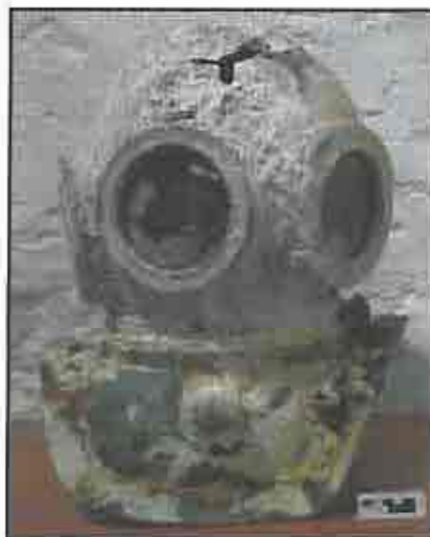
Figure 41. Diving helmet (MC1572)

Improperly supported in its cabinet is the diving helmet—MC1572—; being secured by two wires that are anchored via two screws diagonally opposite each other. While the helmet is heavy and is reasonably stable by this system of support, the cabinet in which it is housed needs maintenance to ensure that the screws hold the perspex in place over the helmet. Possible deterioration is evidenced on the breastplate and top of the helmet. It appears as rust forming on the breastplate and white residue forming on the top of the helmet.

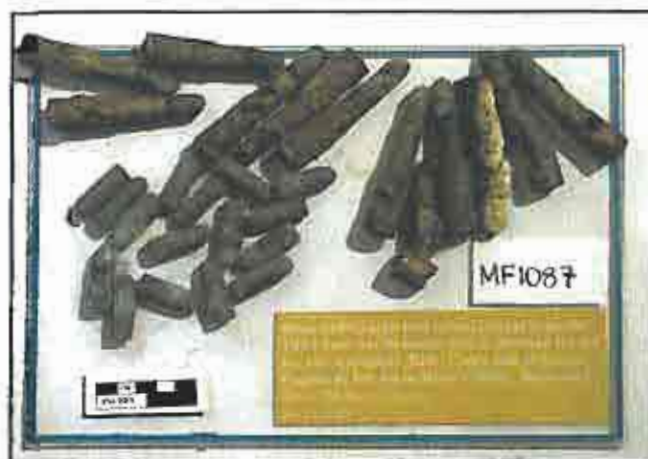
Figure 42. Bullets from the *Mira Flores* (MF1087)

The bullets from the *Mira Flores*—MF1087—as previously stated contain lead. Being in contact or association with chipboard, an increase in the deterioration of these objects can occur, also this can affect other materials in the same cabinet through the release of vapours—from the wood—. White residue is evident on the casings and lead projectiles in the collection, due to possible deterioration from the release of gas from the chipboard.

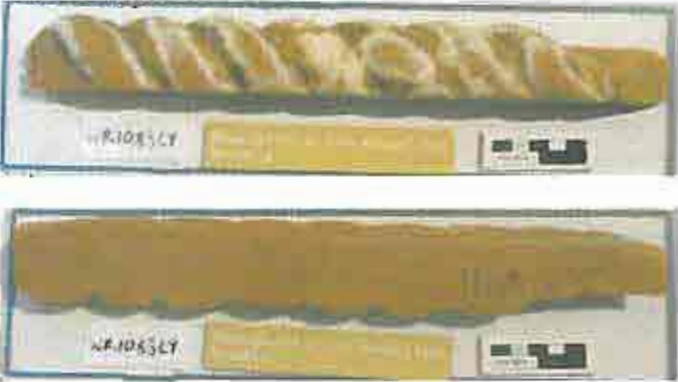
<b>Condition</b> Overall, wood condition is good. Appears to have dried uniformly, no cracking. Top layer of gilt appears to have flaked off rather than worn off, mainly on exposed areas.			
<b>Comment</b> Incorrect reference number on artefact (CY 1083) should be CY2579.			
EXAMINER		DATE	
LOCATION

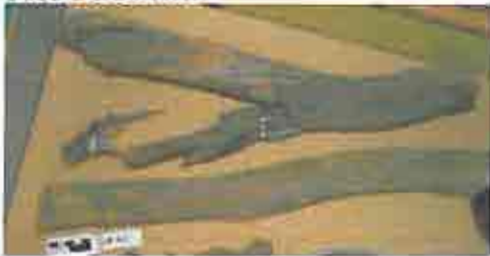
<b>Condition</b> Covered in white powder and crumbling. Timber falling apart.			
<b>Comment</b> 			
EXAMINER		DATE	
LOCATION

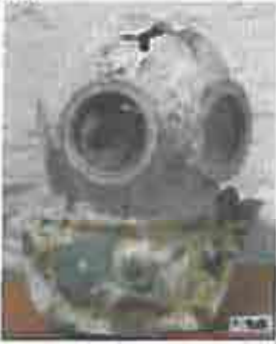
<b>Condition</b> Helmet twisted and cracked,			
<b>Comment</b> Tested for surface chloride concentration (1) 21.1ppm front left side of skirt (2) 5ppm right shoulder of skirt (3) 6ppm exposed metal front left side of skirt			
EXAMINER		DATE	
LOCATION

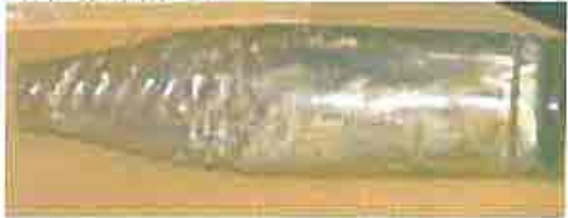
<b>Condition</b> Good overall condition. Top of the bottle has been broken off. Shiny patina (rainbow hue) is apparent so glass products may be coming out. No cracks.			
<b>Comment</b> This artefact does not appear to be deteriorating extensively. Reg no is clear.			
EXAMINER		DATE	
LOCATION

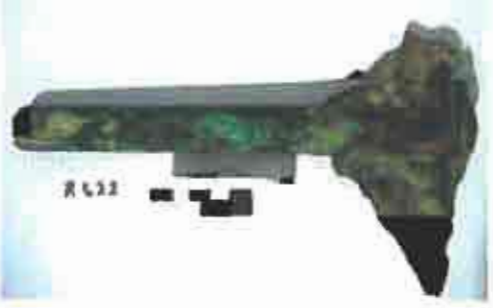
<b>Condition</b> Copper oxide and copper hydroxy, copper sulphide in evidence (copper corrosion products). Bolt has extensive pitting along its length. Not much wood left around the bolt but what is left appears in reasonable condition the wood will be full of copper corrosion products.			
<b>Comment</b> Reasonable example			
EXAMINER		DATE	
LOCATION

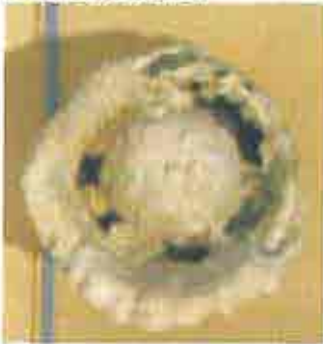
<b>Condition</b> Heavily concreted appears to show remnants of marine borers. Does not appear to have been treated. This may be in danger of laminating.			
<b>Comment</b> May not necessarily need treatment.			
EXAMINER		DATE	
LOCATION

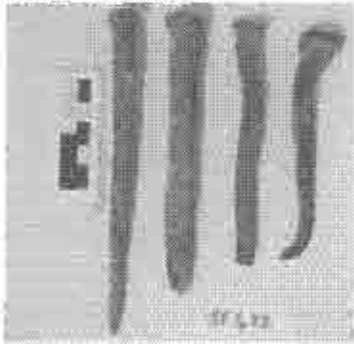
<b>Condition</b> Iron corrosion evident on surfaces.			
<b>Comment</b>			
EXAMINER		DATE	
LOCATION

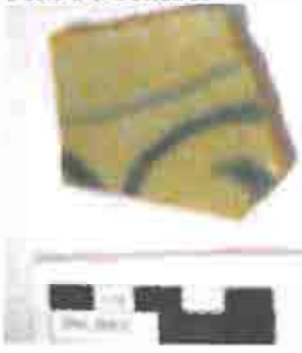
<b>Condition</b> Fine brown lines through glaze, chipping of surfaces.			
<b>Comment</b>  			
EXAMINER		DATE	
LOCATION

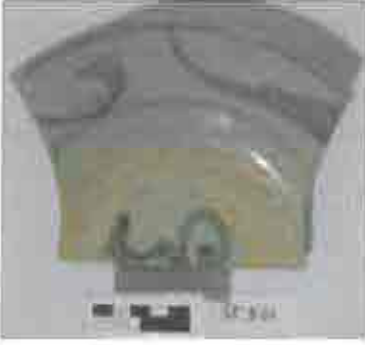
Fine brown cracks forming through glaze. Broken area glued back on.			
<b>Comment</b>			
EXAMINER		DATE	
LOCATION

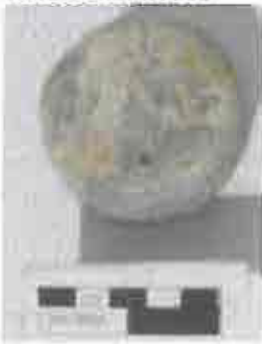
<b>Condition</b> Covered in white powder, forming on edges.			
<b>Comment</b>			
EXAMINER		DATE	
LOCATION

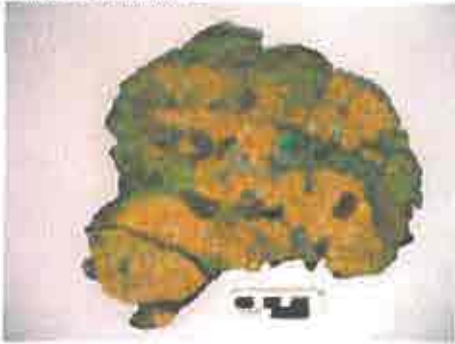
<b>Condition</b> Corrosion products (copper) along the copper and around the nails. Bits of the matting quite brittle but does not appear to be breaking off.			
<b>Comment</b> 			
EXAMINER		DATE	
LOCATION
