Direction Island Unidentified (Cocos Keeling Islands)  
Inspection Report

## Technical Data

**Site Name:** *Direction Island unidentified.*

**Date of Inspection:** 2/11/2004

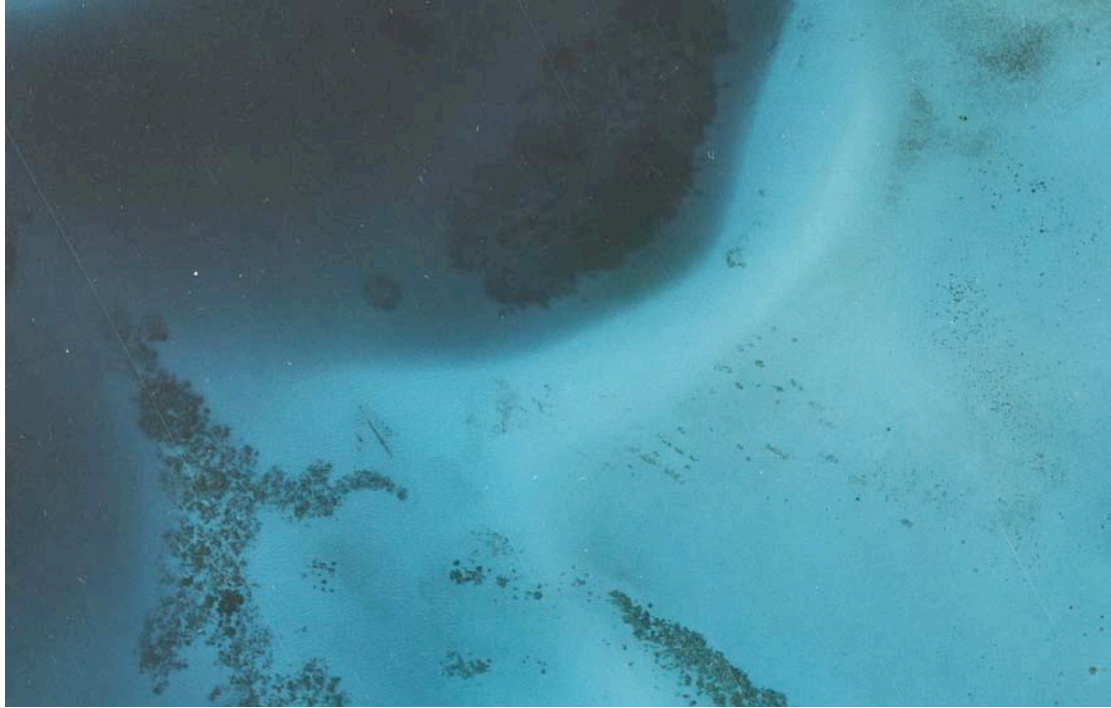
**A satellite image of the wreck site (1987).** Courtesy Parks Australia

Note: The line of the keelson is clearly visible as a distinct dark line on the seabed. The cause of the inverted 'V' shape at the top of the line is unknown at present. (See recommendations)

3. A wreck map and information pamphlets on this and on other maritime sites in the region should be produced.
4. A test excavation in order to ascertain the full extent of the remains could be performed. The cause of the 'V' shape apparent in the satellite image above needs also be ascertained. Further analyses (timber type and dimensions, fastening sizes and composition &c) would also be conducted in order to assist in better identifying the site.

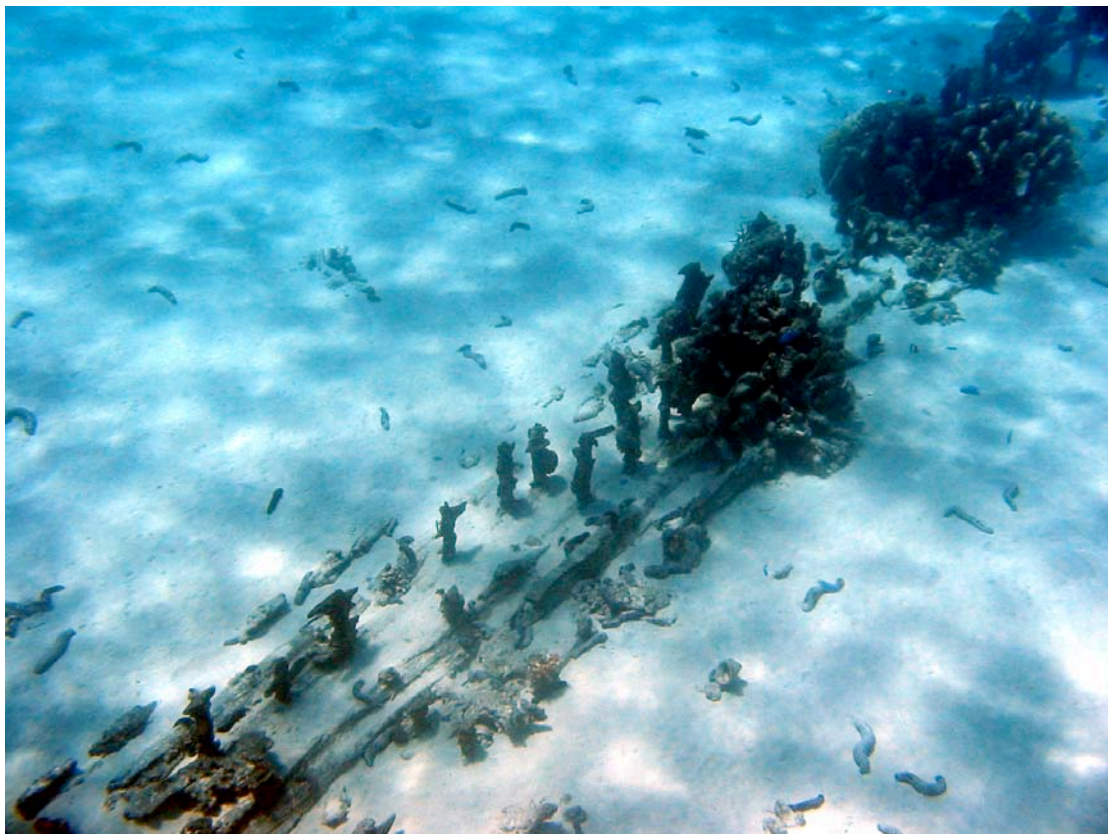
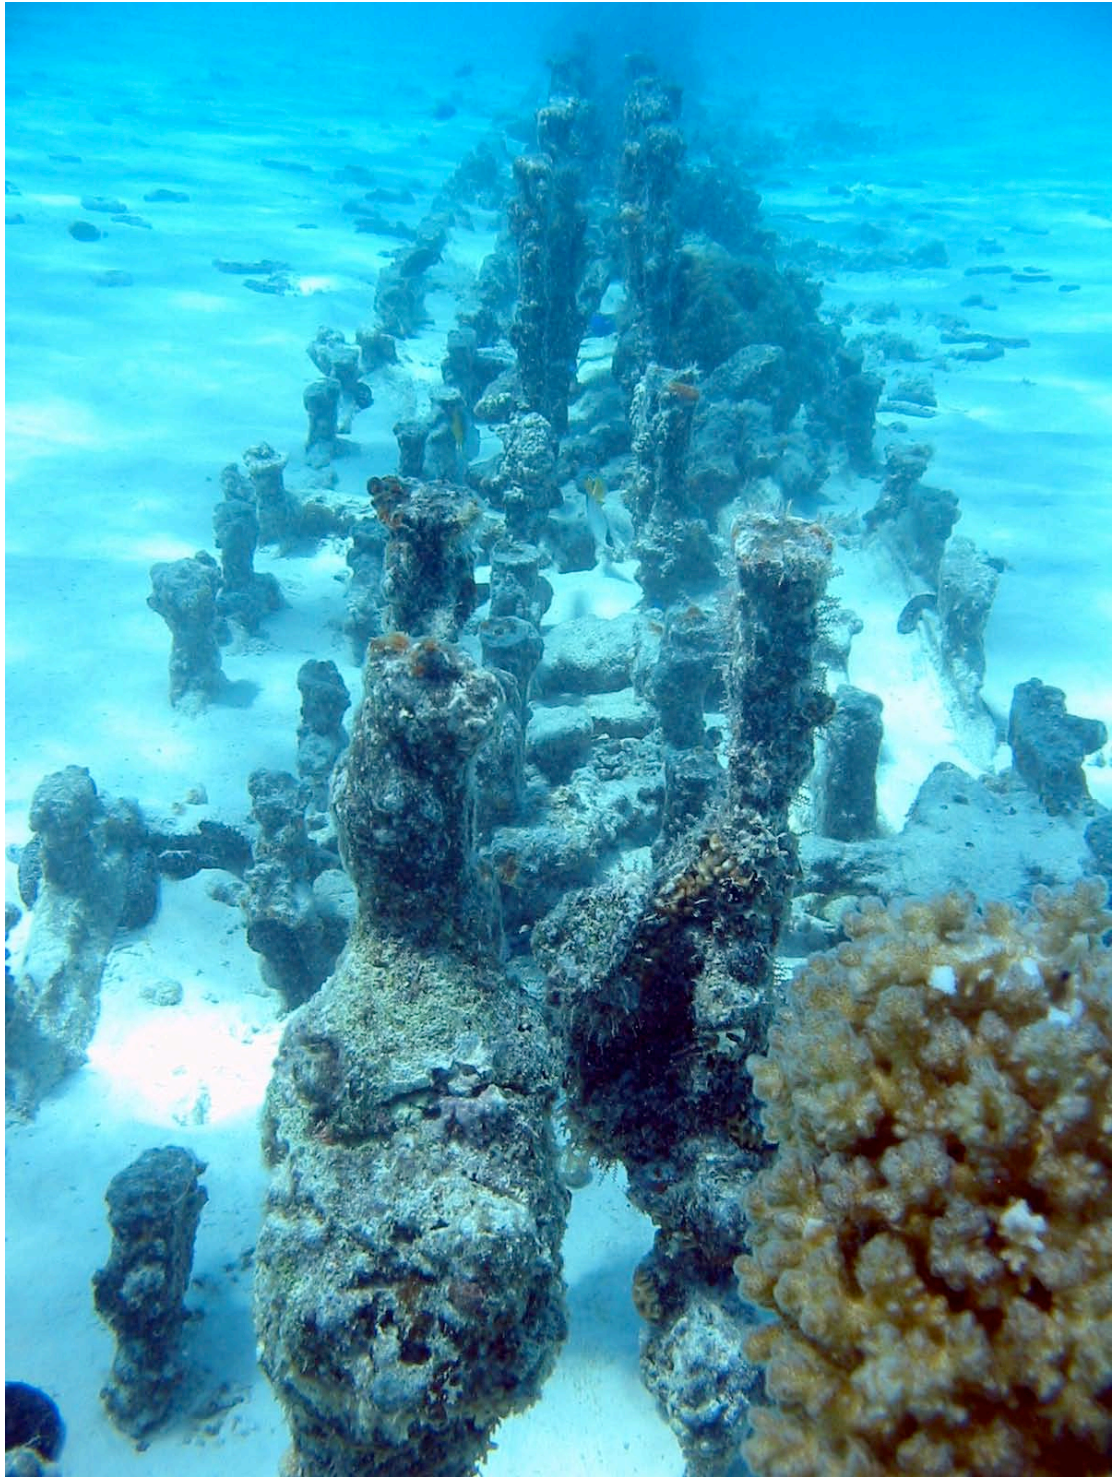
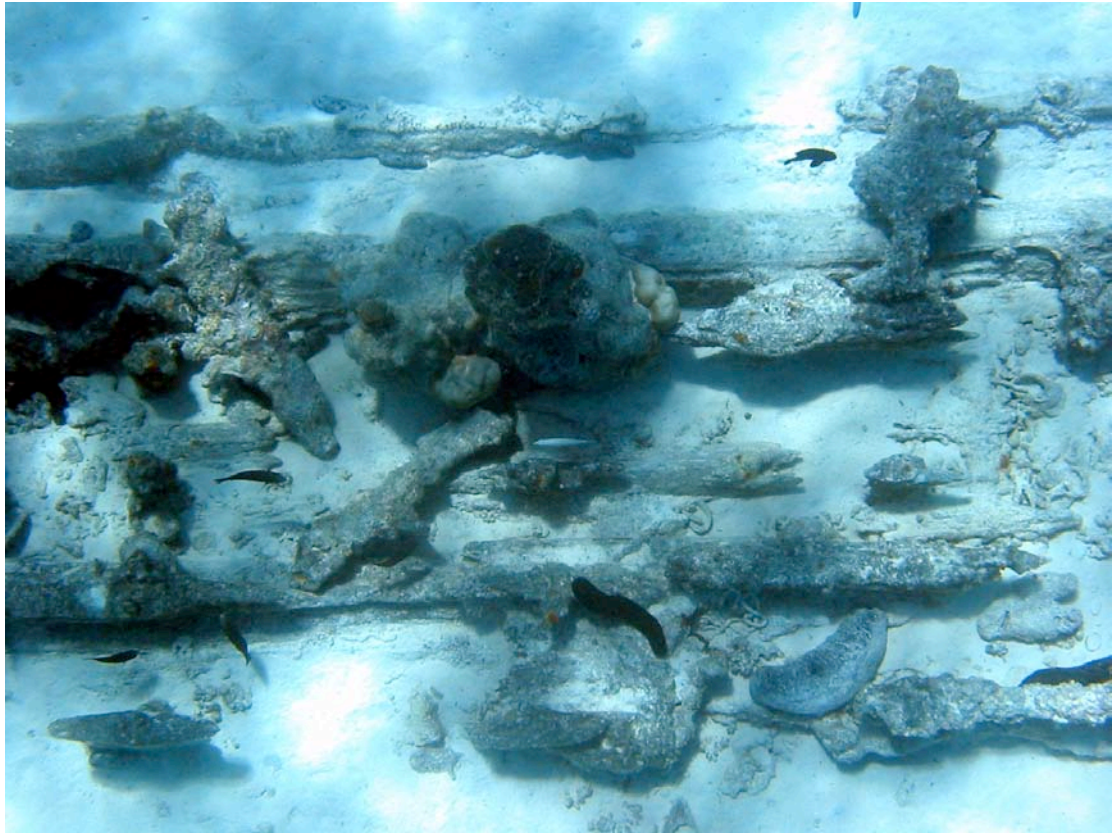
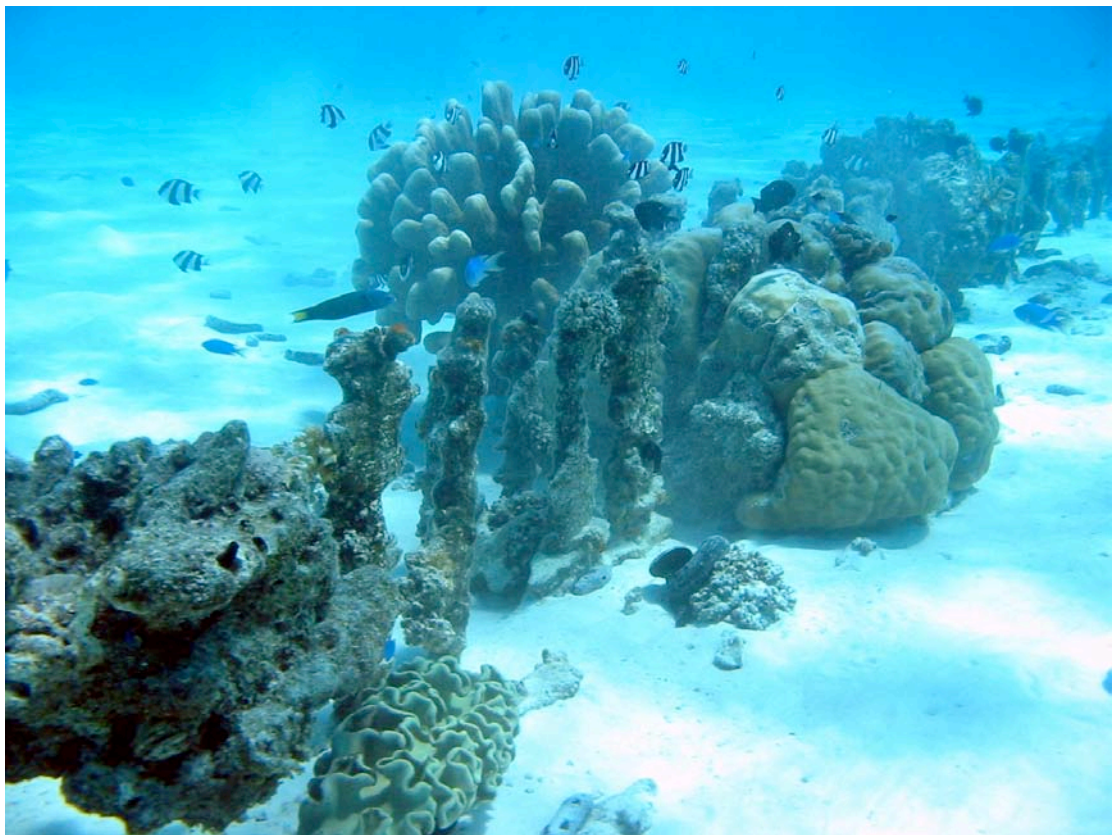
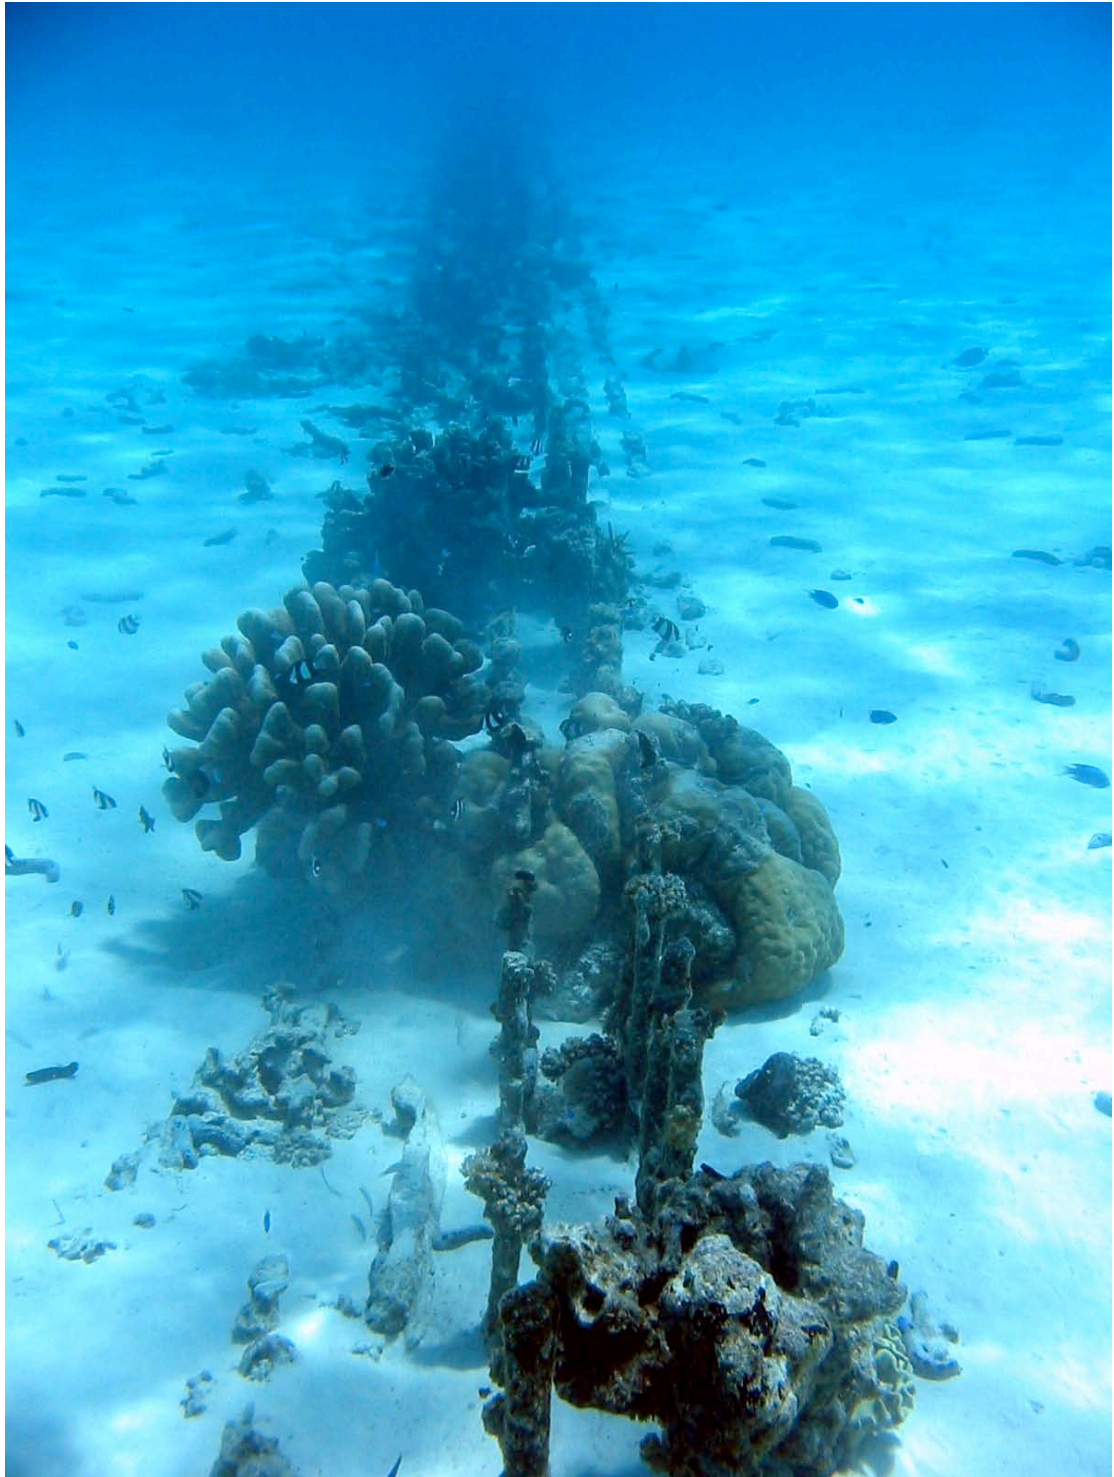
**Views of the Site (R.Thorn)**

This wreck is visible from the surface on a clear day, appearing as a distinct NW/SE line on the sandy bottom just south of Direction Island. Underwater it appears as six rows of concreted iron keel/keelson bolts in 3.8m of water running across hard compacted sand. The bolts, projecting upright through the sand are all of iron and are in lines of three pairs each, all running for 40 metres. One is a central pair rising c.30cm above the sand and others either side of it each rising c.10cm from the sand. Some are colonised by coral,

Appearing at first glance as the remains of an old jetty or similar structure, they are on closer investigation those of a keelson, once supported by sister-keelsons either side. Hand fanning to reveal buried structure adjacent the keelson(s) was difficult due to the hard and compacted nature of the sediment. Nonetheless, there are indications of some floor timbers and a wide, but thin (c. 2 inches thick), planking, alongside the keelson. Being of scantlings too small for ceiling or outer planking in vessels of this size, this timber is possibly a limber strake—a removable plank fitted next to the keelson to clear debris collecting in the bilge. Two timber samples were taken, one of this strake and the other of what appears to be a frame, albeit with considerable difficulty. Across the sand, there were surface indications of more timber under the sediments, though this was not adequately tested, given the difficulties of test excavation without water dredge or airlift equipment. No other clues were visible above the sea floor, though disturbances in the natural contours of the seabed a few
