## Alcoa Jetty Wreck Survey Report 2005

## Introduction

This report concerns a survey carried out on what is known as the Alcoa Jetty Wreck. The survey took place between the dates of 26 April to 18 May, 2005. The primary goal was to produce a survey plan that updates a previous survey carried out in 1987 (See below). Secondary goals were to attempt a more positive identification of the wreck through the use of historical documents and analysis of the material remains. The outcomes were to be able to provide a report on the nature of the site for use by future researchers, as well as a subsequent article for publication in a journal and to provide a report of a sufficient standard to complete the second stage of a Nautical Archaeology Society training program.

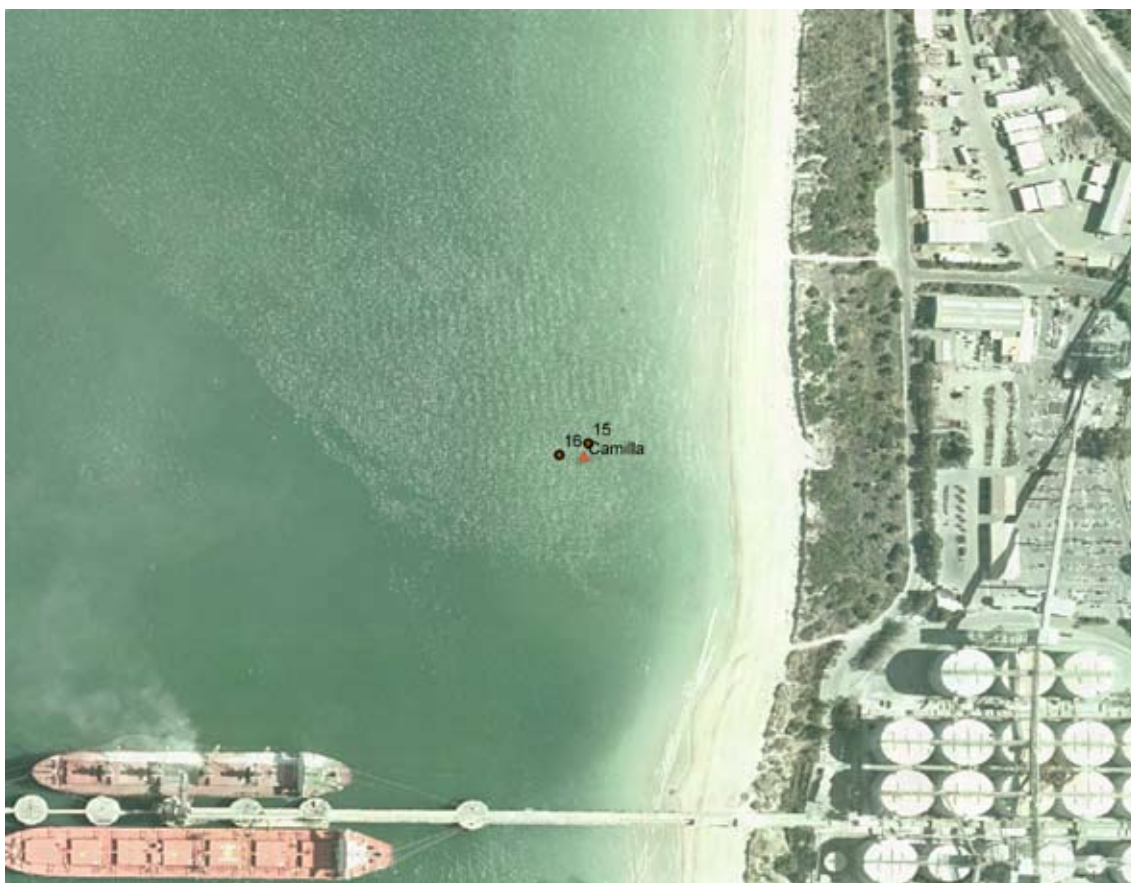
Figure 2. Survey of *Camilla* wreck site.  
#15 S 32.18642931 E 115.77554114 #16 S 32.18636053 E 115.77571365

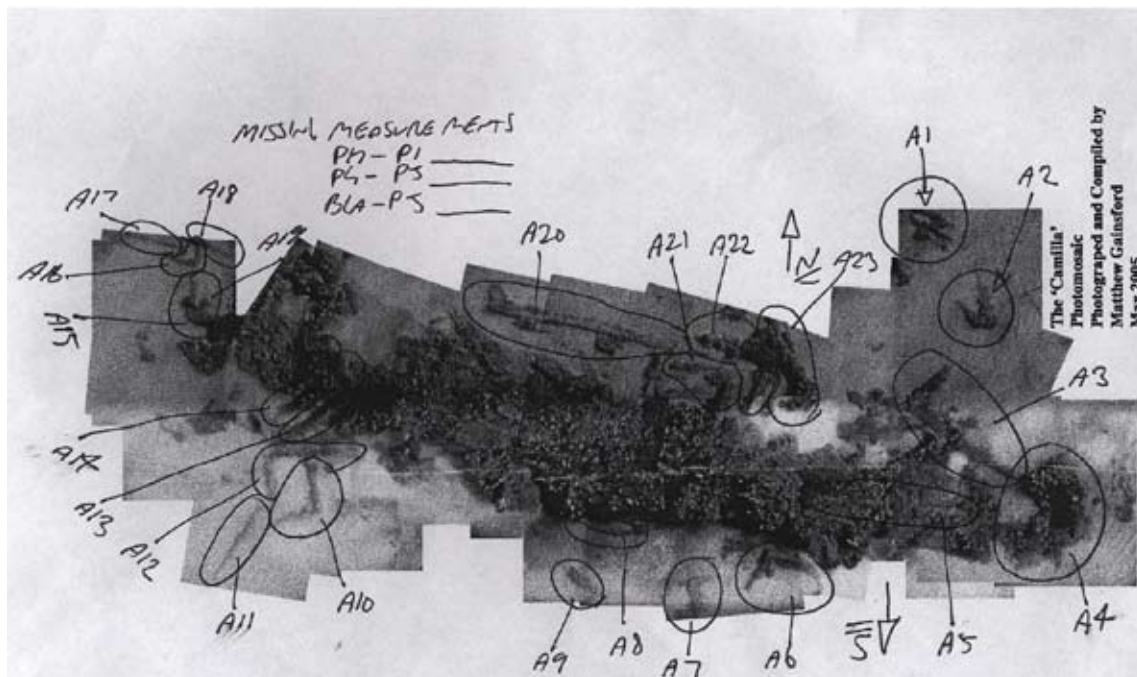
Figure 5. Artefact targeting

From the photomosaic a number of debris artefacts were designated (Figure 5). These shapes were isolated and transferred to two boards, to enable two teams to work simultaneously. In the main the extremities for each of the artifacts were chosen as measuring points. Added to the board were table of the measurements to be taken from the various control points. Again, the angles were taken into account as demanded by the Site Surveyor program. Enough measurements were included to account for redundancy, providing some backup in the event of errors being made (Figure 6).

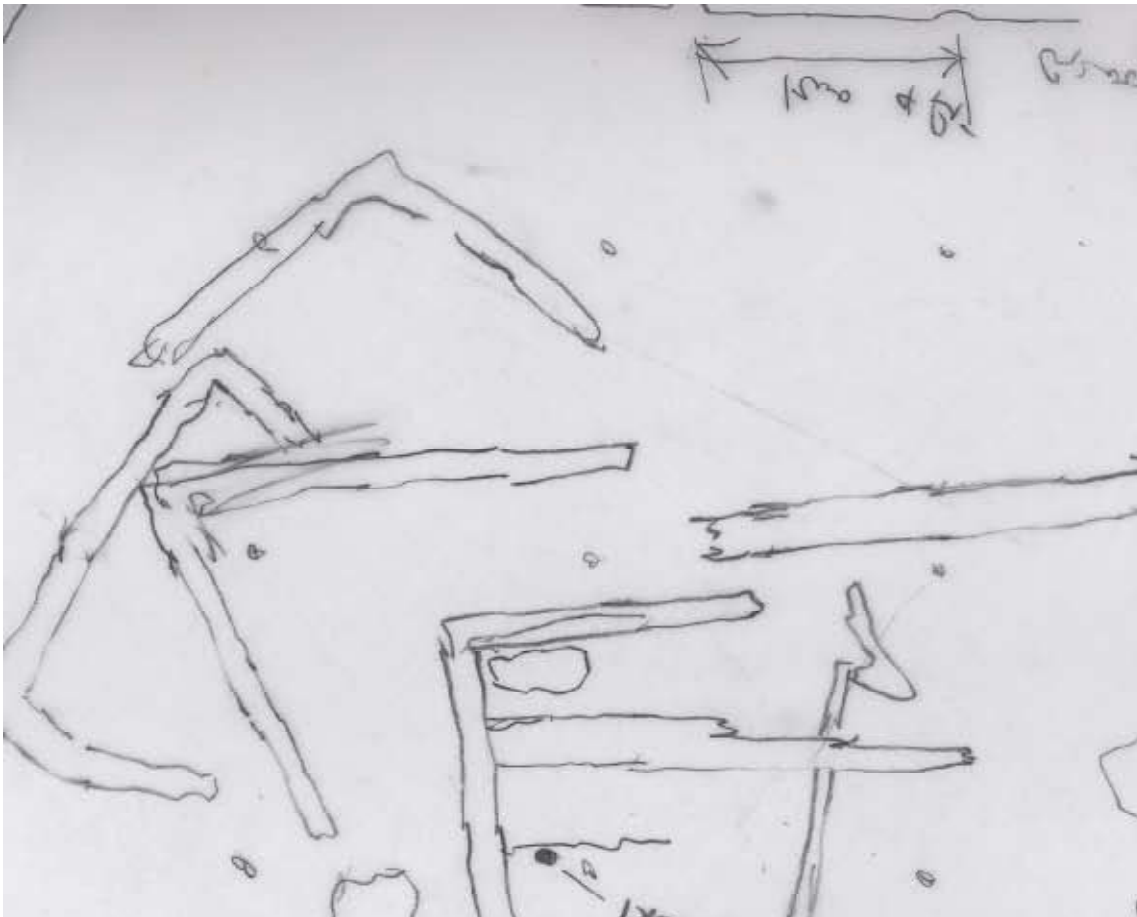
Figure 9. Example of drawing (C. Cockram).

Those divers most confident were given the task of drawing during the last weekend of survey. Unfortunately, the weather had begun to change for the worse by that stage, and the winds were creating a surge at the location. This made the task of drawing a little more difficult and the visibility poorer than usual. However, the drawings were completed to a satisfactory level under these conditions (Figure 9).

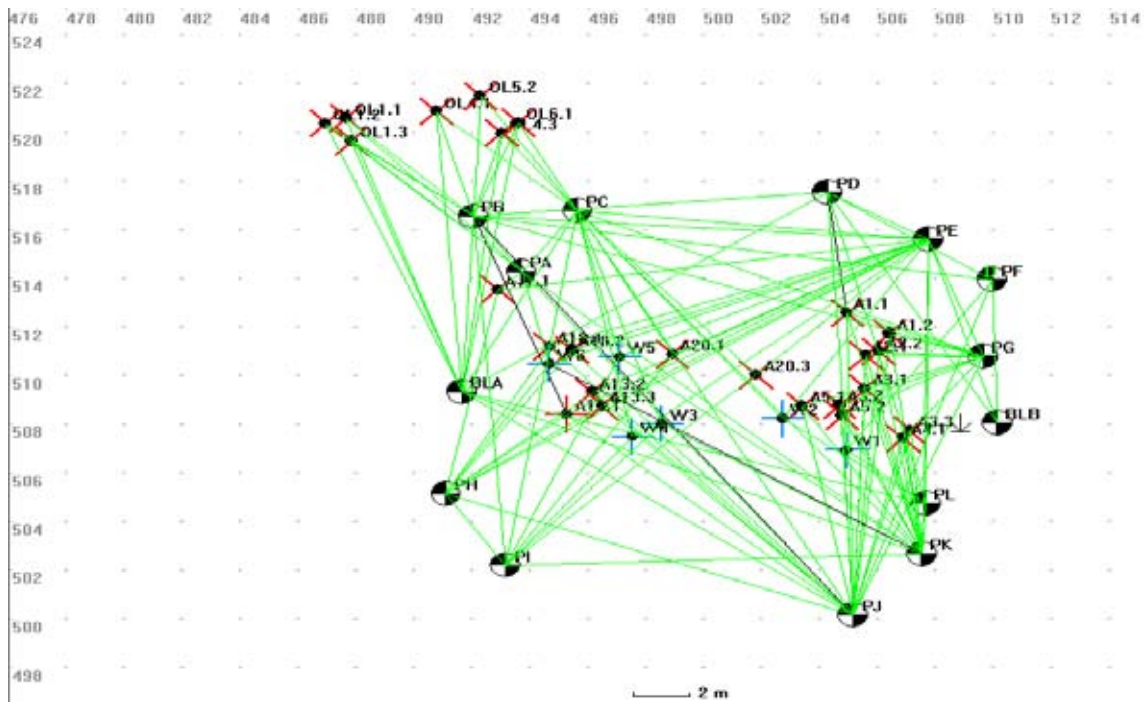
Figure 10. Site Surveyor results.

Once all of the measurements were gathered together they were entered into the Site Surveyor program (figure ten). At this stage the advantages of having so many measurements became apparent. Although many of the measurements and so corresponding angles were accepted, many were not and had to be discarded. However, through this process of enabled redundancy, there were enough accepted results to make out the perimeter of the wreck itself, and much of the surrounding debris.

There was a collection of iron knees that lay to the immediate north-west of the wreck site and that lay outside of the photomosaic. This outlying collection had been measured and drawn and so was able to be added to the site plan.
