WRECK INSPECTION REPORT

7 Mile Beach (Dongara) Unidentified¹

Department of Maritime Archaeology
Shipwreck Galleries
W. A. Museum
Cliff St. Fremantle
April 2018

Site Name: 7 Mile Beach (Dongara) Unidentified
Date lost: Post WWII

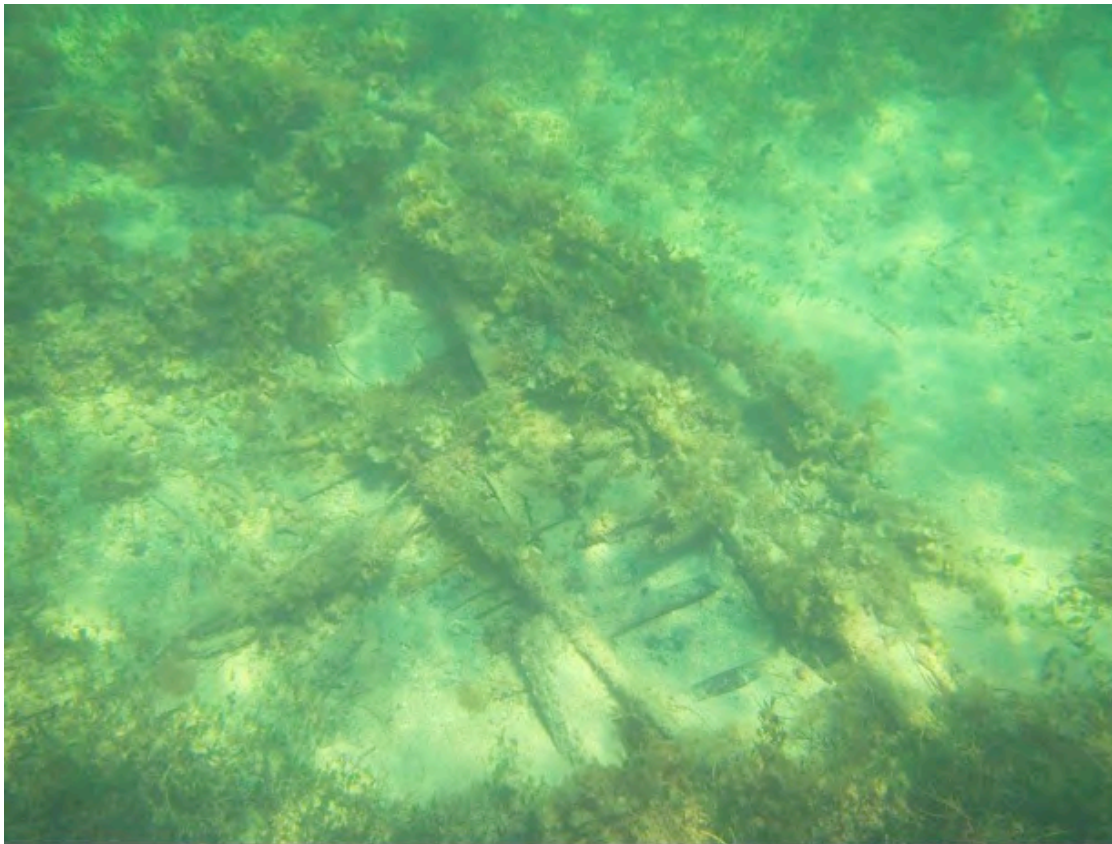
Ms Bussenschutt had reported timbers exposed on the sea bed with copper-alloy fittings, planking and other then unidentified features visible as shown in the image supplied with her report of finding (Front Cover). As advised by the finder, who is an experienced professional marine mammal observer, qualified diver and regular visitor to the area, when found the site has only recently uncovered.

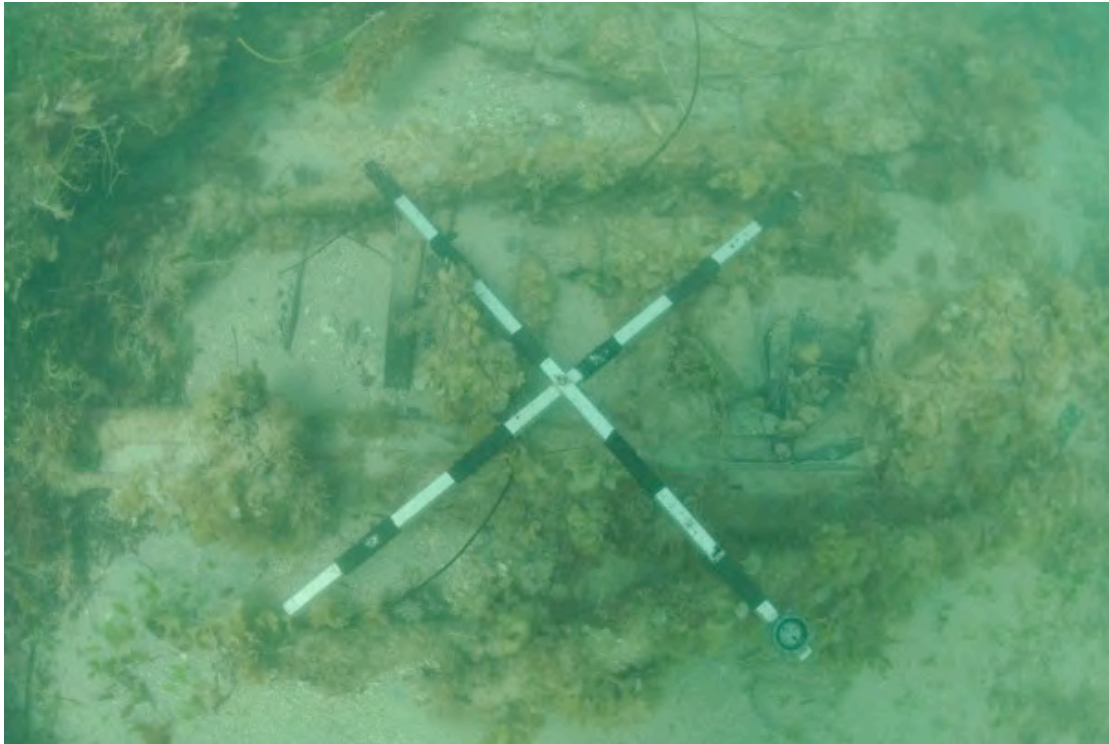
Figure 1: The wreck from above with a one metre scale. The compass on the scale is to the north (All underwater images following: Clay Bryce, WA Museum)

As can be seen from Figure 1 above and in Figure 2 following, the wreck lies on a north-west—south-east axis, with wreckage running under the high weed bank forward (LHS of the image above) and into the sloping bank to the south (top of the image). Along the bottom of the image is the keel and keelson and across the top a propeller shaft. In Figure 2 a copper alloy dovetail fastening the sternpost to the keel is visible to the right of the image. Frames (cleared of sediment by hand fanning) are visible between the propeller shaft and keelson and beneath them are the starboard planks. A loose timber, later found to be the lower part of the propeller aperture was found in the area hand fanned to the right of the image. (See Figure 7). This was later identified as Jarrah (*Eucalyptus Marginata*), a local species often used in boat building.¹

Parts of the keelson and keel project above the sloping sandy bottom at the north edge of the site (lower part of the image). The 15 cm long bone visible in the foreground was found loose on the site. Clearly, it was used for bait.

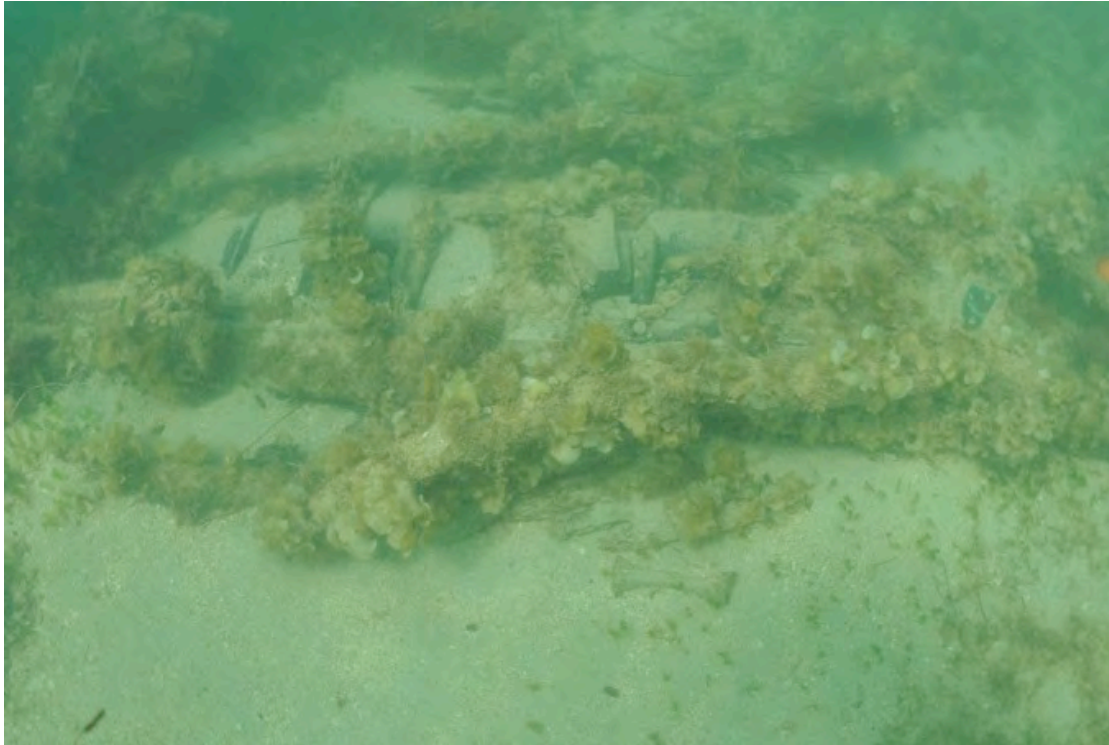
Figure 2 Showing a copper alloy dovetail fastening the sternpost to the keel to the right of the image. Frames are visible between the propeller shaft (top) and keel and beneath them are the starboard planks. The bait bone is in the foreground.

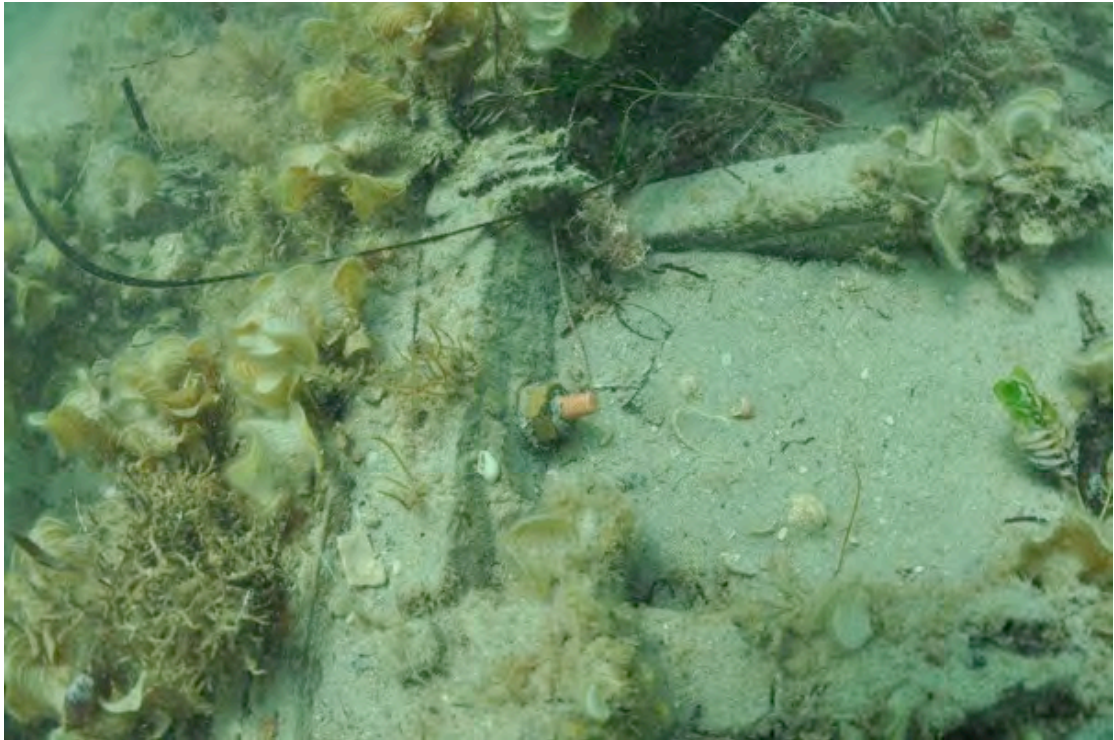
In Figure 3 a threaded copper (salmon pink in colour) keel bolt is found passing through the keel and keelson and this is fastened with a copper - alloy (golden colour) nut. In Figure 4 the copper-alloy dovetail joining keel and keelson to the sternpost dominates the image while a close examination shows that the outer planking aft is fastened with standard small boat rivets. In the Figure 5 a loose screw fastening, possibly a 'hangar bolt' of a type that once secured the engine to its bed is visible. Above it a tarpaulin, nearby lie engine control cables. Frames fastened with copper or copper-alloy boat rivets are also visible.

Figure 3: A threaded keel bolt fastened with a nut

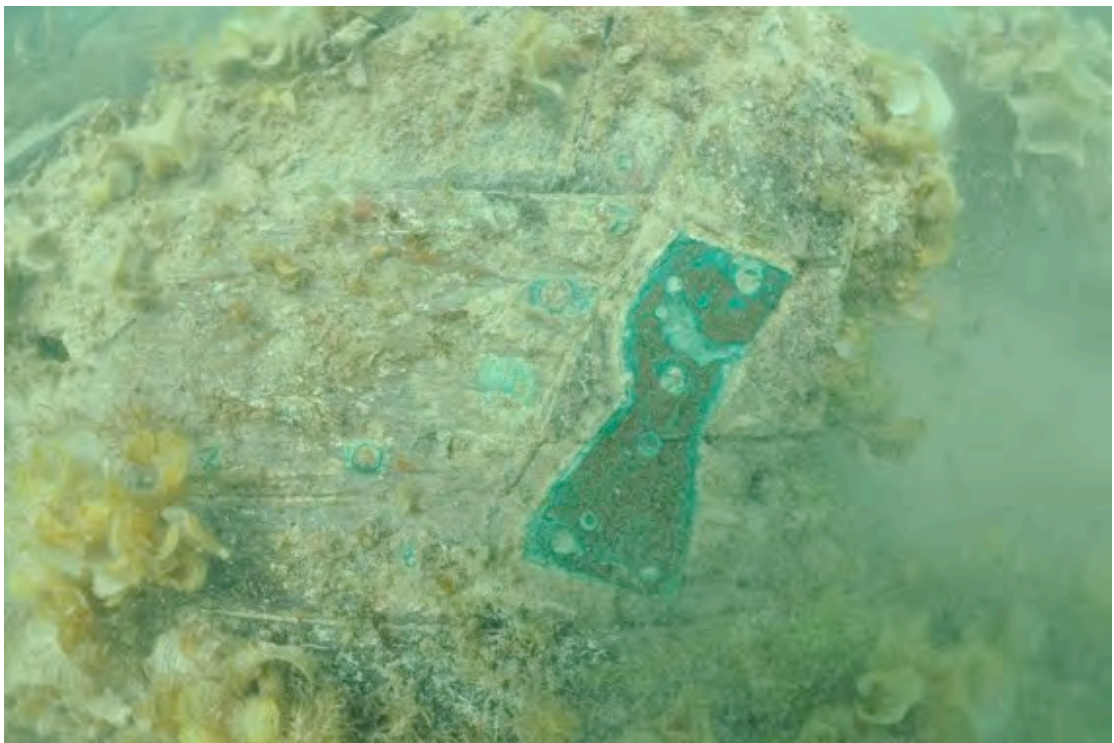
Figure 4: The copper alloy dovetail joining the keel and stempost. Inboard is a plank fastened with copper or copper alloy rivets (All are turned green with copper corrosion products).

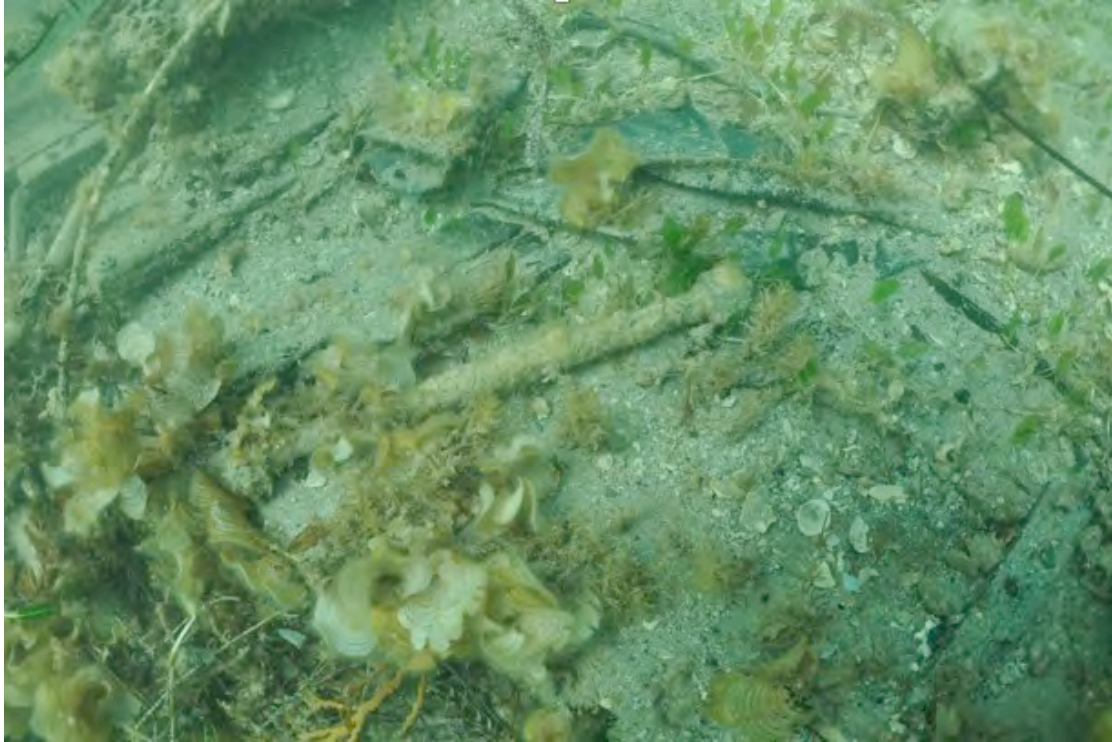
Figure 5: A threaded through bolt with nut, possibly a 'hangar bolt' used to secure and engine to the floors near a synthetic tarpaulin with grommets (centre). Frames are visible top left and bottom right.

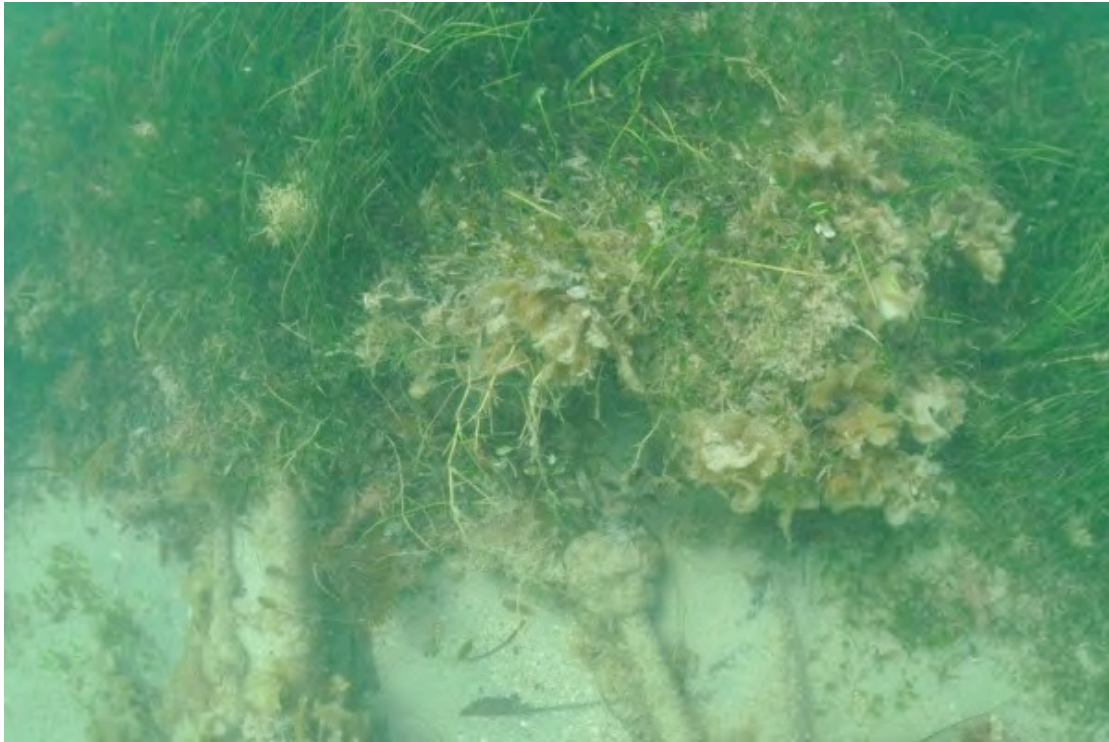
Figure 6: The heavily-colonised engine and below it the propeller shaft.

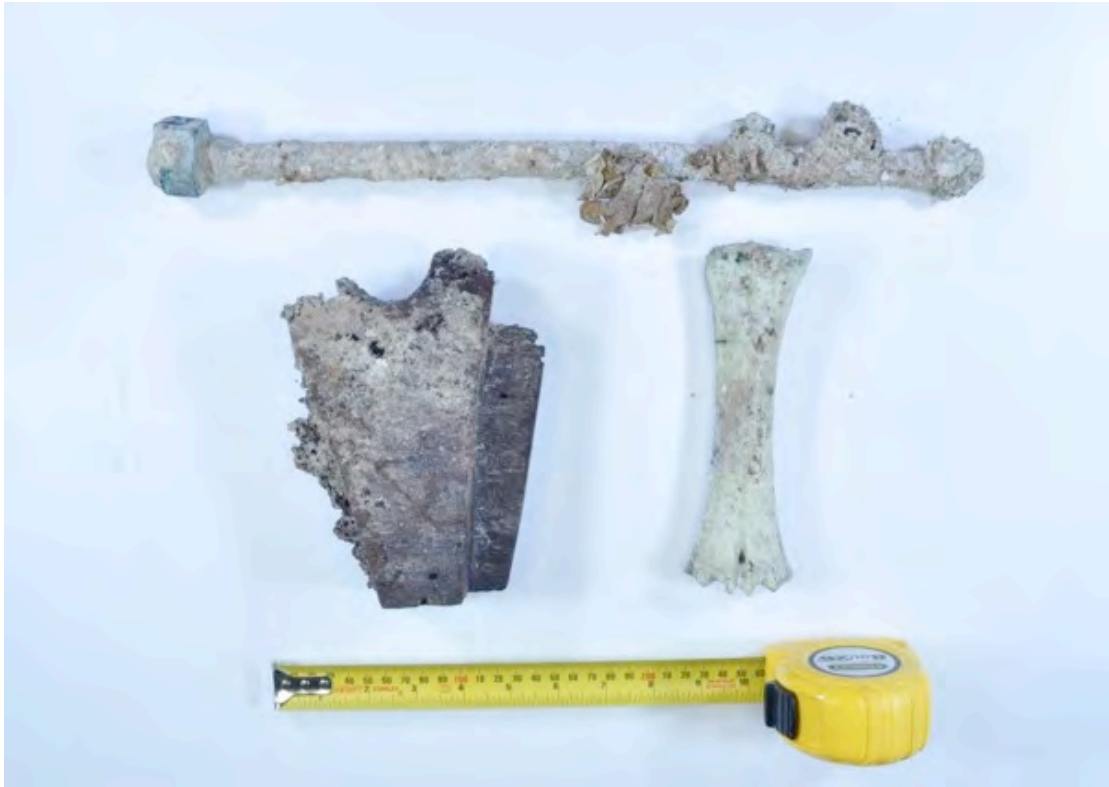
Top) Hangar bolt? (430mm by 18mm diameter, with screw thread and 35mm nut).

LHS lower) Jarrah Stern Aperture (*Eucalyptus Marginata*)

RHS lower) Animal bone (Cut longitudinally)

Figure 7: The material raised (Photo: Liam Phillips, Flinders University)
