# **Site Inspection Report**

# Cervantes (1836 - 1844)

Report No. 342 – Western Australian Museum, Department of Maritime Heritage

19 February 2024

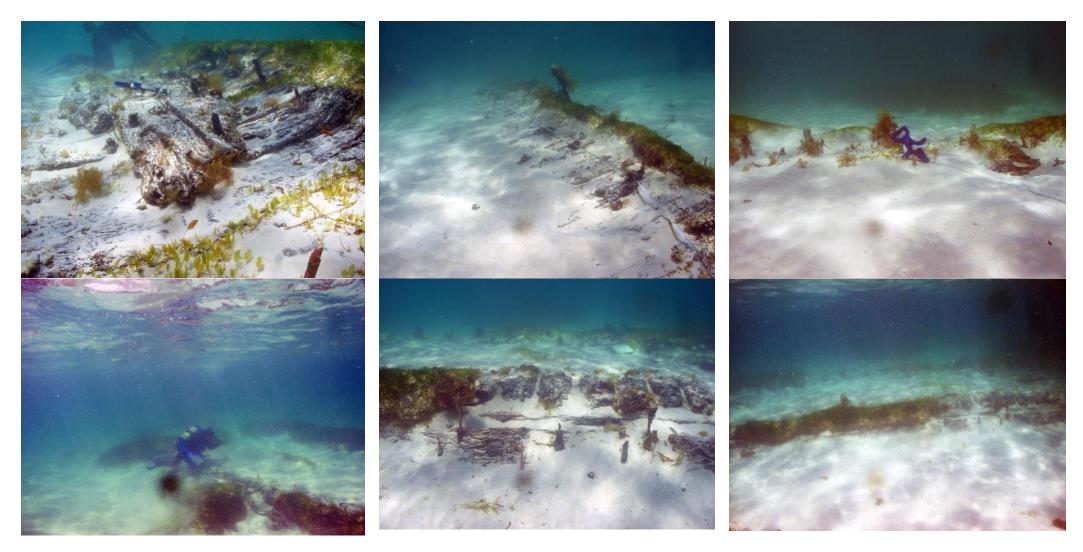
Figure 2. Photographs of the *Cervantes* site taken in 2012 (McAllister, WAM 2013).

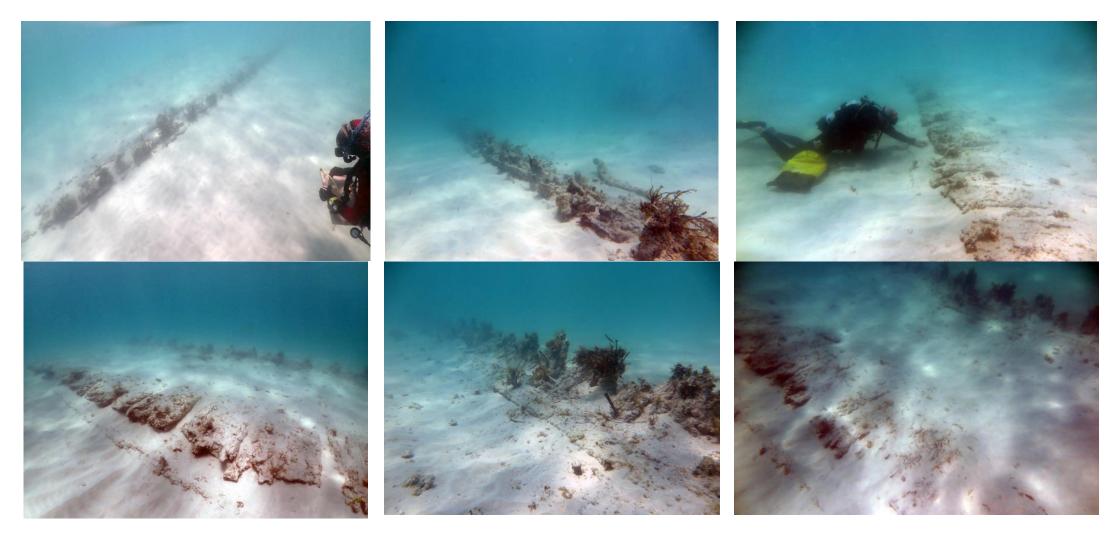
*Cervantes* is located on flat, sandy seabed, in a depth of 2-3 m. Visible features above the sand are keel and frame timbers, as well as fastenings protruding from the frame timbers and sandy sea bed. The overall length of exposed wreckage on the site is 16.97m (*Cervantes* registered dimensions were 28 x 7.5 x 3.5m). At 7.55m in from the western end of the baseline, the width of visible wreckage is 3.93 m. Laying on the sand amongst the wreckage is a small, concreted, iron feature and a brick, possibly a tryworks brick. Exposed timbers on the site are covered in a thin layer of marine growth with evidence of biological degradation as a result of naval shipworm (*Teredo navalis*) activity. The site was photographed to compare the integrity of the wreck to previous visits by the museum in 2012 (Figure 2 & Figure 3). Large swells are likely to be responsible for seabed changes and sand movement over the site.

Figure 3. Photographs of the Cervantes site taken in 2023 (Philpin & Shefi, WAM 2023).

Timbers on the *Cervantes* site do not appear to have deteriorated significantly since it was last visited by the WA Museum in 2012. After comparing the 2012 site photographs with those taken in 2023, it is clear that there has been visible sand movement on the site. Many of the timbers that were exposed during the 2012 inspection are now covered by sand. However, some of the frames that now protrude from the sea bed appeared to have been previously covered by sand and marine growth.

- 1. To continue to monitor the *Cervantes* site for any signs of degradation or sand scouring as a result of the ongoing sand movement in the area.
- 2. In accordance with the management recommendations in McAllister 2013, and on the basis of any observed deterioration or scouring of sand cover, to

consider an expanded, long-term *in situ* preservation program to conduct site reburial activities in order to preserve the remaining timbers.

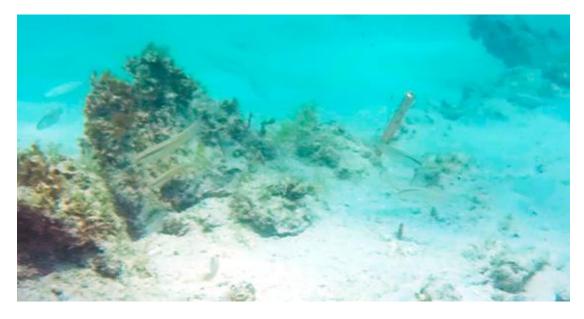
As the sandy seabed surrounding the wreck site is relatively bare, *Cervantes* provides a small amount of structure for small fishes and colonizing macro algae. Majority of the exposed timbers on the wreck site are covered in macro algae. Based on comparisons between the site in 2012 compared to 2023, the macro algae on the site has visibly reduced in the space of ten years. Female Western King wrasse are found living amongst the growth on the wreck site, just as they were in 2012 (McAllister 2013) (Figure 4).

Figure 4. Female Western King wrasse living amongst the *Cervantes* wreckage (Philpin, WAM 2023).

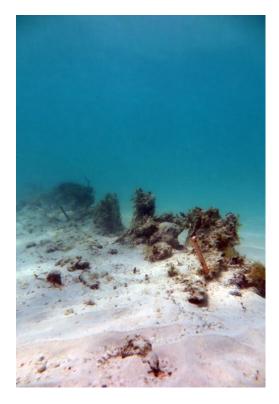
- (i) <u>Natural Forces</u> Given the site location, *Cervantes* does have some natural protection being located on the eastern side of Cervantes Island and related reef system (McAllister 2013). However, the shallow depth of the site and associated exposure to sunlight do not work in favor of the longevity of the wreck. The WA Museum occasionally receives reports of shipwreck timbers washing up on Cervantes town beach, likely from *Cervantes* site following exposure and biological degradation of wooden frames and planking, followed by breakage and transport through natural forces such as wave action. There is notable sand movement throughout this area and this can be seen through the highly polished look of the copper alloy fastenings on the site. Based on comparisons of the site between 2012 and 2023, there is no question that as a result of sand movement *Cervantes* is a dynamic site (Figure 5).

Figure 5. Sand-polished copper alloy fastenings exposed on the *Cervantes* site (Philpin, WAM 2023).

(iv) <u>Projected General site Stability</u> – The structural integrity of *Cervantes* remains relatively unchanged within the space of ten years, meaning that the site appears stable. However, the continual sand movement within the area will mean that parts of the shipwreck are constantly being buried and re-exposed, increasing chances of degradation. Given the community ties with the shipwreck, it is less likely that this site will be impacted by looters.
