Wreck Inspection Report
***Glenbank* (1911), Dampier Marine Park**

**Report—Western Australian Museum, Department of Maritime Heritage,
No. 346**

March 2024

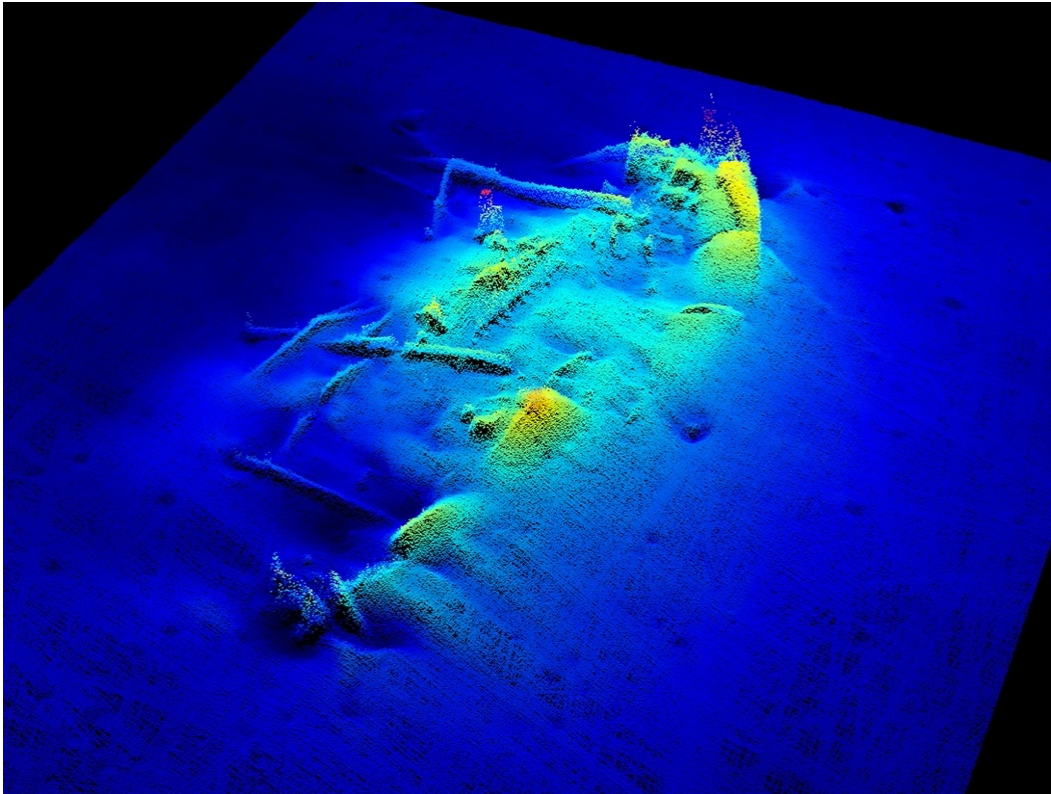
Figure 2 3D view of Glenbank site, view from stern looking north (Precision Hydrographic Services)

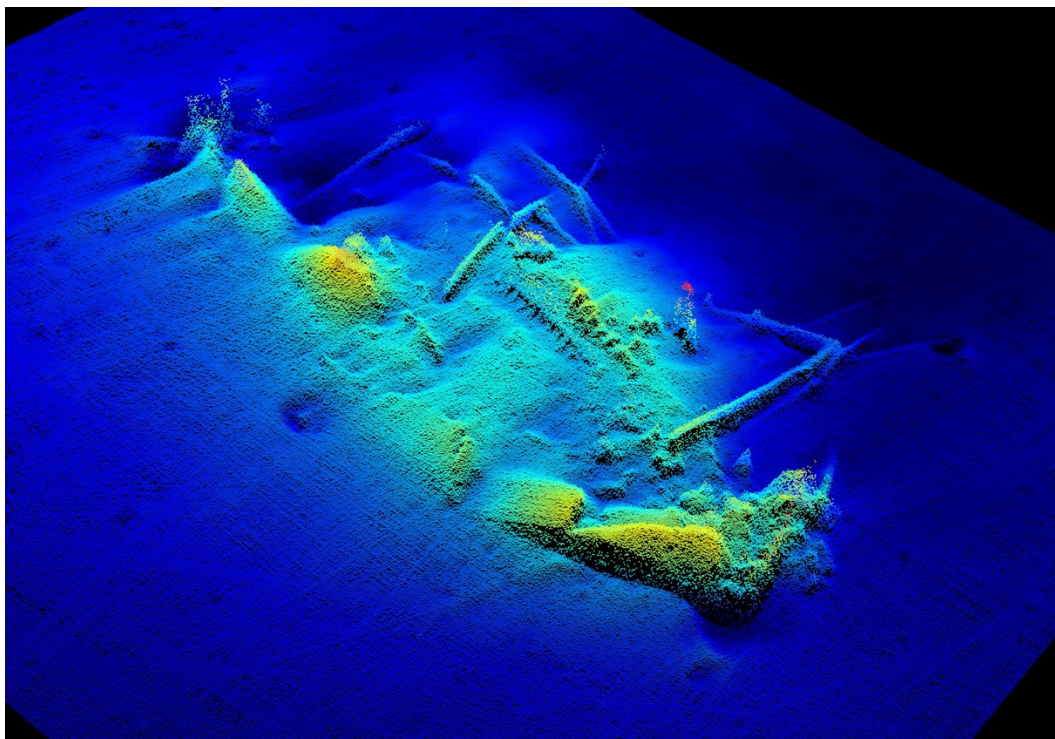
Figure 3 3D view of Glenbank site, view from bow looking southeast. Note buildup of sediment at stern; areas of sediment scouring; exposed starboard hull plating; and port side hull with upper and lower deck beams protruding between the fore and main masts. (Precision Hydrographic Services)

Site formation: The unusual site formation, along with Antti Ketola's report of the vessel capsizing and deck planks being washed up on beaches, enables some understanding of what occurred to *Glenbank*. The evidence indicates that the ship effectively split apart during the sinking event. The different angles of heel of the bow and sternposts (35° and 10° respectively), and section of keel evident in the bow area show that the ship has broken its back in at least one, and possibly two locations, certainly at least one area in the location of the foremast where there are strong leverage forces once the ship was no longer floating. The opposing forces of the weight of the 1600 tons of copper ore; trapped air in the hull; and the weight of the steel masts, yards, and rigging put immense pressure on the hull and deck structures. This likely caused the upper deck, and possibly lower deck, to separate from the starboard-side hull plating during the sinking, and subsequent process of collapse. Over time as remaining structures collapsed, and were likely further impacted during strong tidal currents and cyclones, the intact remaining hull gradually sank into the seabed and filled with sediment. Based on the angle of the stem-post and exposed hull on the seabed, it is estimated that about 85% of the port side is completely buried, along with almost the entire cargo of copper ore.

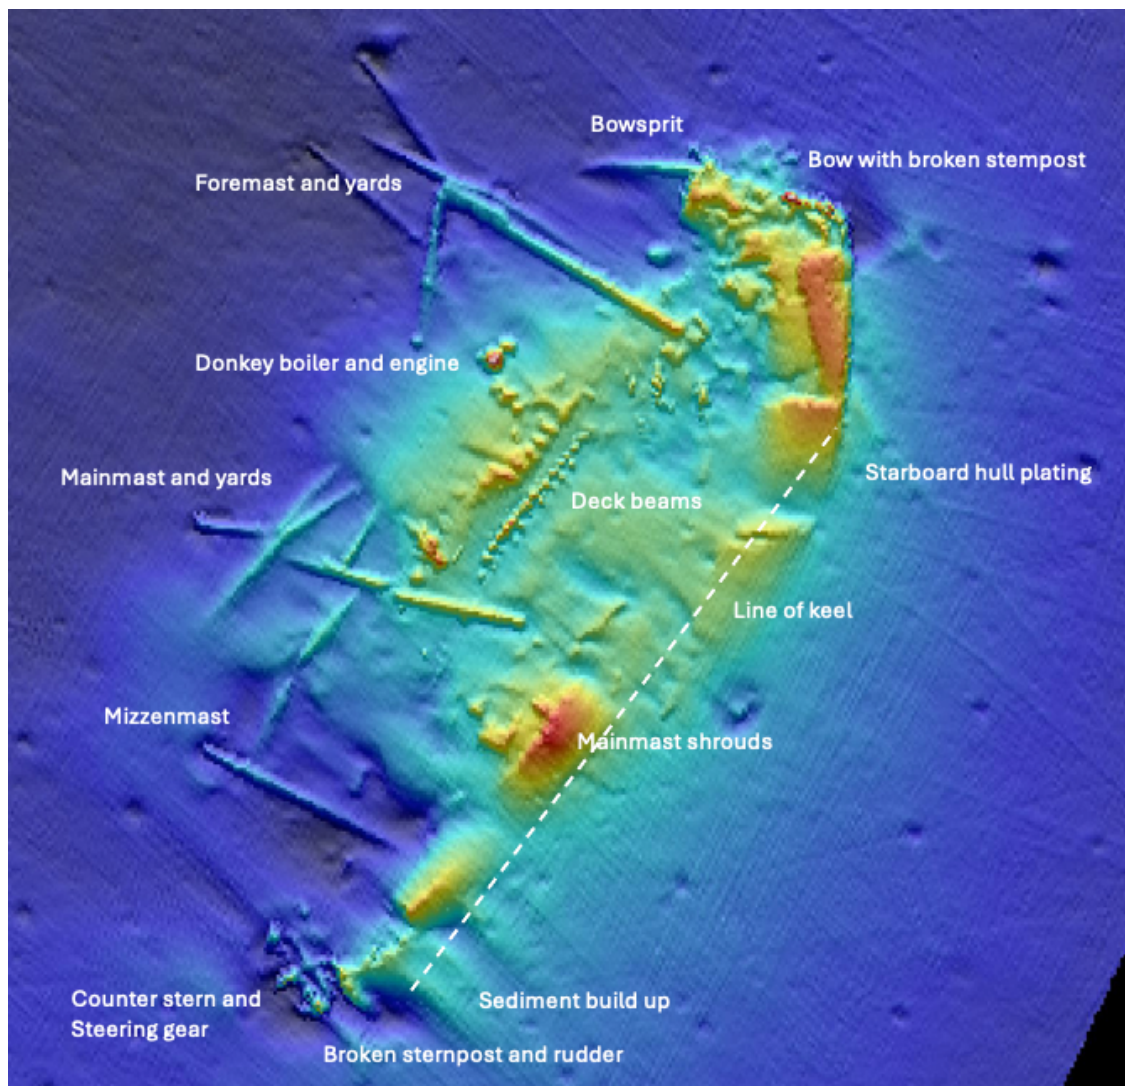
Figure 4 MBES site plan showing major features of the site (WA Museum/ Precision Hydrographic Services)

Bow area: The bow area consisted of the remains of the collapsed bow, with broken stempost, and bowsprit also broken away with a section of detached stempost. The bow is missing all of the starboard side plating, although a small section of plating with the thicker gauge steel hawse hole and hawse pipe has collapsed into the wreckage. Chain coming out of the hawse hole was attached to an iron-stocked starboard bower Admiralty anchor that is lying across the collapsed bowsprit, with an anchor davit and cathead also visible amongst the wreckage. The foremast base was broken. The stempost dimensions were measured to be 12 x 20cm, and the angle of heel of the intact section of stempost still attached to the keel was measured to be 35° from the horizontal, giving an indication of the level of collapse to port. A section of keel with a mast step was located showing that the bow section had broken away, and the ship's keel is broken in at least one, possibly two places.

Amidships area: An intact donkey boiler with a steam winch is standing upright on the seabed just to the west of the collapsed hull plating and decks. It had likely had landed after detaching from the deck during the sinking, in order to land in this position. A manual deck winch lay nearby. A section of both the upper deck, and

another presumably attached section of lower deck and hull is buried on its side with rows of deck beams protruding vertically from the seabed. Hatch coamings are visible. Scattered pieces of copper ore were found in this area, with samples recovered. Remains of the steel fore, main and mizzen masts with their yards and steel wire rigging lay collapsed to the port side. Organic remains above the seabed including all wooden topmasts and yards, and wooden deck planking have been degraded through biological action and are missing. It is likely that organic remains that have become buried in the seabed are well preserved. No keel is visible along the exposed starboard plating, indicating that it is buried in the seabed.

Stern Area: The stern consisted of the sternpost with rudder attached, and remnant hull plating. The sternpost was bent near where it had broken, likely as a result of the weight of the counter stern which had itself broken away and collapsed with the steering gear still mounted, the rudder stock had also broken, and the rudder bracket was lying on the seabed nearby. Some intact port stern plating to the bulwark level with a hawse hole was visible protruding from the seabed. The sternpost was measured to have an angle of heel of 10° from the horizontal, lying almost on its side and again indicating the extent of capsizing and burial.

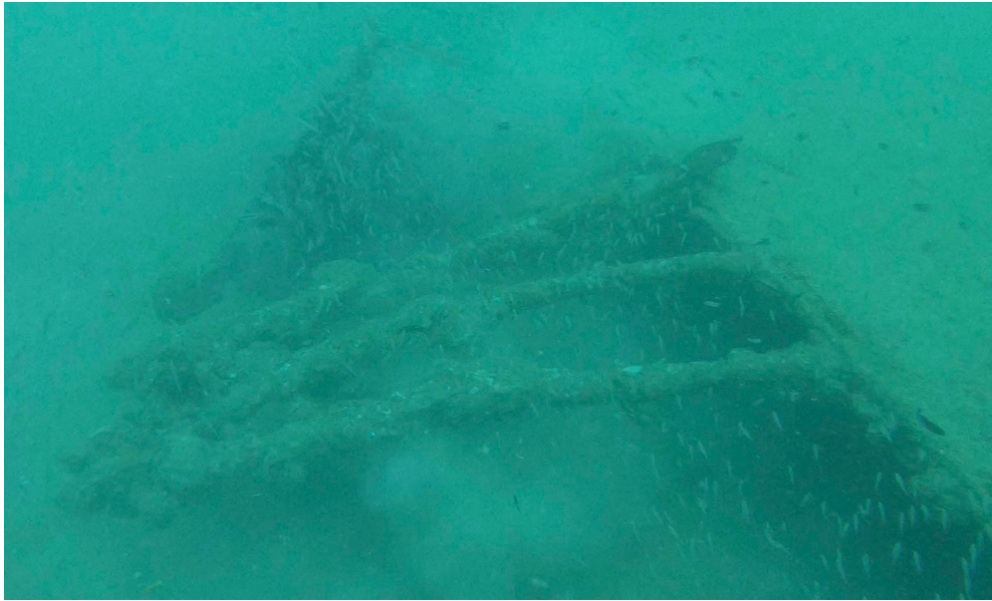
Figure 5 Mainmast shrouds visible on bulwarks of starboard side hull plating (WA Museum/ Terra Australis Films)

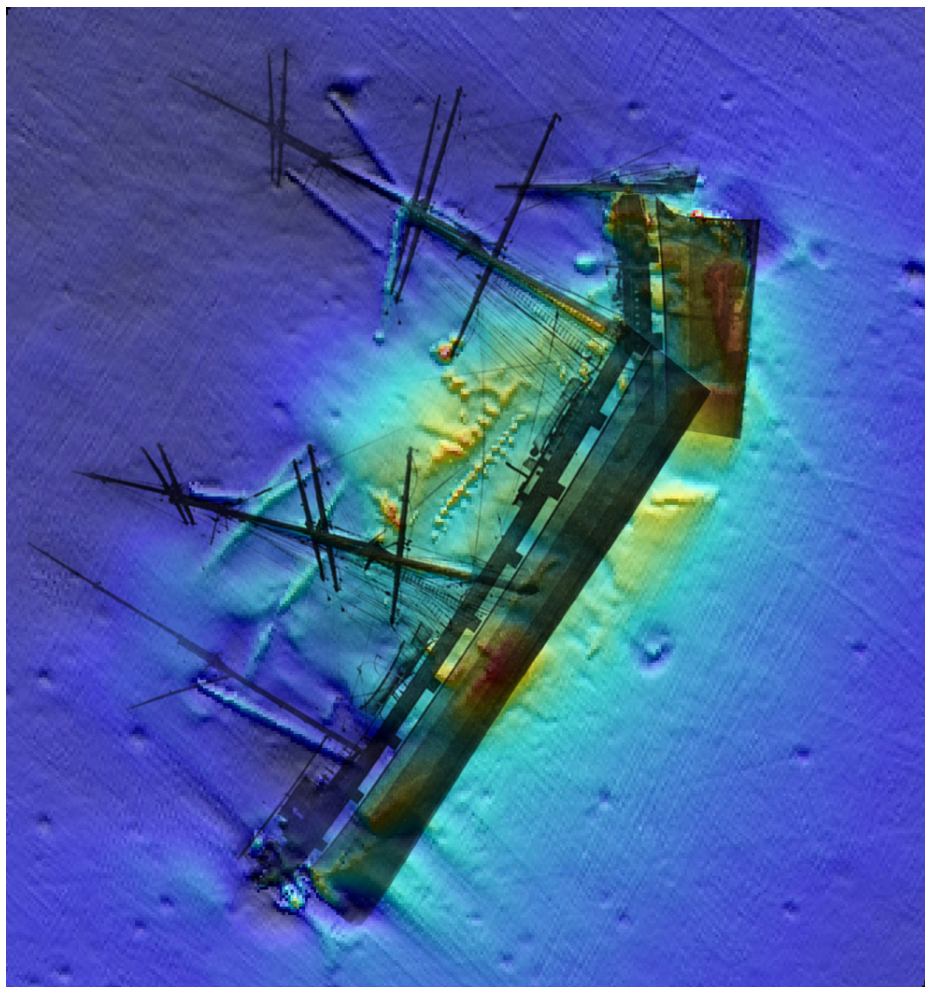
Figure 6 Interpretation of Glenbank site (Ross Anderson/ WA Museum, Images: Precision Hydrographic Services, State Library of SA)

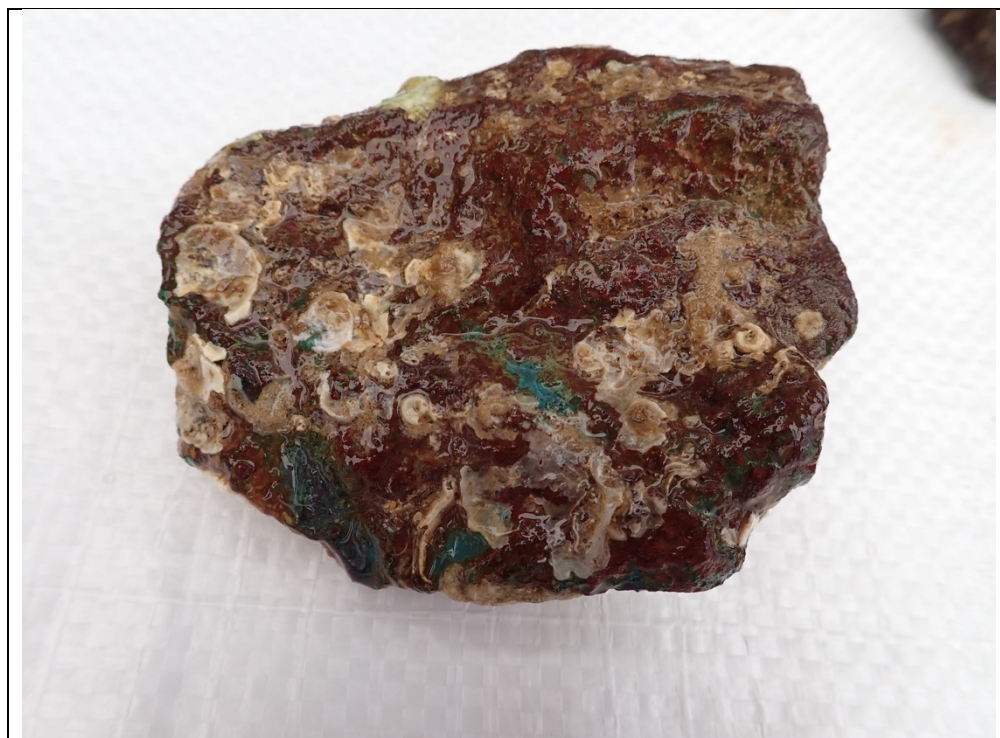
Figure 7 GLB-001 copper ore sample. Note green-coloured copper oxide visible. (WA Museum)

After normalising the data, the results identified significant amounts of copper present, as well as zinc. It is concluded that the copper and zinc are part of the rock core itself, and that the samples have not been contaminated by a non-ferrous object nearby.

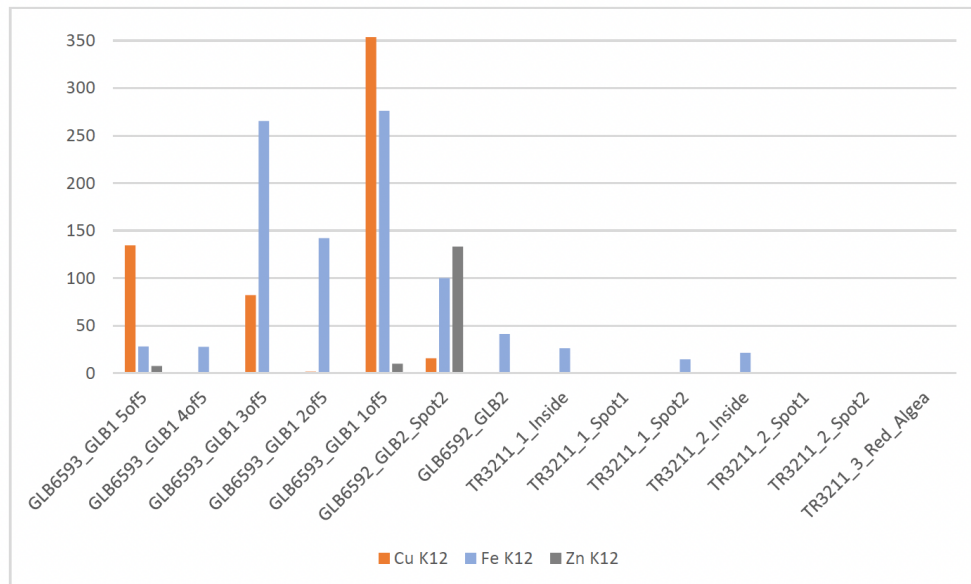
Figure 8 Copper, iron and zinc present in rocks and copper ore samples recovered from Glenbank (1911) compared with ballast rocks from Trial (1622) (Kasi, K. 2022, Table 3).
