INTRODUCTION

The purpose of this paper is to ascertain the possible and probable causes of the loss of H.M.A.S. SYDNEY.

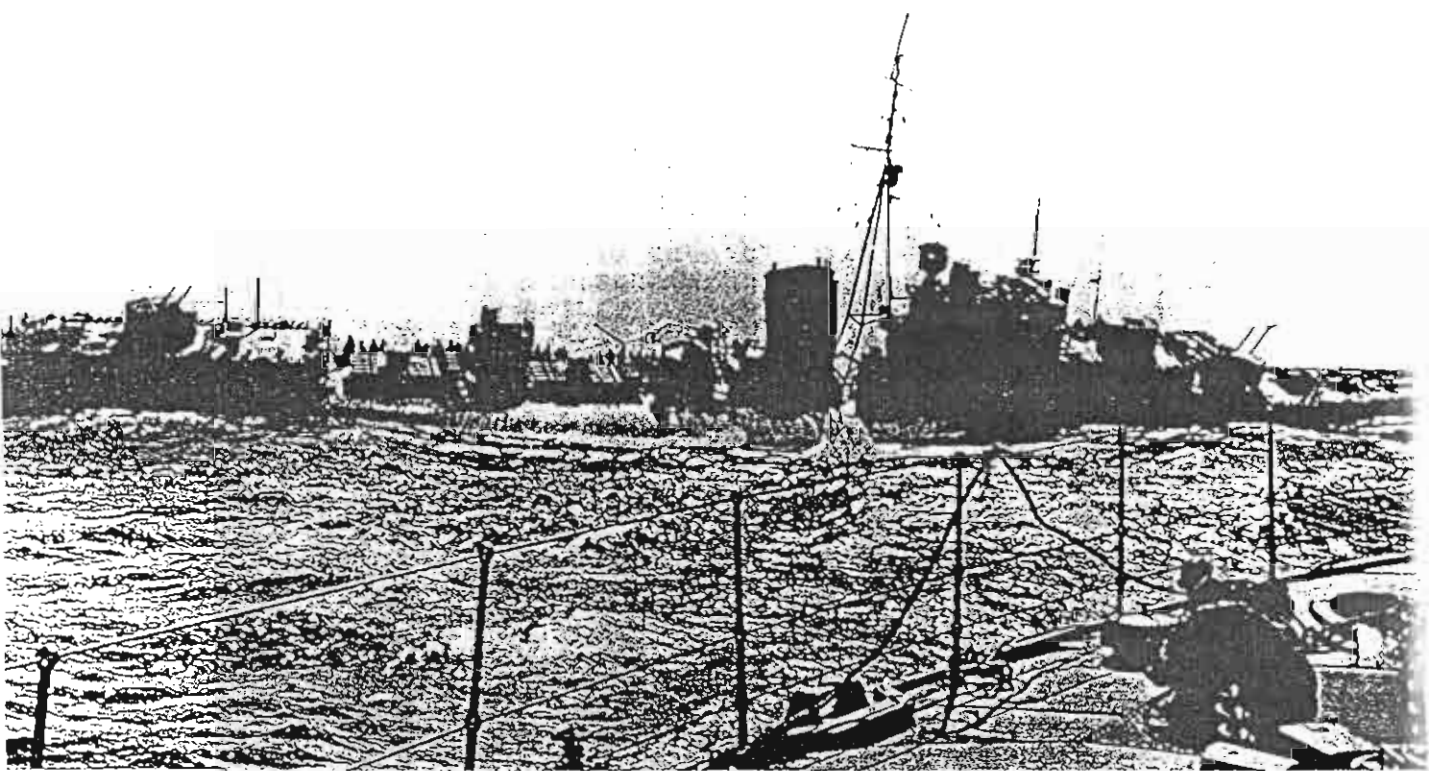
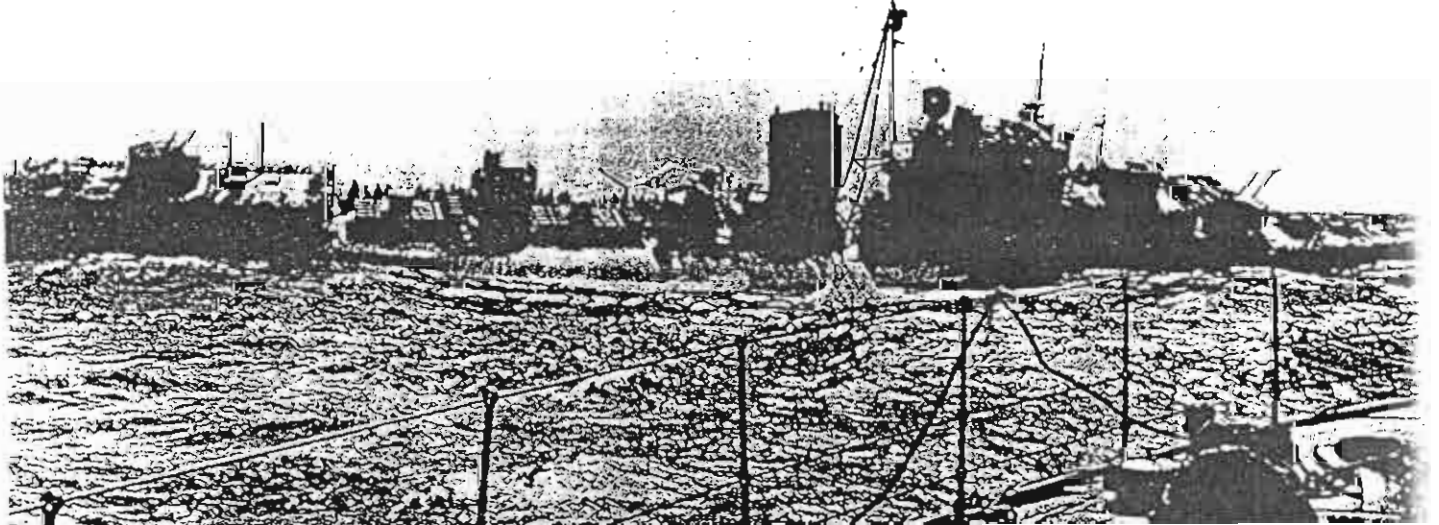
H.M.S. KELLY UNDER TOW AFTER BEING TORPEDOED 9/5/40

IN DRYDOCK THE TORPEDO HOLE IS REVEALED

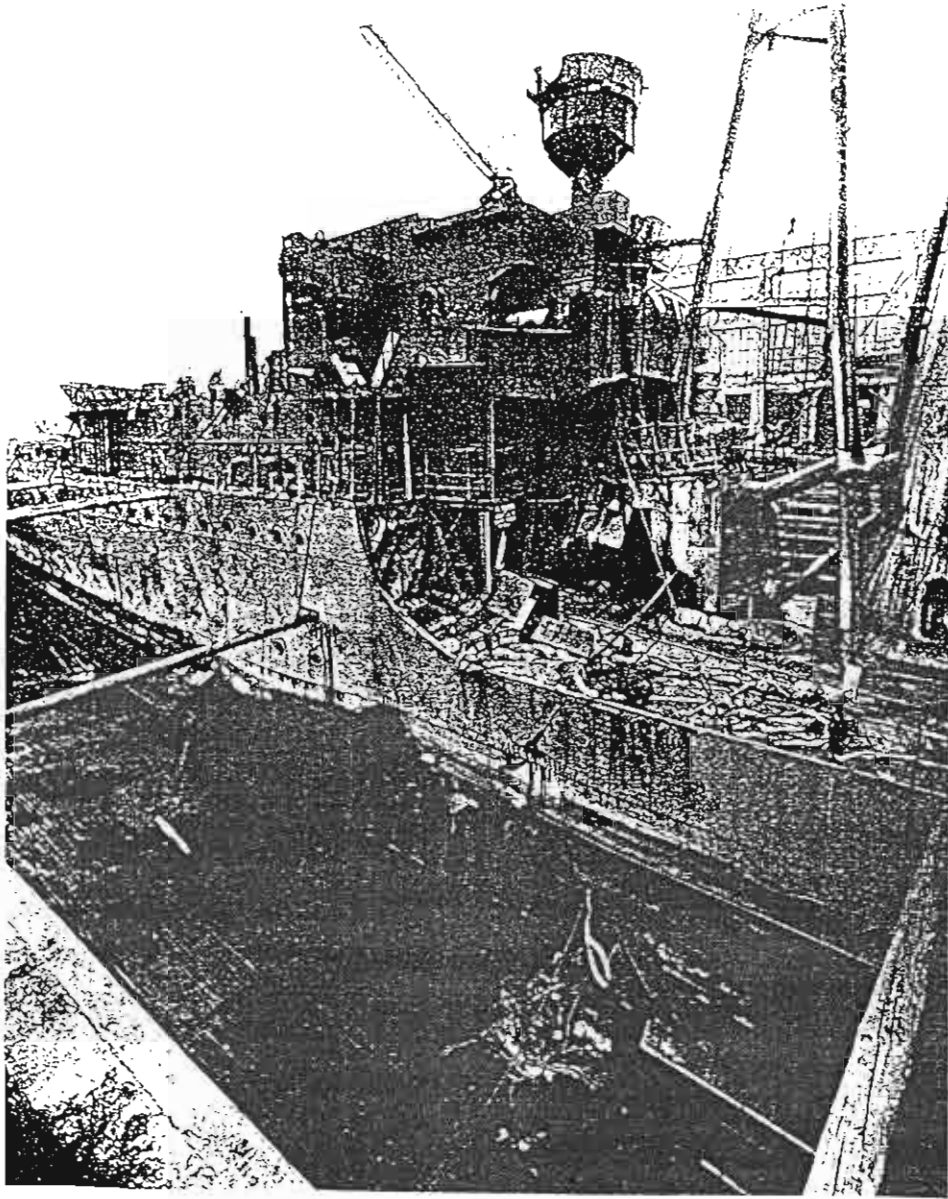
ANOTHER VIEW OF THE KELLY PRIOR TO REMOVAL
OF HER SUPERSTRUCTURE TO FACILITATE HER
REBUILDING.

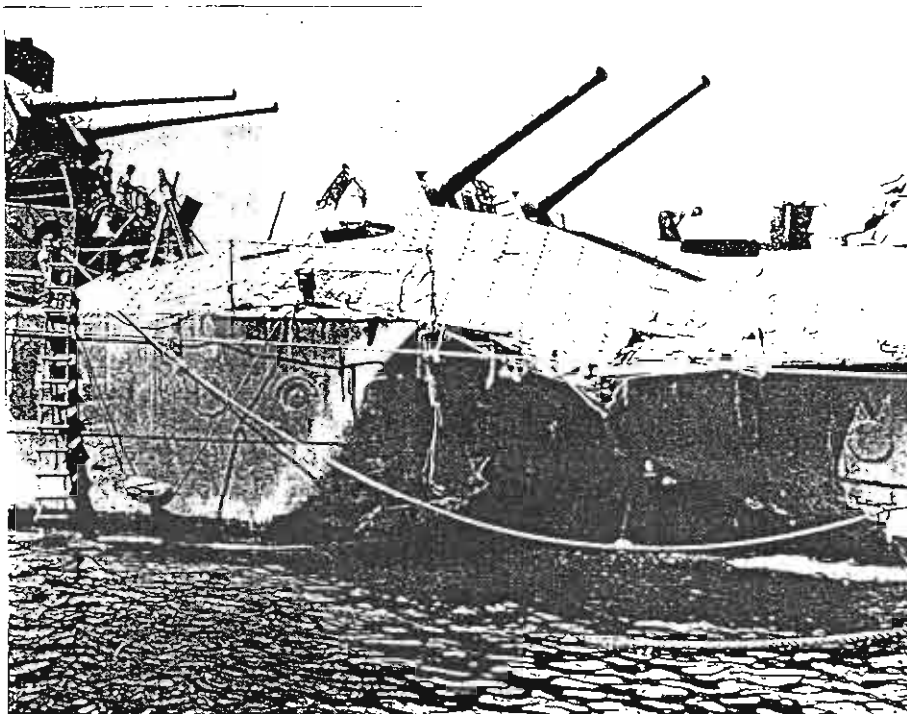
The explosion tore a huge hole in the hull plating just aft of Y turret, causing extensive structural damage, and almost severing the stern. Steering was lost, and the electrical system failed, plunging the ship into darkness. Emergency lighting came on as the ship lost way as a result of the increased drag. The E.R.A. in charge of the after port engine shut off the supply of steam as the turbine started to race. The ship took on a list of 3 degrees to port, and trimmed by the stern, but trim was eventually restored by the pumping of several hundred tons of fuel oil from the after, to the forward tanks. The emergency diesel generators were started, and full lighting restored, while damage repair parties assessed the damage.

The port inner shaft and propellor had been blown off, and the starboard inner shaft badly damaged. The propellor of which, fell off the following morning. Steel hawsers were secured around the ~~ship~~ ~~with a heavy list to port,~~ the LEANDER, escorted by the U.S. destroyer RADFORD, slowly made her way to Tulagi where she was temporarily repaired and fitted with a cement patch to allow her to proceed to Auckland. A complete repair and refit was deemed necessary and on the 30 November, she sailed for the United States as it was not possible to do the work locally, or in Britain. Due to the extensive amount of work required, the LEANDER was not ready for service again until September 1945, and took no further part in the war. (16)

ABOVE AND BELOW:
TORPEDO DAMAGE TO H.M.A.S. HOBART

THE EXPLOSION HAS BLOWN IN THE HULL PLATING
IMMEDIATELY ABAFT Y TURRET AND TORN OPEN
THE QUARTERDECK IN THE VICINITY.
THE CURVED STRUCTURE TO THE IMMEDIATE LEFT
OF THE BOTTOM PHOTO IS THE BARBETTE OF
Y TURRET

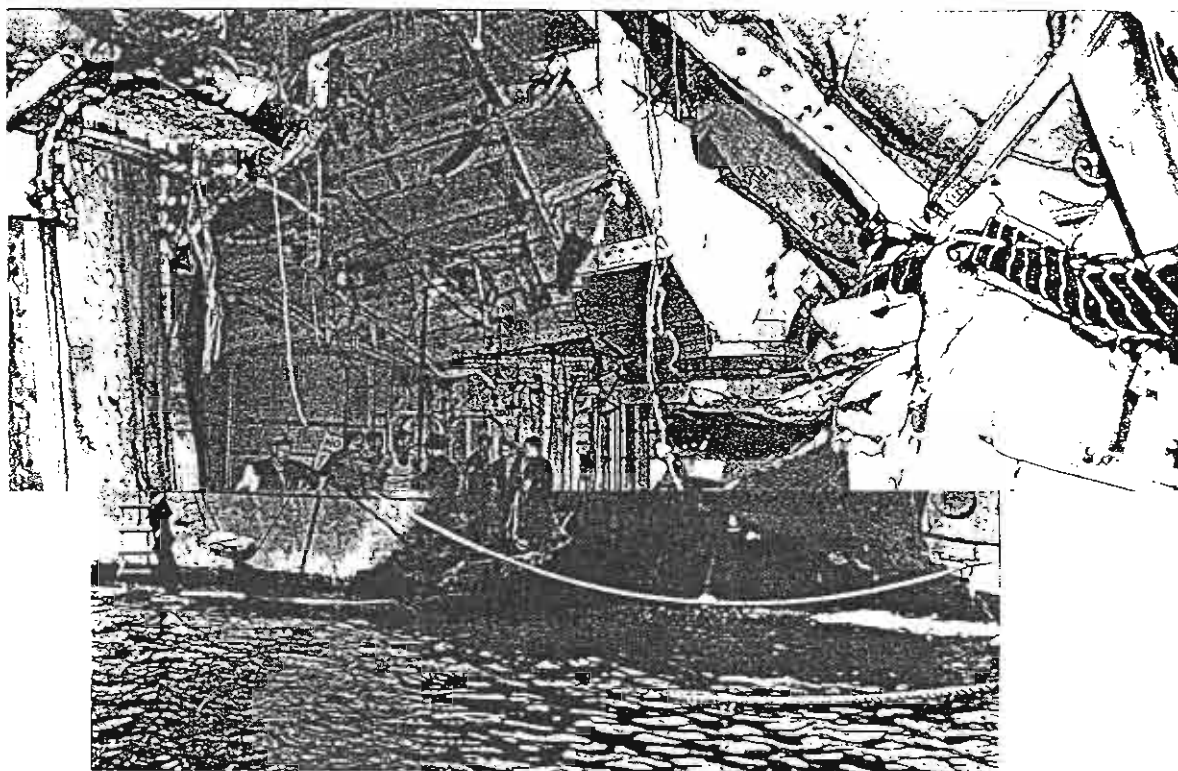
ABOVE AND BELOW:
TORPEDO DAMAGE TO H.M.A.S. HOBART

THE EXPLOSION HAS BLOWN IN THE HULL PLATING
IMMEDIATELY ABAFT Y TURRET AND TORN OPEN
