Report to the Australian Bicentennial Authority
on the February - March 1985 Bicentennial Project
Expedition to the Wreck of HMS Sirius (1790) at
Norfolk Island

Compiled by Graeme Henderson and Myra Stanbury,
with contributions from Ian MacLeod, Paul Clark,
Mark Staniforth and Paul Brown.

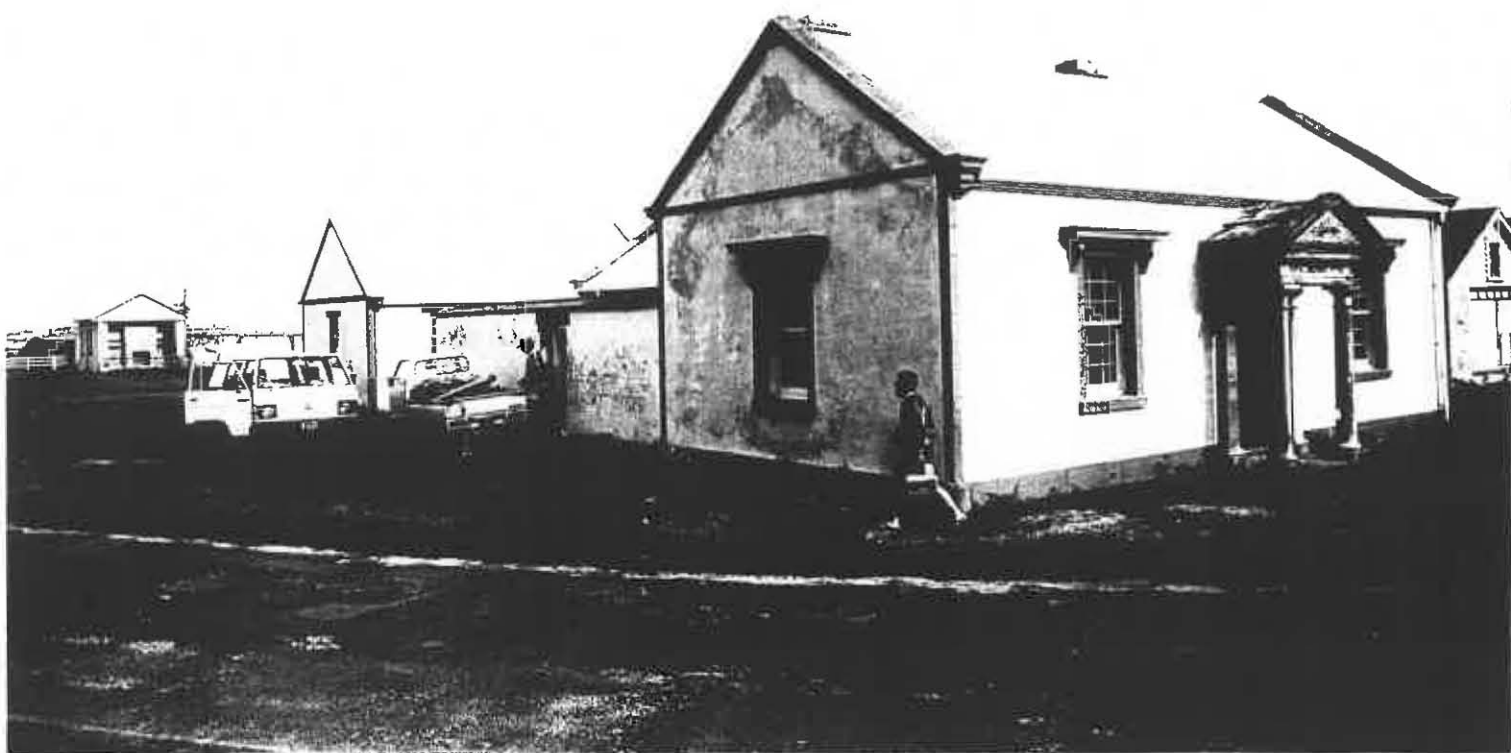
Figure 2. Equipment was stored behind the Royal Engineers' Office at Kingston. Photo: Pat Baker

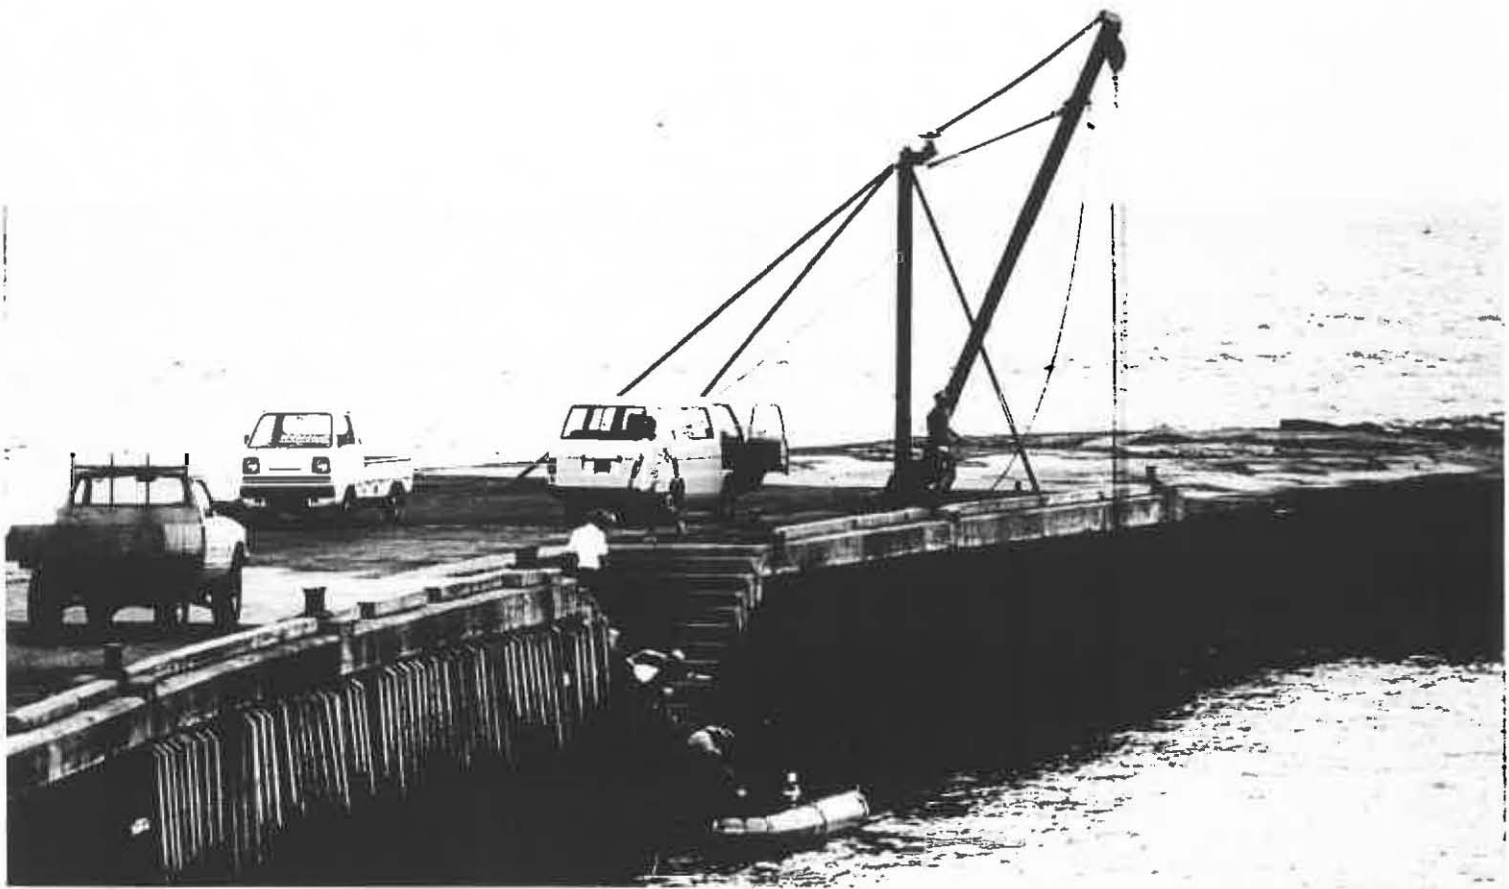
Figure 3. The inflatable dinghy was launched at the Kingston Pier.
Photo: Pat Baker

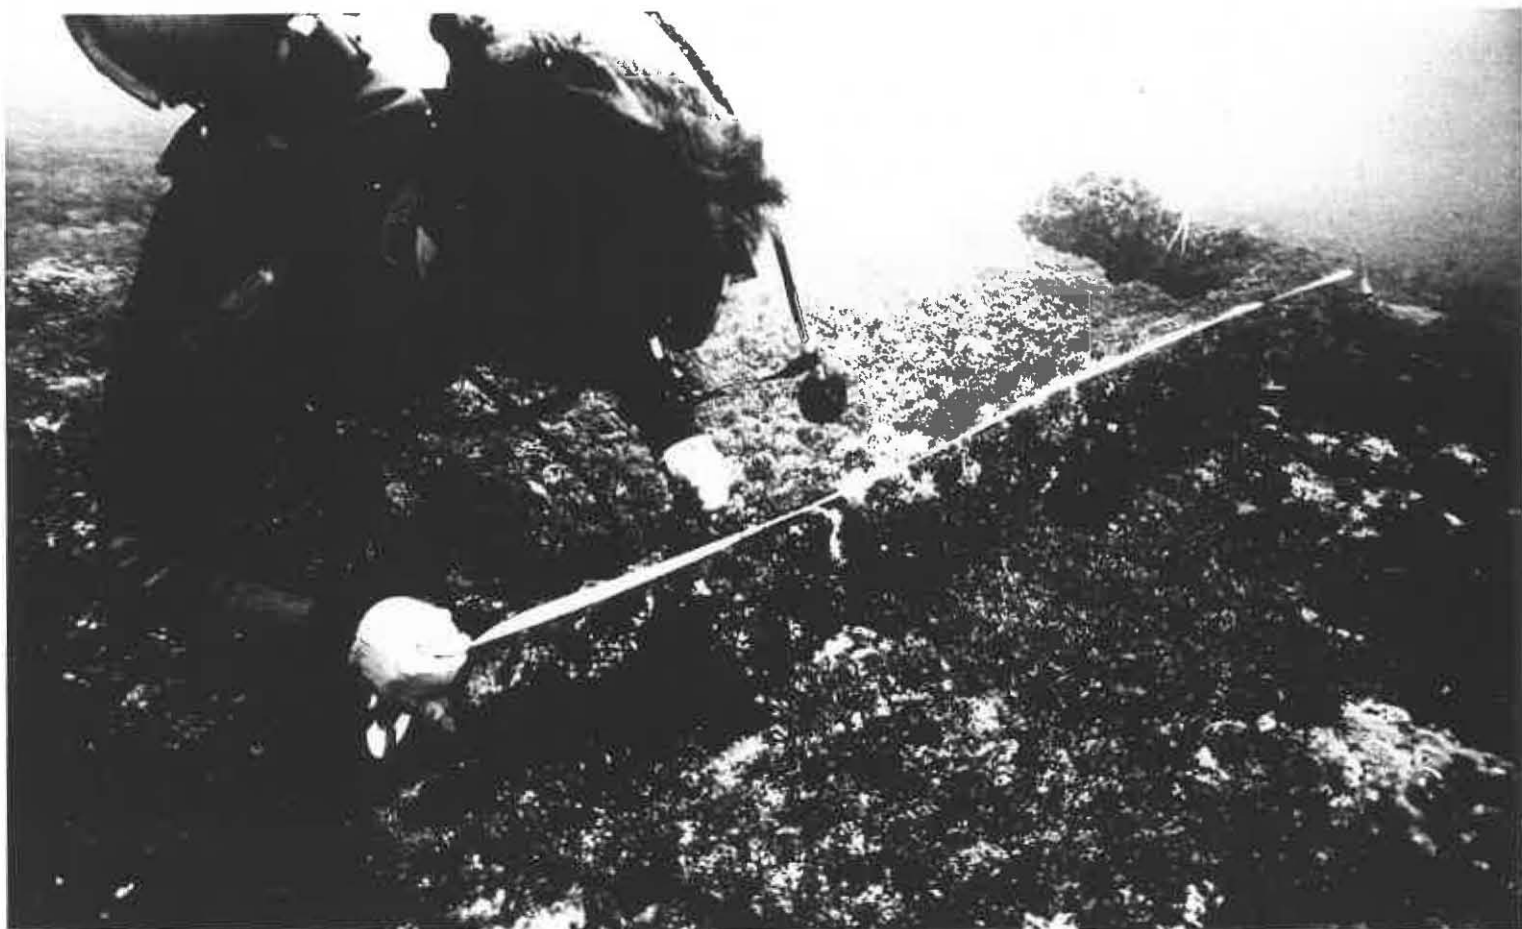
Figure 4. Henderson measures a broken anchor on the initial stranding site. Photo: Pat Baker

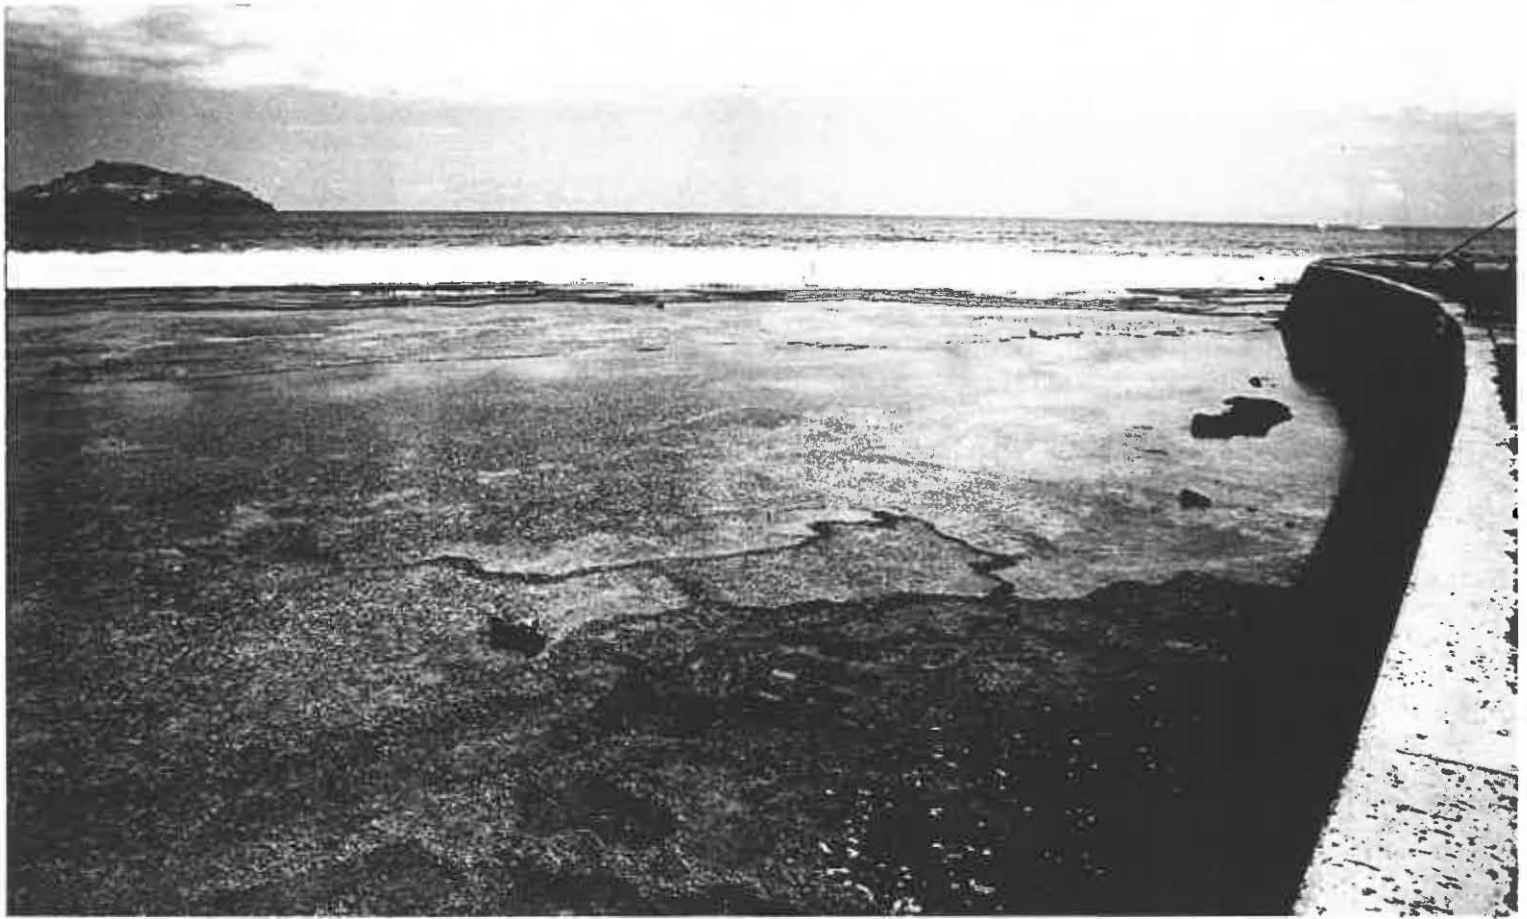
Figure 5. Low tide east of the pier, showing some iron wreckage.
Photo: Pat Baker

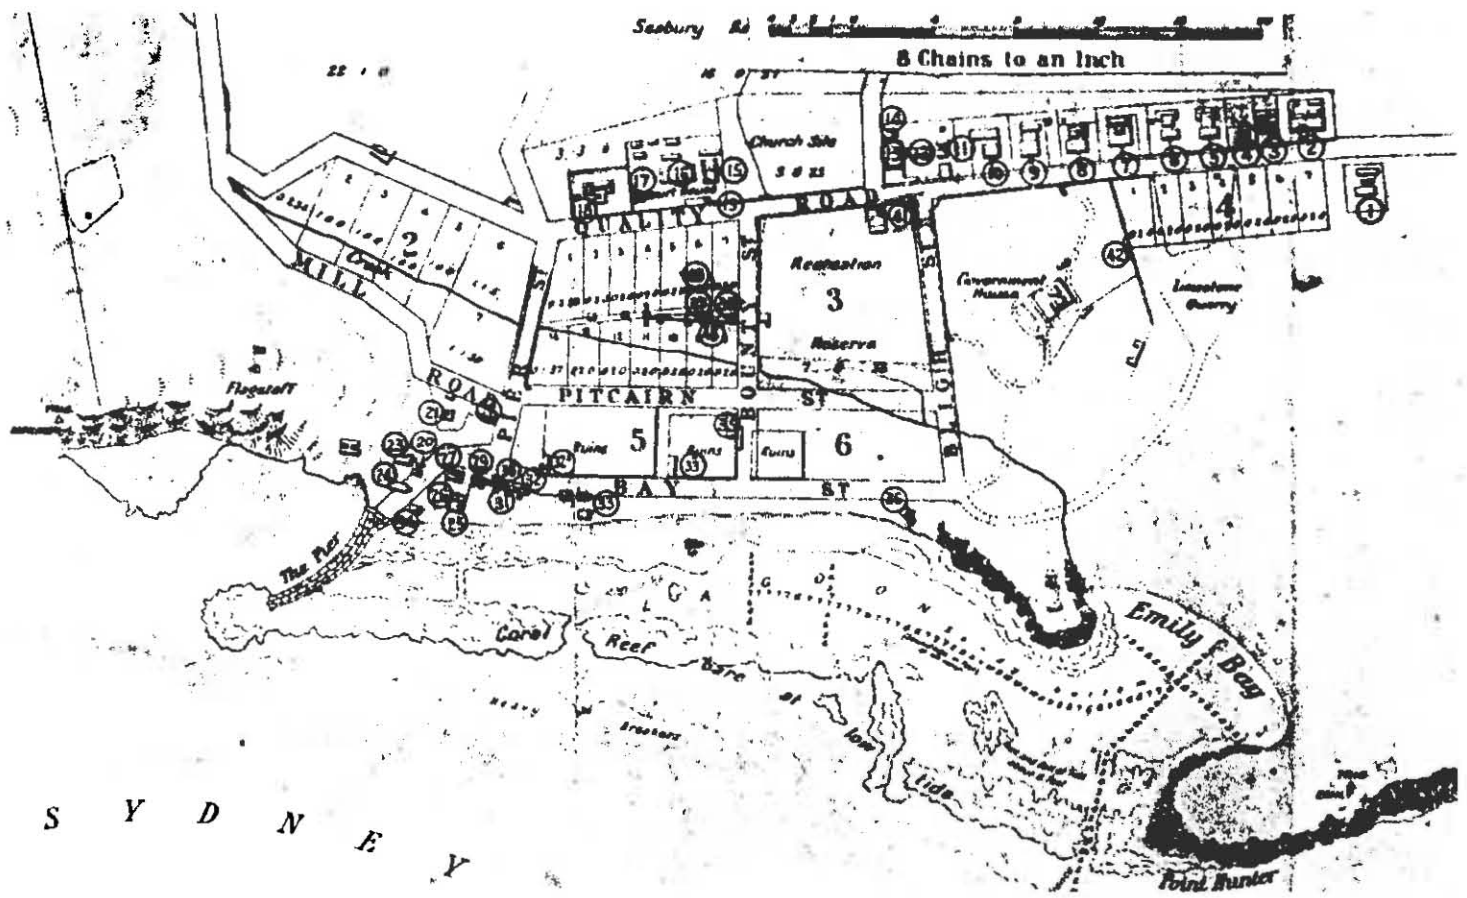
Figure 7. A chart of 1904 showing the causeway of limestone rubble heading out to sea/

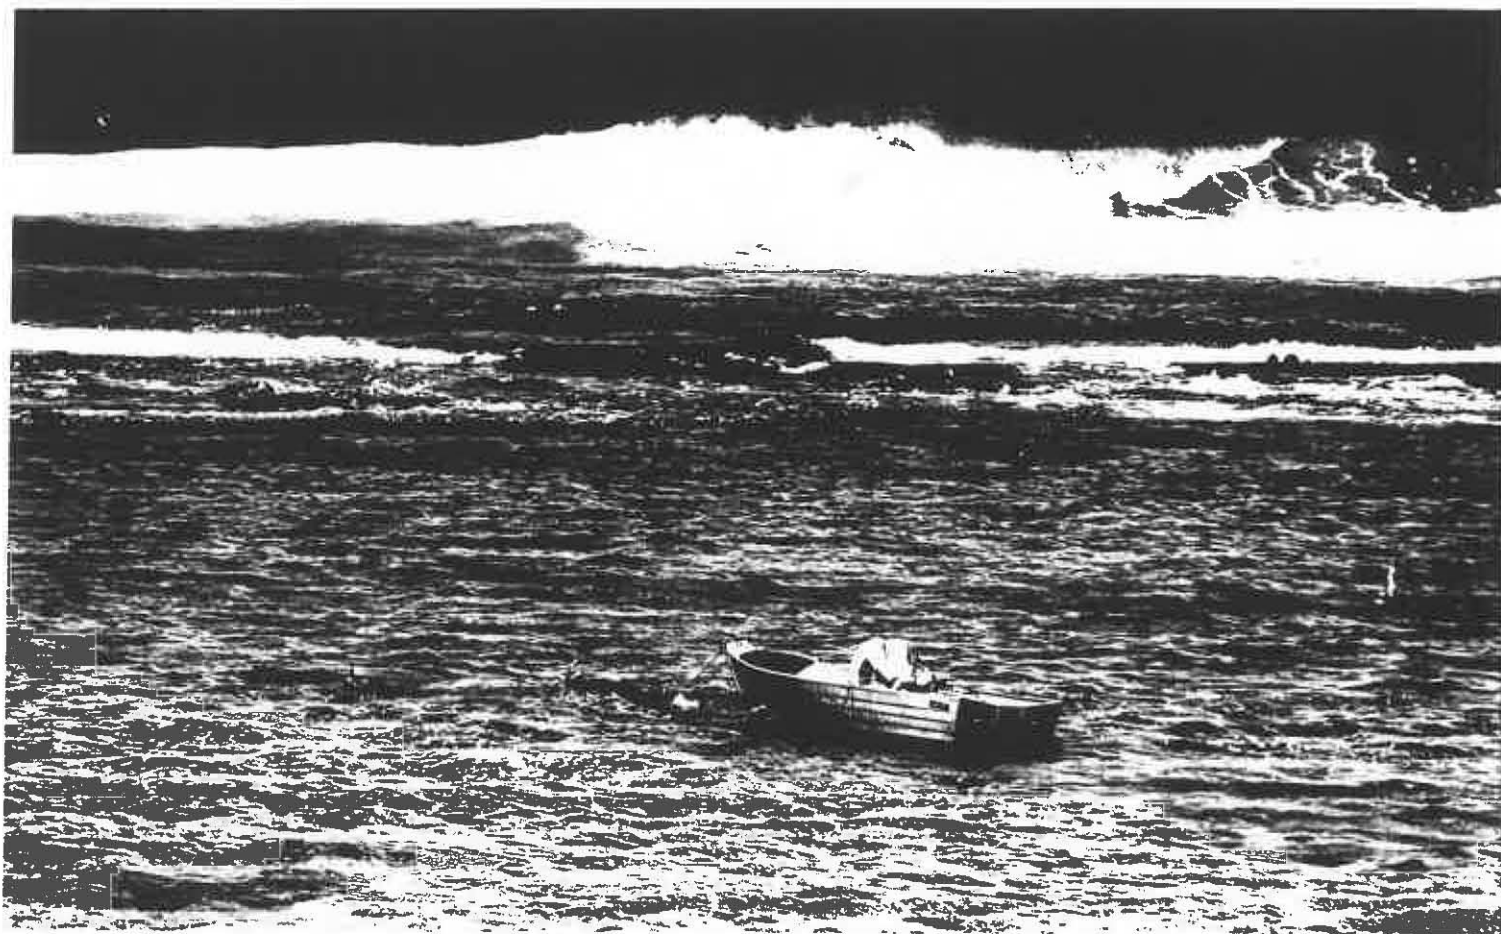
Figure 8. One diver tows the dinghy, while another dangles the detection head over the grid in the lagoon. An operator in the dinghy shelters the magnetometer from direct sun while taking readings.
Photo: Pat Baker

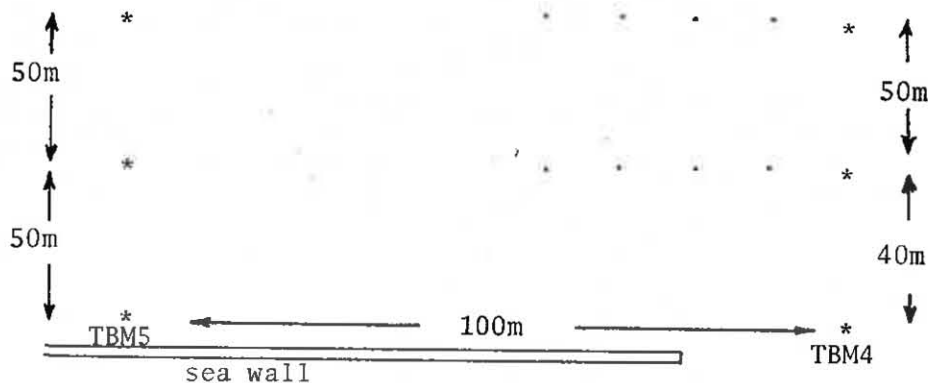
The corners were delineated by iron 'pigs tails' hammered into the bottom with a floating buoy attached.

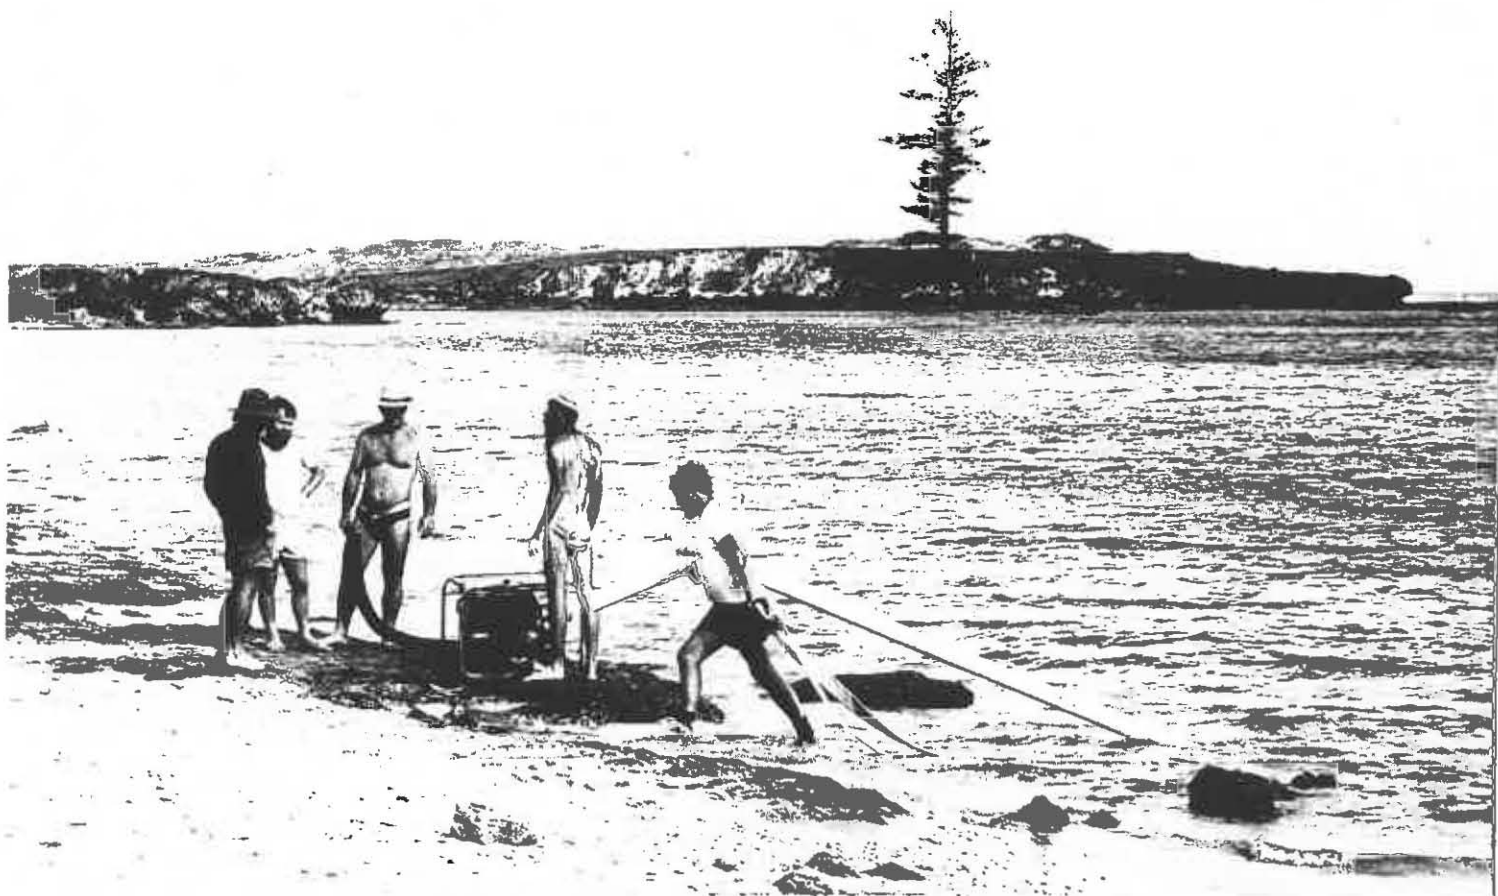
Figure 11. Divers prepare the water dredge for investigation of targets in the lagoon. Photo: Pat Baker

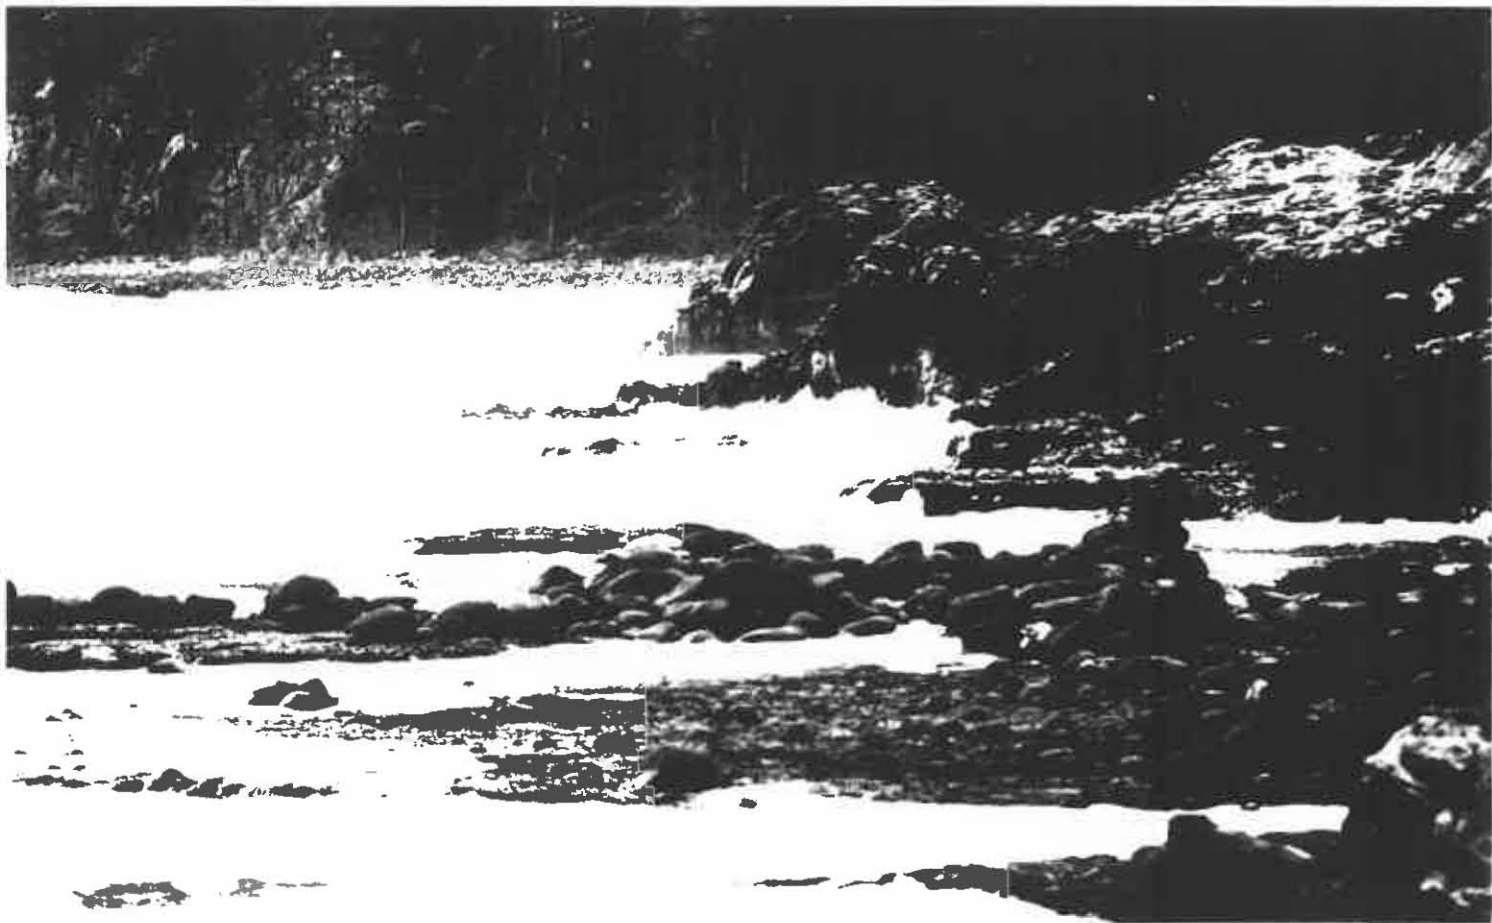
Figure 12. The site west of the pier lies adjacent to exposed rocks.
Photo: Pat Baker

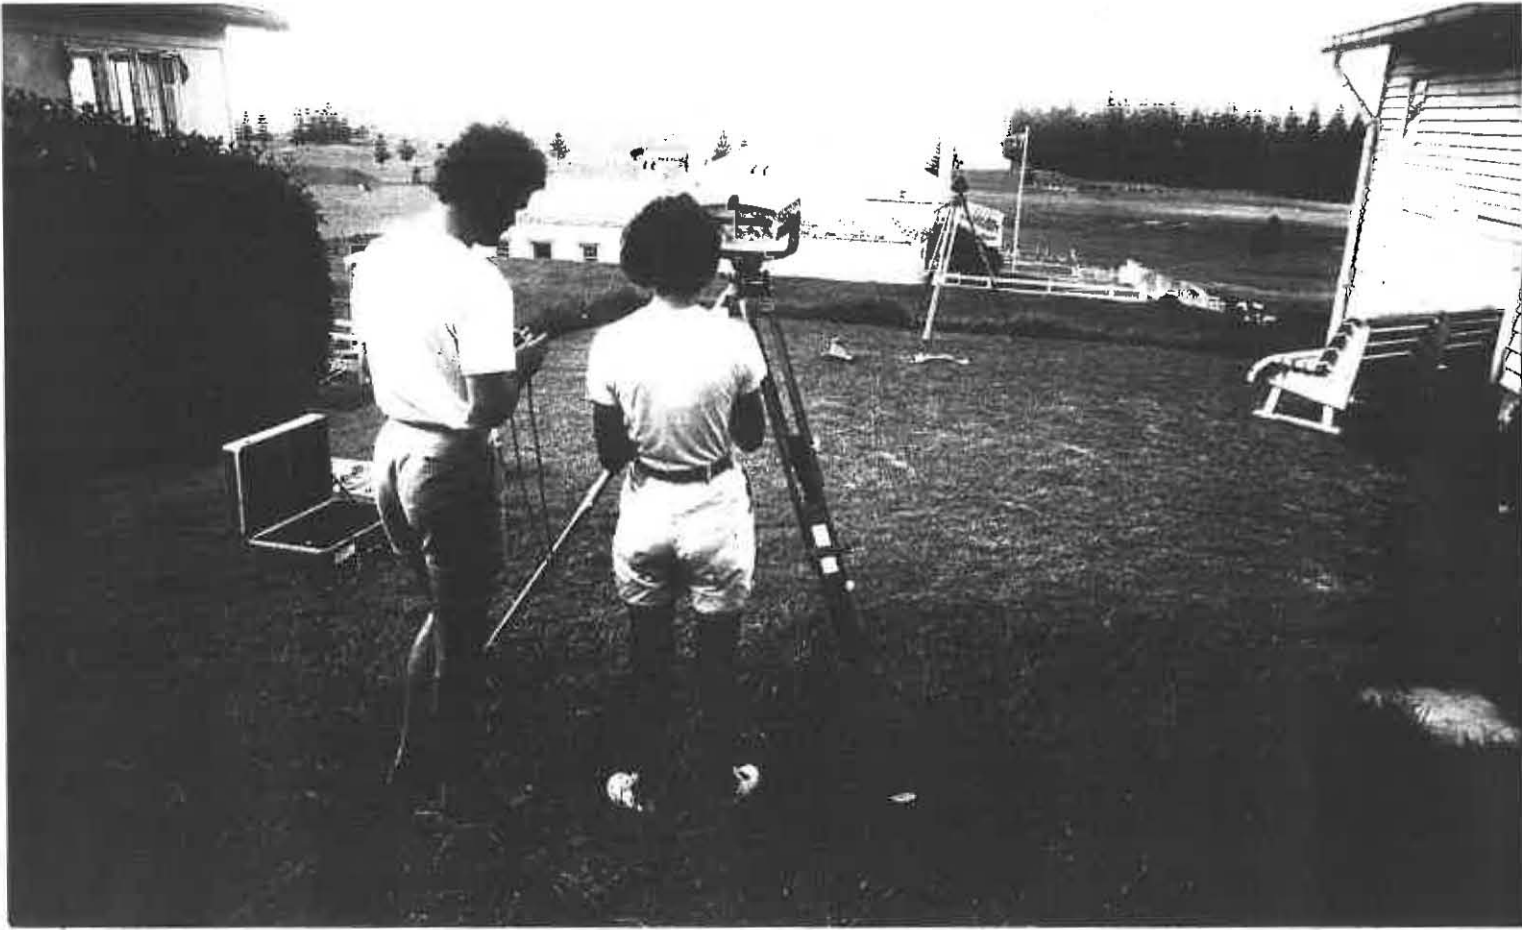
Figure 14. Clark and Stanbury prepare the survey equipment.
Photo: Pat Baker

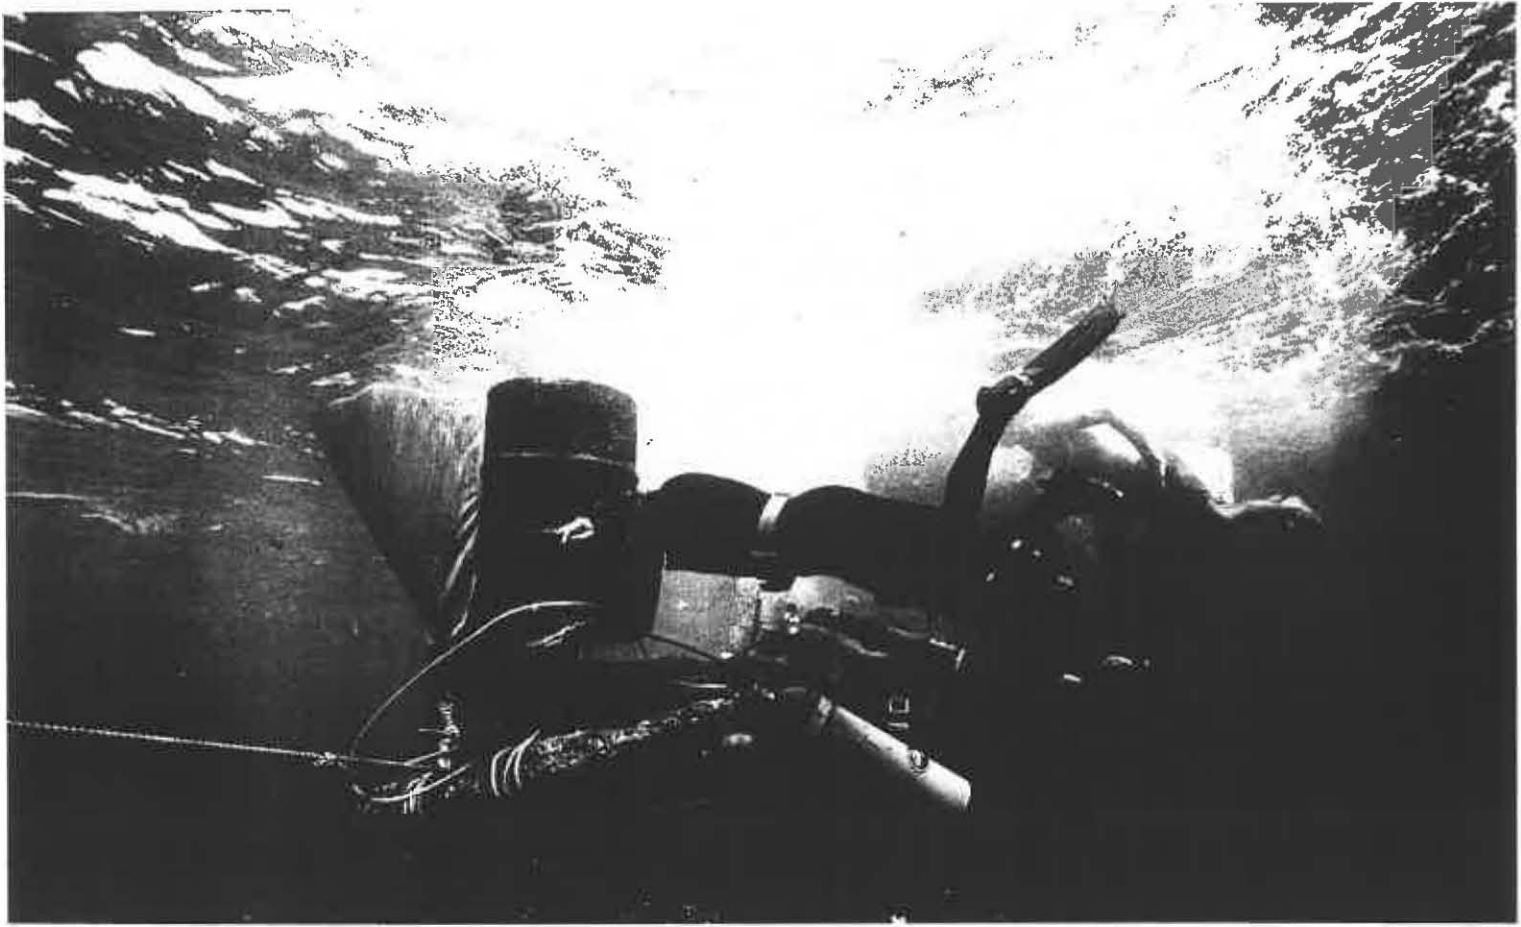
Figure 15. An anchor, floated with drums, is towed into deeper water.
Photo: Pat Baker

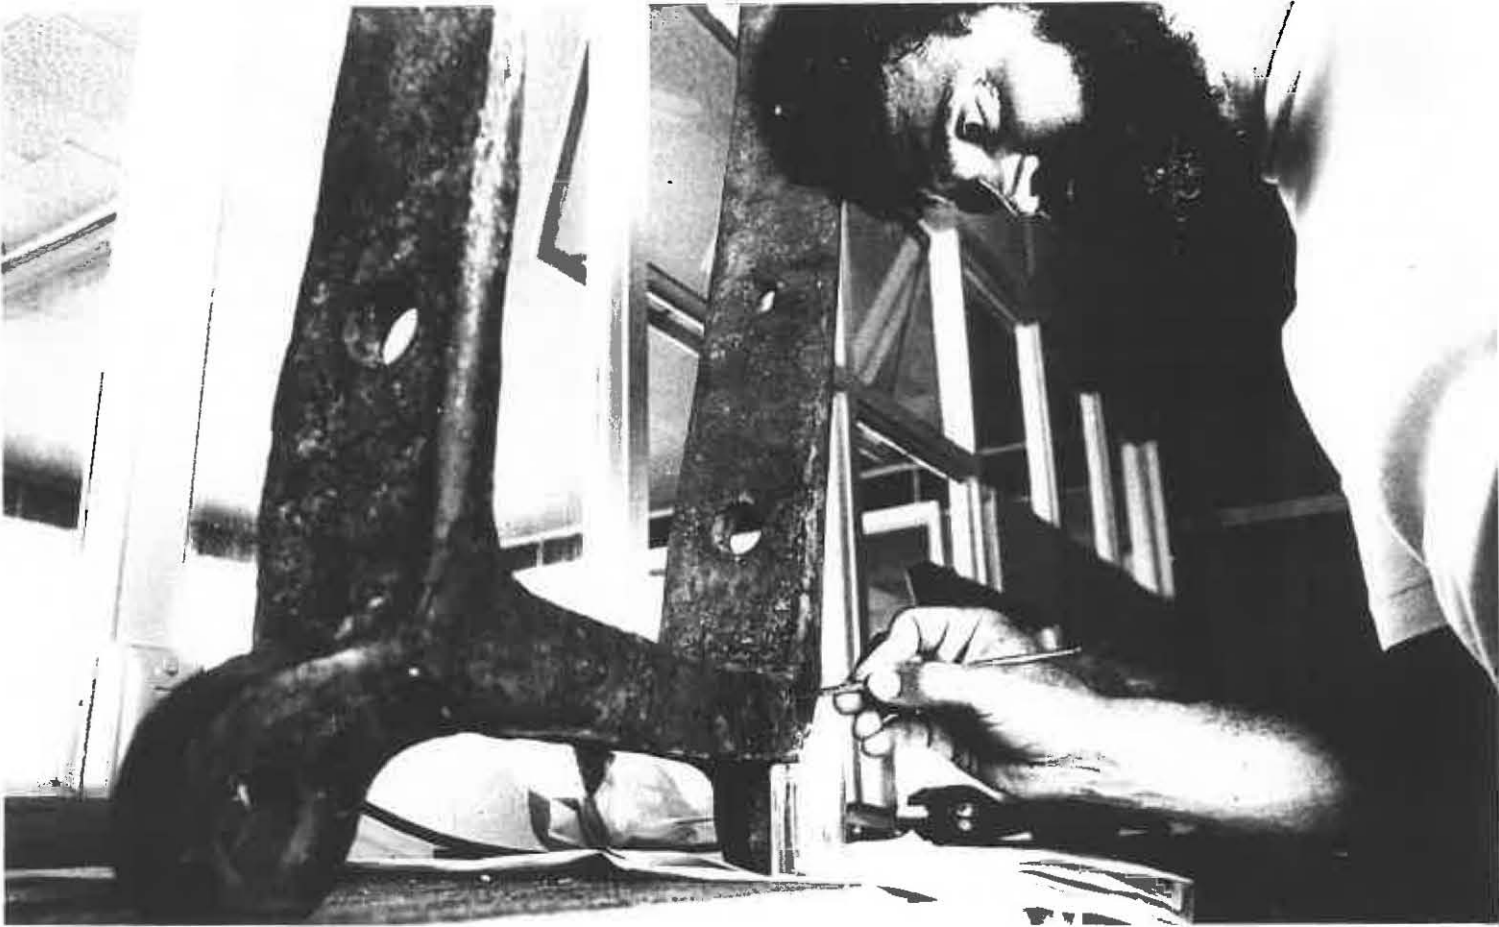
Figure 16. Conservator Dr Ian MacLeod inspects the spectacle plate.
Photo: Pat Baker

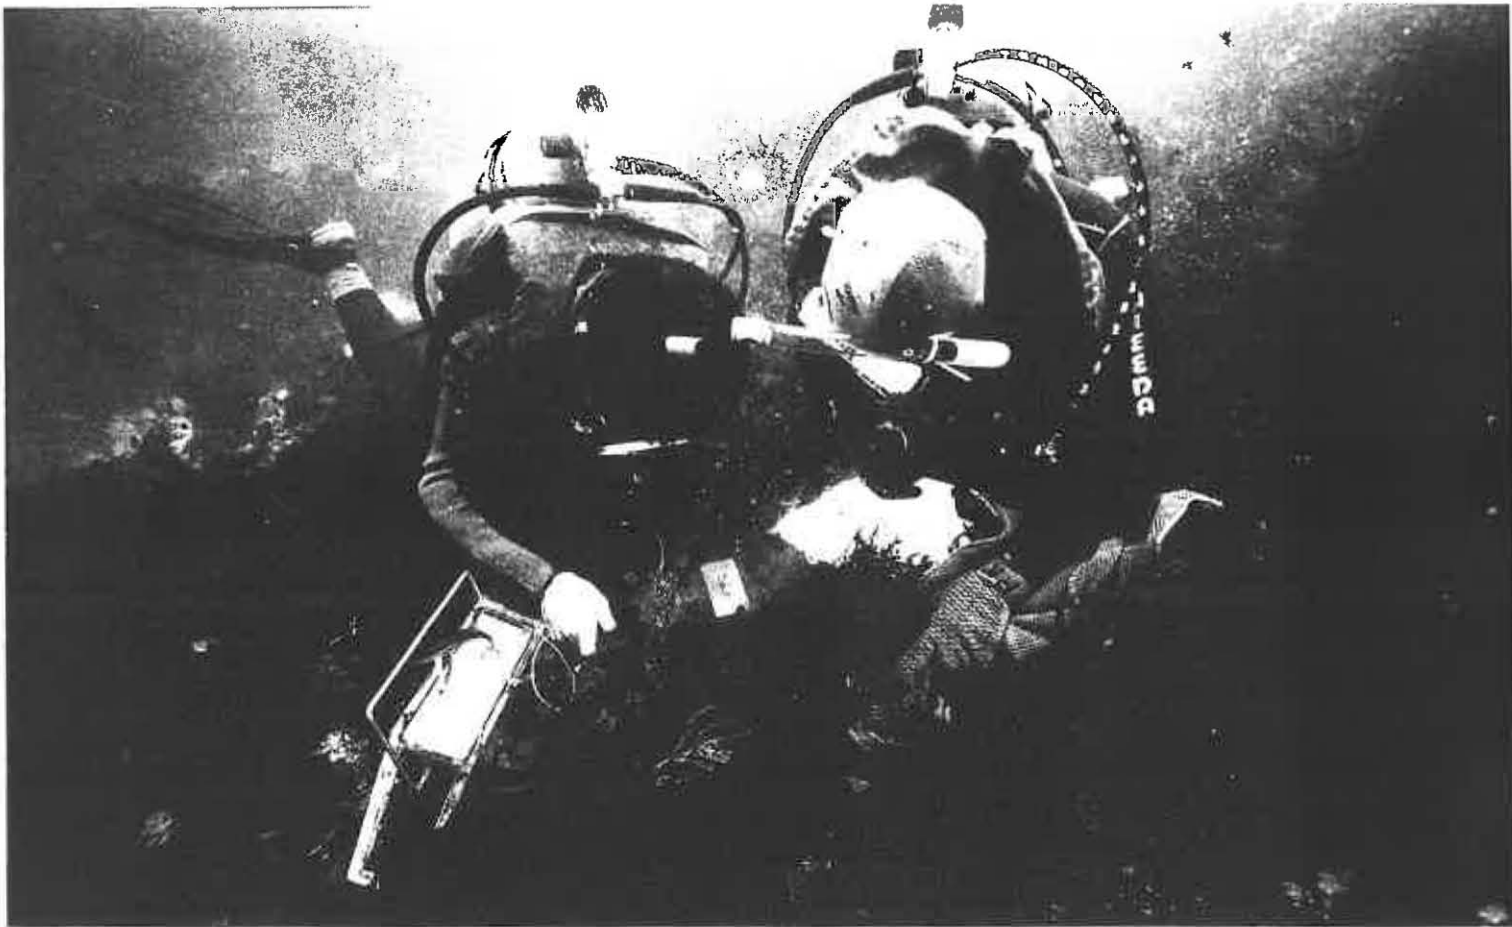
Figure 17. Divers take corrosion potential readings from iron objects on the west of pier site. Photo: Pat Baker

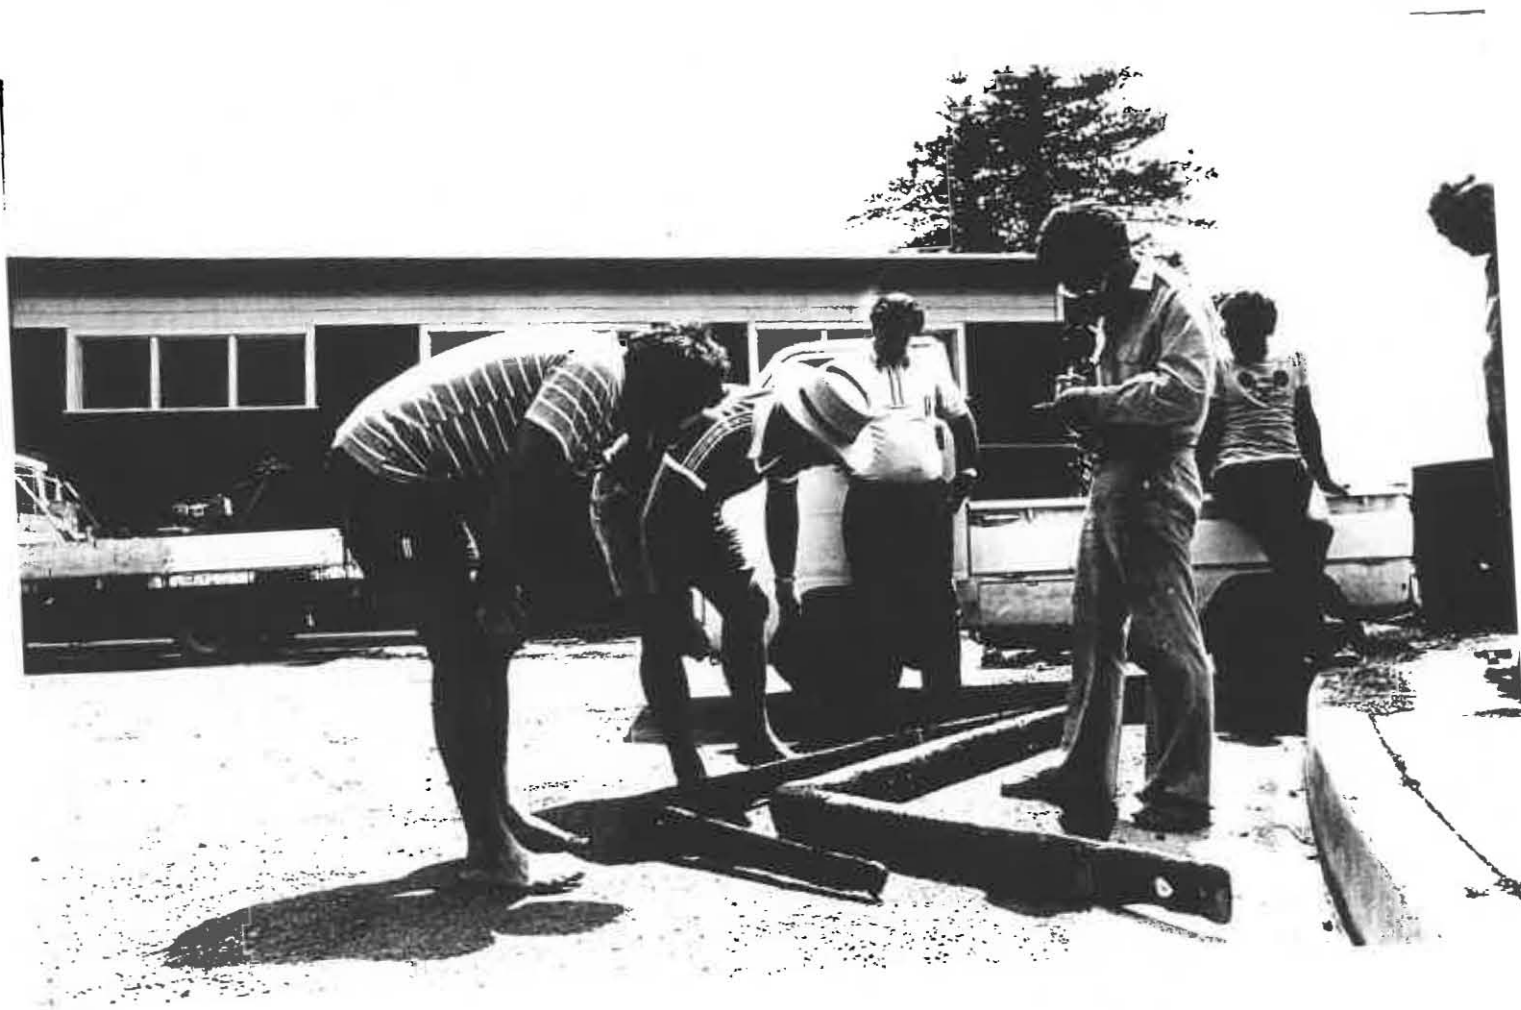
Figure 13. Iron knees from Mary Hamilton and Renaki are compared.
Photo: Pat Baker

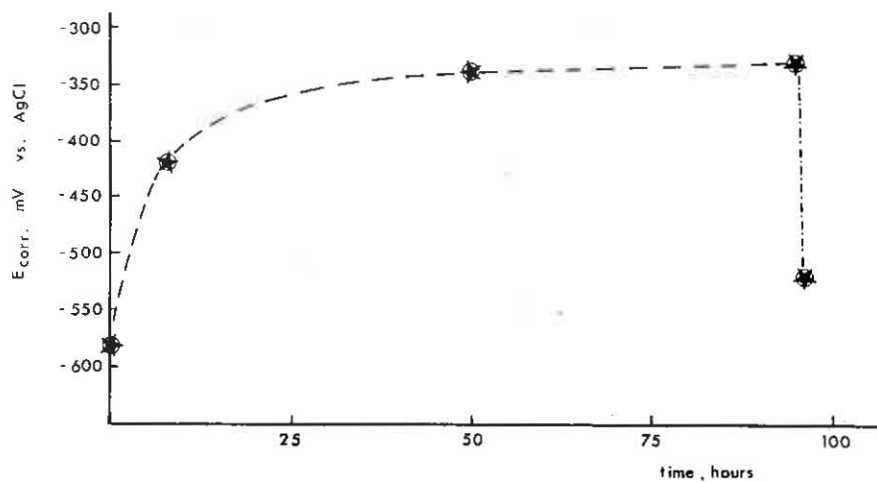
Fig. 19. Plot of the corrosion potential of the *Sirius* anchor, by the Kingston pier, versus the time since the anchor was shifted from the main site. The final measurement refers to the potential shortly after connection of the sacrificial anode.

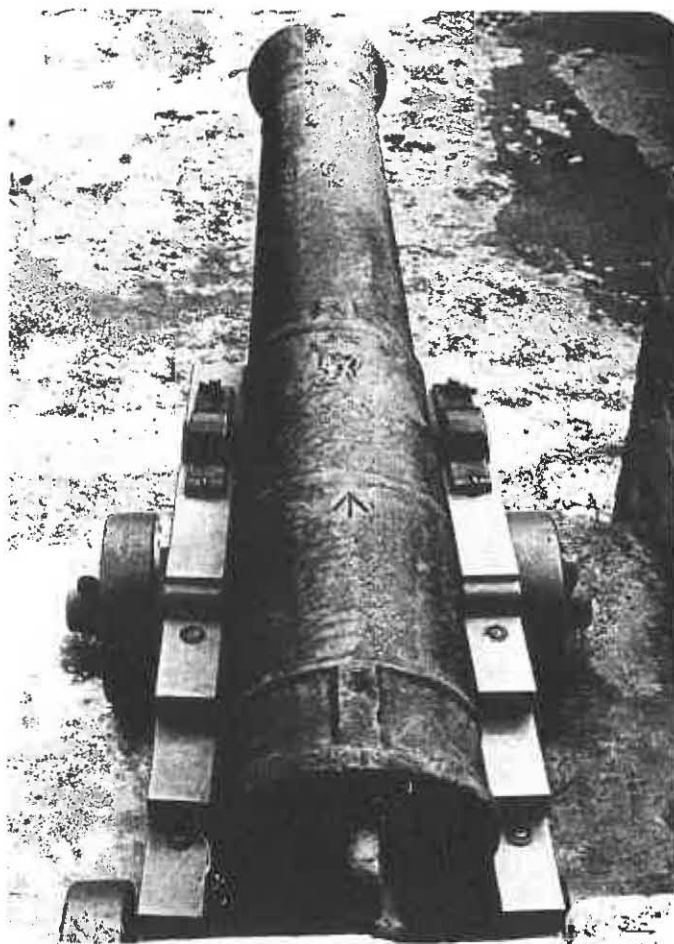
Fig. 20. Cannon outside the administration building showing marked surface rusting on the areas most exposed to direct sunlight. This photograph was taken before the conservation treatment.

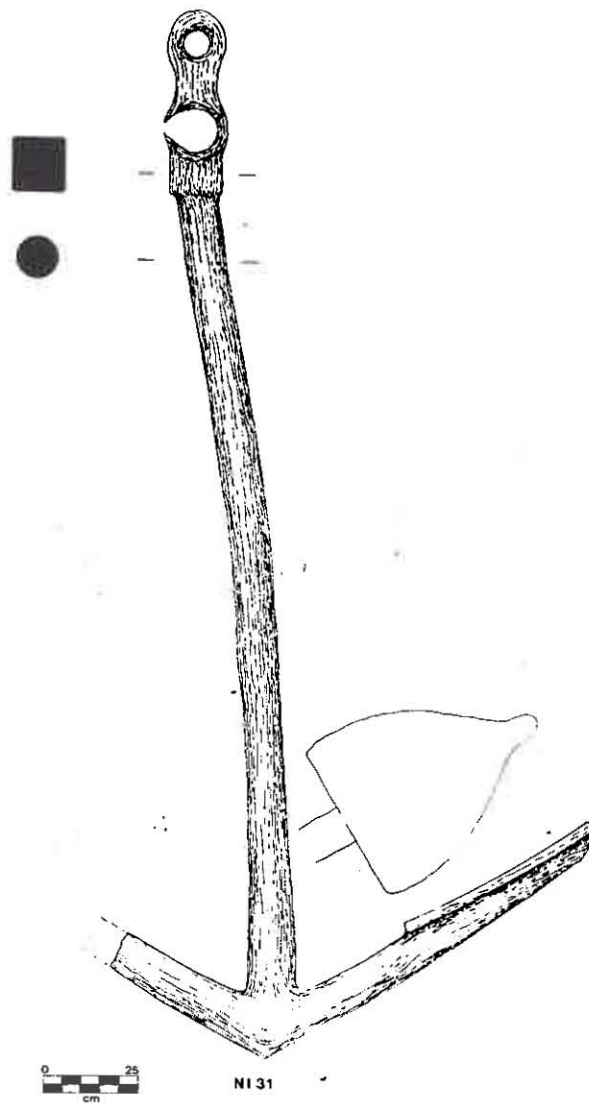
Cascade Bay, Norfolk Is.
Located: Castaway Hotel
Drawn 1985 M.S.

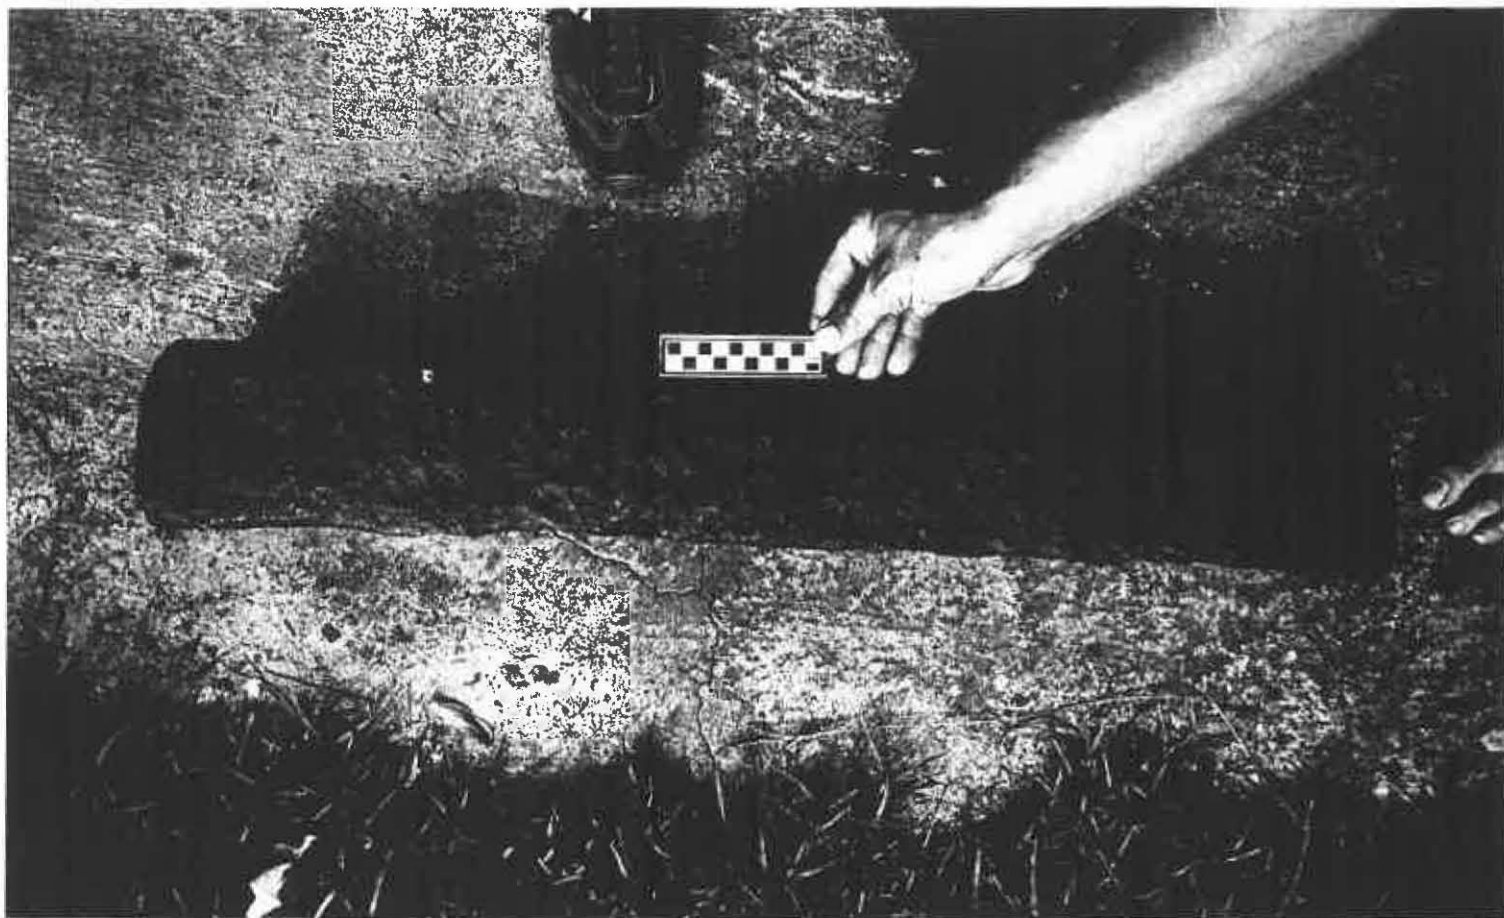
Figure 41. Iron ballast from residence of Bev McCoy.
