THE V.O.C. SHIP BATAVIA 1629

REPORT ON THE THIRD SEASON OF EXCAVATION

Report - Department of Maritime
Archaeology, Western Australian
Museum: No. 3

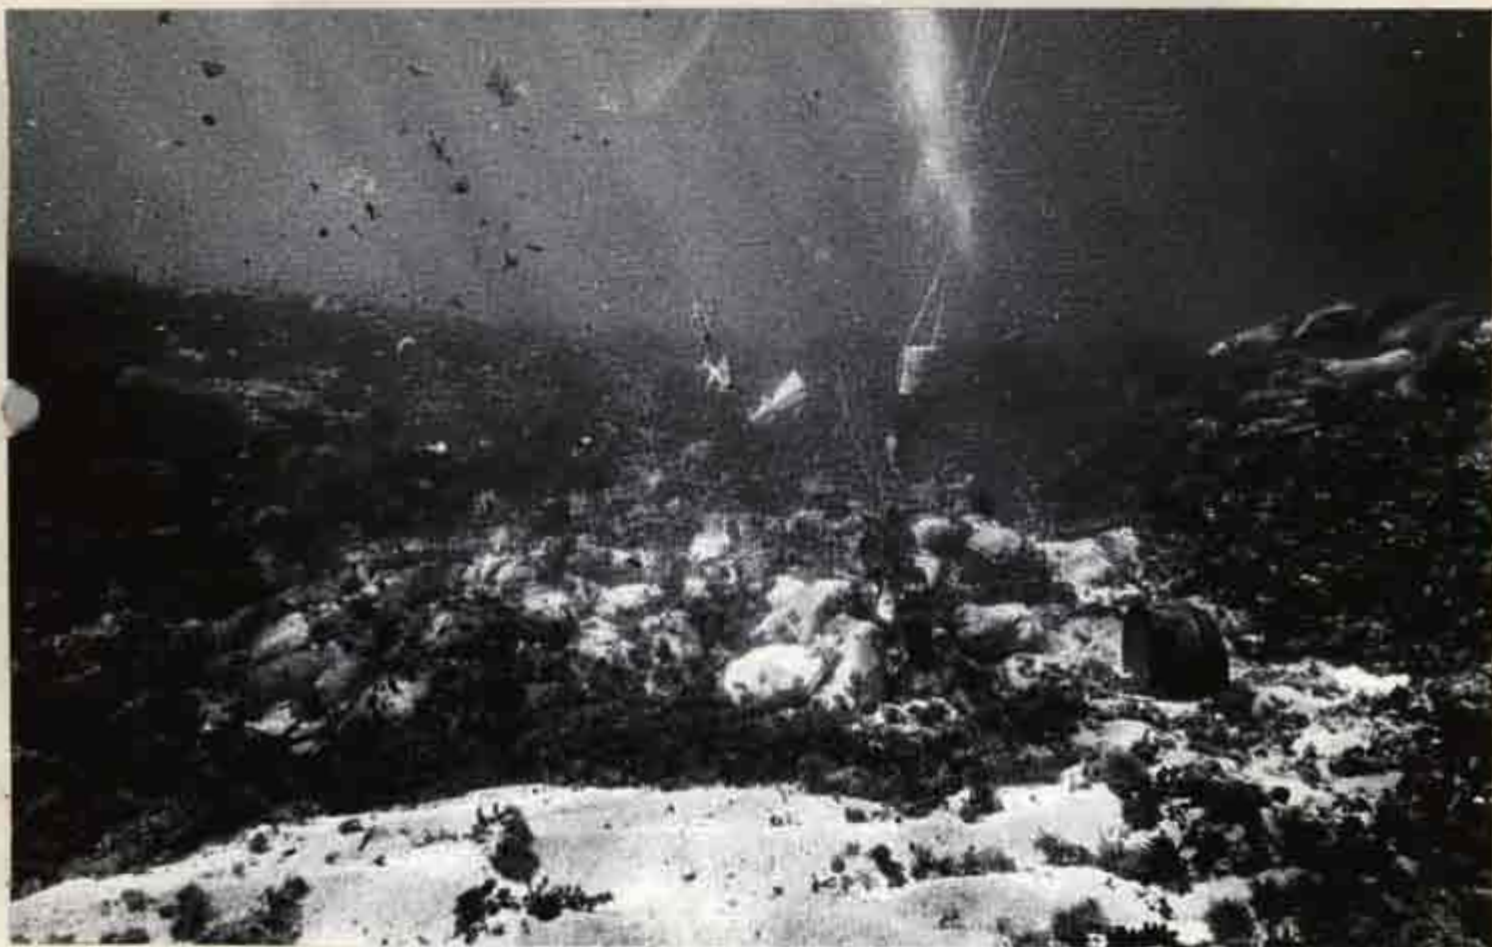
FIGURE 2. Coral bags and railway irons protecting Batavia's stern timbers.

At the southern end of the wreck one third of the ship's stern section has been preserved. Part of this area was exposed in 1974. In order to protect the cleared timbers from the damage of the surge and wave action during the off-season in 1974, 150 bags of sand and coral, each weighing 100 Kg, were put over this part of the site together with about 50 sections of railway line (Fig. 2).

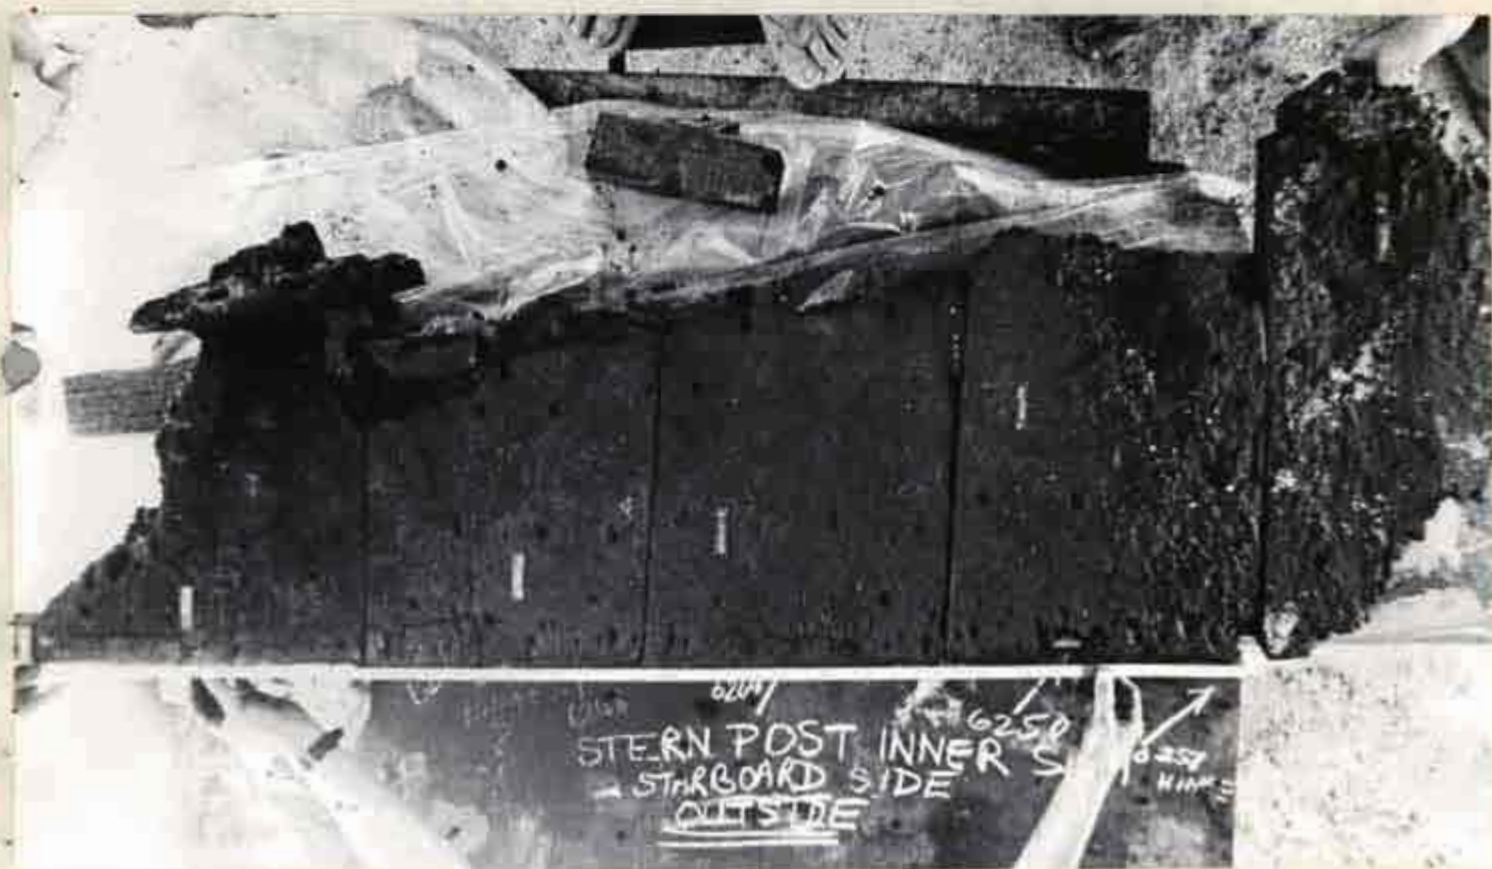
FIGURE 4. The inner skin of the sternpost.

During that work a 1.37m and 18-27cm wide section of Batavia's stern-post was found (Fig. 3). The part of the stern-post recovered consists of the inner and outer skin (Fig. 4, Fig. 5). The outer skin has five Roman style water-line markings (Fig. 6). They are horizontally carved into the wood parallel to and 288mm* from each other. Half values are indicated by a single point. The outer skin is fastened to the inner skin with iron nails diagonally positioned 4cm from each other. Between the outer and inner skin is a layer of tar and cow hair. The edge of both the inner and outer planking at the stern-post has been protected with copper sheeting, fastened with copper nails. Small parts of the copper sheeting were salvaged together with the stern-post.

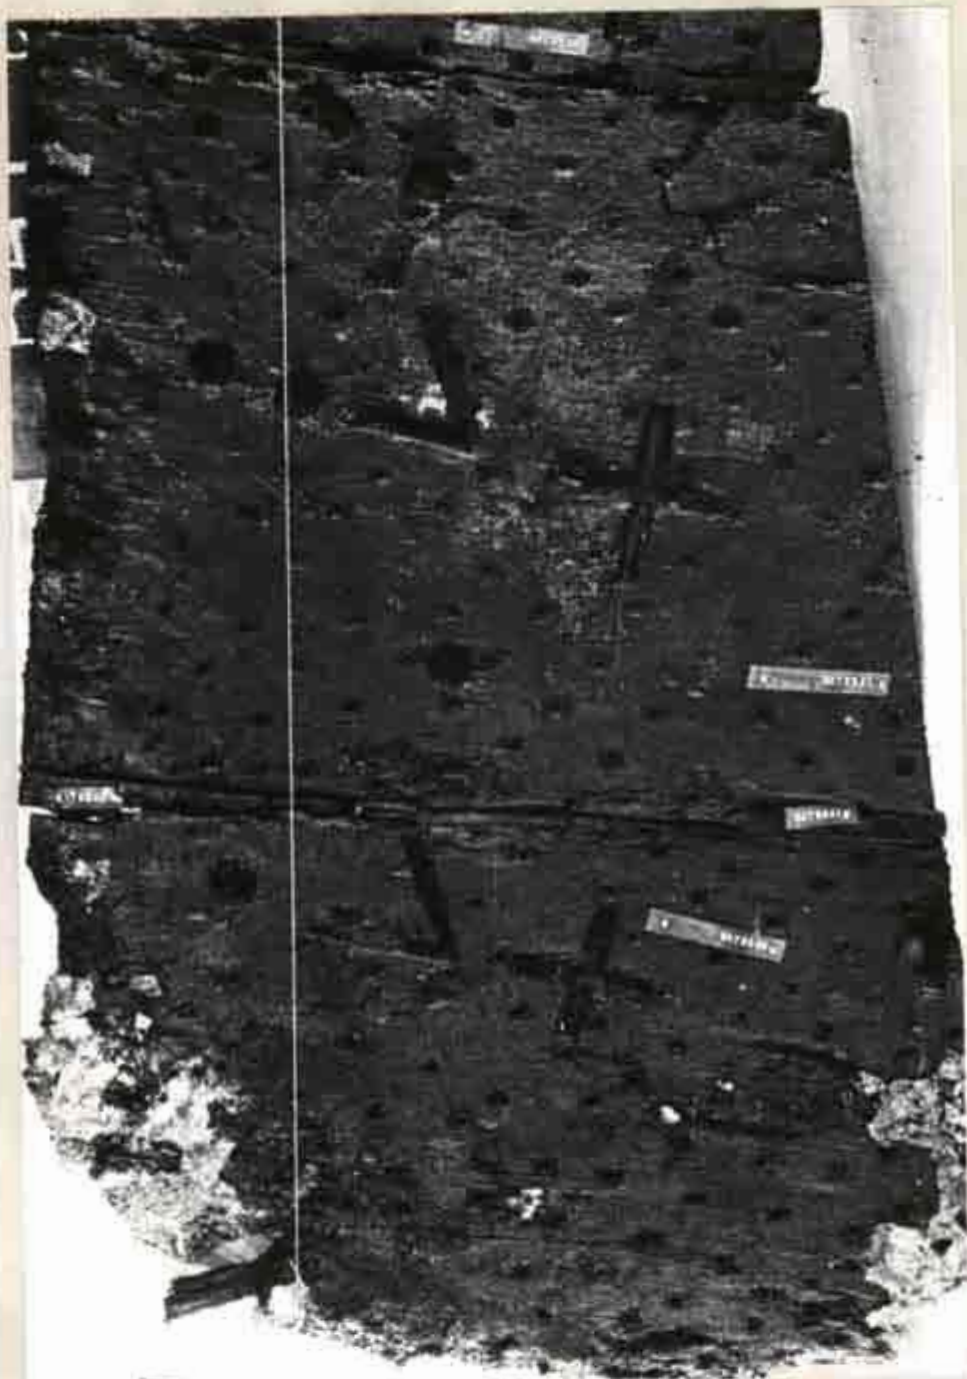
FIGURE 6. Waterline markings on the Batavia.

*288mm is close to the Amsterdam foot of 278-284mm (284mm van Ijk, 278mm Witsen). The draught marks on the warship Wasa, contemporary with the Batavia, resemble the ones on Batavia's stern-post (Fig. 7). There the markings are carved about 292mm from each other.

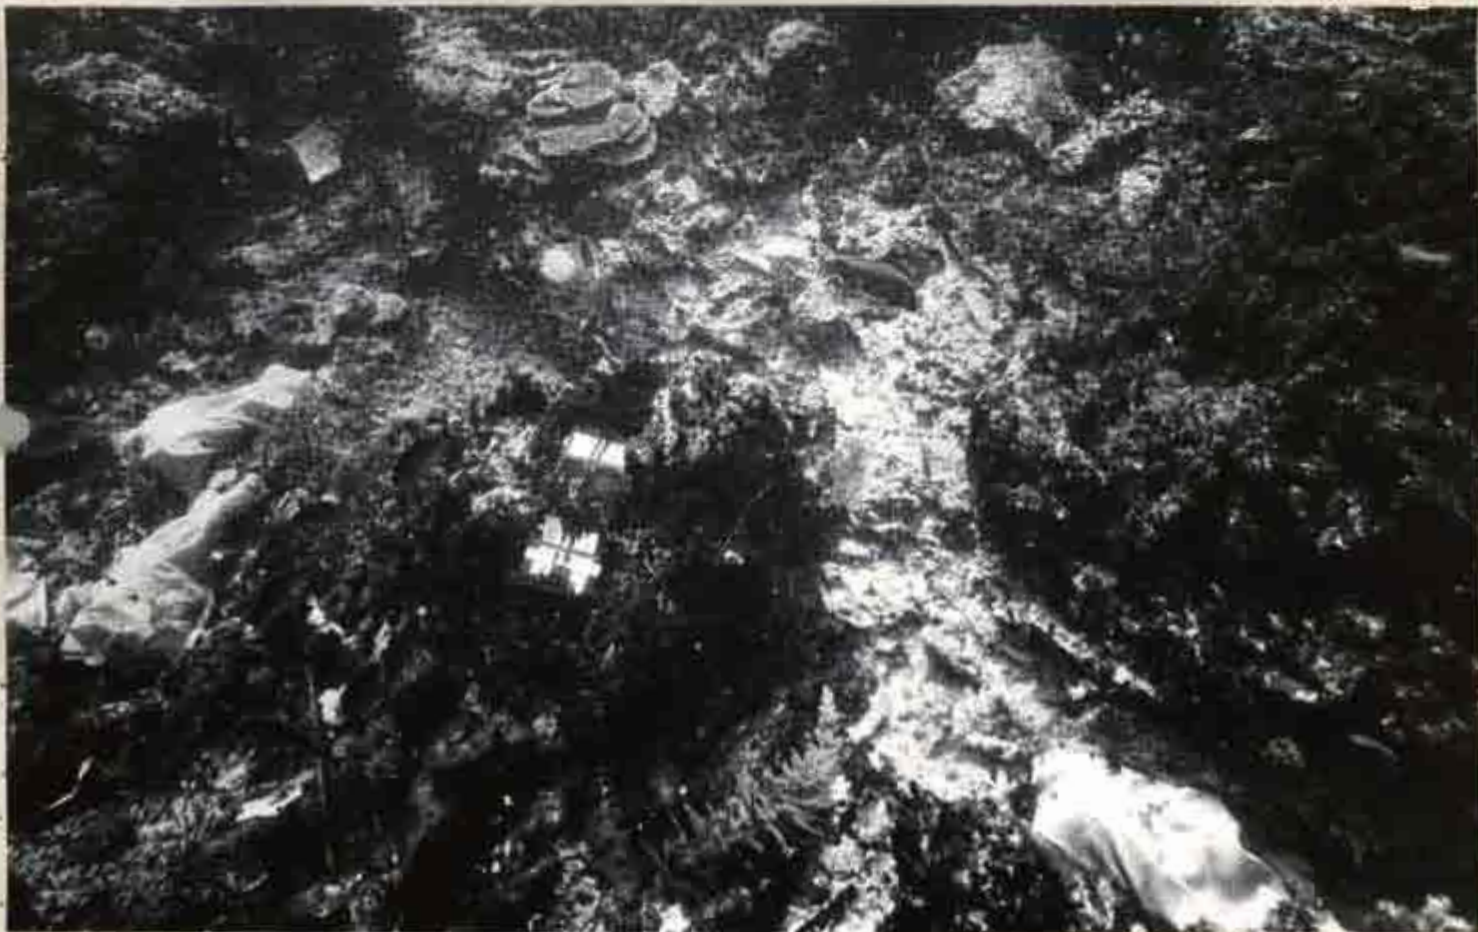
FIGURE 8(a). 2g Metabel explosive charge, with cordtex and detonator in place on the rubber mat prior to detonation.

In order to loosen the very hard concretion, charges of 2 g "Metabel" explosives were used. The explosive, with cordtex-train and electric detonator, was placed under a rubber mat (Fig. 8 (a) (b)), over the required area. After detonation, lumps and fragments of the shattered concretion were easily chipped away with geo-picks and hammers, and the loosened cannon balls salvaged.

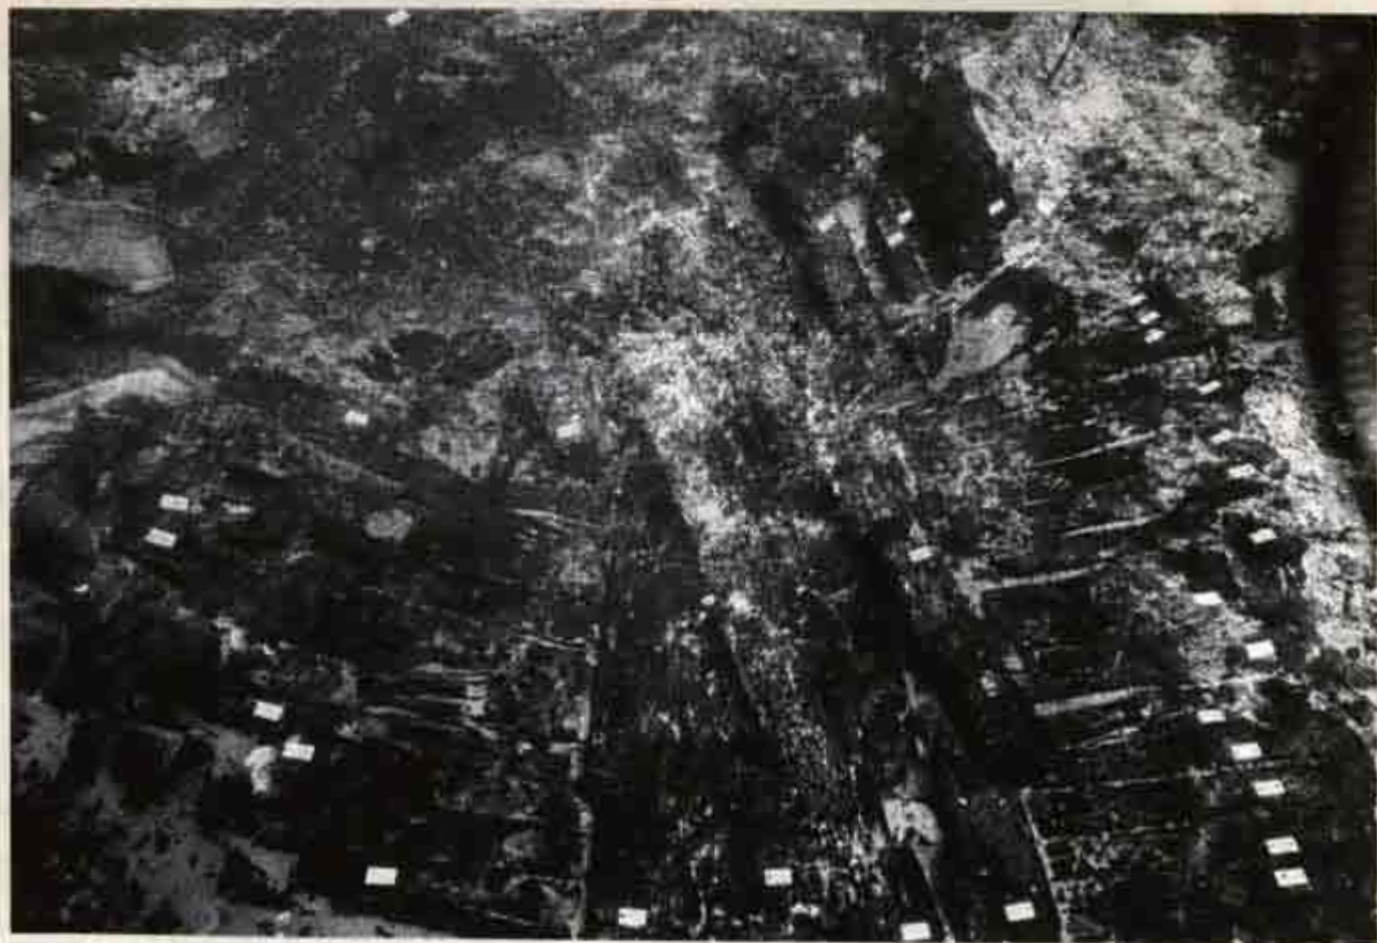
FIGURE 9. The timber area at the stern section of the ship.

For overall plans of the ship's stern a Nikonos camera with a 15mm water-corrected lens was used. At a distance of 4m, the whole timber area could be covered in one exposure (Fig. 9). Five different layers of timber were photographed in this way: the transom knees, the ceiling, the ribs, the inside strakes and the outer planking.

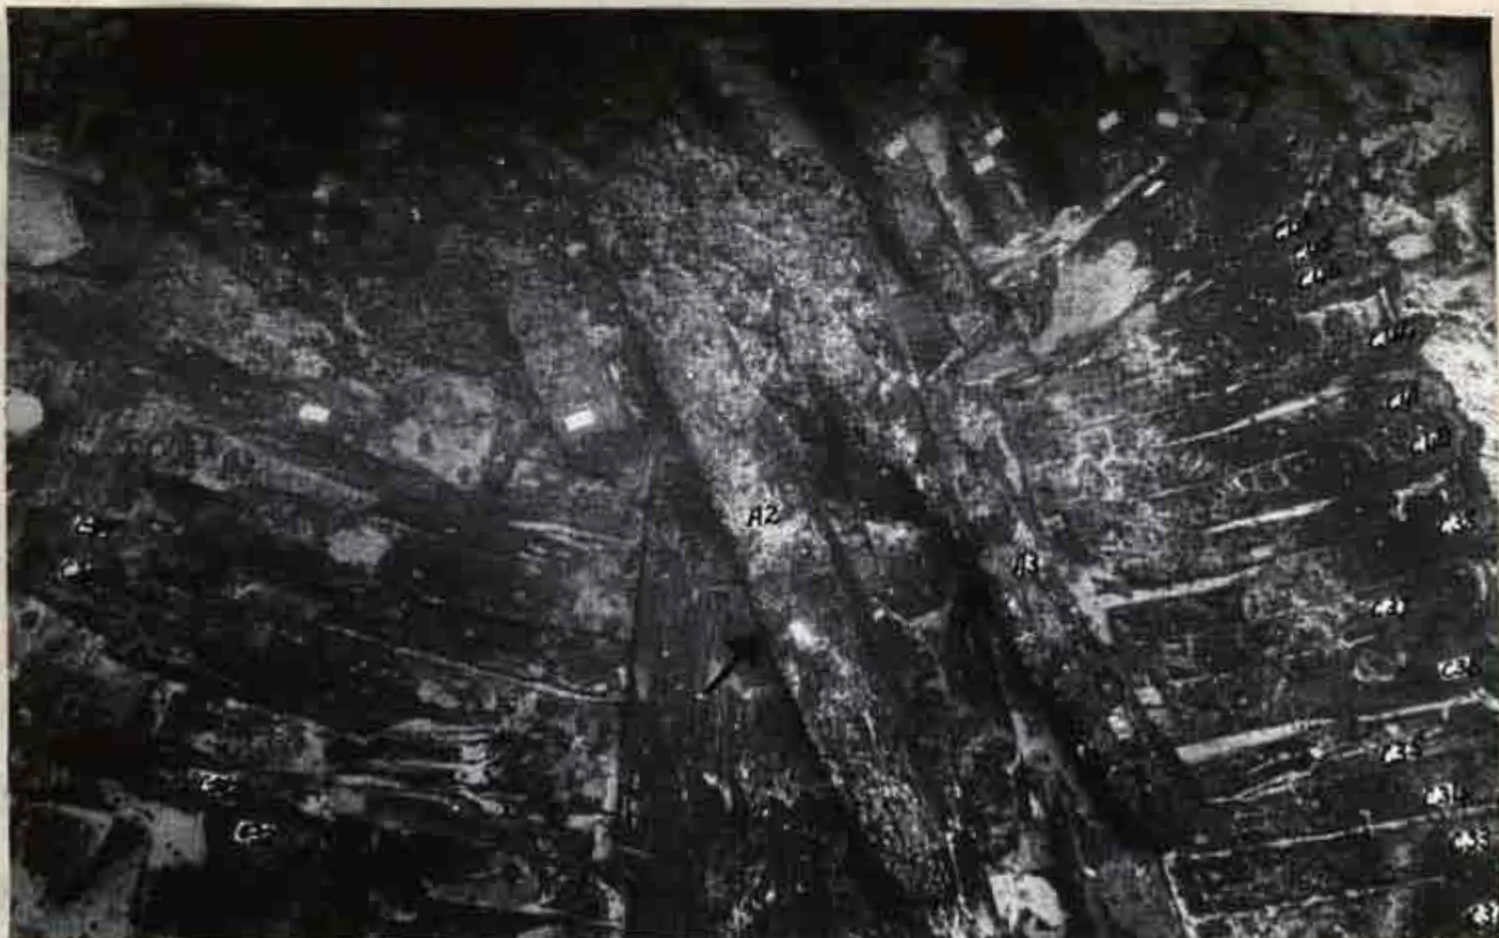
FIGURE 11. The transom lodging knees.

At the joint, between the stern and the side of the ship on the inside, there are massive transom lodging knees (A-layer). These cover the transom at the quarter stern and the ceiling at the side of the ship (Fig. 11). Sometimes small braces were found between the knees and the ceiling (Fig. 12). Underneath the knees, at the junction between the stern and the side, lies the fashion piece (Fp Fig. 13). Dove-tailed into the fashion piece below the transom knees, part of the transom wing and the transoms have been preserved (T-layer Fig. 14).

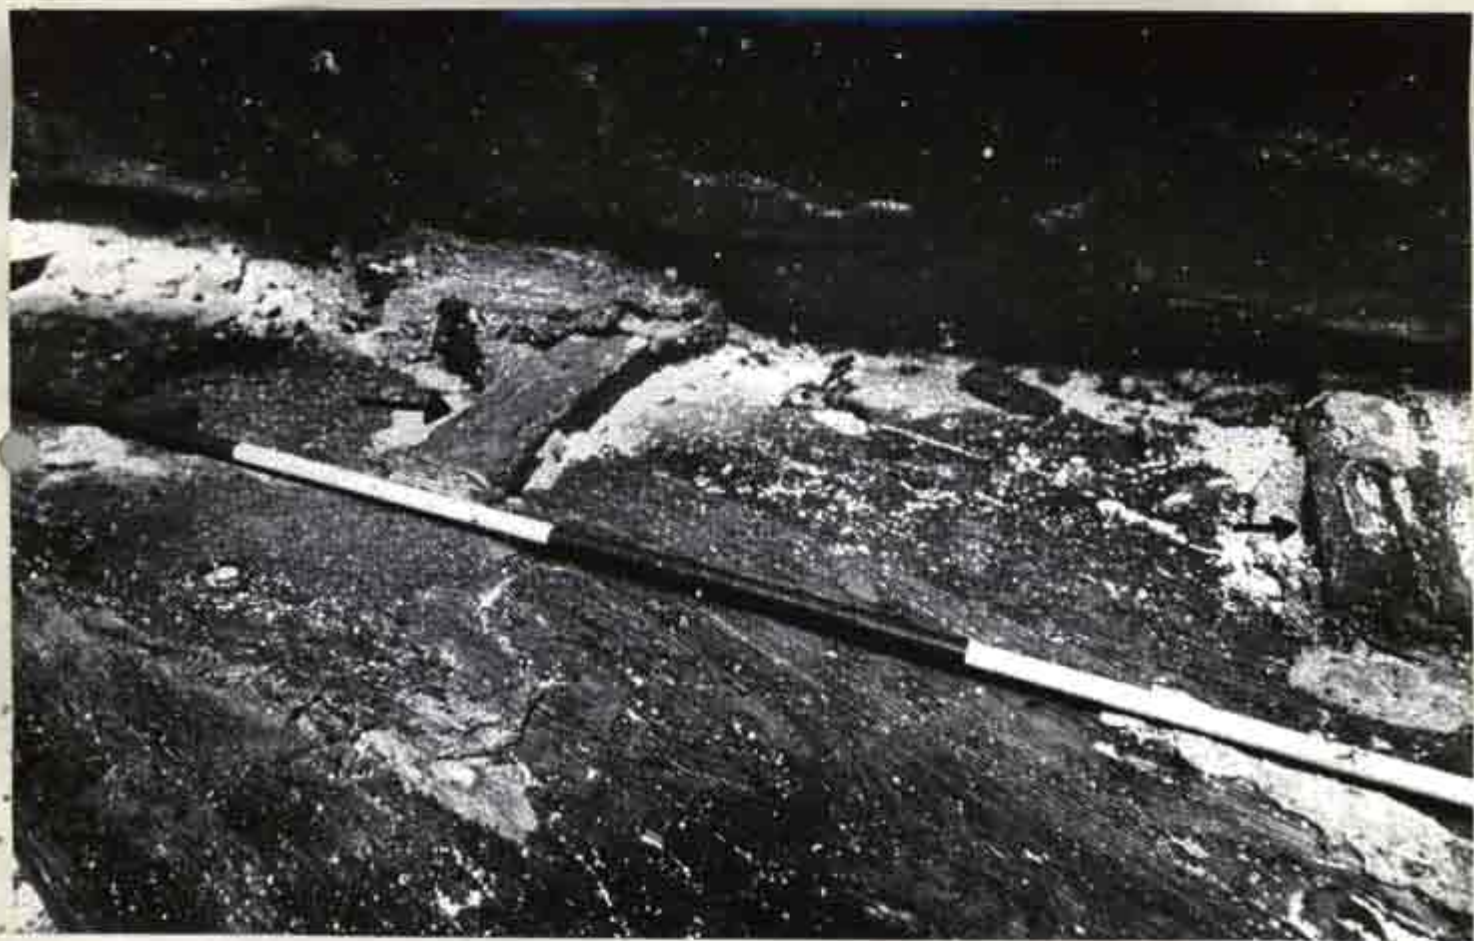
FIGURE 12. Braces underneath the knees.

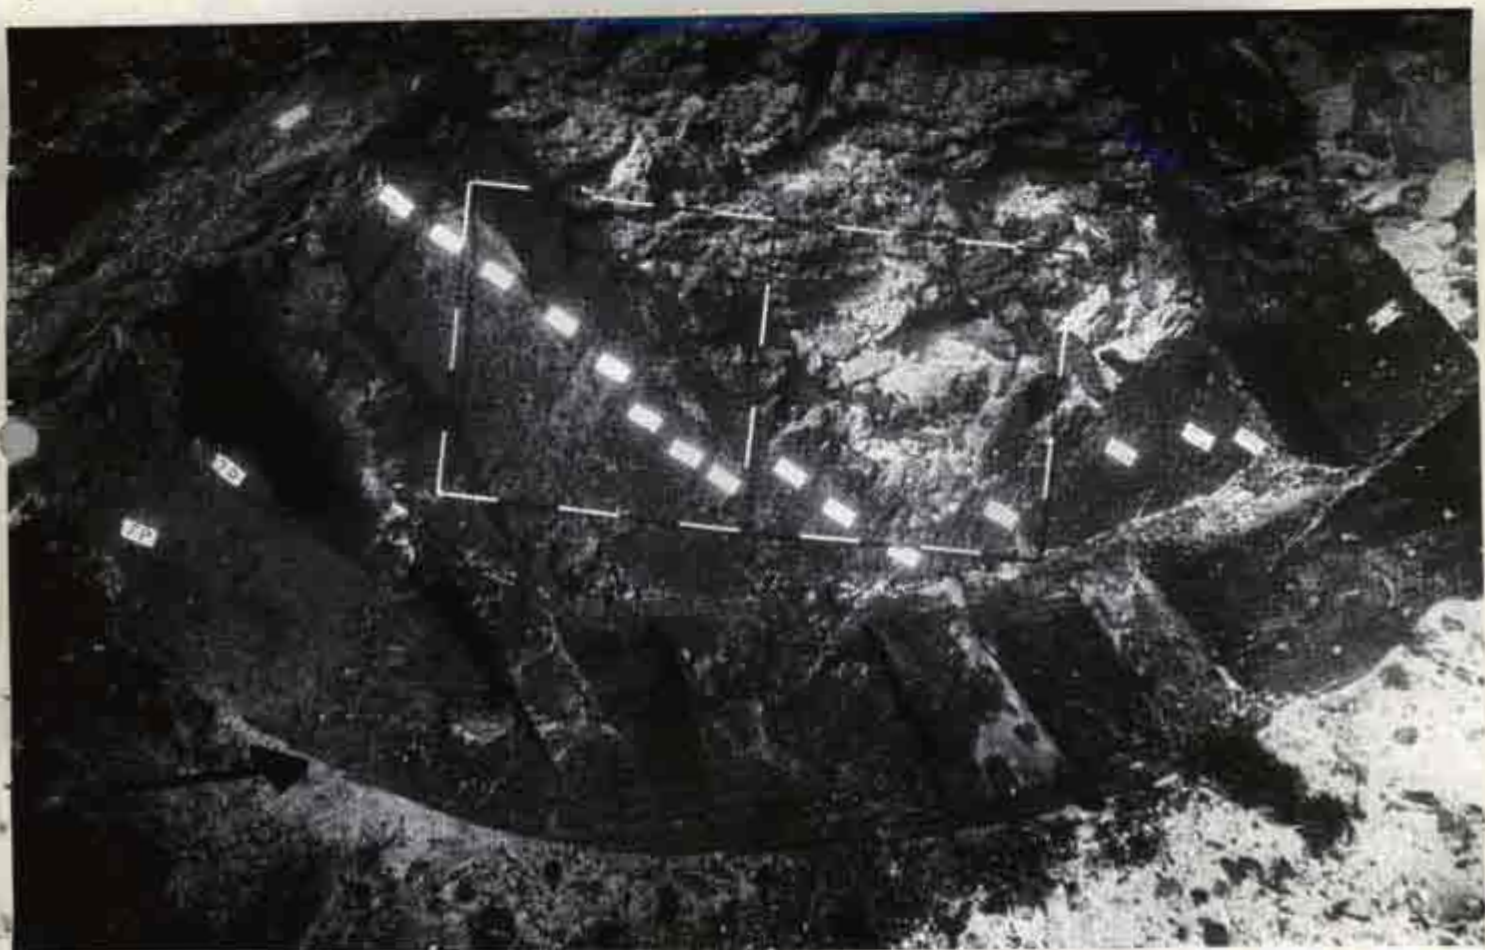
FIGURE 13. The fashion piece.

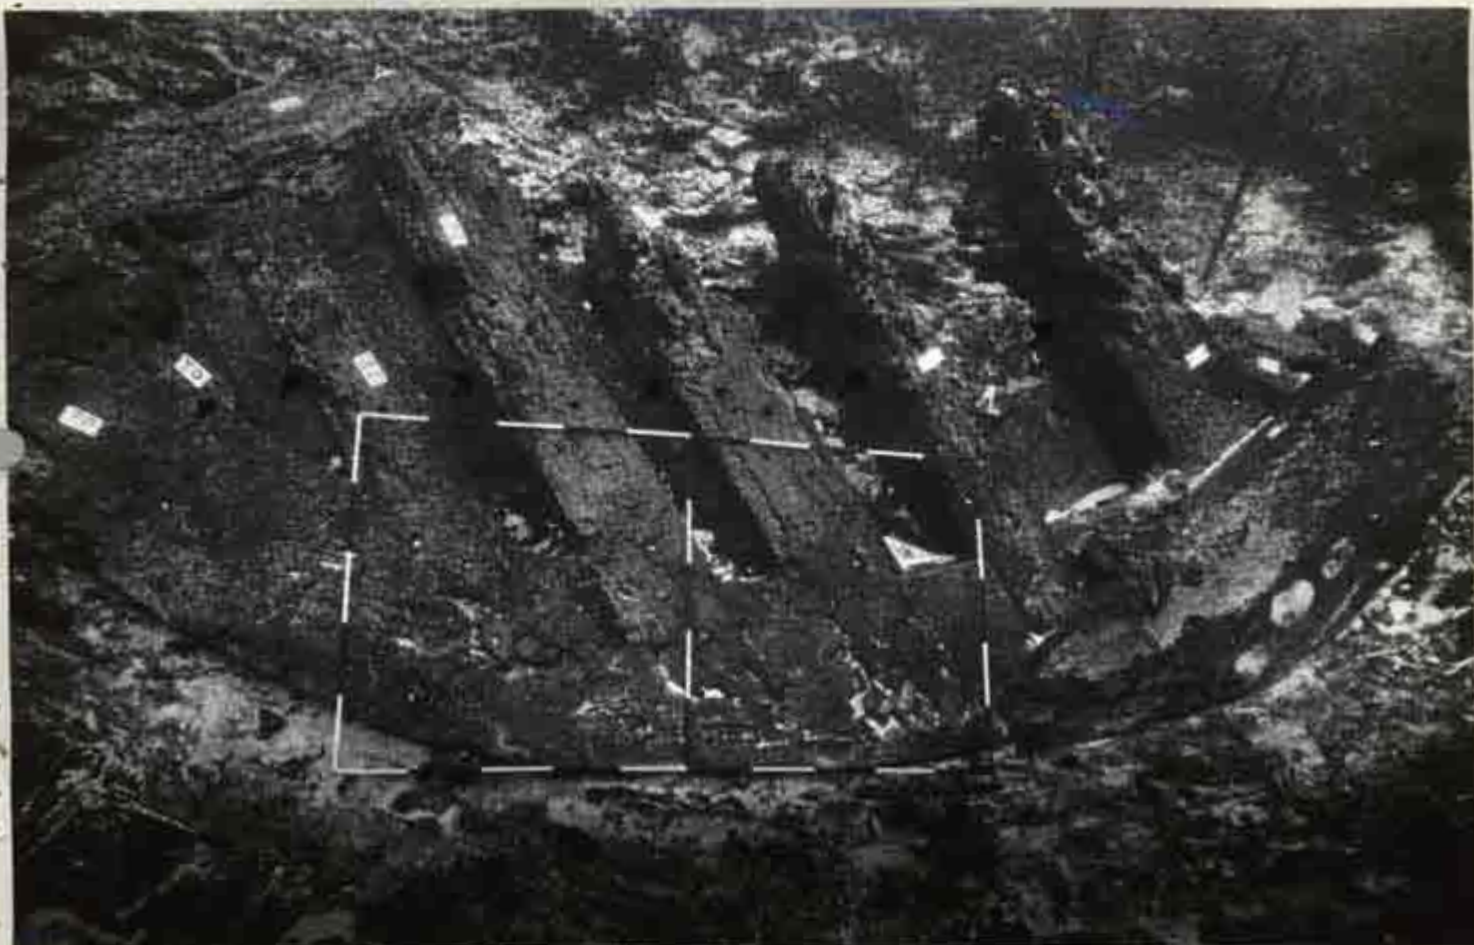
FIGURE 14. The transoms and the transom wing.

Three of the transoms are connected to the stern-post at its lower end, while at the upper part they have been worm-eaten and worn away to two-thirds of their original length. However, with the length of the transoms preserved, and with the information gained from the stern-post and the fashion piece, it would be feasible to reconstruct the stern to the level of the wing transom.

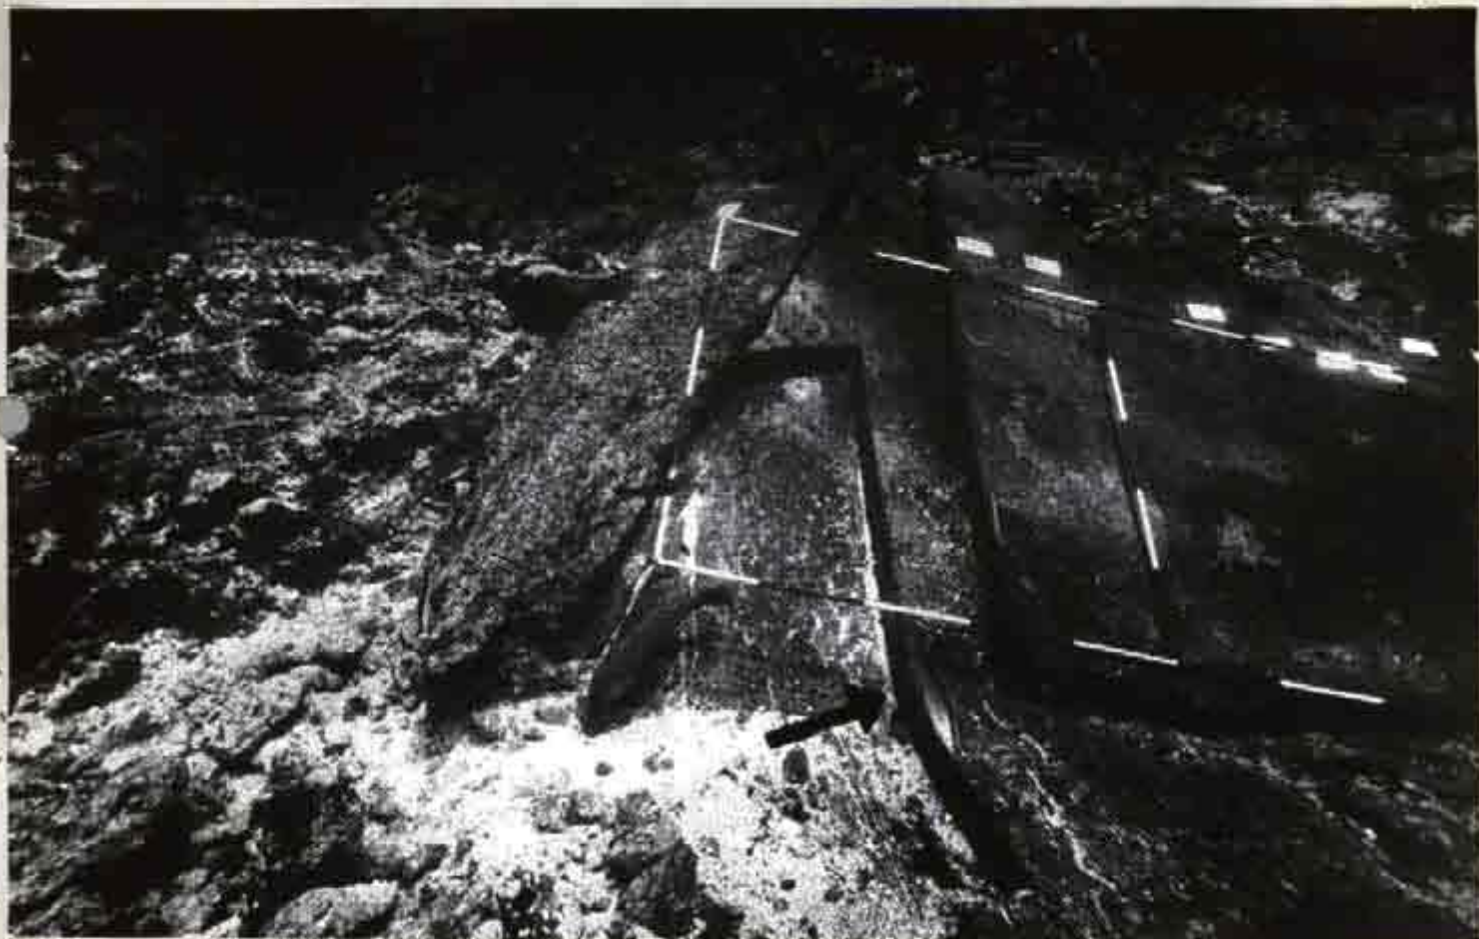
FIGURE 16. Bent outer layer of planking running underneath the transom planking and the inside strakes.

Beneath the transom planks, a layer of bent outer planking appears (Op-layer Fig. 16). These strakes lie underneath the transom planking (Tp-layer) at the quarter stern, and under the inside strakes (D-layer) at the port side of the ship (Fig. 17). The planking is bent at an angle of 130° over the stern and the side of the ship. At the outside of the outer transom planking there is in addition a thin layer of "skin".

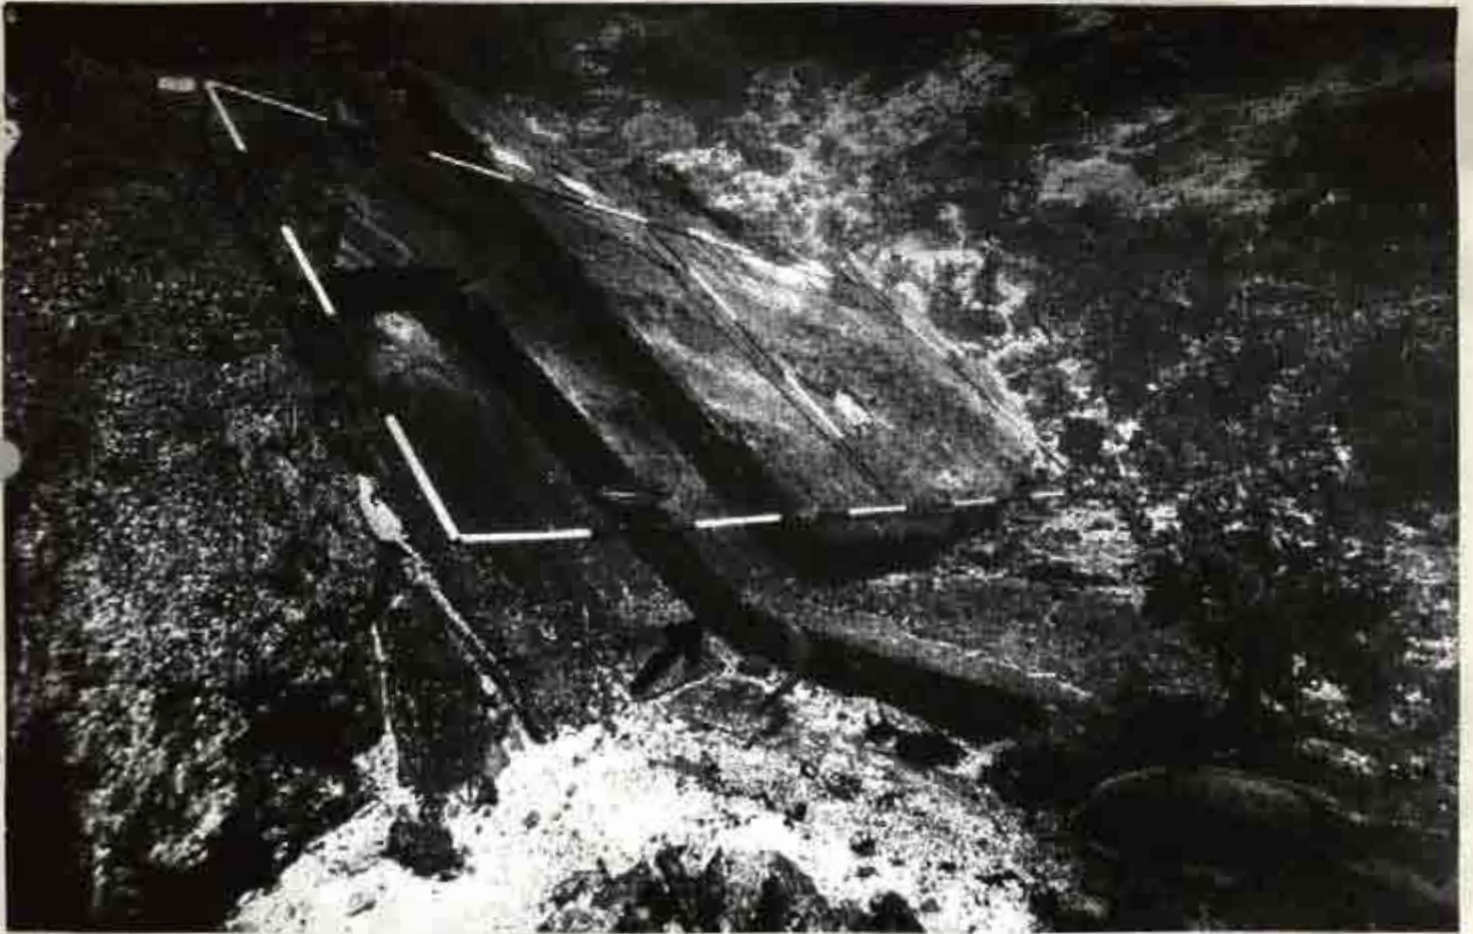
FIGURE 17. Detail of the bent outer planking.

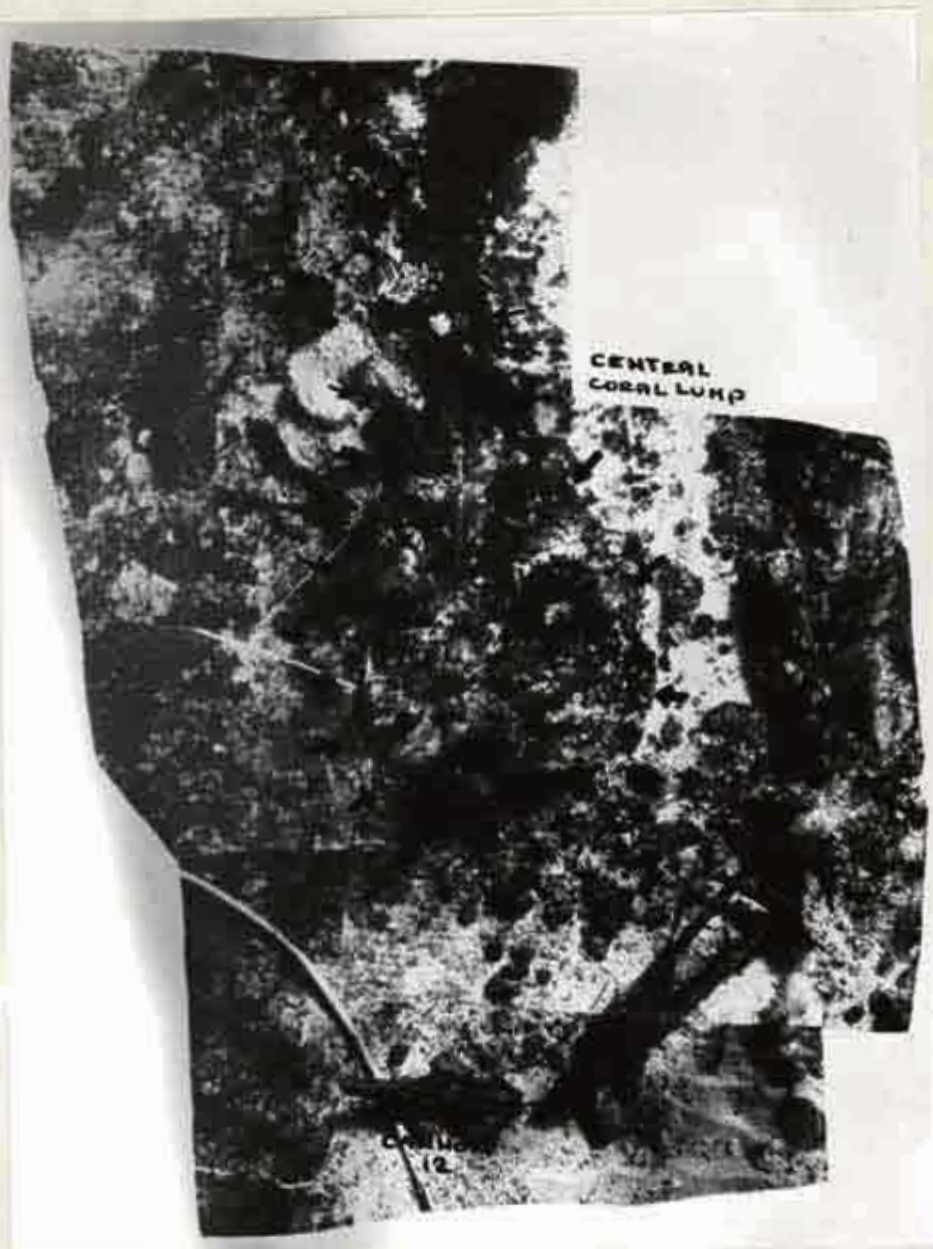
FIGURE 19. The central coral lump.

Further north, in the area of the bow half of the ship and more exposed to the breaking swell, there was a huge 30m² concentration of different kinds of coral mixed up with various artifacts (Fig. 19). This concentration (referred to as the central coral-lump) mainly covered area 2703 - 2709 to area 3205 - 3208. It was of a complicated structure. Topmost there was a 10-25cm layer of light and loose coral concretion containing almost no artifacts except the ubiquitous bricks. Towards its centre the concretion was hard
