Maritime Archaeology in Sri Lanka

The Galle Harbour Project—1993

Interim Report

Report—Department of Maritime Archaeology
Western Australian Maritime Museum, No. 65
1993

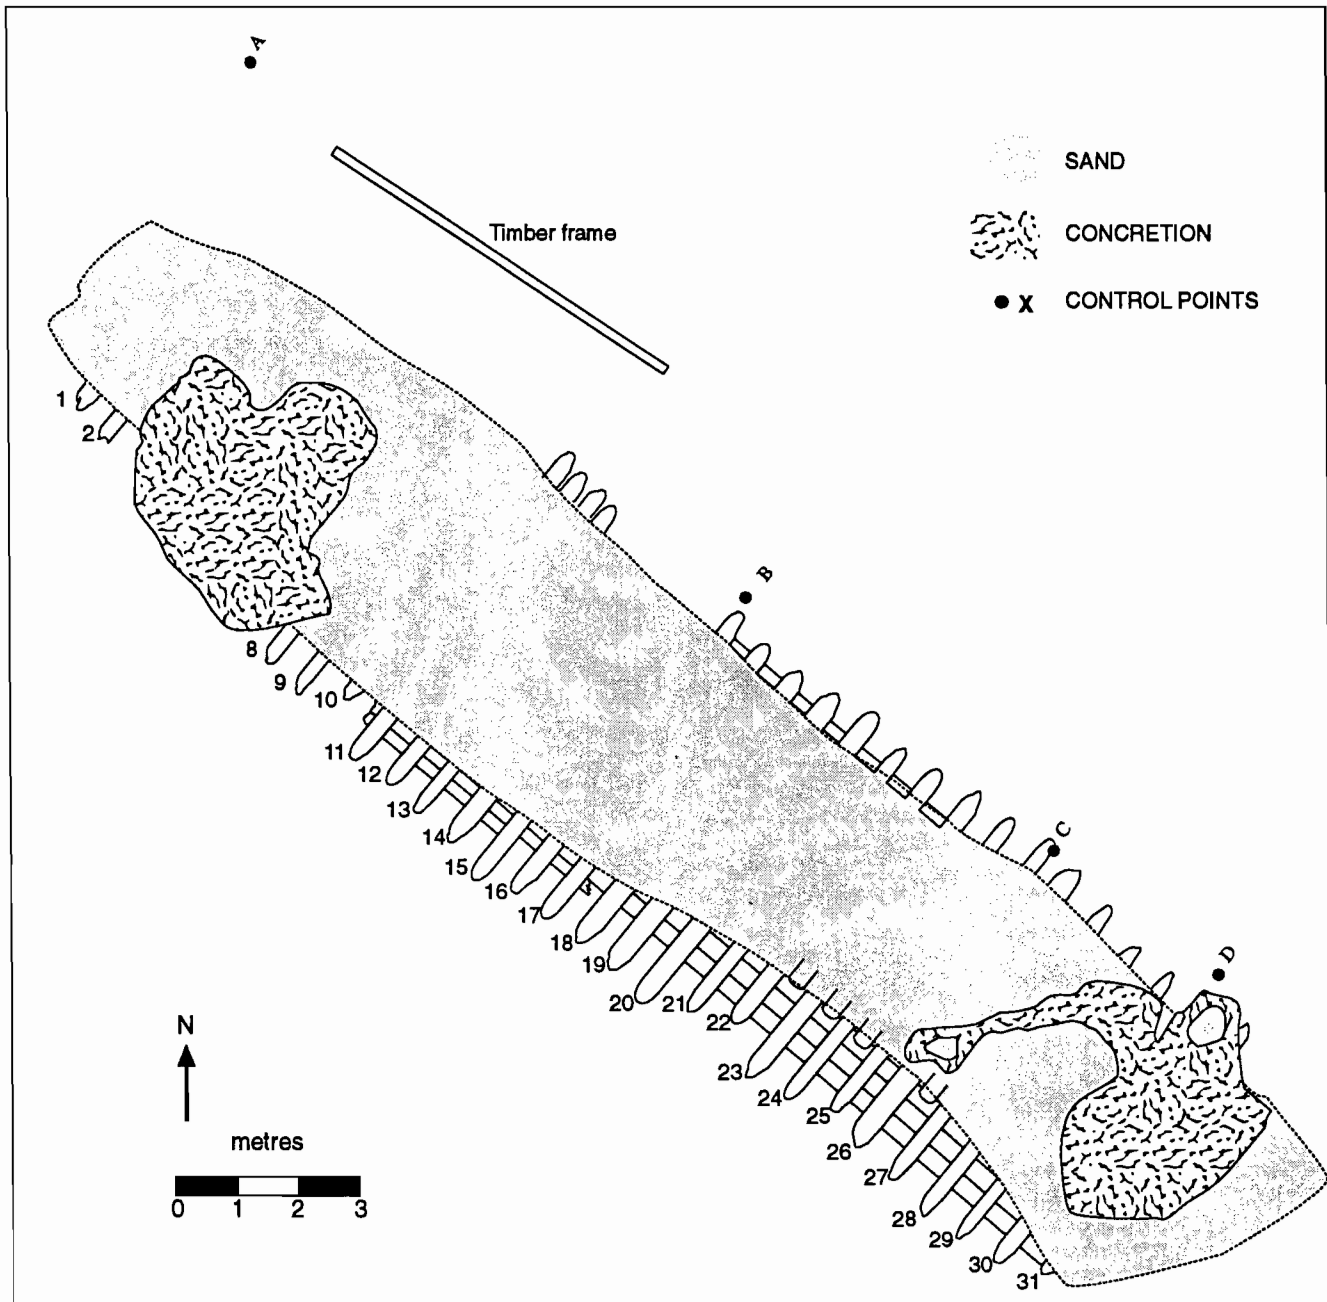
Figure 3. Plan of Site E drawn by Paul Clark.

The site is partially buried in very fine siliceous sand at a water depth of 3 m and lies in a north west to south east orientation in aerobic open water. This wooden wreck was much more extensively uncovered than when first surveyed in 1992. In all, just over 24 m of the site was visible.

The central part of the site was covered in sand, while the edges were uncovered allowing a detailed survey of the site to be undertaken. Control points were established in various places along both sides of the vessel and surveyed in using trilateration. This formed the basis of the site plan allowing the details of the hull structure to be filled in. Paul Clark undertook the survey of this site (Fig. 3).

Iron knees, remnants of the composite wooden hull, iron chain concretions, copper-alloy fastenings, treenails and a variety of small artefacts (fragments of ceramic, glass, pipe bowls, stems and ballast) were lying on the site. Some sheets of copper alloy sheathing were seen between floors 29 and 30 (Fig. 3). Marine borers are active on the site.

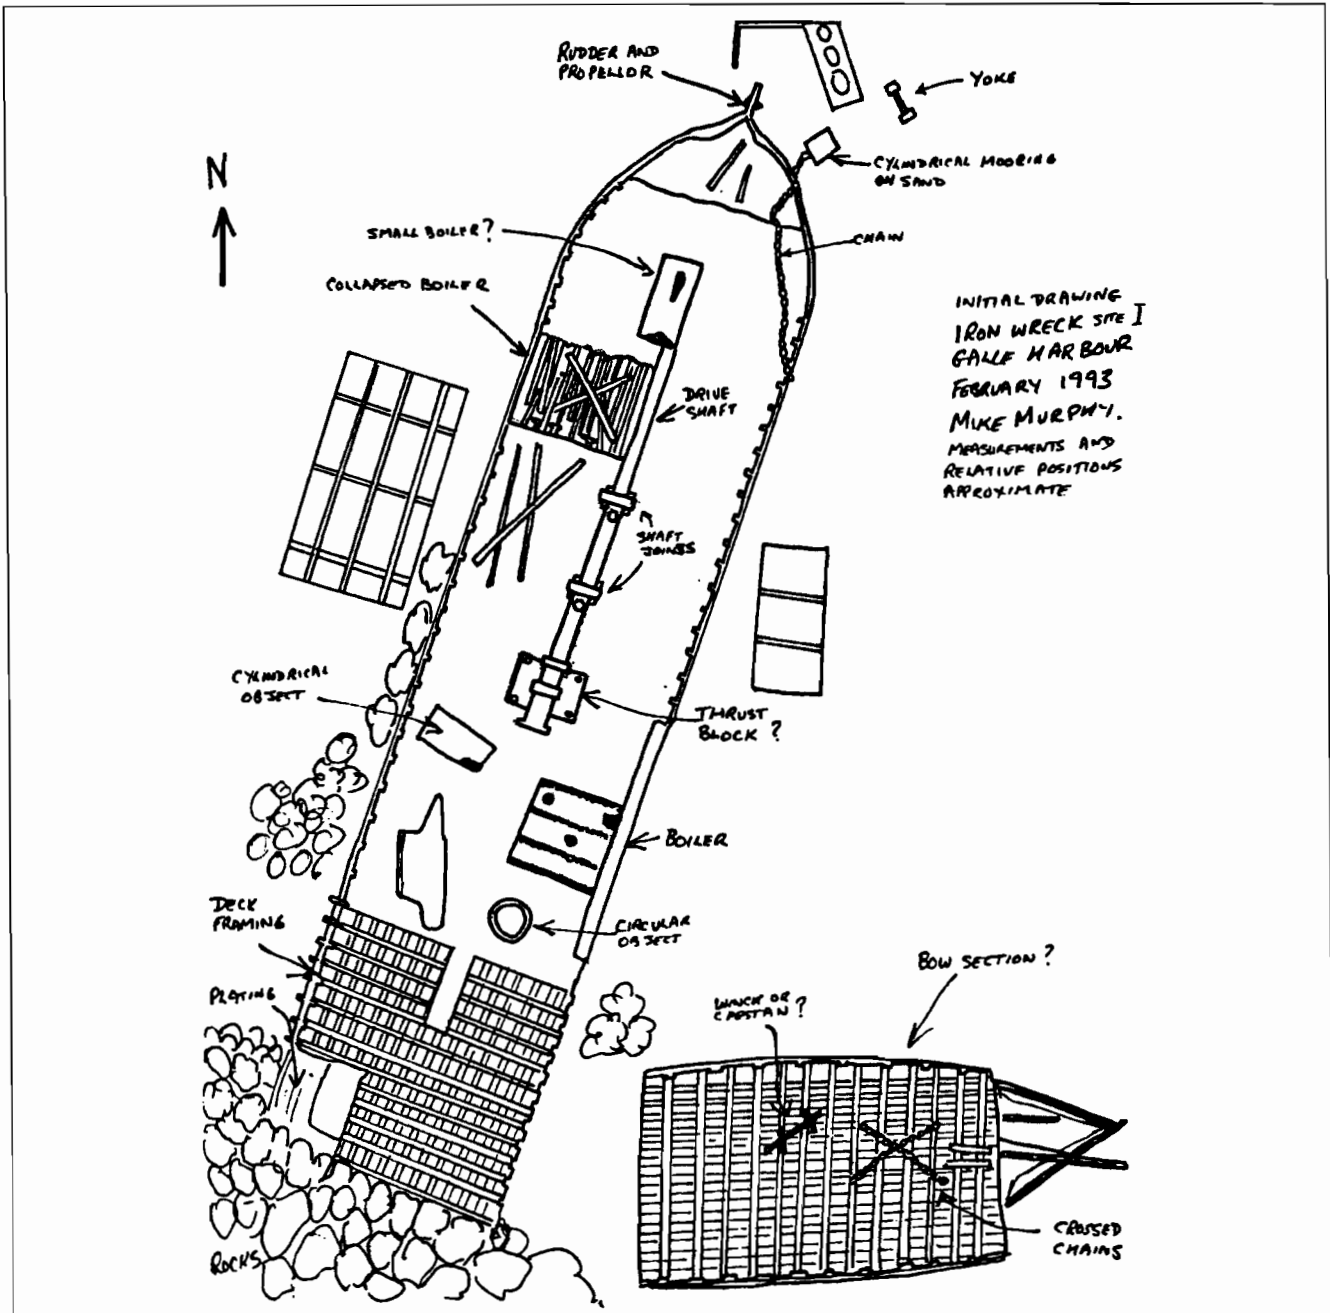
Figure 5. Sketch plan of Site I drawn by Mike Murphy.

This site was searched for during the 1992 season, but not located. During the 1993 season the site was successfully located and is now plotted on the chart. The site (Fig. 5) is a large iron ship with the bow broken off and lying to one side. There are two boilers, a single screw propeller, rudder and drive shaft. The engine appears to have been salvaged.

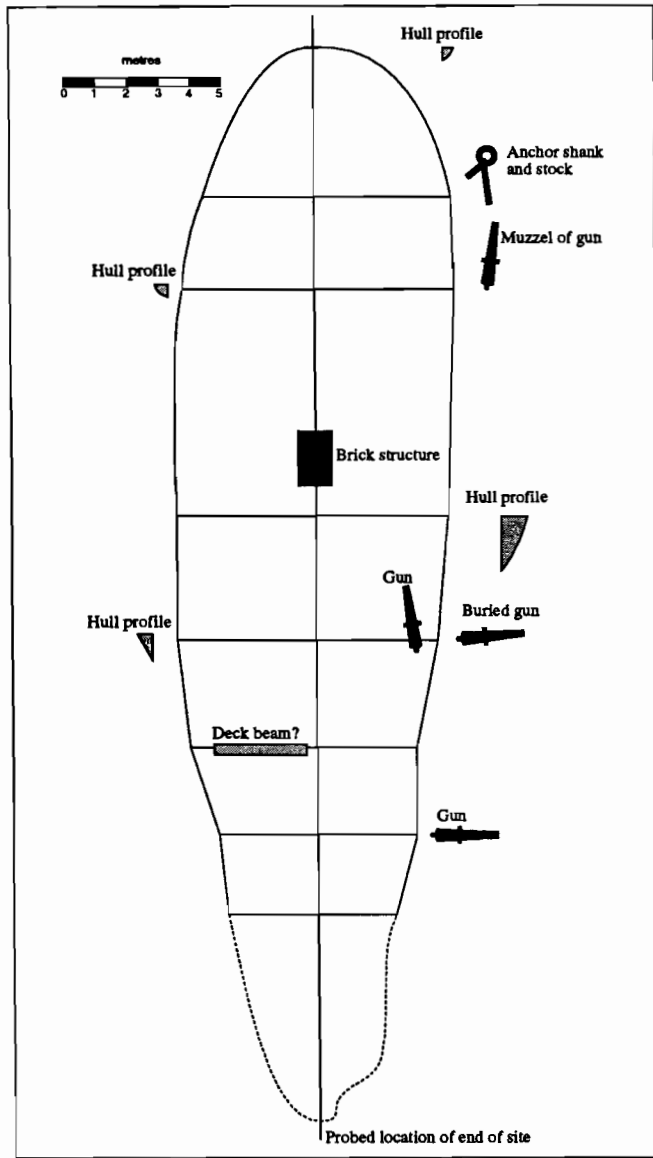
Figure 7. Interim plan of Site L.

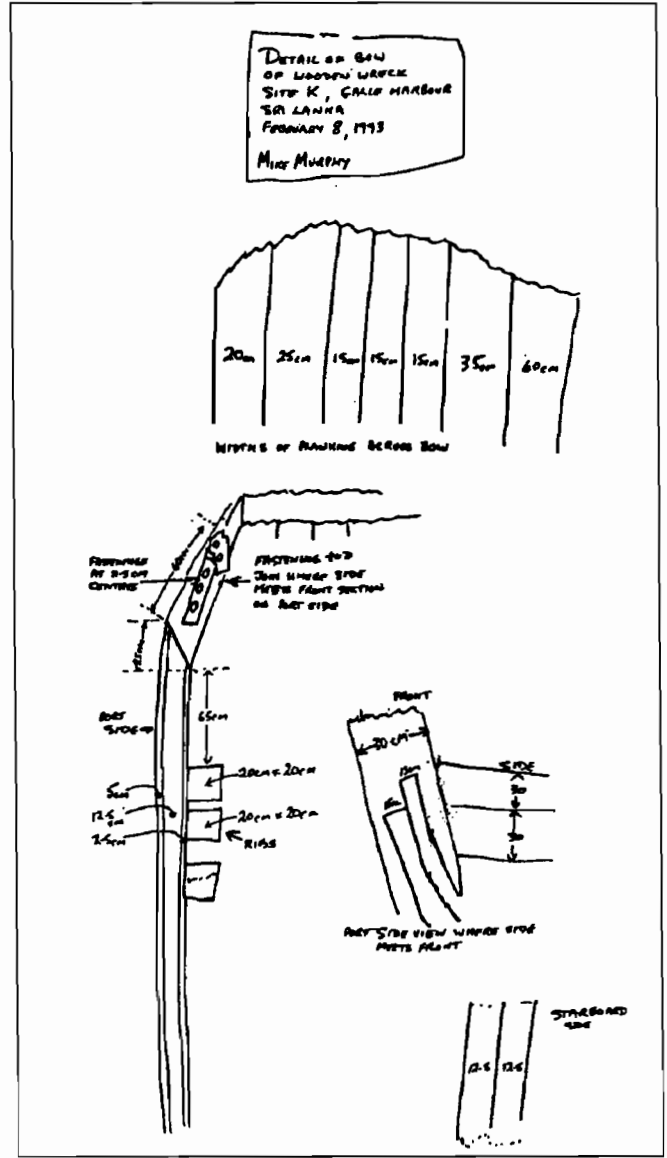
Figure 8. Details of what is thought to be the bow section of Site L drawn by Mike Murphy.

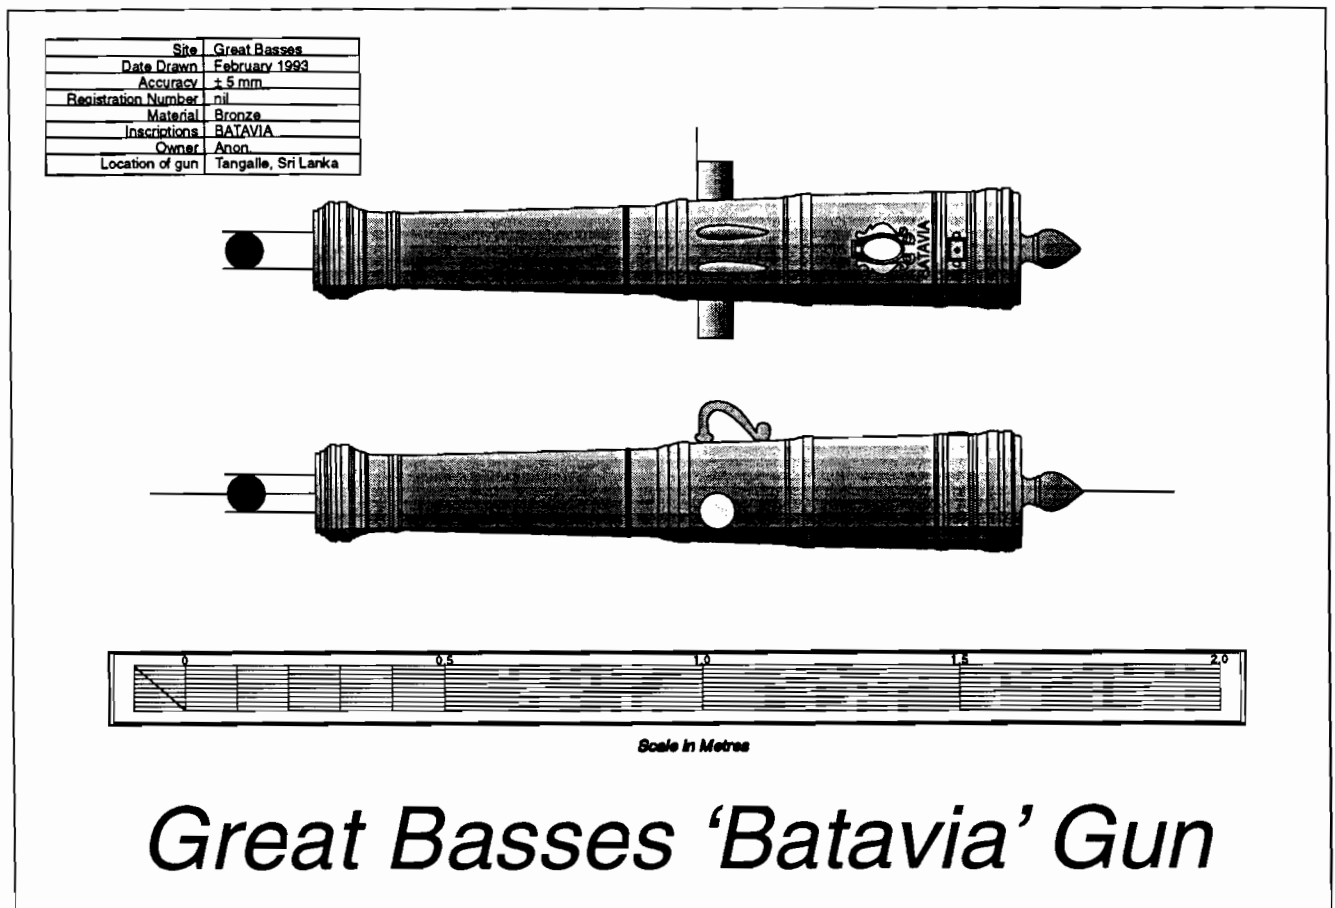
Figure 10. Detailed drawing of bronze gun from the Great Basses.

the word "BATAVIA" was examined. It is said to have come from the Great Basses 'coin' wreck and raised in approximately 1967. The gun was photographed and drawn (see Fig.10). The gun is very interesting as it is a land service gun, with dolphins (the left hand one is broken off), a shield which, unfortunately, is very eroded. The cascabel is flat with a lotus-shaped button. The bore diameter is about 80–85 mm. The word "BATAVIA" incised on the second reinforce just below the escutcheon suggests that the gun was at some point in its career at Batavia and thus almost certainly in the hands of the VOC. Because the word is inscribed rather than cast in relief it is unlikely that it was cast for the Company. The gun looks to be 17th century, possibly mid-17th century. The design is unusual and it may not be Dutch. The normal weight marks on the gun are missing possibly due to erosion.

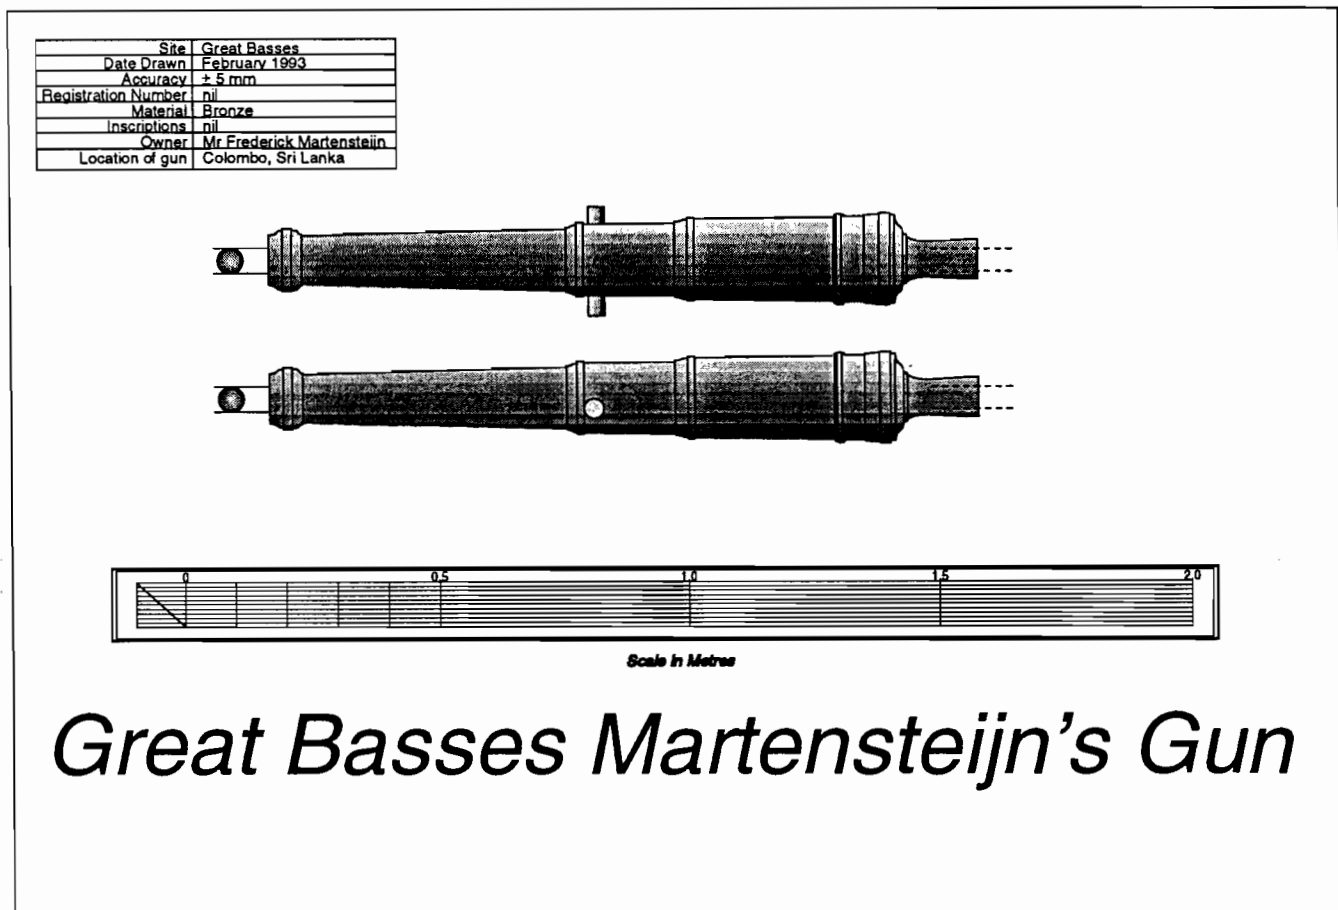
Figure 11. Bronze gun recovered from the Great Basses Site by Mr Frederick Martensteijn.

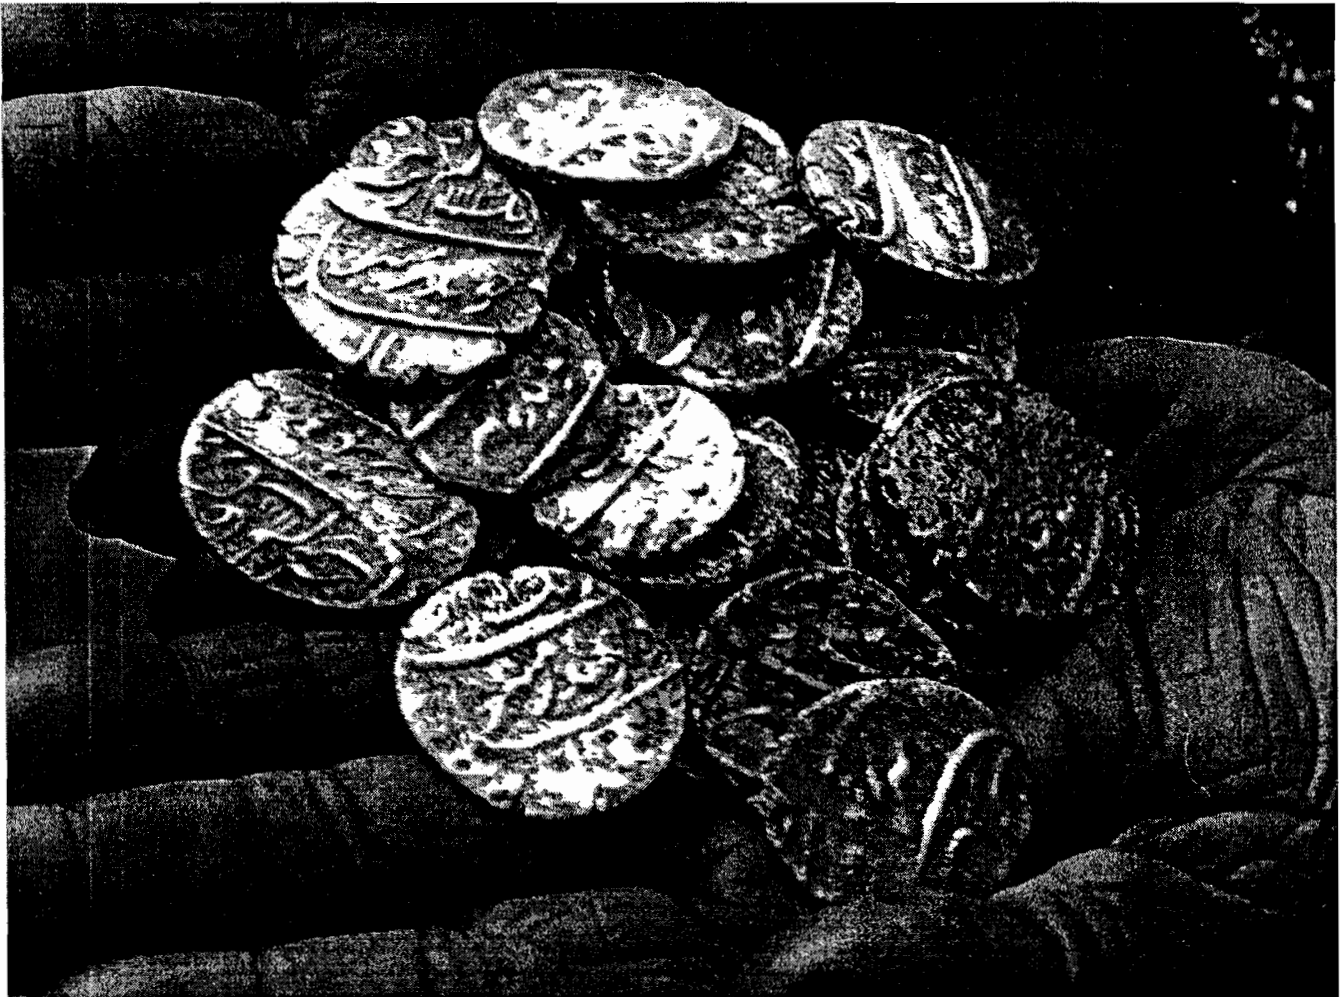
Figure 13. Coins from the Great Basses Site.

The silver coins exhibit varying degrees of corrosion. Some of the better preserved coins have iron corrosion deposits indicating that cathodic protection influenced their condition. The lead shot was found in an excellent state of preservation. With the exception of the beads, the
