Castletown Jetty Esperance

Maritime Heritage Site Inspection Report

Compiler: Dena Garratt
Consulting Maritime Archaeologist
June 1994

Report - Dept. of Maritime Archaeology
WA Maritime Museum, No 86.

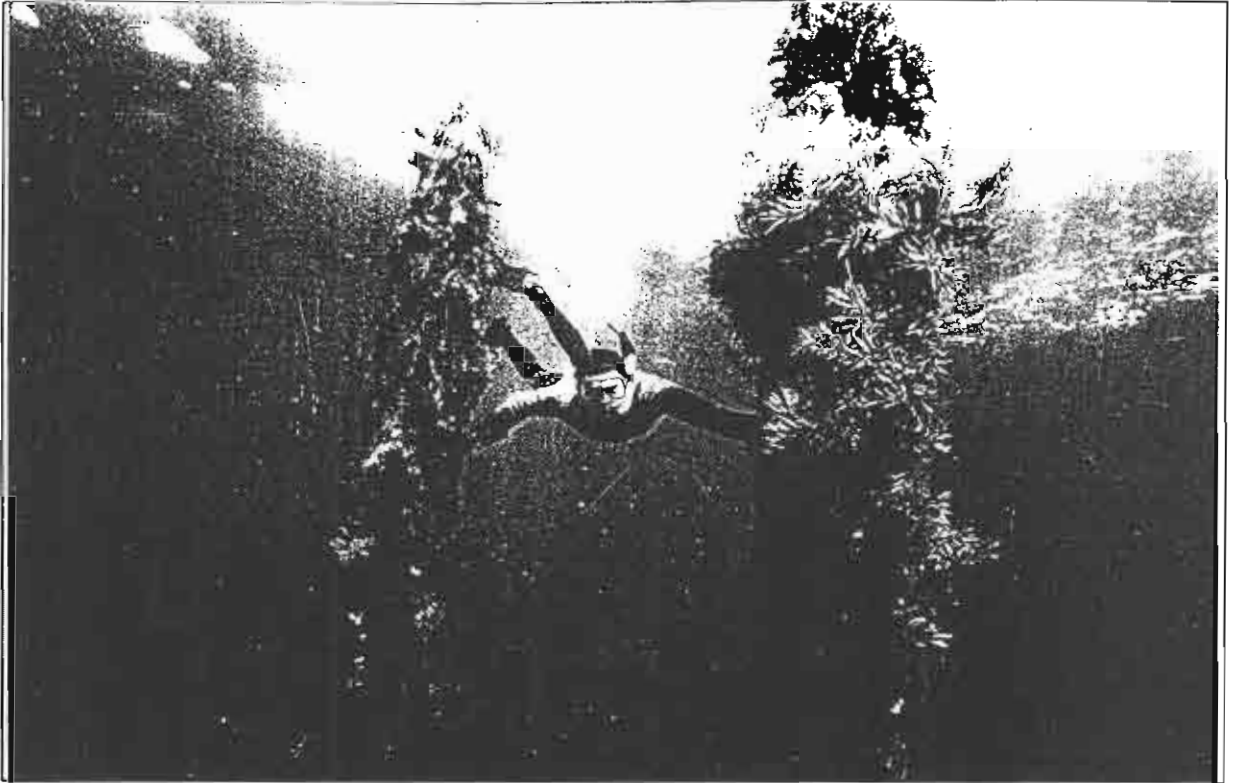
Figure 6. Castletown Jetty, showing the distance between the piles. (WA Maritime Museum)
