# **The Analysis of a Boiler Safety Valve Recovered from SS *Xantho* (1848–1872) and its Historical, Social, and Engineering Ramifications**

**ALEX KILPA**

The work in this project was undertaken to partially fulfil the requirements of Flinders University for the degree of Master of Arts (Maritime Archaeology).

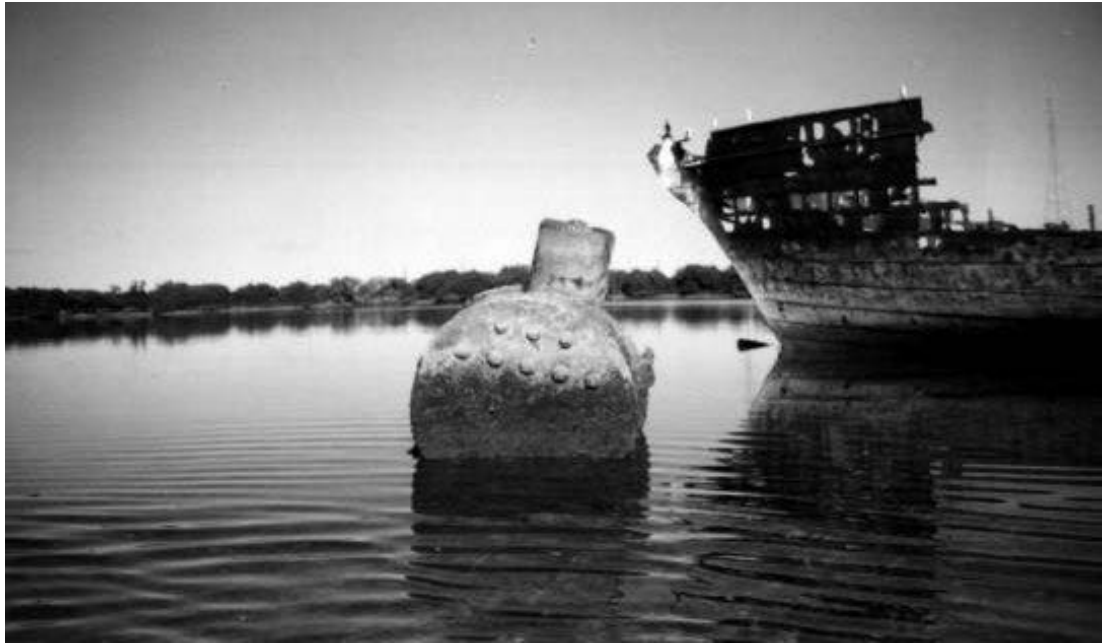
**Figure 1-1. SS *Killarney* (1928) and its marine boiler located at the Garden Island ship graveyard, South Australia. This vessel was stripped of all its precious metals (Richards 1997:48).**

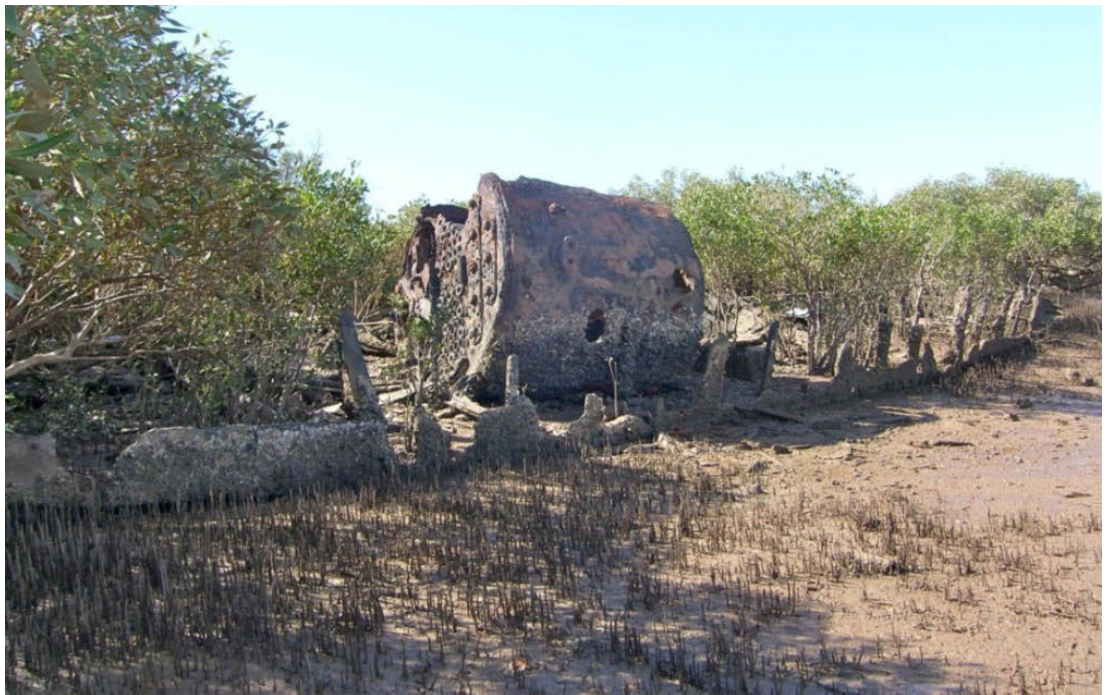
**Figure 1-2. The remains of *Silver Star* (1942). The salvaging of this vessel removed all precious metals including the copper steam pipes and brass safety gauges. Only the base of the safety valve remains (C. Cockram, 2012).**

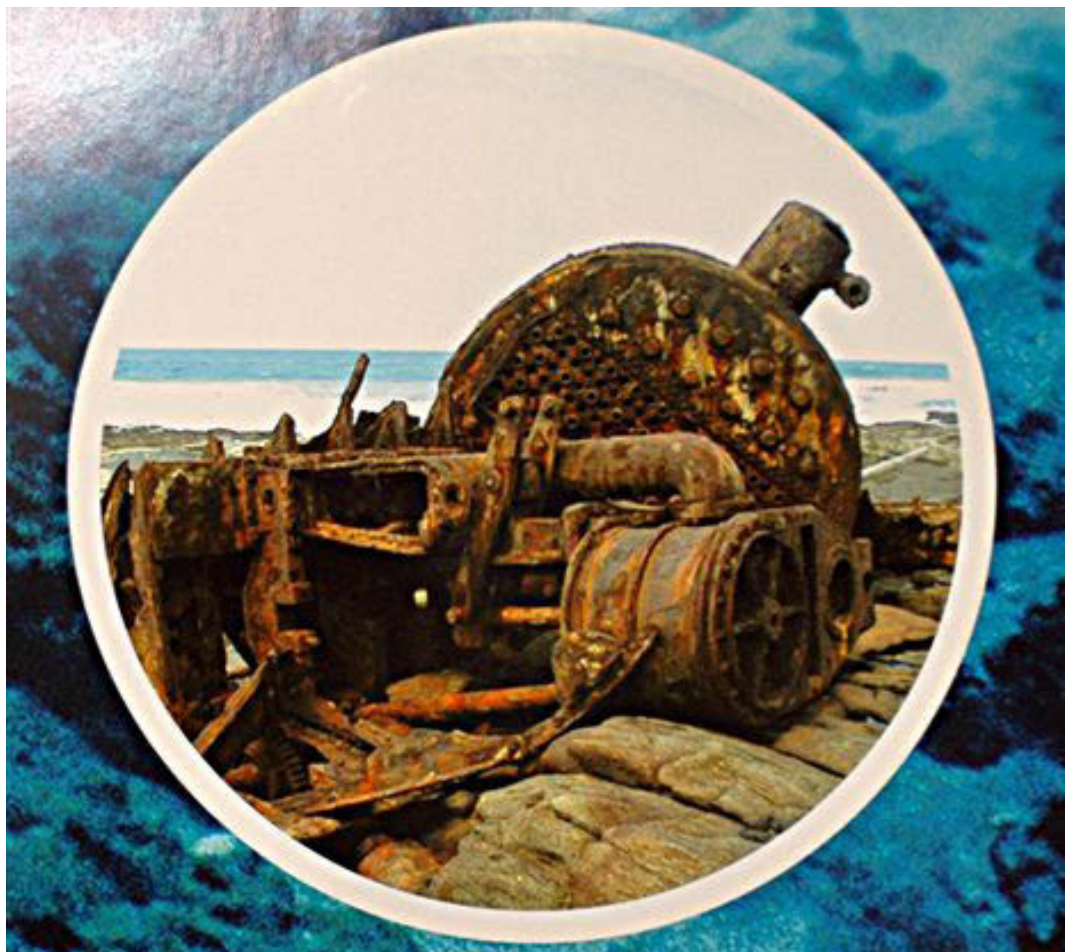
**Figure 1-3. Boiler from *Nightingale* (1933), a fishing boat wrecked at Glenmore/Munster in KwaZulu-Natal, South Africa. Although the boiler is intact, all precious metals such as the copper pipes have been removed (J. Sharfman 2012, reproduced with permission).**

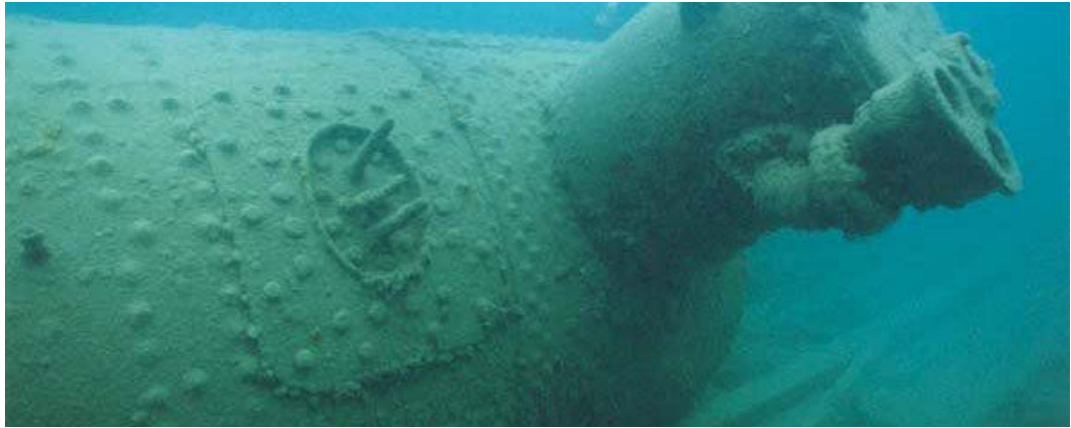
**Figure 1-4. Tugboat *Alice G* (1927) located in ca. 10 meters of water that sank as a result of a severe storm in Little Tub Harbor in Tobermory, Ontario. Visible are the boiler and the base of the safety valve. The rest of the valve appears to have been salvaged, possibly as a trophy (ScubaQ 2012).**

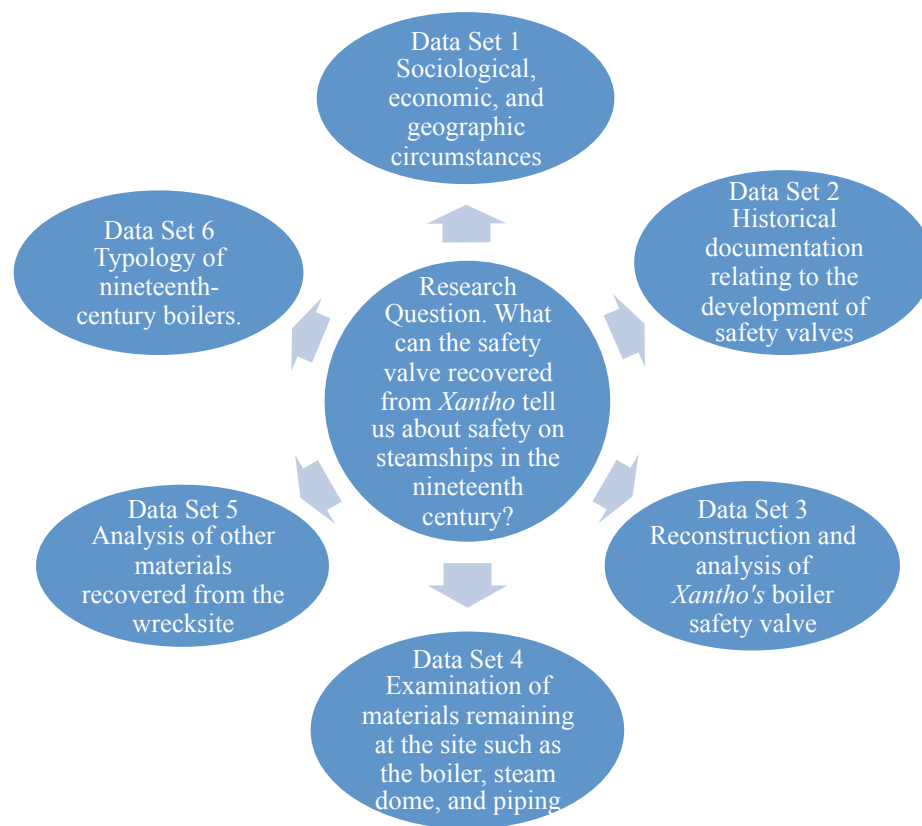
**Figure 2-3. Mind map of data sets used to answer the thesis research question (A. Kilpa, 2012).**

These six data sets are represented schematically in the Figure 2-3. The conclusions obtained from these datasets form a cultural interpretation of the value of safety valves to society in the nineteenth century.

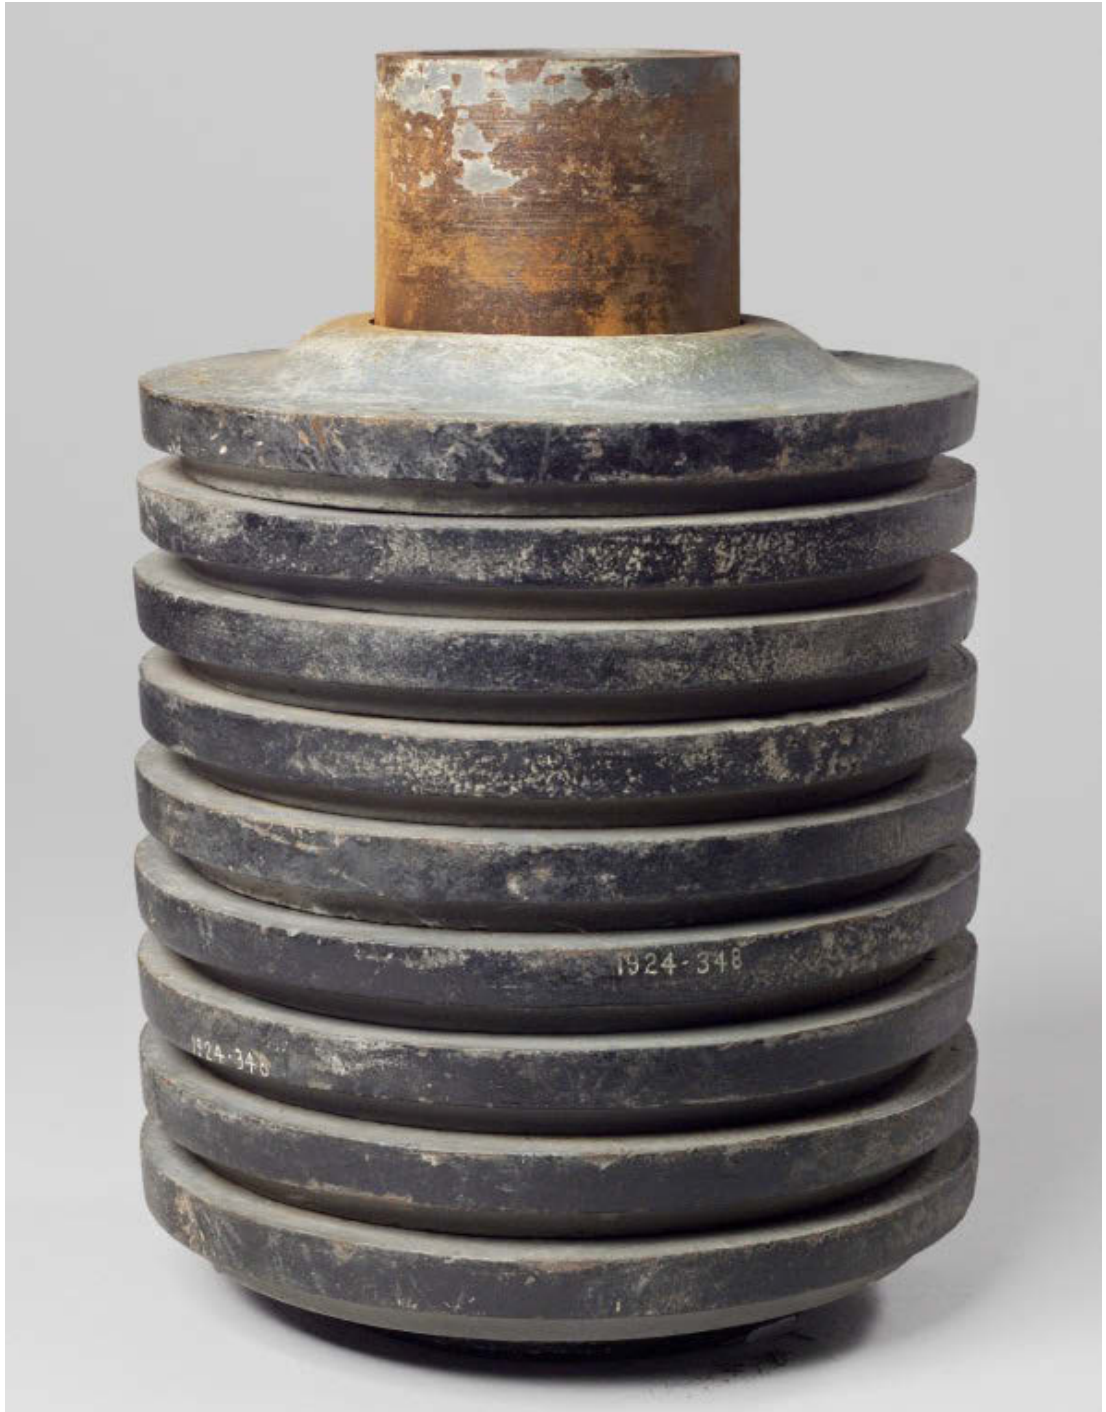
**Figure 4-3. An example of a 2-inch (ca. 5.4 cm) diameter single deadweight safety valve. Such systems were vulnerable to corrosion and would frequently stick (Science Museum, Kensington, 2012, reproduced with permission).**

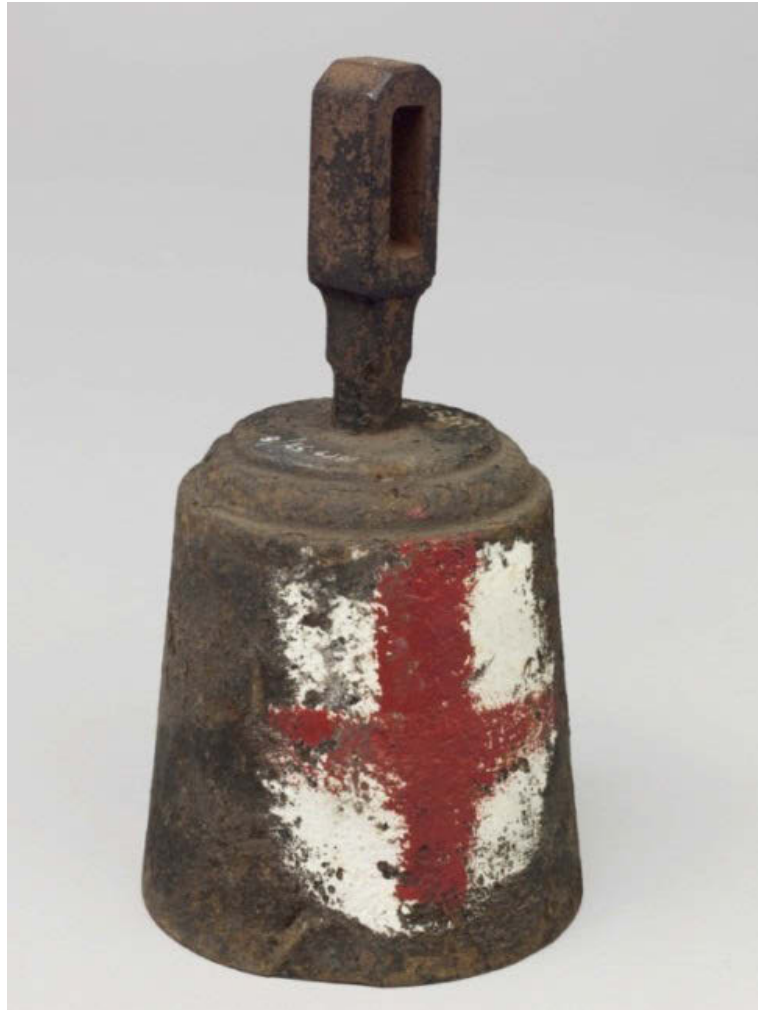
**Figure 4-7. Weight from a lever-weighted safety valve. This device has a similar profile to the weight recovered from *Indiana* (Science Museum, Kensington, 2012, reproduced with permission).**

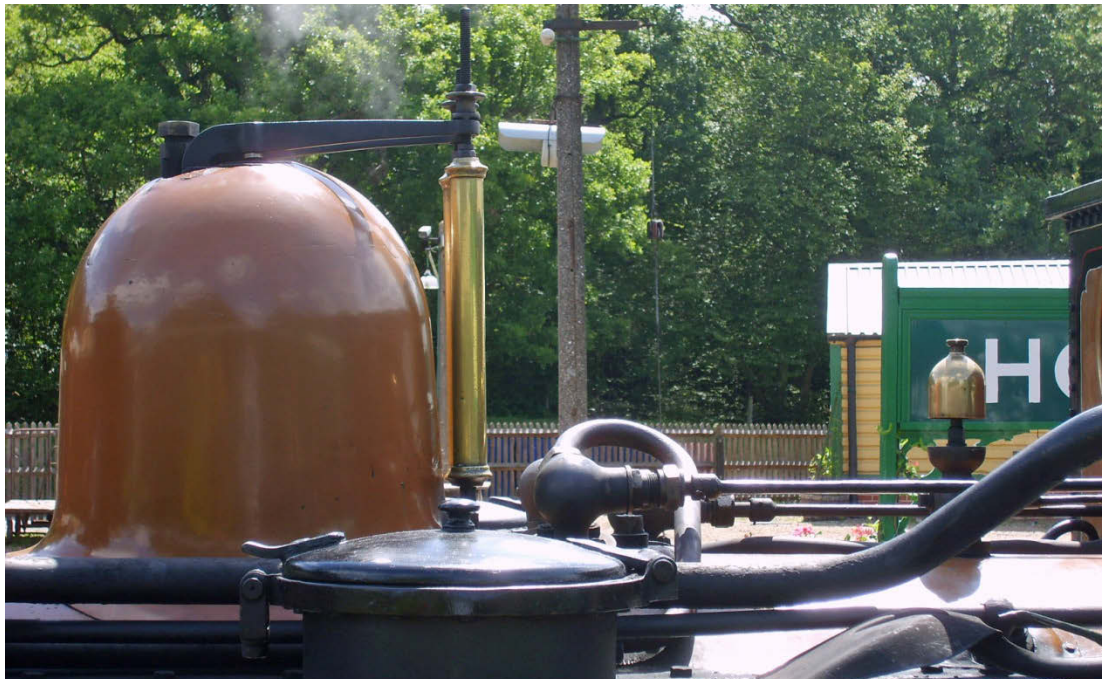
Figure 4-14. Salter spring-loaded valve as installed on the locomotive *Stepney* (1847). These devices are rare to see in operation because they were superseded by ‘pop valves’ (Matt Durkan Railways, 2012, reproduced with permission).

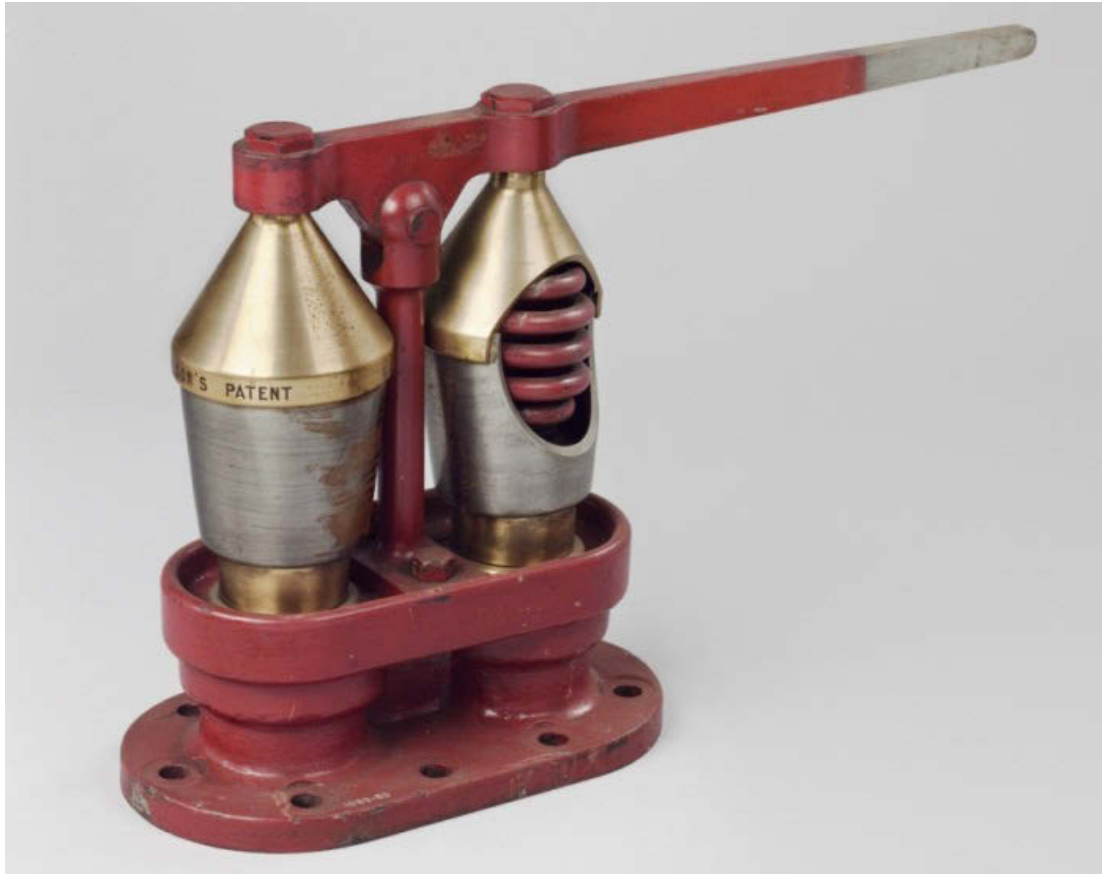
**Figure 4-16. Wilson patent safety valve with enclosed springs. This valve operated on similar principles to the Ramsbottom arrangement. Any increase in the tension applied to one of the valves would be counterbalanced by a release of pressure on the other (Science Museum, Kensington, 2012, reproduced with permission).**

One of the major disadvantages of the Ramsbottom arrangement was that the spring tension could easily be tampered with, either by adjusting the nut (Ripper 1909:198), or as reported by F. W. Webb “putting a clip on two or three coils on the spring” to alter its compression ratio (Wilson 1877:182). An improvement on the Ramsbottom device was the Wilson patent safety valve which had its springs enclosed in two housings making them tamper proof and protecting them from the effects of moisture. An example of this type of valve is shown in Figure 4-16.

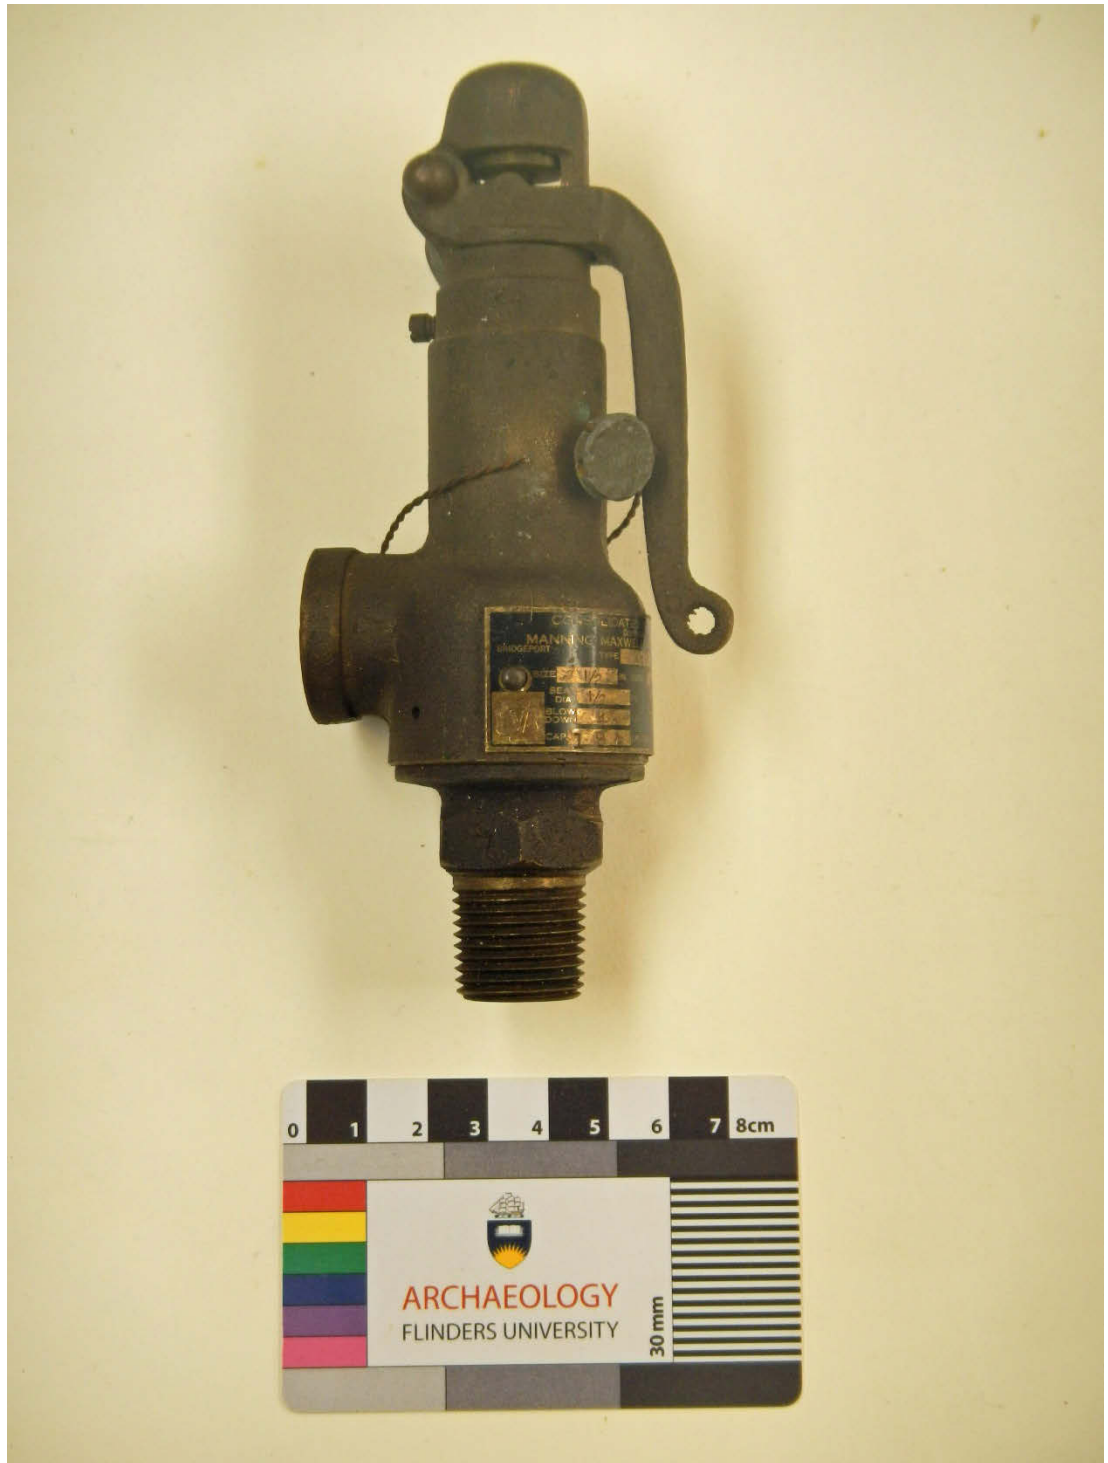
**Figure 4-17.** This 'pop valve' was manufactured by the Consolidated Pop Valve Company. The attached specification plate indicates that it was calibrated to operate to pressures of 758.4 kPa (110 psi) (A. Kilpa, 2012).

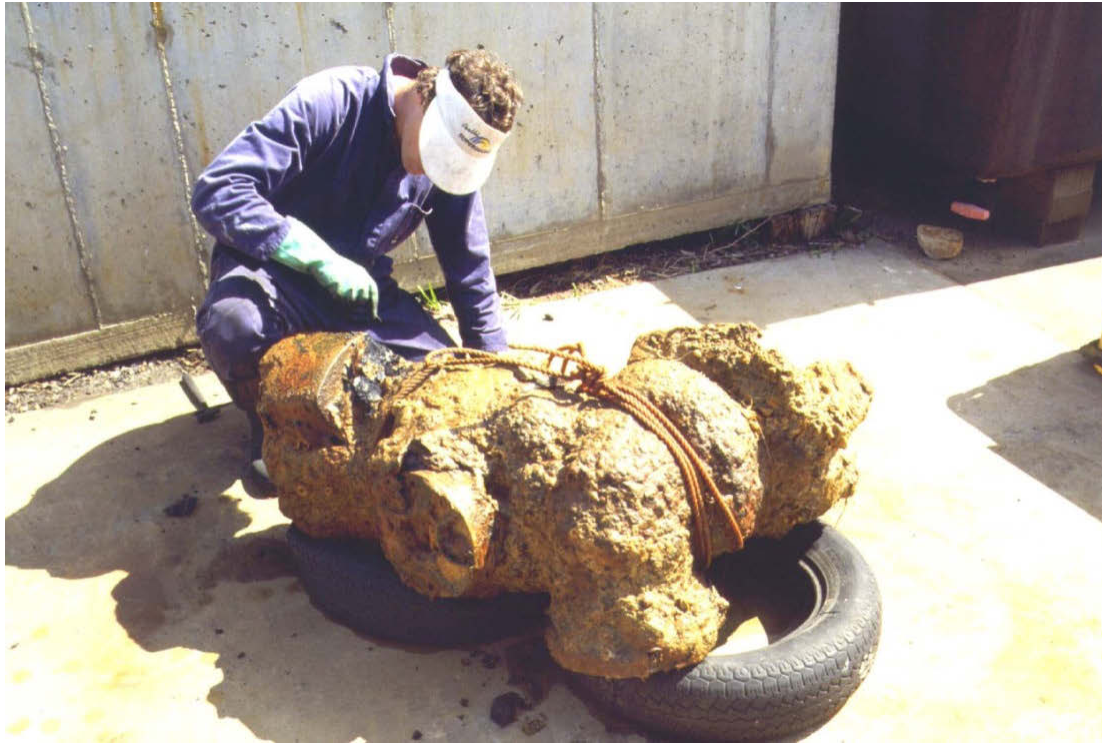
**Figure 5-2. The safety valve being de-concreted by conservator Alan Kendrick (Western Australian Museum, 1994).**

Stage 1. Conservators removed the calcified remains of marine biological matter in a process considered by the archaeological director to be an excavation in its own right. This was accomplished mechanically through the use of hand tools, such as picking devices, chisels, and scalpels. Figure 5-2 shows the safety valve at the commencement of the de-concretion process whereas Figure 5-3 shows the final result.

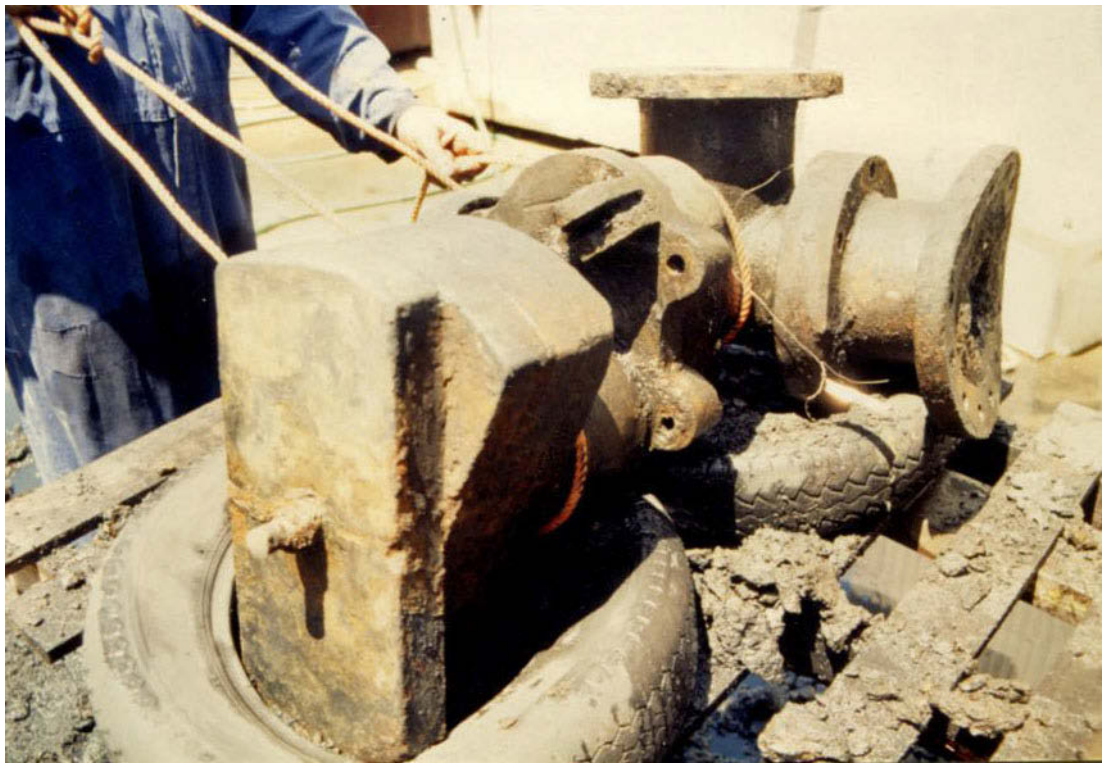
**Figure 5-3. The safety valve after de-concretion (Western Australian Museum, 1994).**

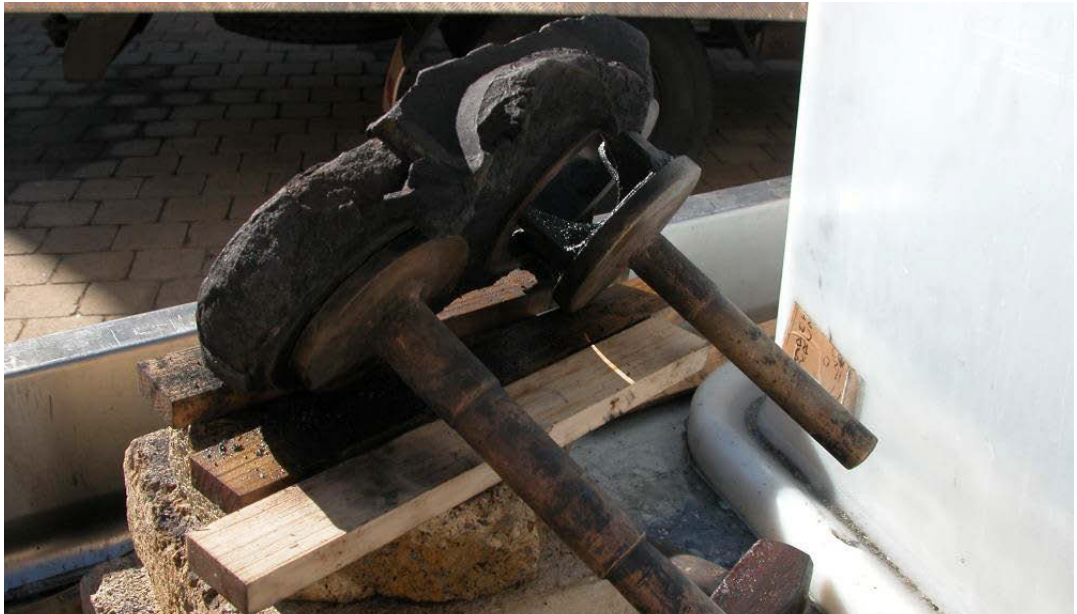
Figure 5-5. The remains of *Xantho's* safety valve housing prior to reconstruction. In this state the artefact had little interpretative value. The larger of the spindles (XA339 i) is for the deadweights (A. Kilpa, 2010).

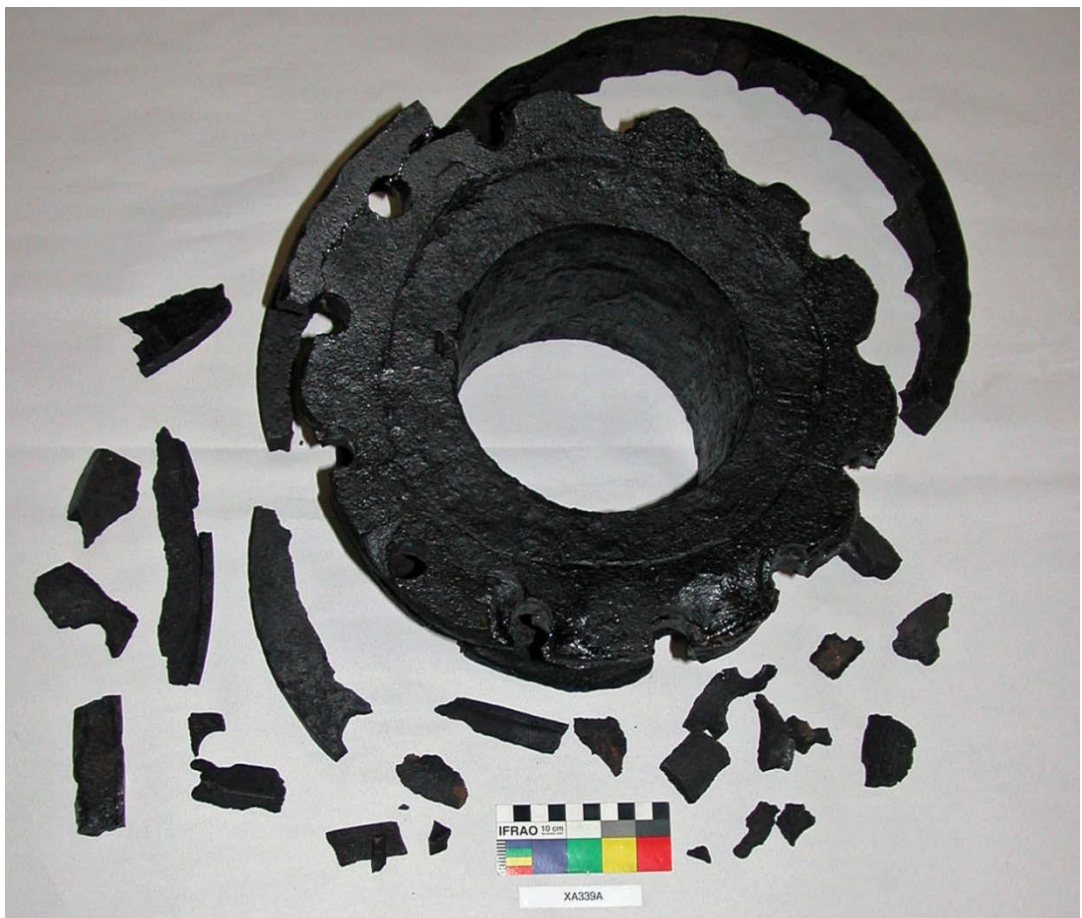
Figure 5-6. Boiler flange mounting (XA339A) prior to reconstruction. Additional fragments found at a later date are now also integrated into the object (A. Kilpa, 2010).

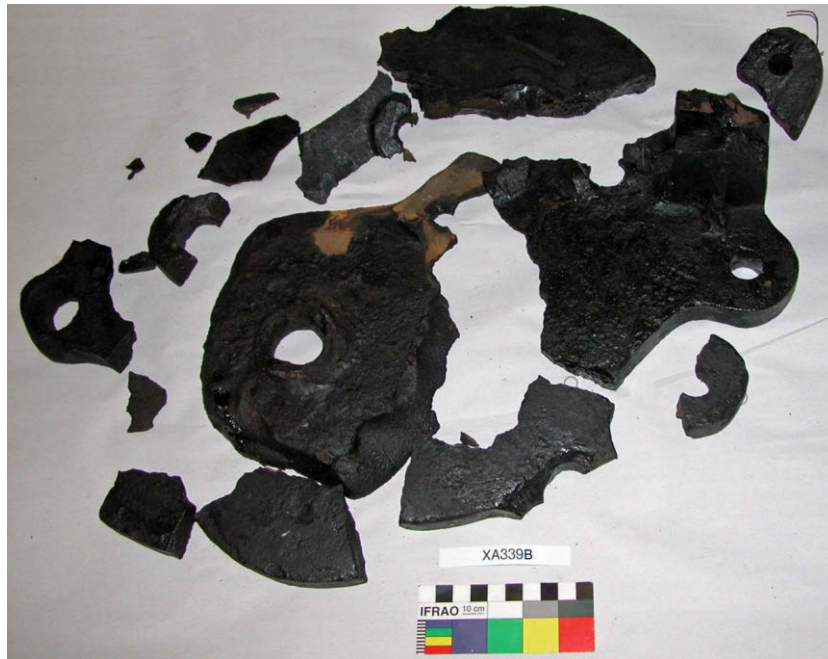
**Figure 5-7. Fragments of the safety valve plate prior to reconstruction (XA339B) (A. Kilpa, 2010).**

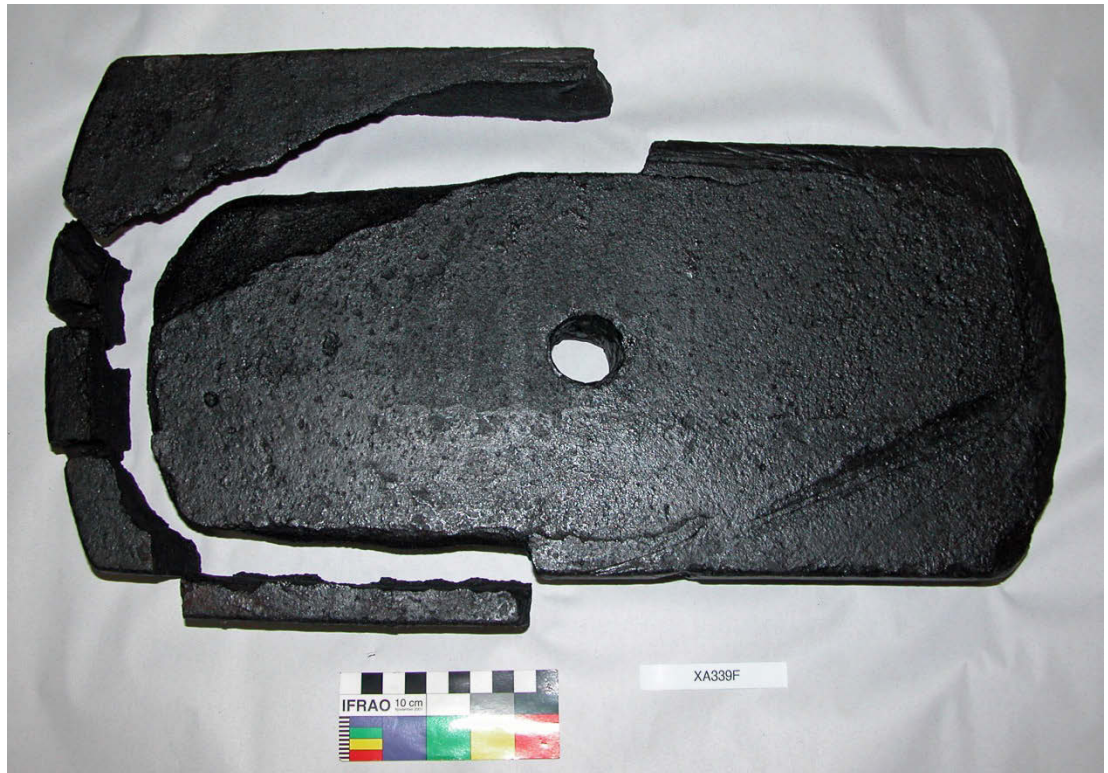
**Figure 5-9.** One of the oblong deadweights before reconstruction (XA339F) (A. Kilpa, 2010).

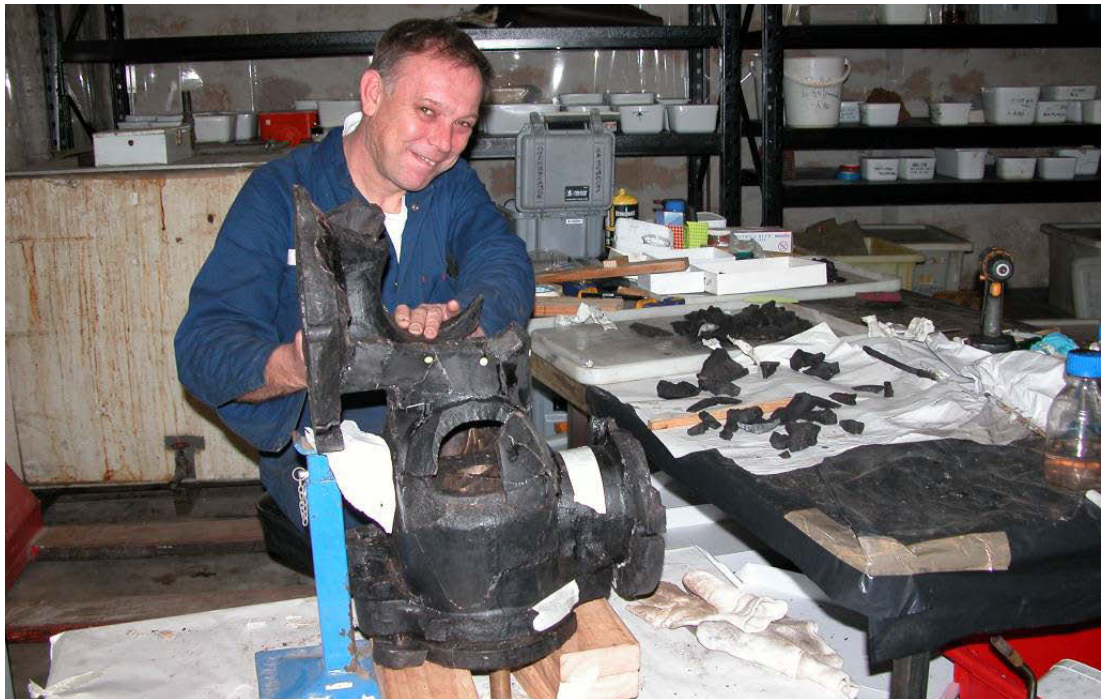
**Figure 5-10.** The author reconstructing the valve housing with three flanges. The block with the valve bores, shown in Figure 5-5, has already been integrated internally, while the valves are excluded from this photograph (M. Myers, 2010).

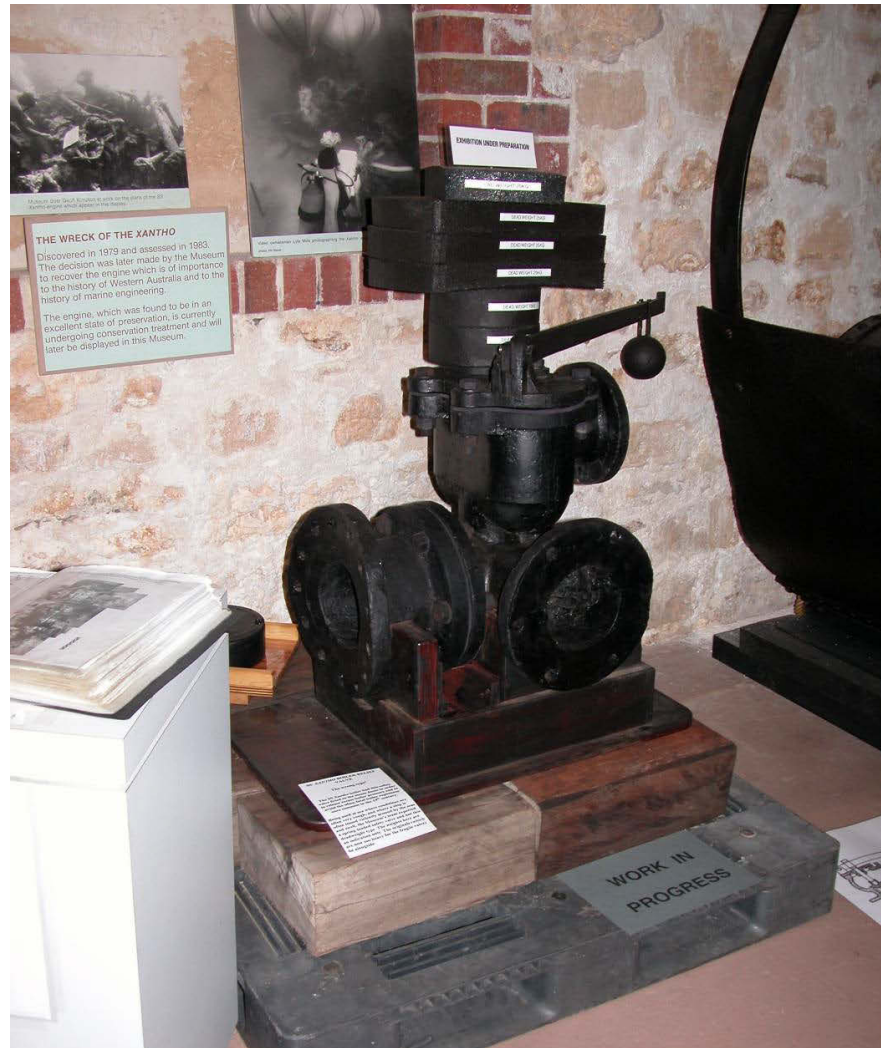
**Figure 5-16. *Xantho*'s safety valve on display in the Steamships-to-Suffragettes Gallery, Shipwreck Galleries, Western Australian Museum. The large blocks located on top of the housing are foam replicas of the deadweights. The arm and ball weight are interpretative and have been added to facilitate discussion on the direction of future excavation activity at the wreck site and also to assist the public and scholars to visualise the operation of the valve (A. Kilpa, 2010).**

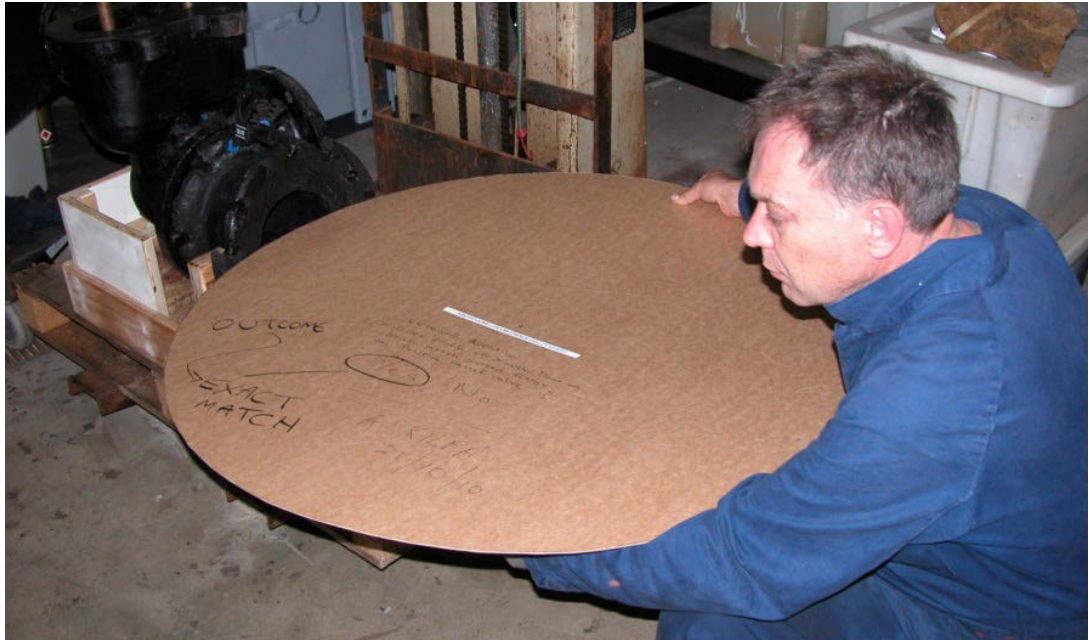
**Figure 5-21.** The template constructed representing the width and curvature of the steam dome matched exactly the concave shape of the safety valve flange (M. Myers, 2010).

A re-evaluation of the safety valve that took into consideration the concave structure of the large flange (XA339A) suggested that the valve housing was attached to a cylinder and that it was installed in a vertical position. After studying the site plans relating to *Xantho*'s boiler, the author hypothesized that the safety valve may have been attached to the side of the steam dome. To test this theory a 91.4 cm (36 in) diameter template representing the known dimension of the steam dome was

constructed and butted against the curvature of the valve flange. The results clearly indicate a snug fitting profile match (Figure 5-21).

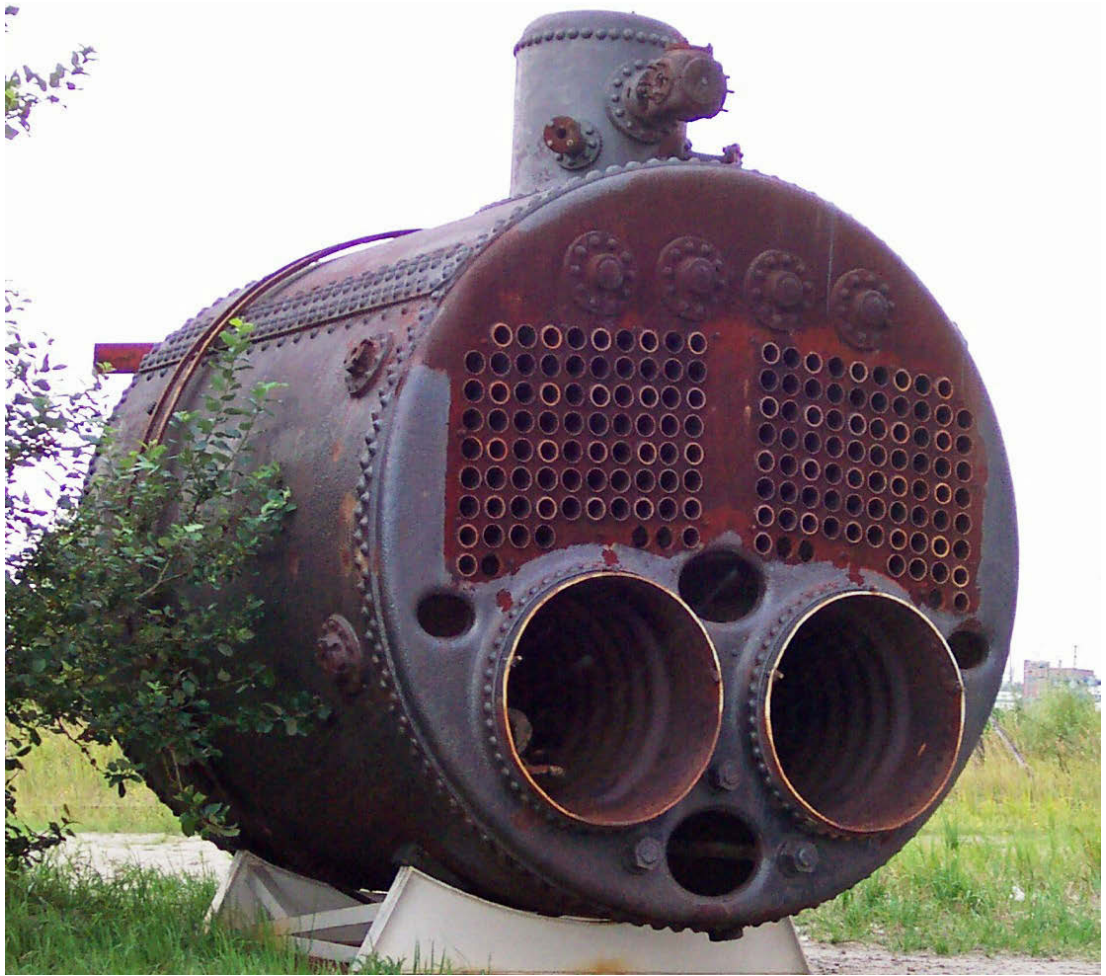
**Figure 5-22. A cylinder boiler with two furnaces (Hochhaus, 2007).**

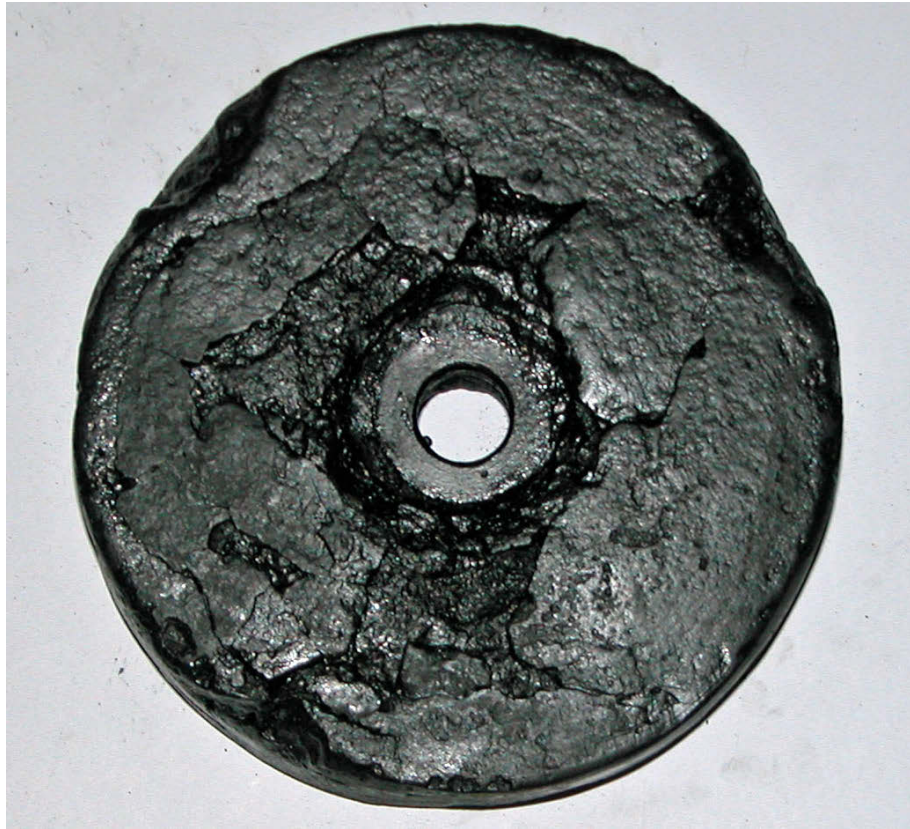
**Figure 5-24.** Circular disc after reconstruction showing the copper-alloy bush in its centre (XA339C). This bush sat on a step located on the spindle (A. Kilpa, 2010).

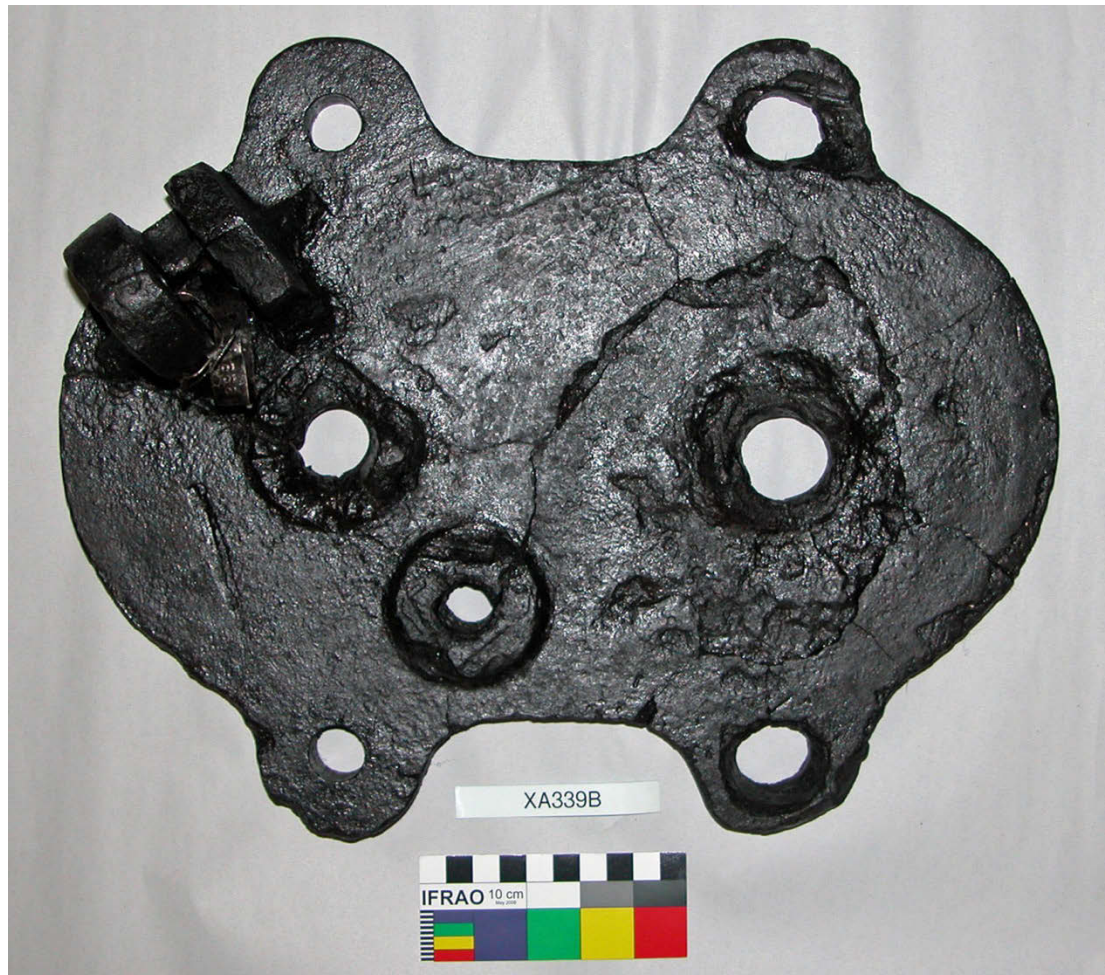
**Figure 5-26. Safety valve plate after reconstruction (XA339B) (A. Kilpa, 2010).**

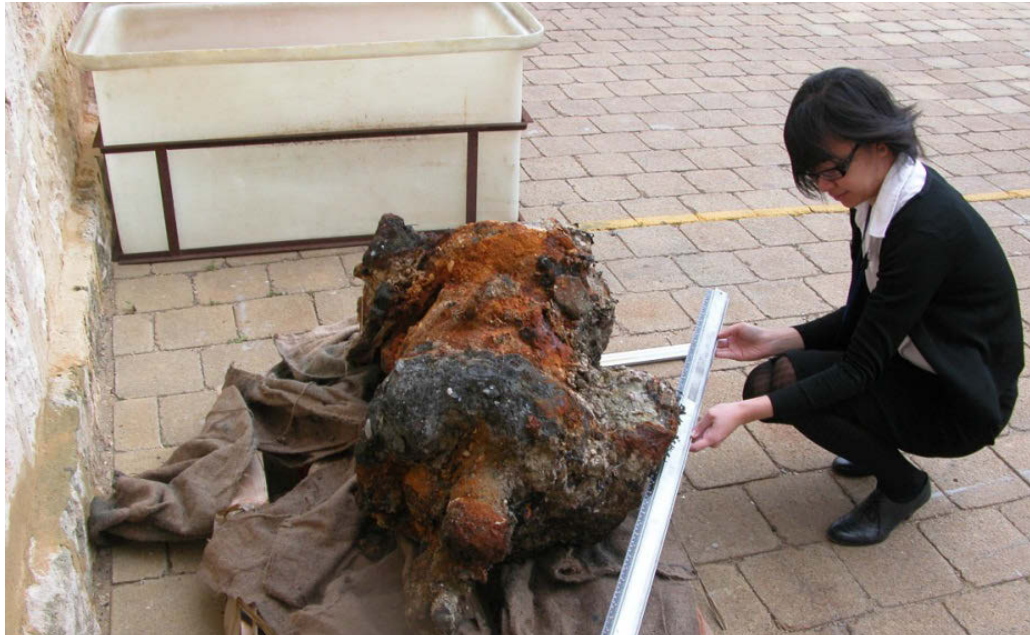
**Figure 5-30.** The isolating valve in the conservation court yard prior to being de-concreted (A. Kilpa, 2012).

Although heavily concreted with up to 10 cm of marine growth, the artefact was well preserved and still contained solid metal allowing the de-concretion process to be undertaken with few complications. Figure 5-30 shows the isolating valve prior to de-concretion and Figure 5-31 after the event. A detailed photographic record of the de-concretion process is presented in Appendix C.

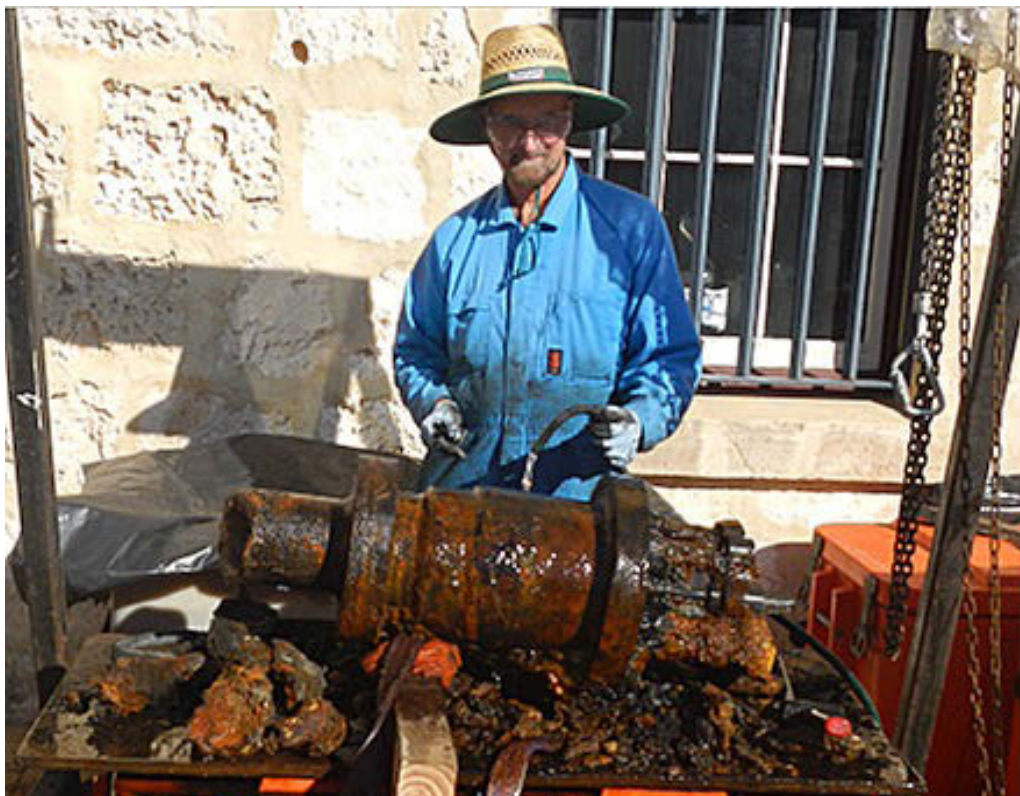
**Figure 5-31.** Conservator Jon Carpenter de-concreting the isolating valve recovered from the wreck site. The metal in the concretion was found to be more solid than anticipated (A. Kilpa, 2012).
