# **The Analysis of a Boiler Safety Valve Recovered from SS *Xantho* (1848–1872) and its Historical, Social, and Engineering Ramifications**

**ALEX KILPA**

The work in this project was undertaken to partially fulfil the requirements of Flinders University for the degree of Master of Arts (Maritime Archaeology).

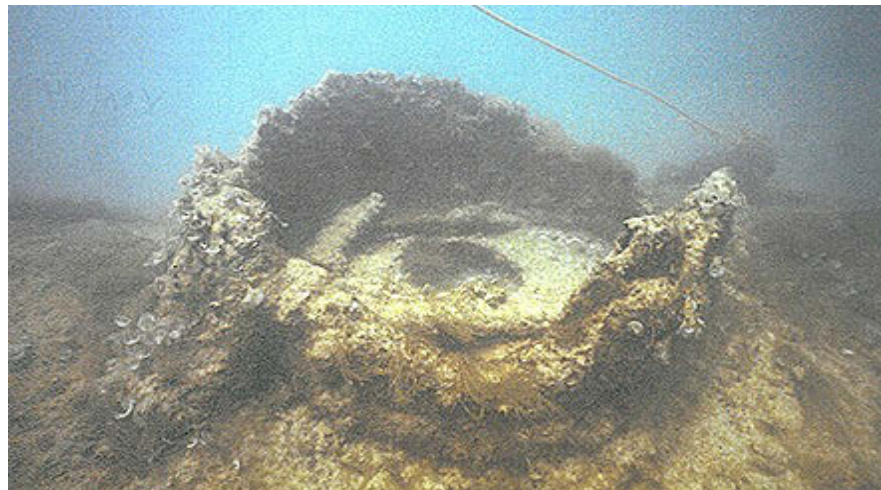
**Figure 6-6. The collapsed remains of *Xantho*'s steam dome. Data from the 1985 site survey indicate that the width of the dome measured 91 cm (36 in) (Western Australian Museum, 1994).**

The archaeological investigation of *Xantho*'s steam dome indicates that it measured 91 cm (36 in) in diameter (Figure 6-6). Although the height could not be established, photographic evidence of other nineteenth-century steam domes suggests that the height and width of these devices were often similar, if not identical.

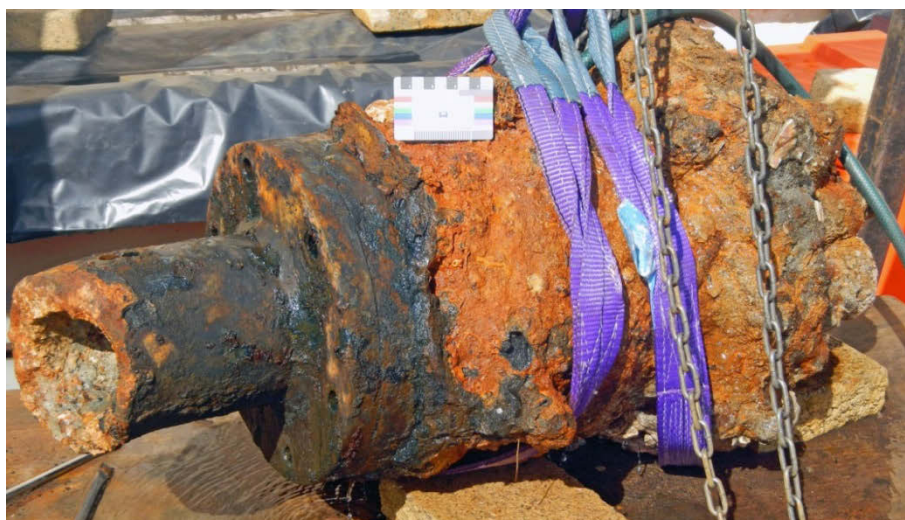
**Figure 6-7. The isolating valve recovered in June 2012. The de-concretion of this artefact showed that part of the steam pipe (left) was still attached and that it was constructed of iron (A. Kilpa, 2012).**

The main steam pipe transferred steam from the boiler to the engine. Such pipes were constructed to take the shortest and most direct course to the engine with as few bends as possible (Hutton 1891:306). *Xantho*'s main steam pipe consisted of two sections: A horizontal pipe (remnants of this were attached to the isolating valve) (Figure 6-7) and a connecting vertical pipe that was attached to the engine (Figure 6-8). The author's initial hypothesis was that the horizontal pipe was constructed of the same material as the vertical pipe, i.e. bronze, and being a valuable metal this was most likely salvaged by Broadhurst in 1872. The de-concretion of the isolating valve in August 2012 however revealed that part of the steam pipe was still attached to the isolating valve and that it was cast iron. The de-concretion of the isolating valve also confirmed that the horizontal steam pipe was connected to the isolating valve and not directly to the boiler.

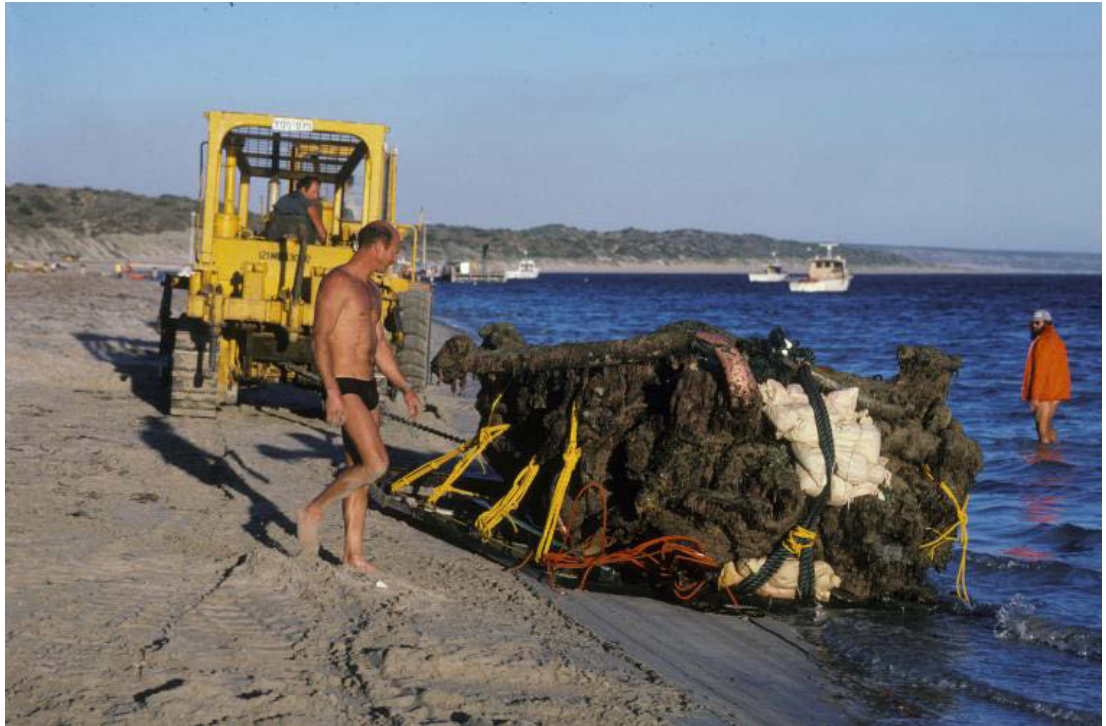
**Figure 6-8. *Xantho*'s horizontal trunk engine after excavation on the beach at Port Gregory. The twisted steampipe is seen here in a horizontal position. This led to confusion and resulted in an erroneous interpretation of how the boiler and engine were connected (P. Baker, 1985).**

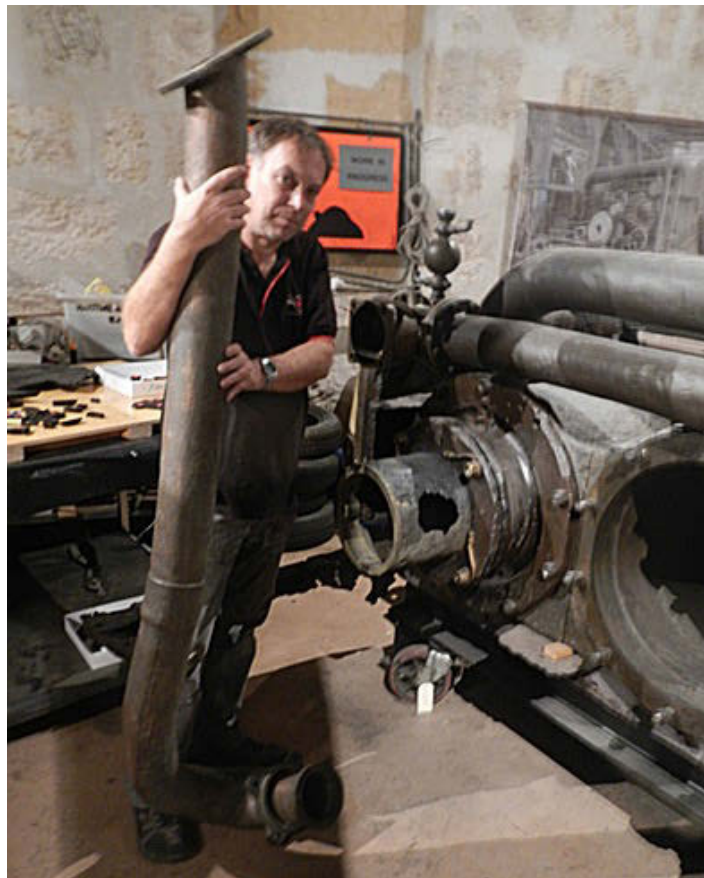
**Figure 6-10.** The author Alex Kilpa holding the copper alloy steam pipe recovered from *Xantho* in a vertical position (C. Cockram, 2012).

The steam pipe recovered from *Xantho* appears to be kinked at the base with split seams (Figures 6-10 and 6-11). This suggests that it was struck by an object with considerable force.

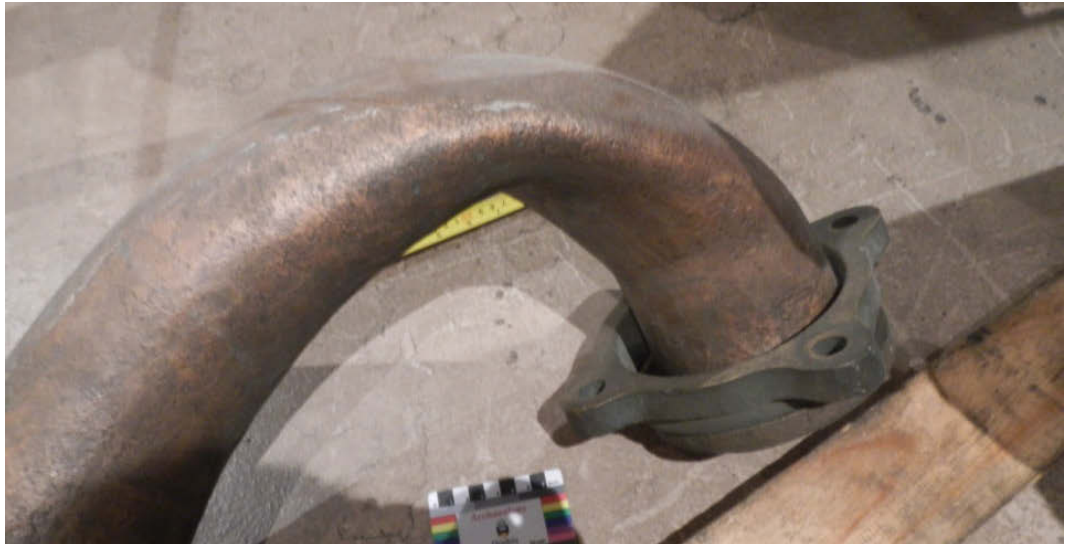
**Figure 6-11.**The distorted base of the steam pipe. This pipe would have been installed on the engine in an upright (vertical position). It is possible that the copper alloy pipe bent and rotated on its swivel when struck by a ship or other heavy object (A. Kilpa, 2012).

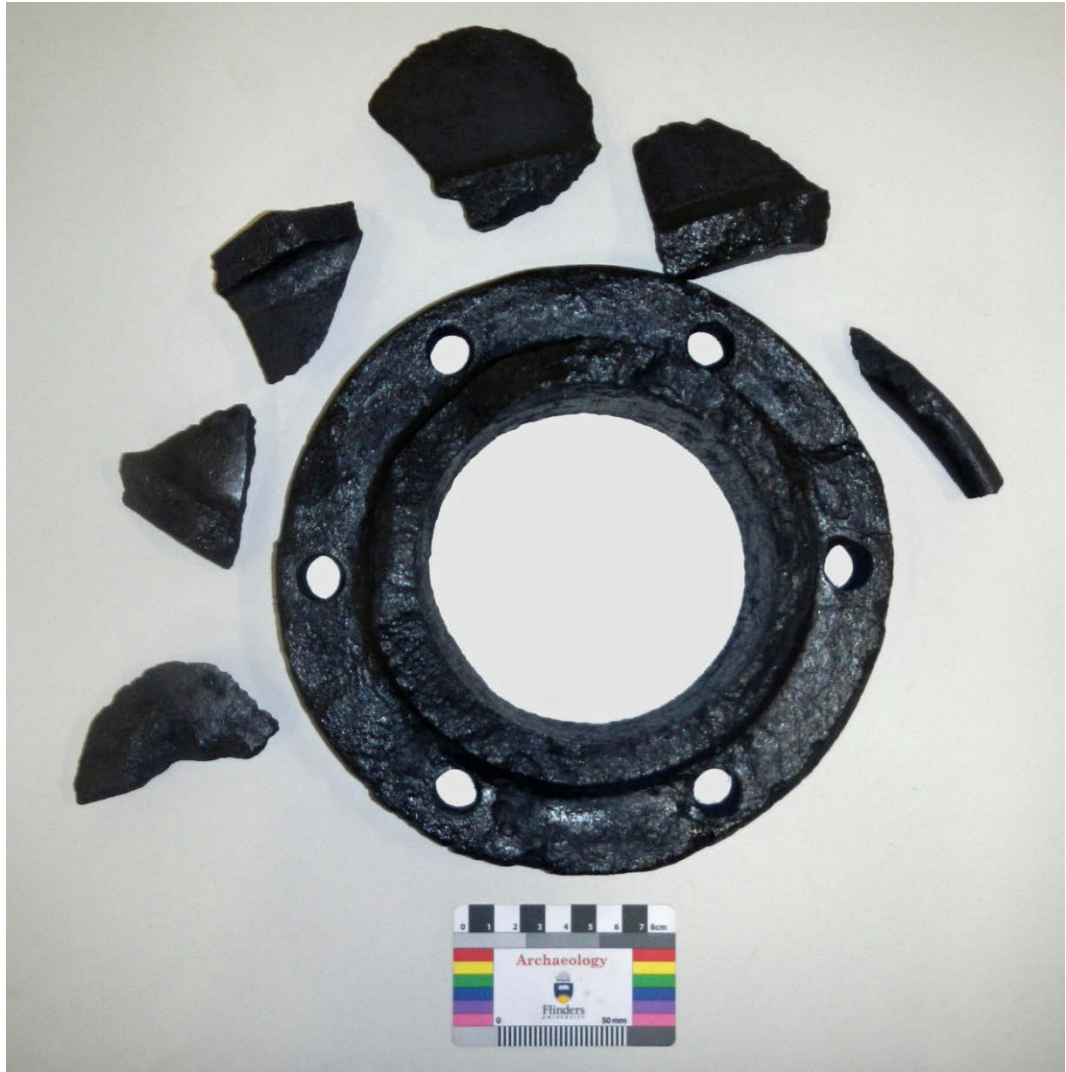
**Figure 6-12.** The flange and several fragments from *Xantho*'s steam exhaust pipe (A. Kilpa, 2012).
