THE ALBANY REPORT

THE AWHINA SURVEY

ALBANY 1990

THE ATHENA (?) WRECK INSPECTION

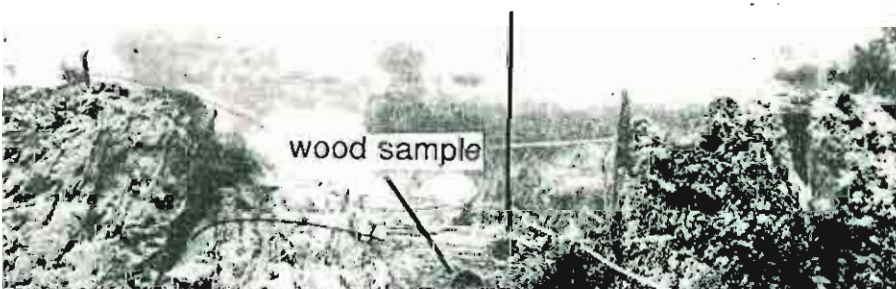
treenail location in outer planking

The remains of longitudinal timbers were noted along the length of the exposed port side of the hull (see Figure 8, timber number 1). These timbers were 7- 10 cm. thick and were fastened to the external face of the frames, with metal sheathing tacked on to them. They therefore constitute the outer planking of the hull. Within the wreck, the accumulation of sand meant that only the planking section was visible. When the hull was viewed from the exterior, between 20 to 40 cm. deep of planking could be seen rising from the sea bed. It was not possible to ascertain the width of the outer planking of the hull as the sheathing obscured this detail. Also, the method of fastening the strakes of the planking to the frames is largely hidden. Occasional treenails in the timbers (see Figure 9) suggest a typical method of fastening .

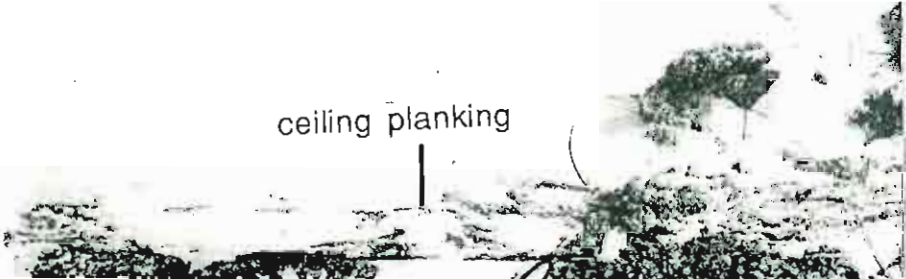
In some places along the the length of the vessel, remains of longitudinal timbers are attached to the interior face of the frames. These are probably ceiling timbers and are smaller in dimension than the outer planking (see Figure 10). Remains of a number of thin sectional boards found immediately forward of the boiler include 3 planks laid edge to edge (see Figure 8, timbers numbered 4). Another example (timber number 5) lies beneath the previous three with the same orientation. Their insubstantial nature suggests their function may have been as lining boards on the interior of the hull.

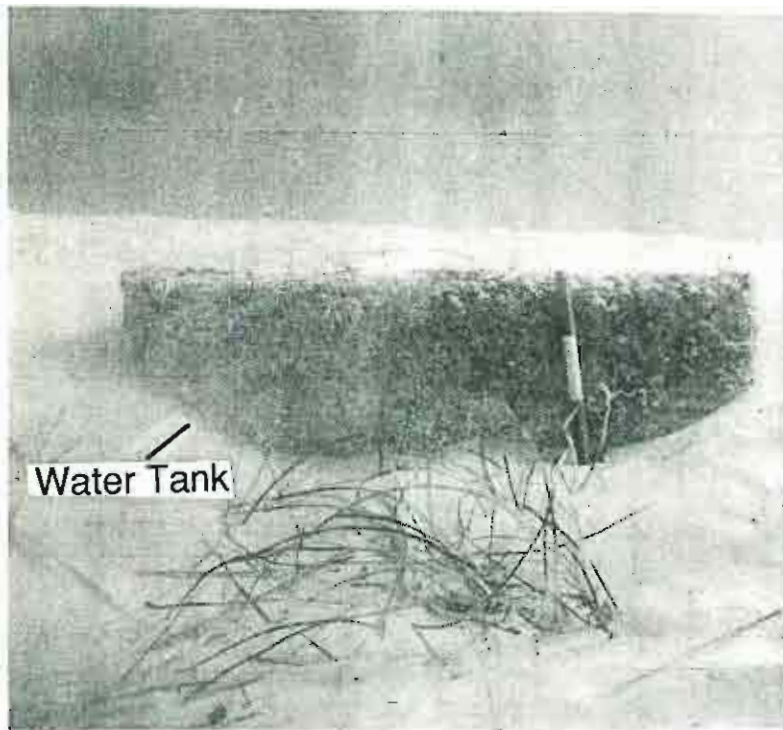
Figure 12 Water Tank

Water Tank (see Figure 12)

The water tank was located 50m away from the stern section of the vessel. It was partially covered in sand and so no useful measurements could be taken to help in its analysis.

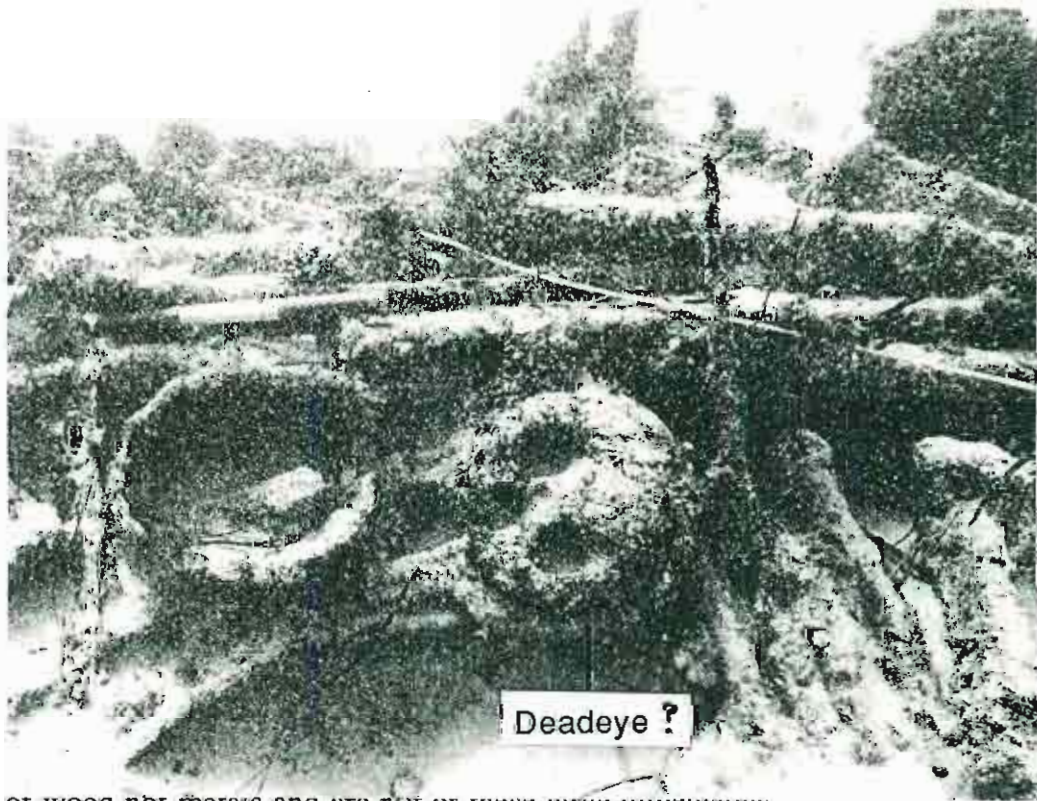
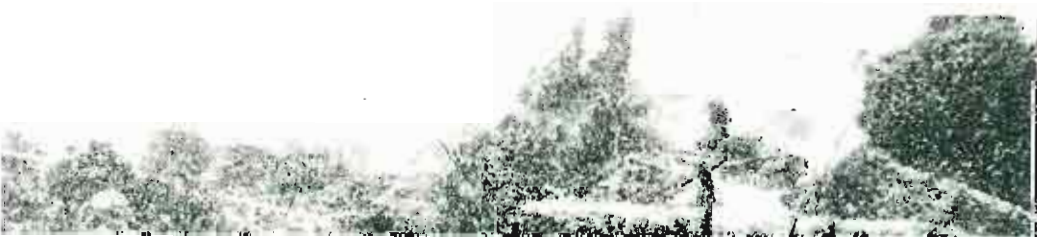
Deadeye ? (see Figure 13)

The feature in question was located 6.5 m aft of the bow and is of metal construction. Although it was originally thought to be a dead eye this assumption has been questioned with future analysis. While the photographic evidence indicates that the mast was located in this region it does not show any deadeye associated with it. Further, deadeyes were generally constructed of wood not metals and are not of these large dimensions.

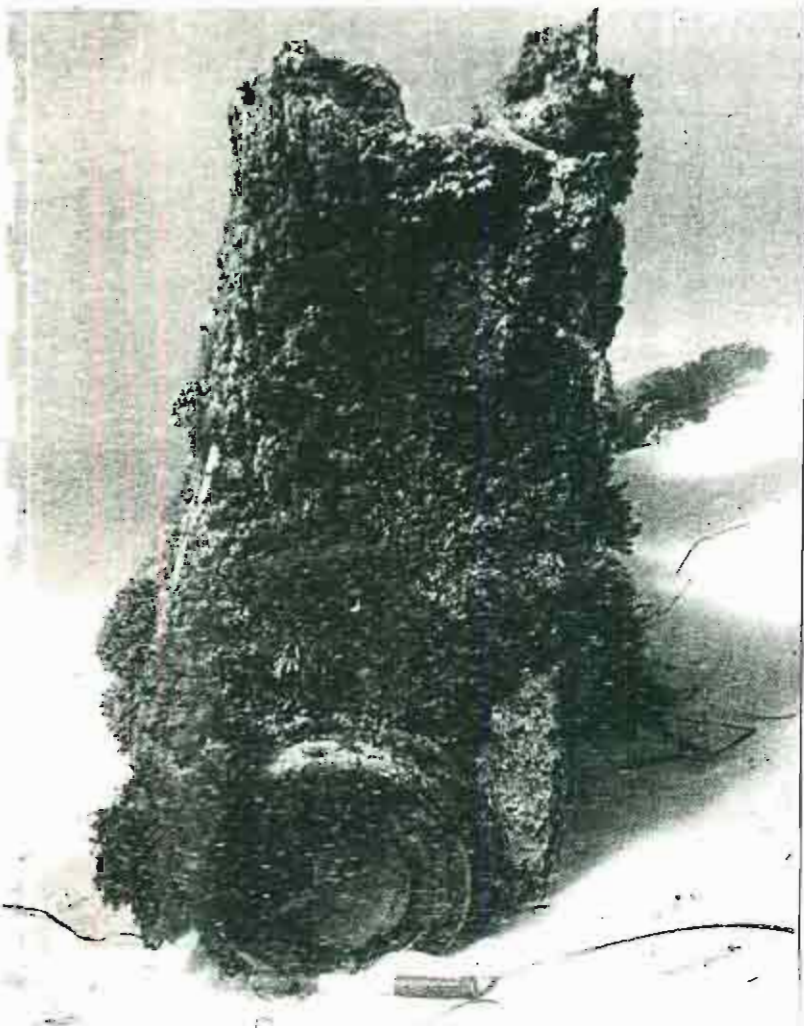
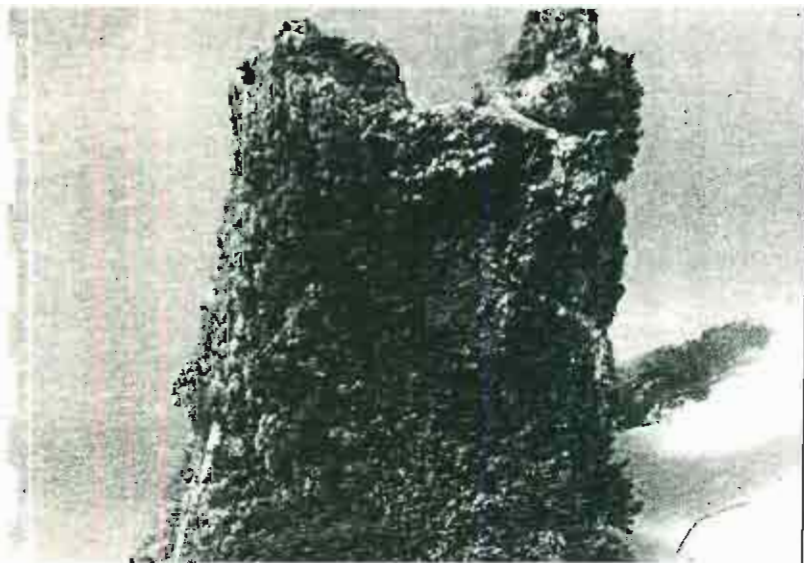
Propeller Block (see Figures 14 and 15)

The feature designated Propeller Block stands to a height of approximately 1.5m. The propeller shaft opening is intact and the lignum vitae lining is still in situ. Traces of sheathing exist on the right edge.
