MANAGEMENT PLAN FOR
THE HISTORIC SHIPWRECK
SS MACEDON
1870–1883

This document is a plan of management for the historic shipwreck *SS Macedon*.

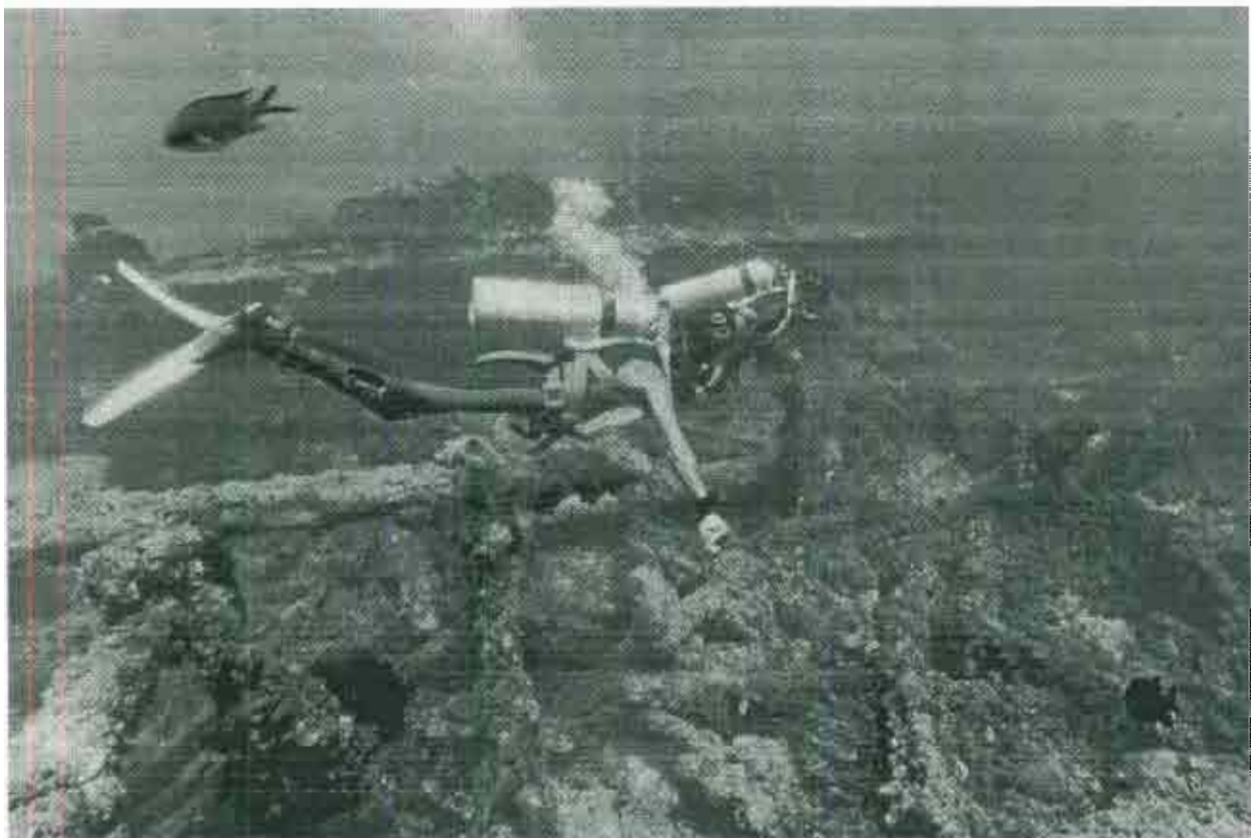
Figure 5. *Macedon* wreck site (Photo: WA Maritime Museum)..

The wreck lies on Kingston Reefs with the bows to the east, approximately 1600 m [0.85 nautical miles] west-nor-west of Bathurst Point. The area is prone to strong surging swells, an environment conducive to active corrosion of iron. The depth of water over the site ranges from 3–6 metres. The hull is intact to the main deck line amidships, however the bow is canted over on the starboard side and the stern is completely broken up. A boiler is the most prominent feature, along with the portion of the ship's sides that have remained upright. Coal and the remains of a cargo of iron is scattered over the site. Small items such as clay pipes and fragments of bottles and ceramic can still be seen.

In December 1992 the wreck site was inspected by staff of the WA Maritime Museum. Electrochemical measurements of the iron remains indicate that the wreck is actively corroding. Some sections of the hull are completely corroded, with no parent metal remaining.

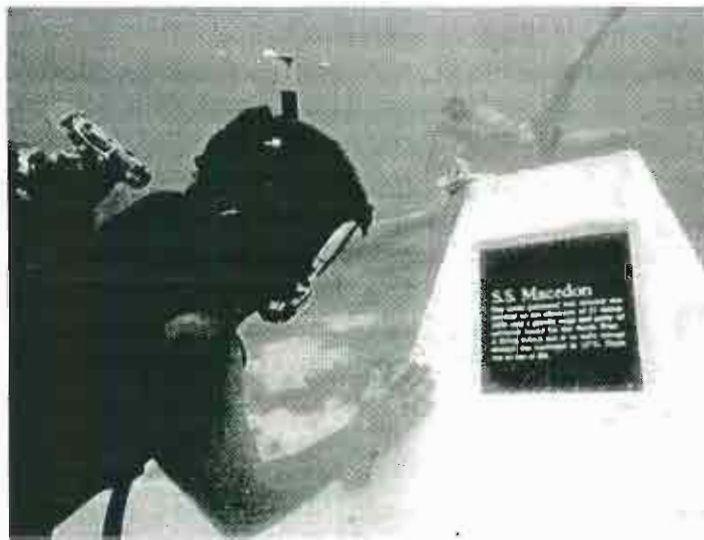
Figure 6. SS *Macedon* information plaque.

There are no legal limitations to public access to the wreck for recreational diving although fishing on the pamphlet is included as Appendix G). An interpretive plaque has been erected along the heritage walking trail at a point overlooking Kingston Reefs where the *Macedon*, *Denton Holme* and the *Janet* were lost. Underwater information plaques have been placed adjacent to each wreck site, providing divers with a brief summary of the circumstances surrounding the loss of the vessels.
