Norwegian Whaling Station Frenchman Bay

Maritime Heritage Site Inspection Report

Compiler: Dena Garratt
Consulting Maritime Archaeologist
June 1994

**Report - Dept. of Maritime Archaeology
WA Maritime Museum, No 82.**

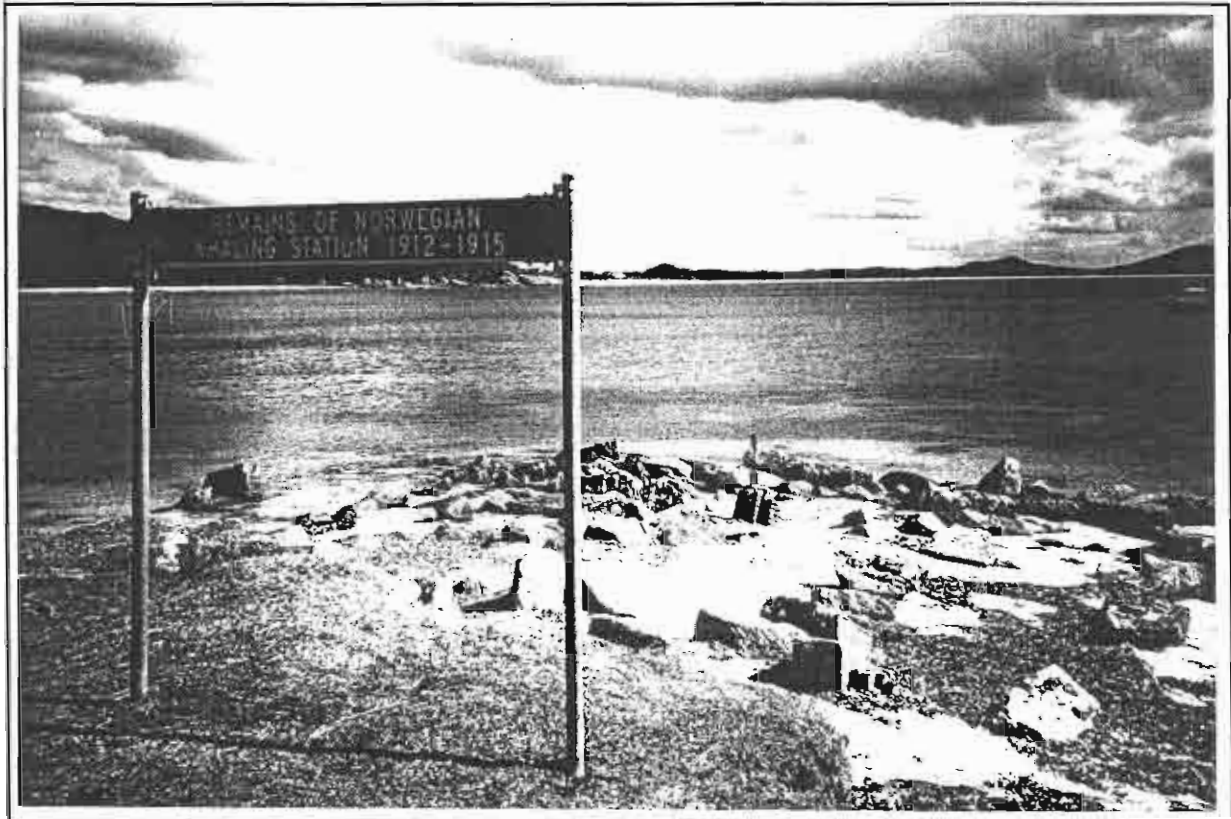
Figure 3. Site of the Norwegian Whaling Station, Frenchman Bay. (WA Maritime Museum)

- (i) Recommend that the site of the Norwegian Whaling Station, including the underwater remains, be gazetted as an Historic Site.
- (ii) Erect a marker at the site that will include suitable interpretive material.
- (iii) Initiate an archaeological survey, with provision for the rehabilitation of the excavated areas and the treatment, conservation and display of any artefacts recovered from the site.

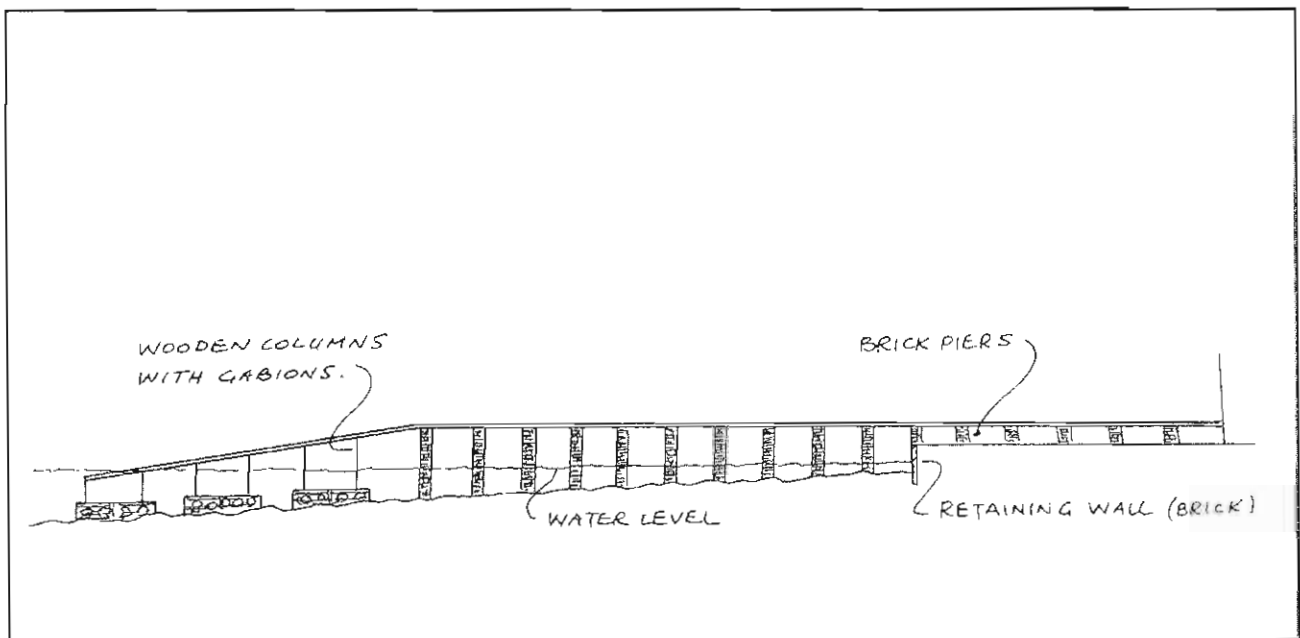
Underwater observations confirms Mr Douglas' description of the flensing deck and slipway . The inner section of the flensing deck was supported on piers of bricks and concrete, while the outer (seaward) section that sloped down into the water was supported on wooden piles. The stability of the footings was reinforced by the surrounding stone embankment. The use of stone-filled crates, called "*gabions*" is an ancient stabilisation method used first by the Romans in harbour construction, and later adopted by the French (Oleson, 1988, p.149). This construction method is logical when one considers the stress requirements of the deck. The outer end of the slipway was susceptible to wave action and the bumping of whale carcasses, and therefore this section required greater lateral stability rather than compressive strength. Brick piers however, have little lateral strength but possess the considerable compressive strength that would be required to support the immense weight of the whales as they were hauled onto the flensing deck. In addition, the load-bearing capacity of the seaward end would not need to be as substantial as the landward end, because dead whales would be partially buoyant while still immersed in water.

Figure 5 Sketch depicting the possible layout of supports for the flensing deck and slipway. Longitudinal Elevation (R. Shaw)

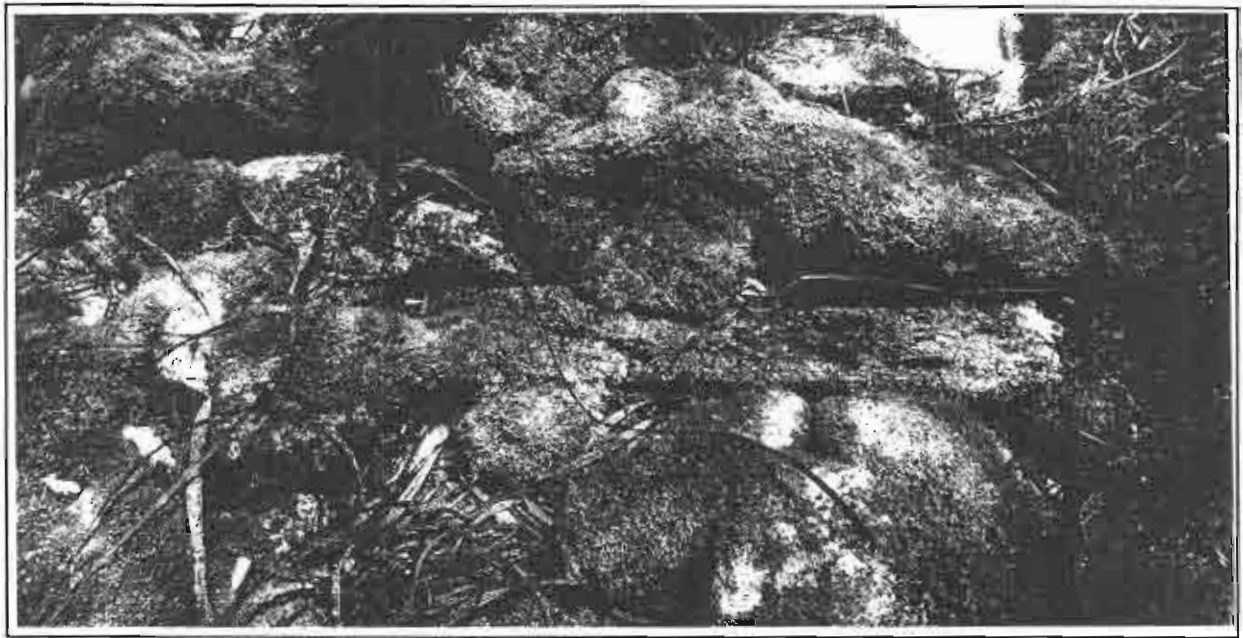
Figure 8. Timbers from the site of the slipway. (WA Maritime Museum)

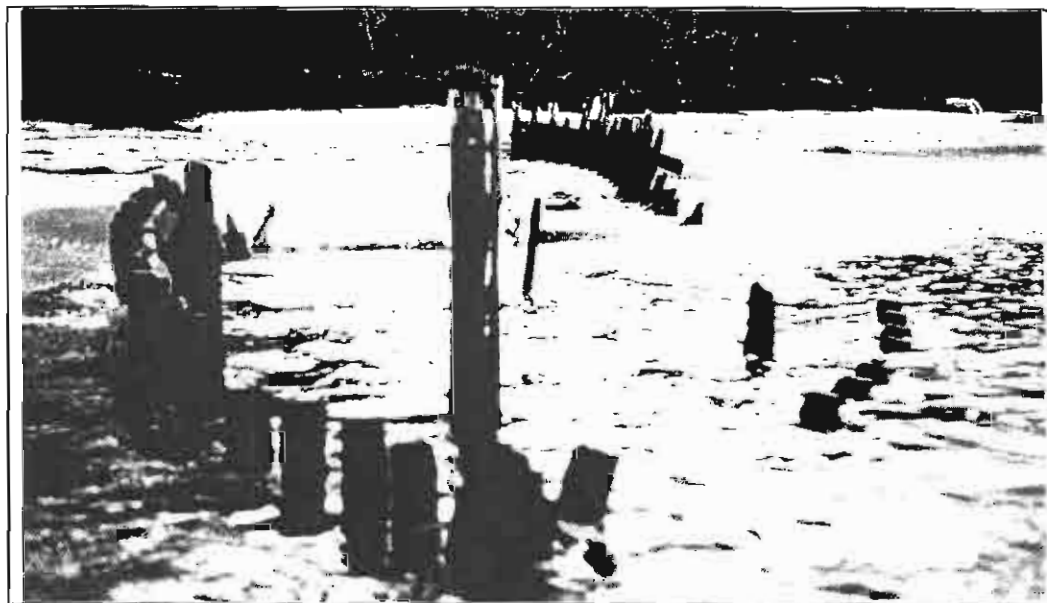
The *Elvie* was a wooden lighter which was used to carry barrels of oil out to the whaling vessels anchored in Frenchman Bay. After the closure of the whaling station the vessel was anchored in the bay. She dragged her moorings and was driven ashore during the violent gale in 1921 that destroyed part of the whaling station. The remains of the *Elvie* lie partially buried in the sand within the tidal zone on the western end of Vancouver Beach. (Boocock, Bower, et al, 1990, pp. 41-58)

Figure 11. View of *Elvie*, July 1991. (WA Maritime Museum)

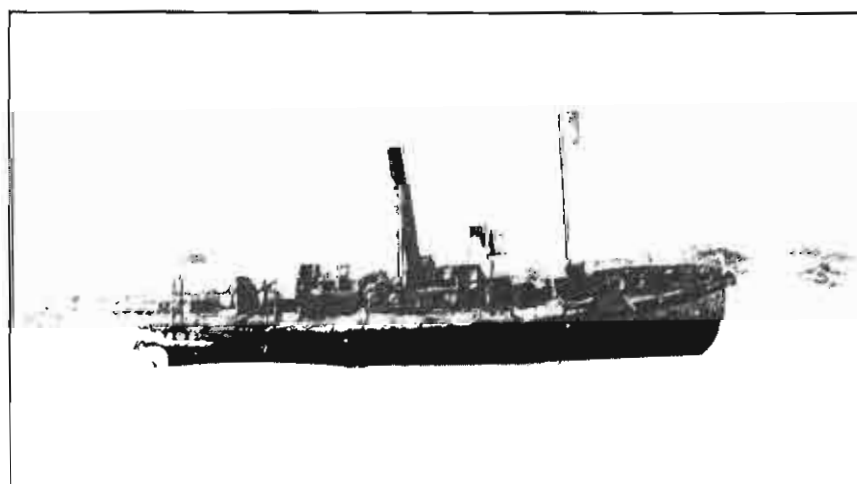
The *SS Finn* was one of two small Norwegian Whalers, originally operating from Frenchman Bay. After the closure of the southern station, the *Finn* was engaged in the northern whale fishery at Point Cloates. It is shown here on Fraser Island, where it was blown ashore during a cyclone in 1923. (Source: WA Maritime Museum, File Name: *Fin*; File No: MA 22.80)

Figure 12. *SS Finn* aground on Fraser Island, c 1924. (WA Maritime Museum)
