# Site Inspection Report

*Alex T. Brown (1903 - 1917)*

**Seasonal exposure of the coastal shipwreck site  
recorded on the 9<sup>th</sup> of September 2024**

**Report No. 353 – Western Australian Museum, Department of Maritime  
Heritage**

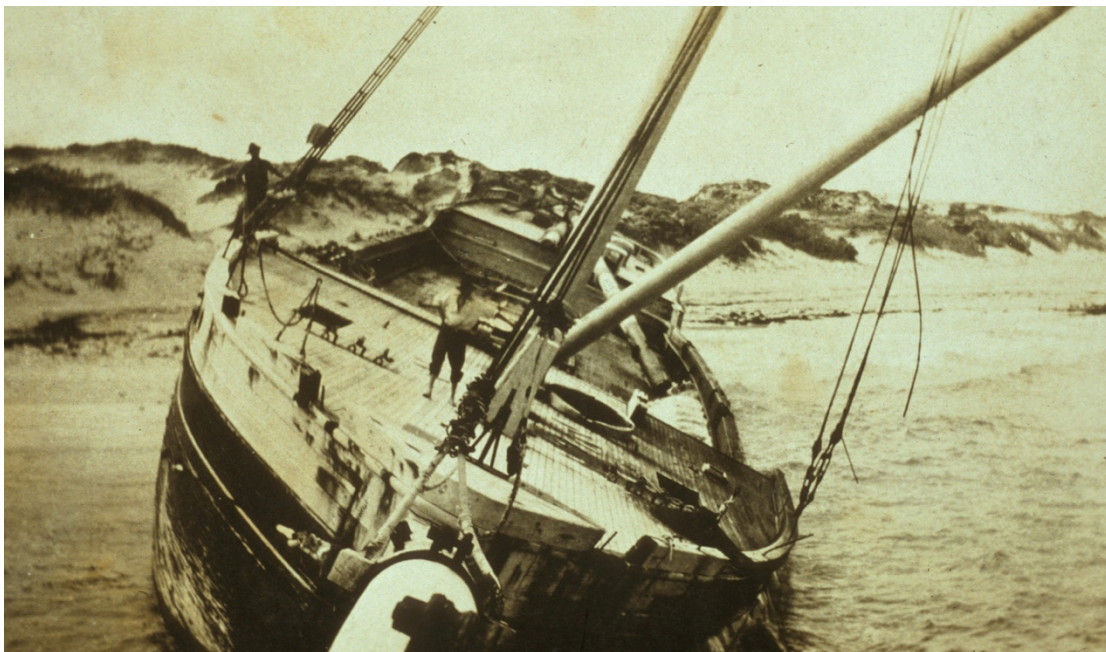
Figure 2. 1920 image of the *Alex T. Brown* wreck, before breaking up on the beach. Image courtesy of the Wanneroo Museum.

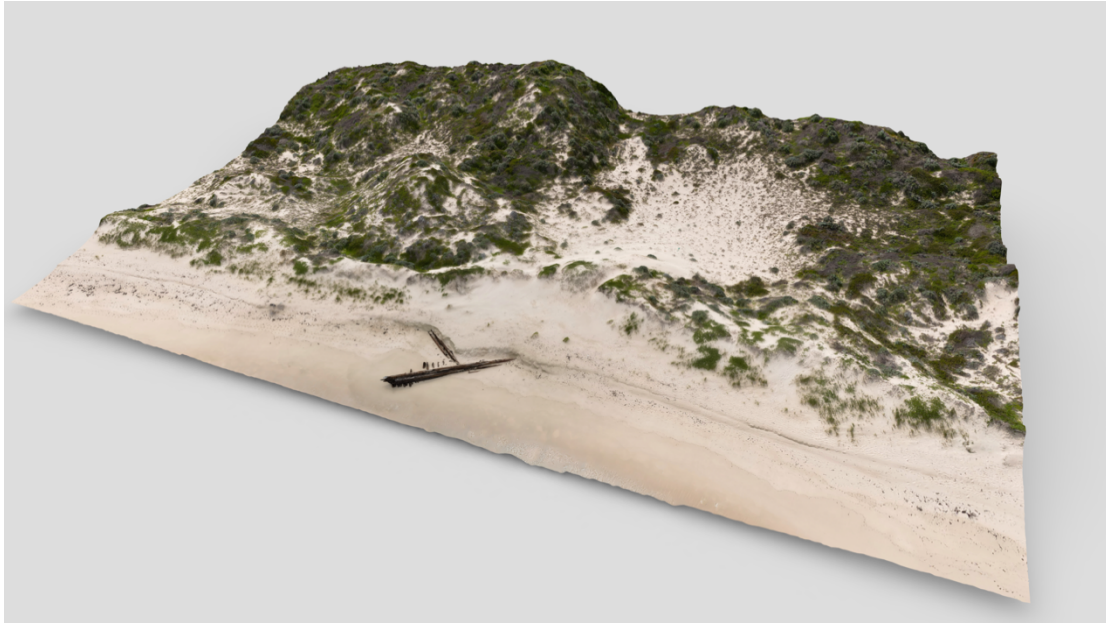
The site was photographed and recorded photogrammetrically with a DJI Mini 3 Pro drone. Agisoft Metashape was utilised to process 189 images, resulting in a landscape-scale 3D model – recording the condition of the wreck and the surrounding coastal environment. This was aligned with previous imagery of the wreck site in 2021, in accordance with the USGS coastal photogrammetry procedure (Over 2021). The model is stored on the Museum server, and is published on Sketchfab: <https://skfb.ly/pruwO>.

**Figure 4. Drone photogrammetry model of the *Alex T. Brown* and surrounding environment. A total of 189 images processed in Agisoft Metashape show the wreck in the context of a coastal dune system, eroding from the foredune.**

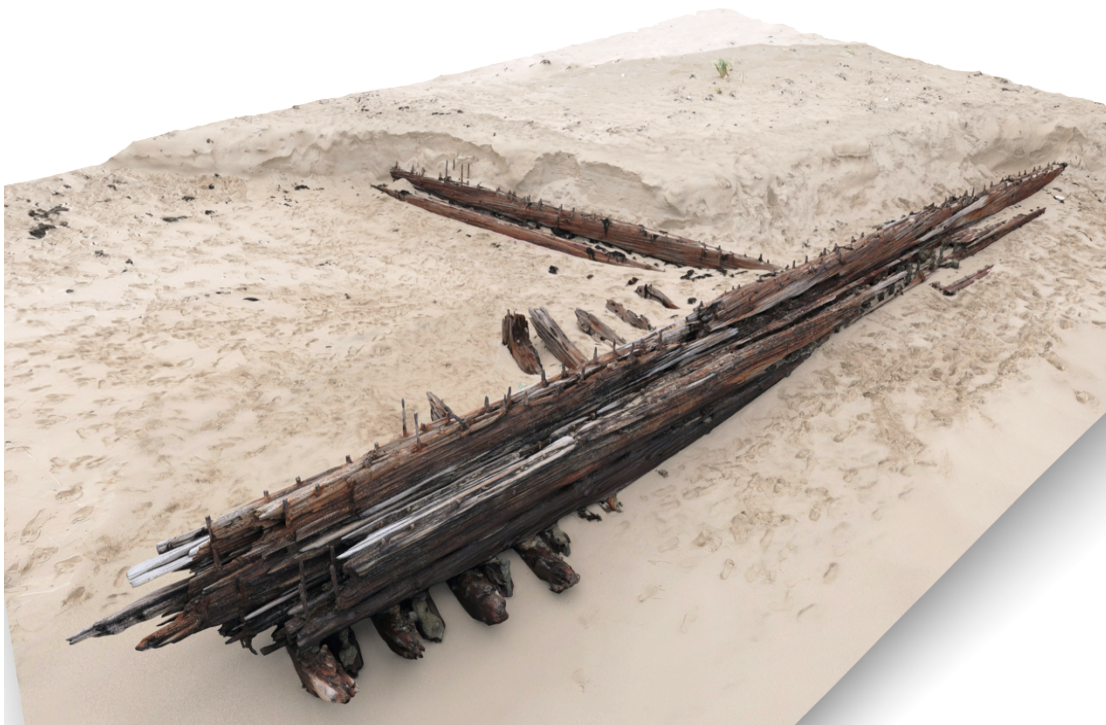
The wreck was recorded photogrammetrically in detail using a Panasonic Lumix S5ii, with 549 images reconstructing the timbers in detail. The model is stored on the Museum server, and is published on Sketchfab: <https://skfb.ly/pruuV>.

**Figure 5. 3D photogrammetry model of the *Alex T. Brown* wreck site on the 9<sup>th</sup> of September 2024. A total of 549 images were processed in Agisoft Metashape showing the condition of timbers eroding from the beach.**

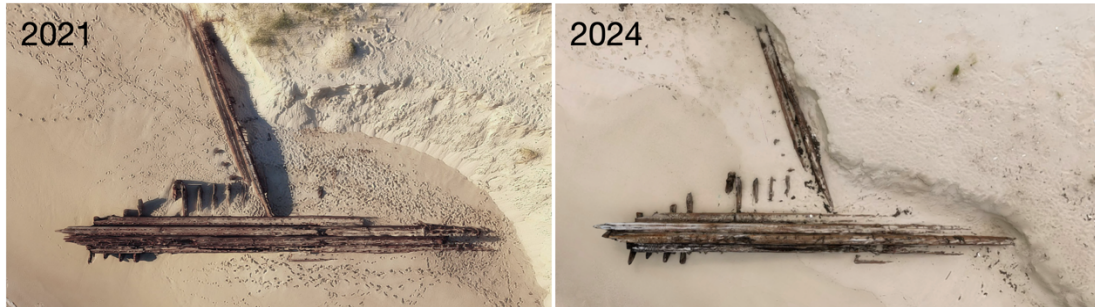
The wreck is eroding from the foredune, on the coastal side of a vegetated aeolian dune system. No major deterioration is evident since the Museum's last visit to the site, apart from the vandalism reported in 2017. We also compare it to Patrick Morrison's August 2021 model of the site (Figure 6), noting no major changes (<https://skfb.ly/opnX9>).

**Figure 6. Comparison between Patrick Morrison's 2021 model of the *Alex T. Brown* wreck site, and the Museum's latest 2024 model.** No major structural changes are evident on the site over this 3-year period, and a similar pattern of coastal erosion is visible.

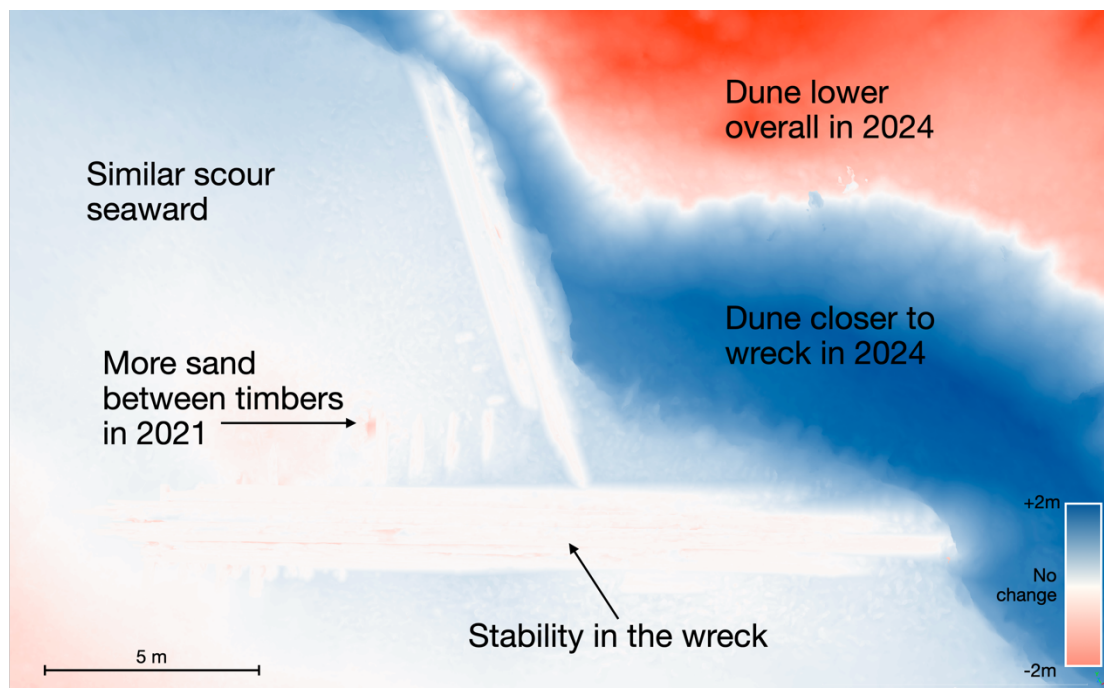
The 3D models were formally compared using CloudCompare, computing the distance between the 2021 mesh and the 2024 mesh, which show no changes to the timbers (Figure 7). This demonstrates that the seasonal exposure of the site does not rapidly degrade the wreck year-to-year, supporting long term observations.

**Figure 7. Formal comparison of 2021 and 2024 meshes of the *Alex T. Brown* photogrammetric models.** Red areas indicate a reduction since 2021, and blue areas indicate an increase. The dune is further collapsed in 2021, but the timbers show stability. This was computed using the CloudCompare Cloud-to-Mesh distance tool, on two 10,000,000 polygon models reconstructed in Metashape.

1. Annual monitoring and photogrammetry recording of the *Alex T. Brown* shipwreck, in September/October following winter storms.
2. Provide a copy of this report to the City of Wanneroo and State Heritage Office.
