Elvie (1900-1921) and other sites on Whalers Beach, Albany

WRECK INSPECTION REPORT – 13TH TO 14TH OF AUGUST 2020

Department of Maritime Heritage

Report Number 335

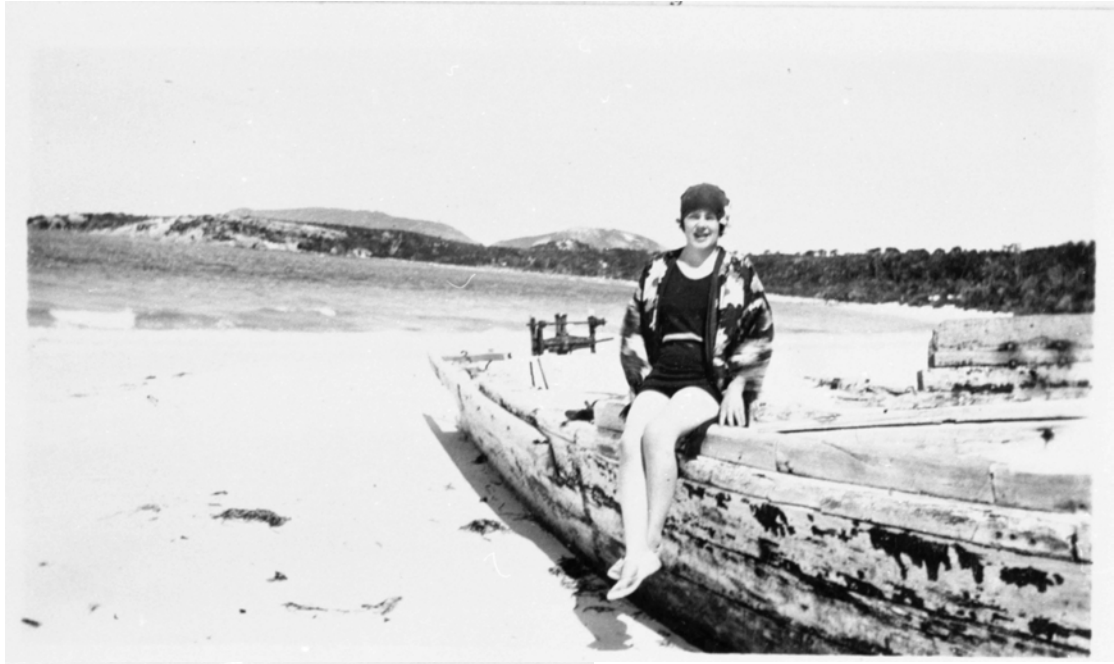
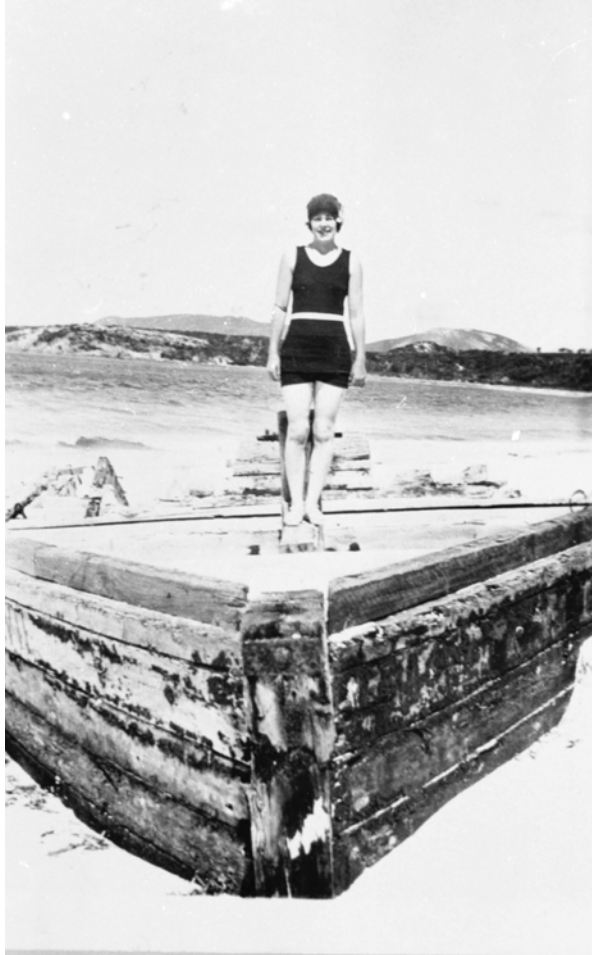
Elvie has been damaged by natural processes since its wrecking. The earliest known images of the wreck site are from Mrs H Hartman in the 1920s (Figures 2 & 3). These show the wreck in a state of disrepair, but with far more structure than there is today.

Figure 2. Elvie in the 1920s. Images from Mrs H Hartman. WA Museum MA Negative 1423-05 and 1423-06.

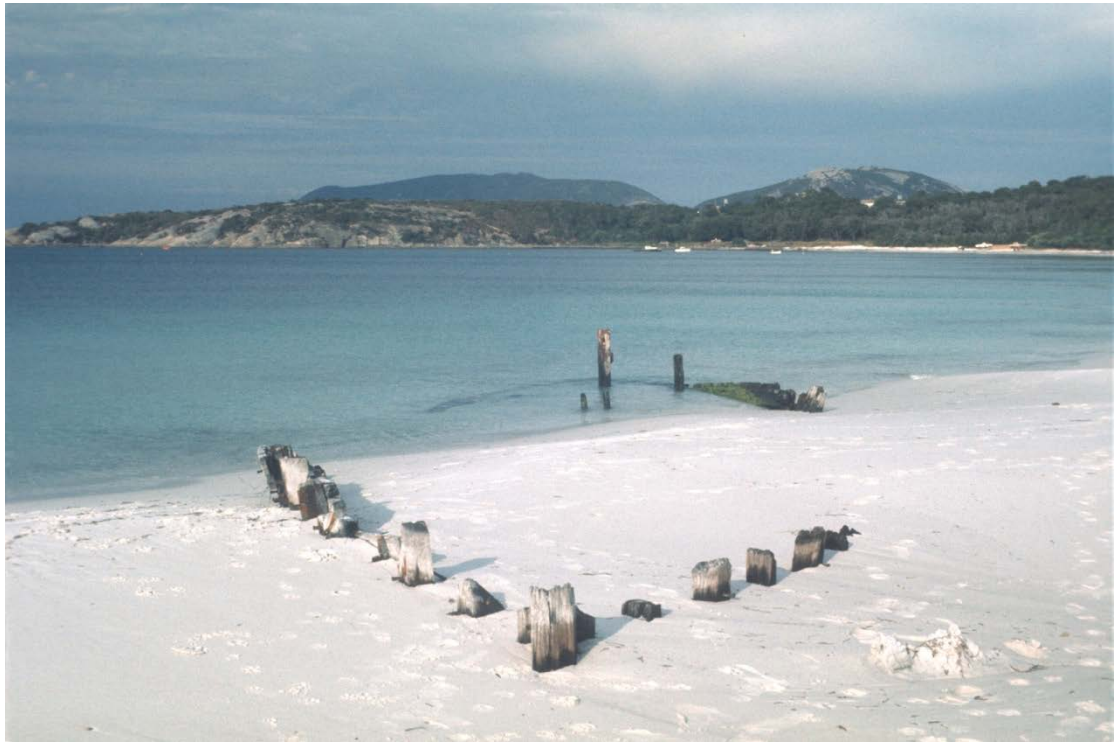
Photographs in the WA Museum archives (Boocock et al. 1990) and images provided by members of the public illustrate a progressive loss of structure over the last 30 years (Figures 4-11). As is evident from Figures 4 & 5, the majority of the shipwreck is normally buried under beach sand. The port side was mostly lost between the 1990 excavations and 1991. The wreck was very exposed after a strong storm in 2003 (Figure 7). The loss of almost all but the lower hull occurred some time since 2003, and the starboard side mostly disappeared between June and early August of 2020 (Figure 9). During inspection in August 2020, only the bottom of the hull and a small part of the port stern hull remains (Figures 10 & 11).

Figure 3. Pre-disturbance photograph of Elvie in 1990 (WA Museum).

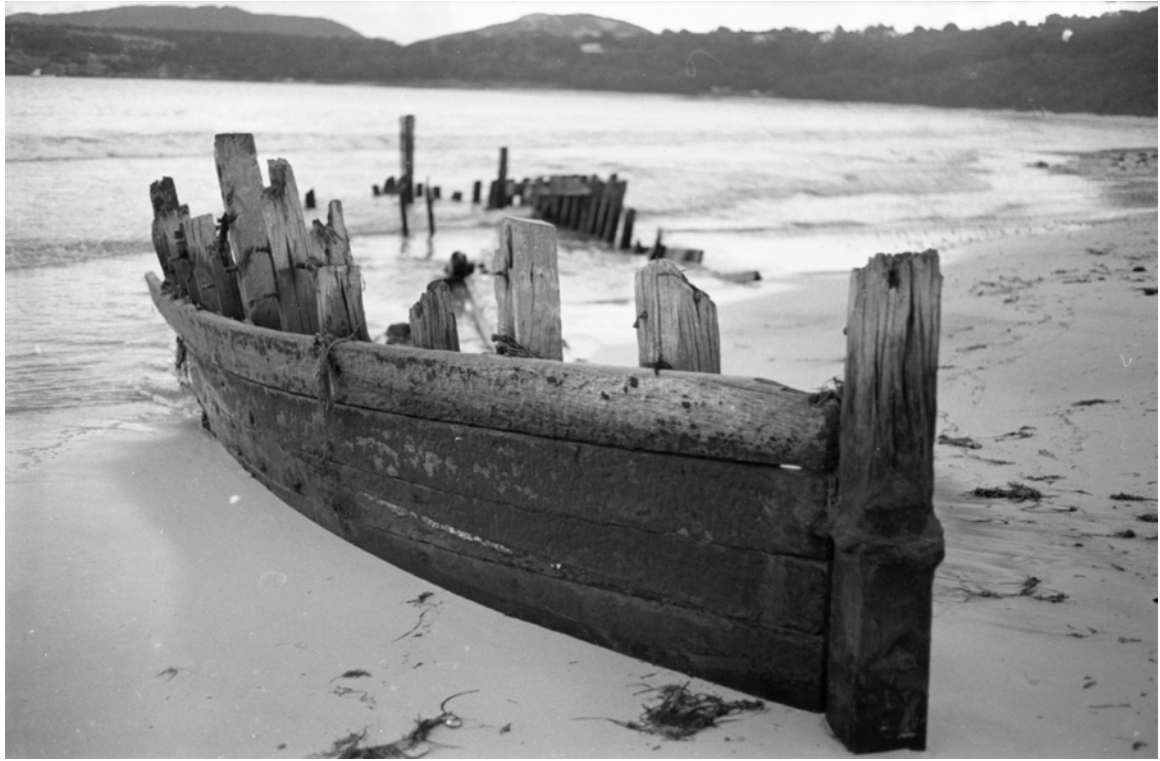
Figure 5. Elvie in August 1991. Photo by Adam Wolfe/WAM MA Negative 4227

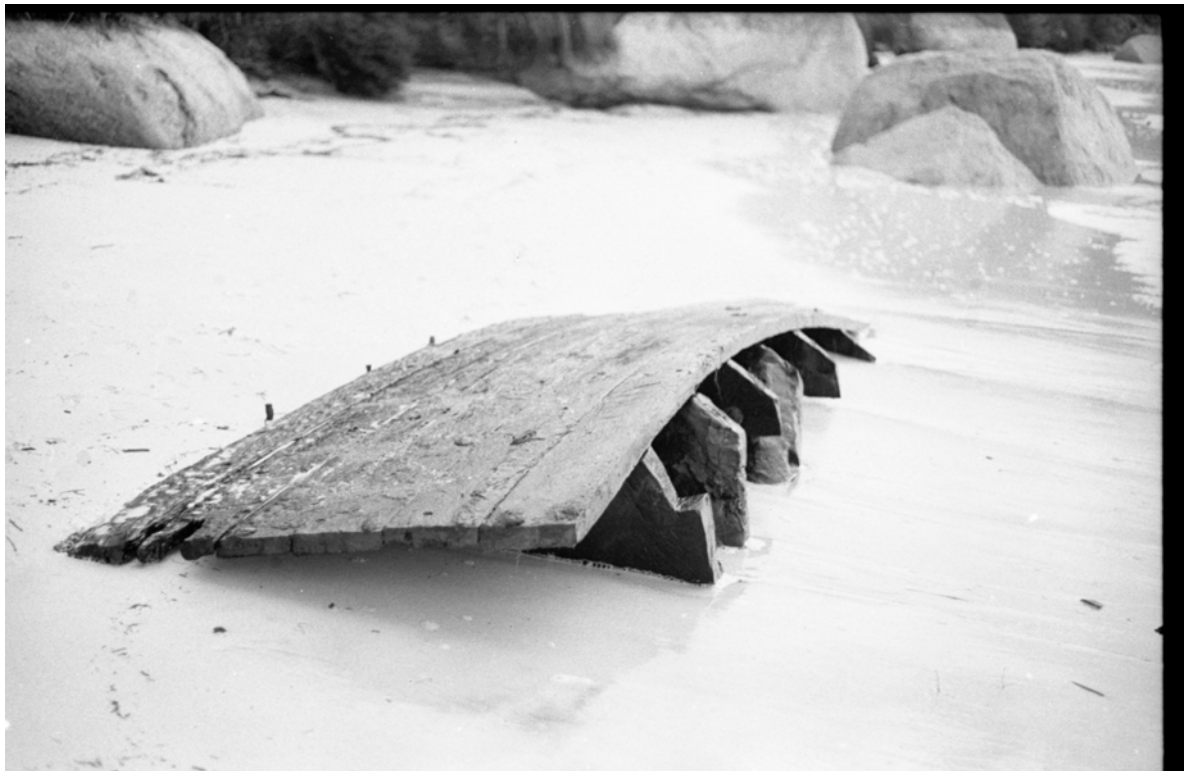
Figure 6. Part of Elvie in July 1991. Photo by Adam Wolfe/WAM MA Negative 4226

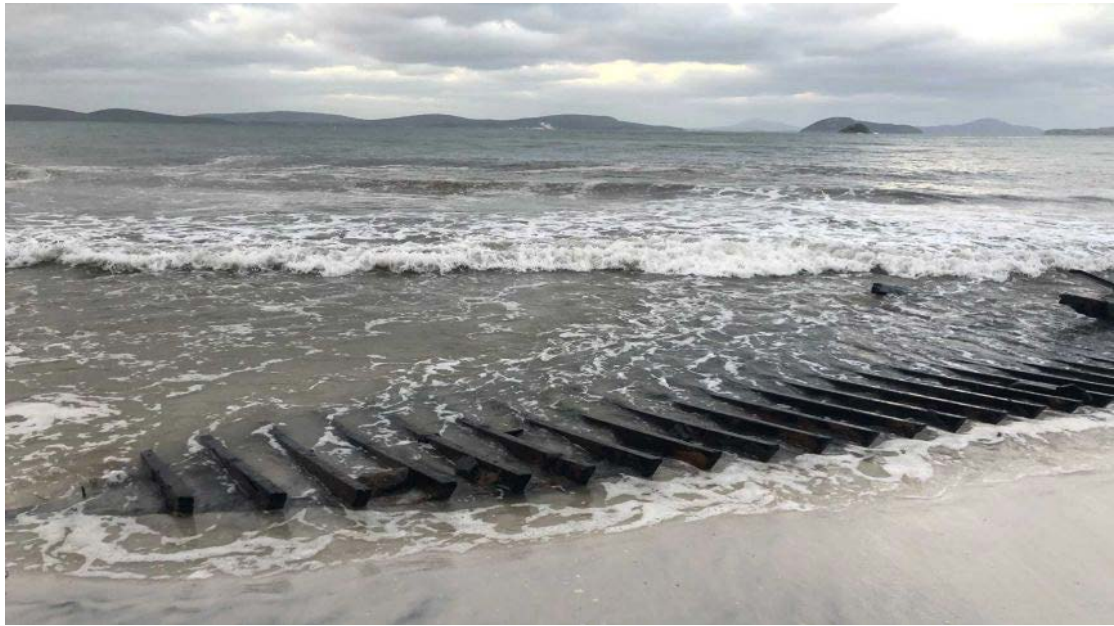
Images from the ABC news article indicated the bilge and interior of the hull were almost completely exposed. By the time WA Museum staff arrived, nearly one-quarter of the wreck was reburied in sand. At the lowest tide (0.5m) the hull was still located below the low water mark. Whilst undertaking the pedestrian and drone surveys, staff noted that sediment continued to move over the site.

Figure 9. Elvie fully exposed immediately after the 2020 storm (ABC News).

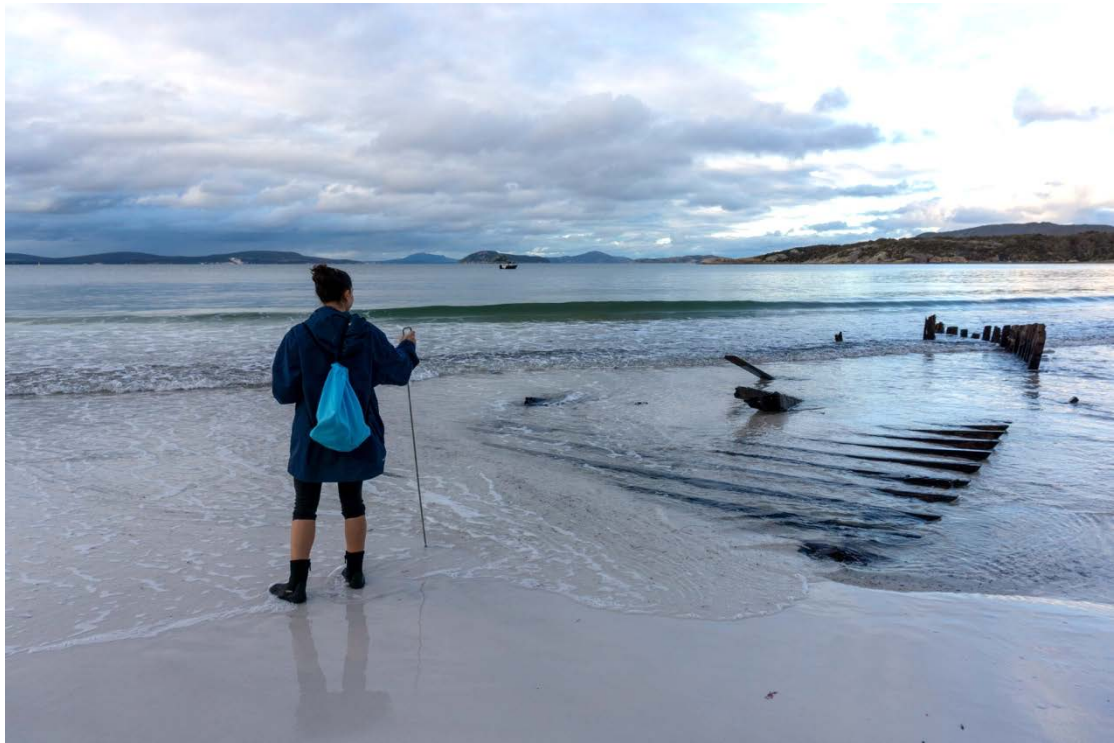
Figure 10. Deb Shefi probing the extent of the wreck after the storm in August 2020 (Patrick Morrison/WA Museum).

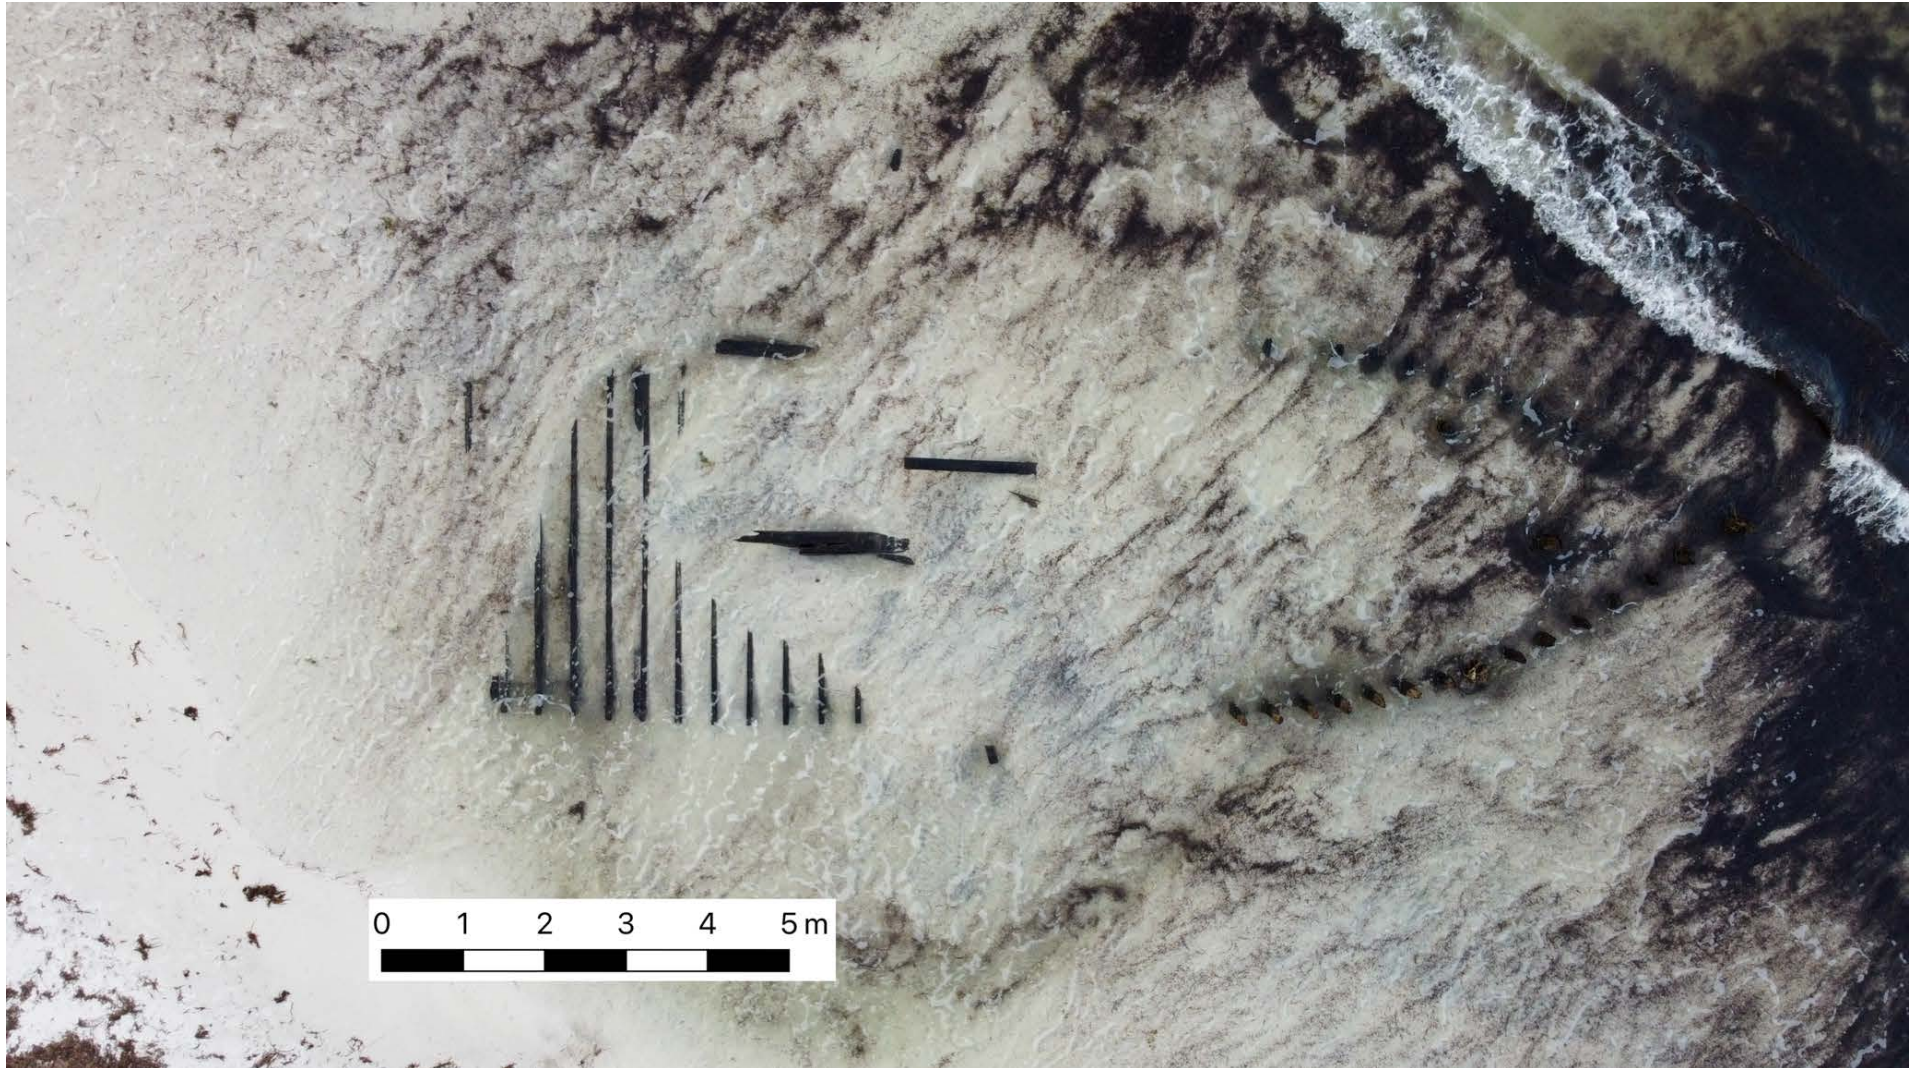
Site Image (Plan View) – Elvie

Figure 11. Drone image recorded on 14/08/2020 at 16:51. (Patrick Morrison/ WA Museum).

Based on the dynamic nature of the sediment movement during storms, without intervention, this site will continue to erode. It is expected, that without available legislative protection and interpretation in the nearby vicinity, the site will be subject to further interference.

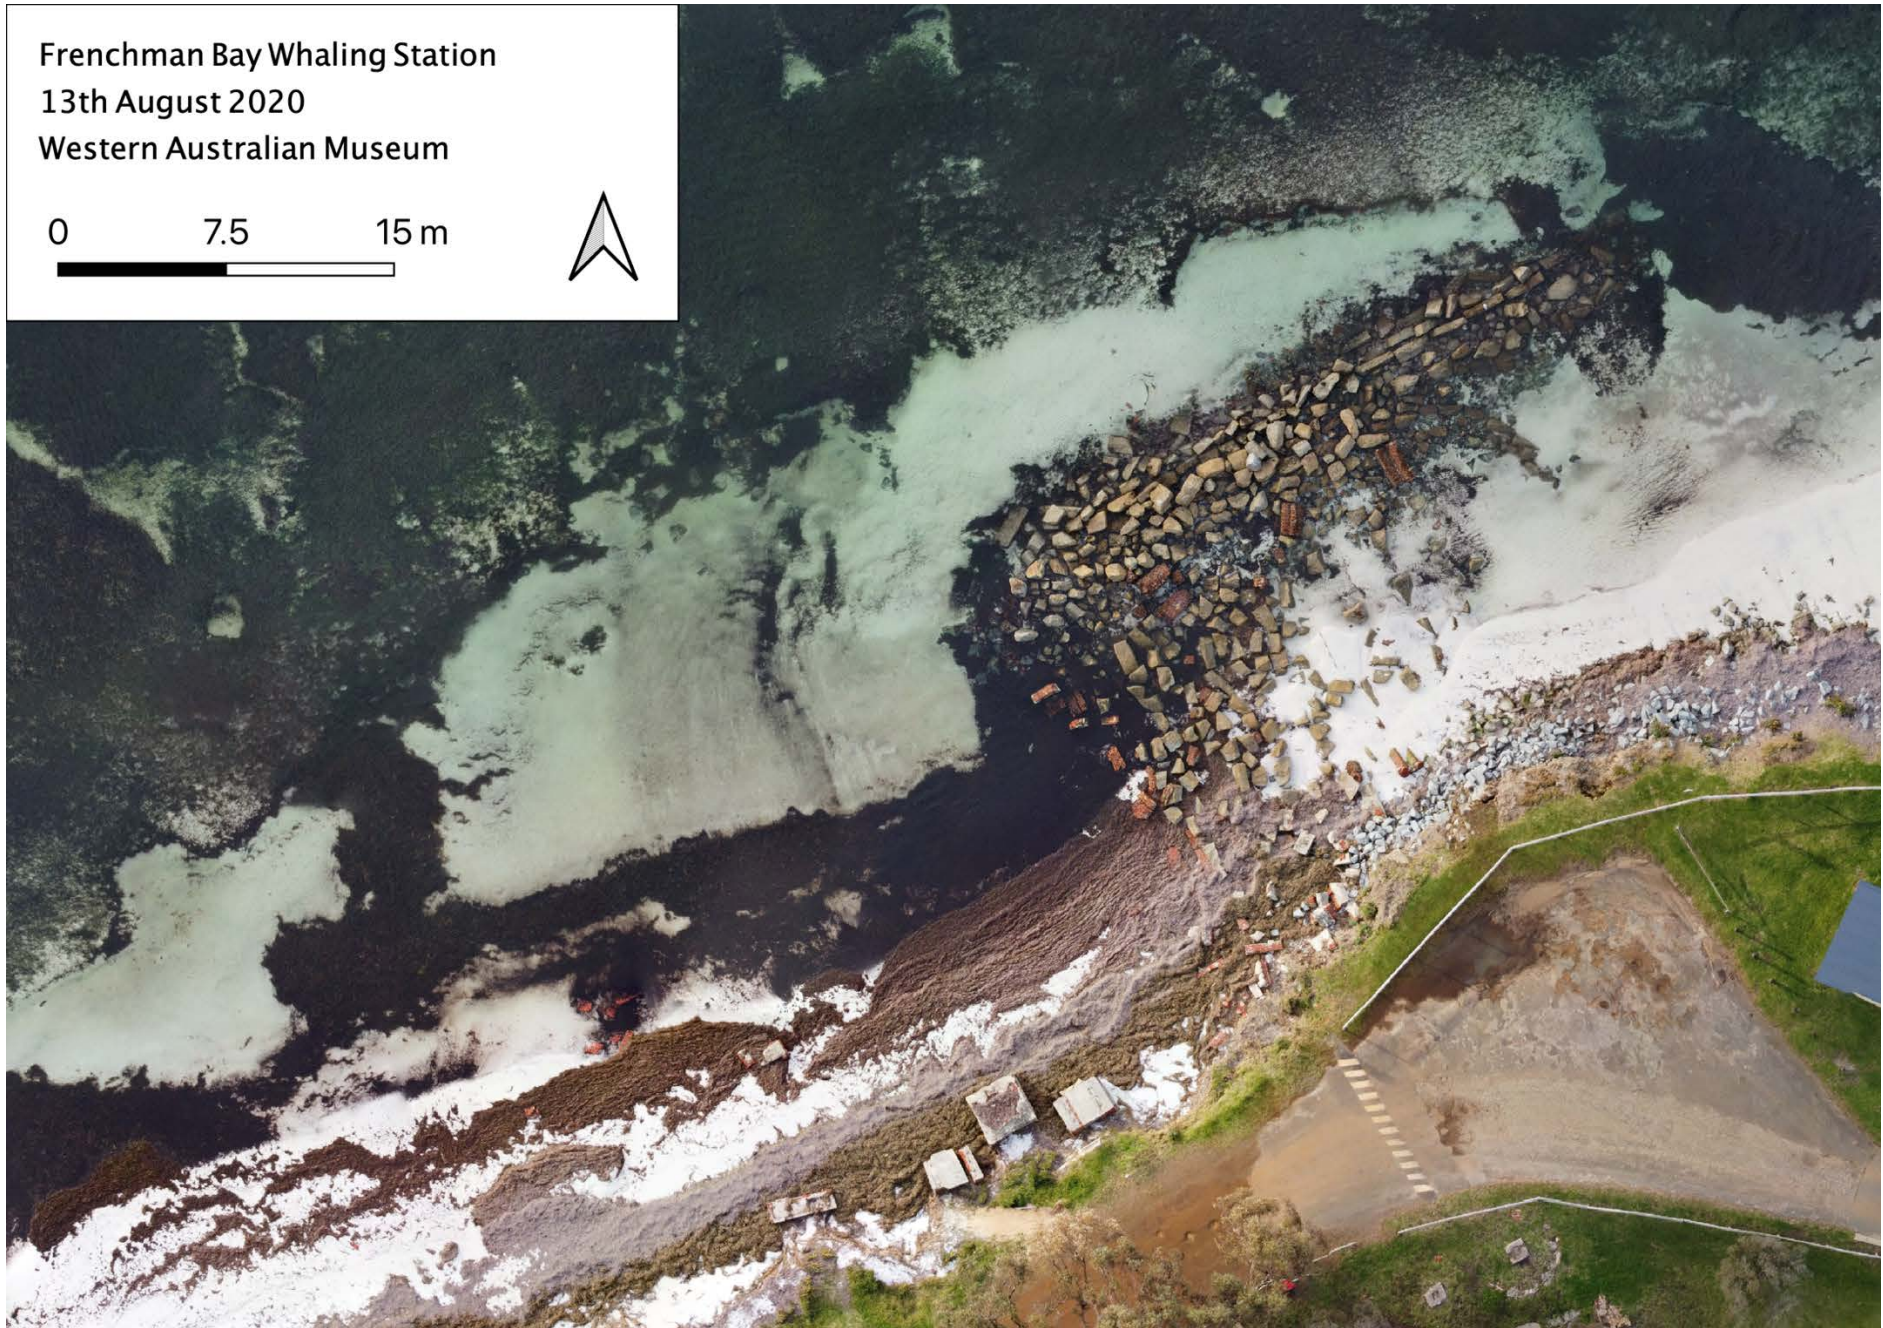
The remains of the Norwegian Whaling Station (1912-1915) can be found in the south-east of Whalers Beach (Garratt 1994) (Figure 12). Currently, all that remain exposed are piles of weathered red brick and foundations.

Figure 12. Frenchman Bay Whaling Station orthomosaic. Recorded by Mavic Mini drone and processed in Agisoft Metashape. (Patrick Morrison/ WA Museum).
