Site Inspection Report

City of York Bay Unidentified - *Transit* (1875-1899)

**Report No. 359 — Western Australian Museum, Department of Maritime
Heritage**

February 2025

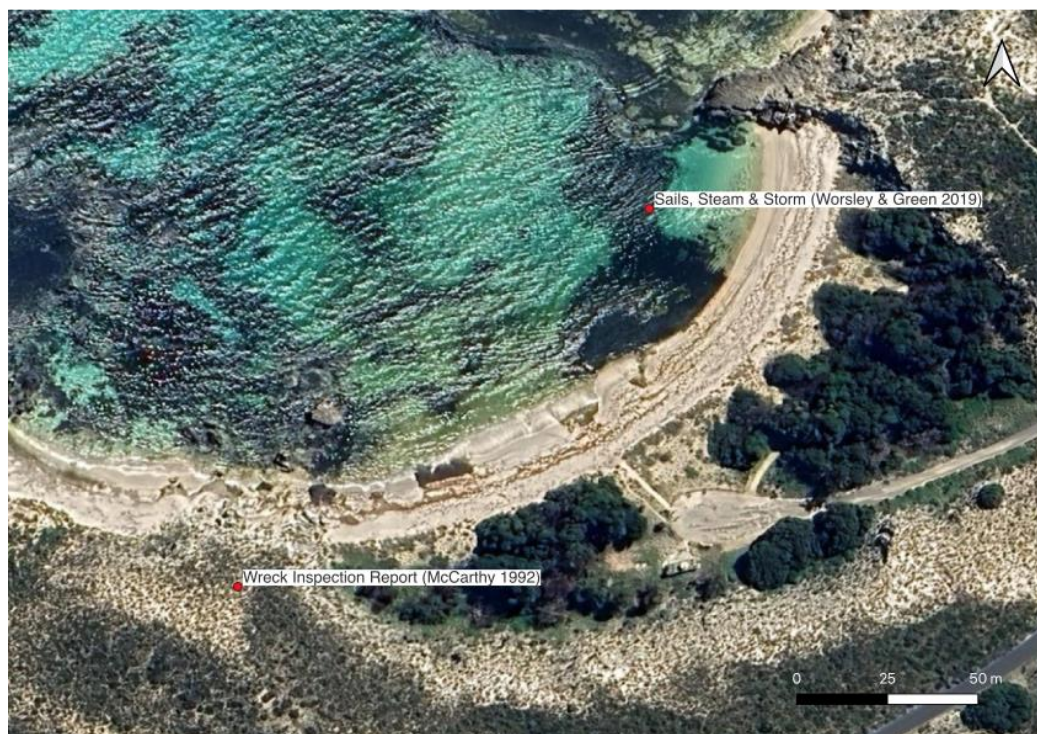
The site inspection was unable to confirm the current location of the City of York Bay Unidentified, due to not being able to re-locate the site. Co-ordinates for the City of York Bay Unidentified were updated via Landgate aerial photographs in 2019, listed in Worsley & Green (2019). As a result of GPS selective availability in 1992, the original GPS position listed in the initial inspection for this site was only accurate ± 50 m. Co-ordinates used in this survey were those listed in Green & Worsley 2019:753, as the co-ordinates from 1992 were shown to be on land (Figure 1).

Figure 1 Updated location for City of York Bay Unidentified derived via aerial images in 2019, shown with the location listed in the initial Site Inspection from 1992 – City of York Bay, Rottnest Island (Aurora Philpin, WA Museum).

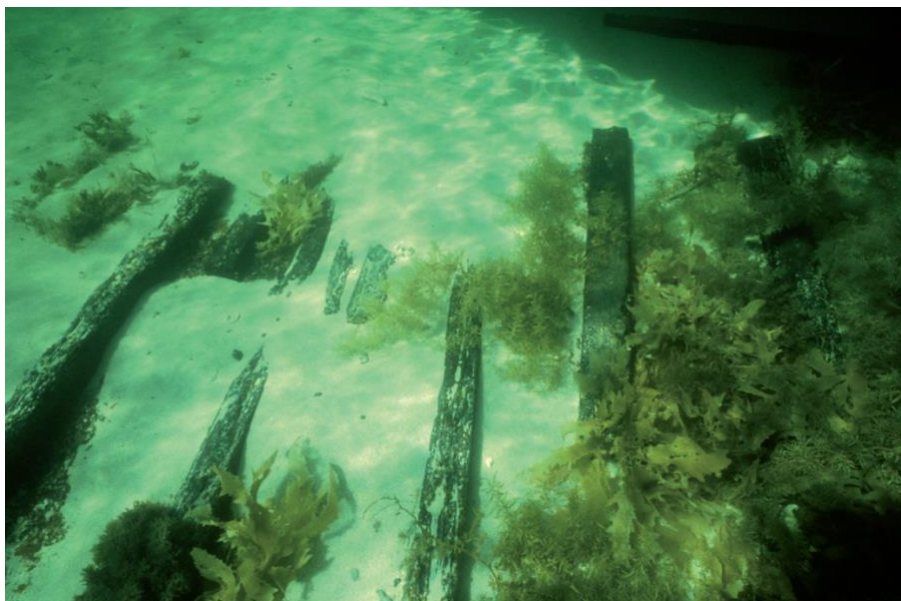
The City of York Bay Unidentified was originally recorded in 1992, described as loose timbers amongst thick ribbon weed and sand (Figure 2). Wreck site timbers were recorded in 1992 as lying at a right angle to the shore, with some projecting under the sand. In total, exposed wreckage measured 9.6 m in length and 4 m in breadth. Visible timbers appeared to consist of the keel, a section of flat-bottomed hull with machine cut frames measuring 12-14 cm x 10-12 cm and planking with dimensions 22 x 3 cm (insert reference e.g. McCarthy 1992).

Figure 2 Visible timbers of the City of York Bay Unidentified (Michael McCarthy, Western Australian Museum, 1992).

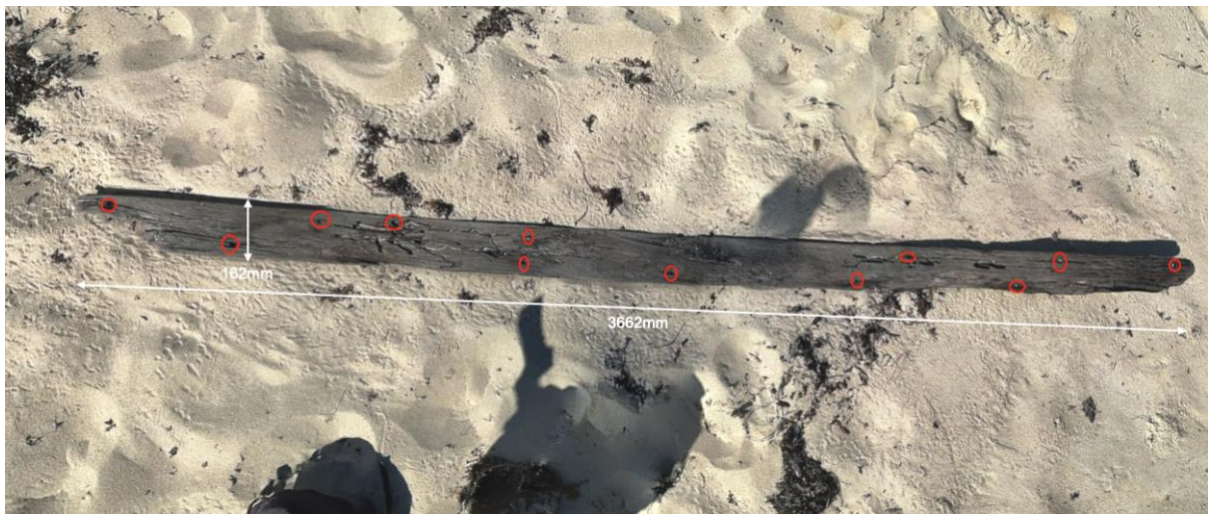
Timber 1, a curved hull timber, had likely been dragged up on to the beach by a member of the public and placed vertically, lying flat along the beach. Dimensions for timber 1 were recorded (Table 1), as were the placement of its fastening holes which were approximately 17mm in diameter (Figure 3). Timber 1 had completely dried out due to being out of the water for an unknown period and there is extensive teredo worm damage from when the object was still located on the wreck site.

Length	3662 mm
Width	162 mm
Thickness	25 mm

Figure 3 LiDAR model with measurement of timber 1 with fastening holes circled (Aurora Philpin & Patrick Morrison 2025).

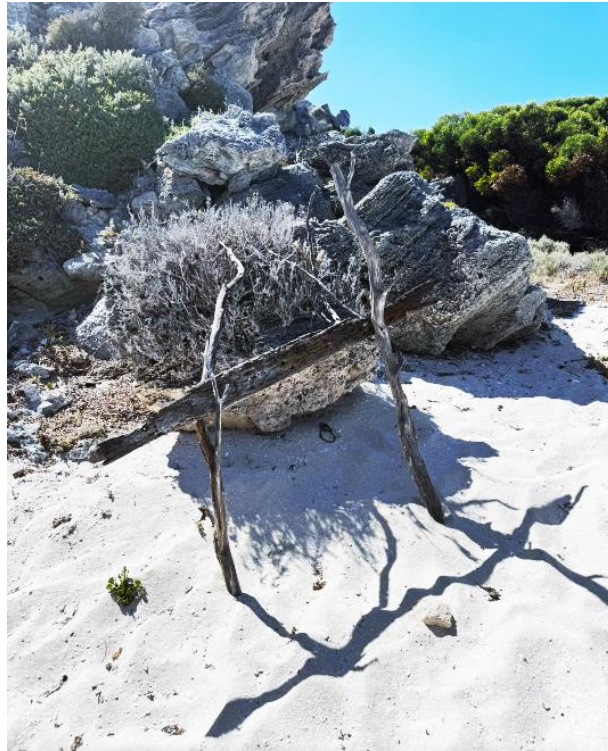
At the northern end of City of York Bay, members of the public had placed a second timber on a makeshift stand, made from branches (Figure 4). Timber 2 is considerably shorter than timber 1 (Table 2) and has fastening holes present. The condition of timber 2 is poor, showing signs of teredo worm damage and being completely dried out as a result of being on the shore for some time.

Figure 4 Timber 2 on a makeshift stand crafted by the public (image credit?).

Length	1879 mm
Width	12 8mm
Thickness	26 mm

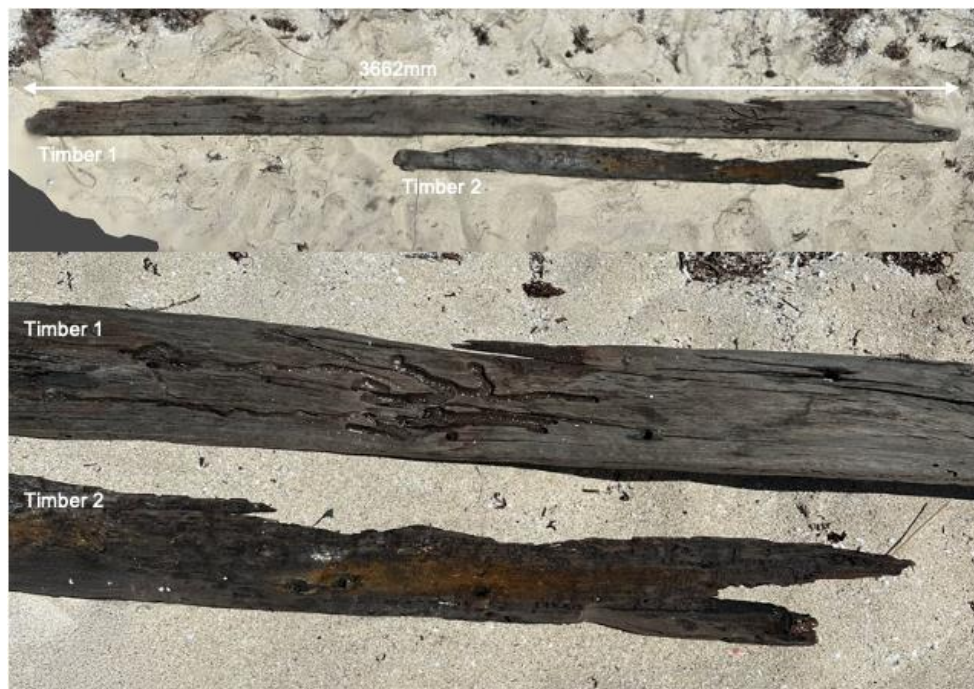
Timber 2 appears to have been burnt via blackening, however public interference with the timbers leaves the question of whether the timber was burnt at the time of wrecking or due to the individual timber being set on fire by a beachgoer. There are visible signs of iron oxidation on timber 2, as a result of the corrosion of iron fastenings embedded within the timber (Figure 5).

Figure 5 Comparison between timbers 1 & 2, showing iron oxidation and charcoal present on timber 2 (image citation?).

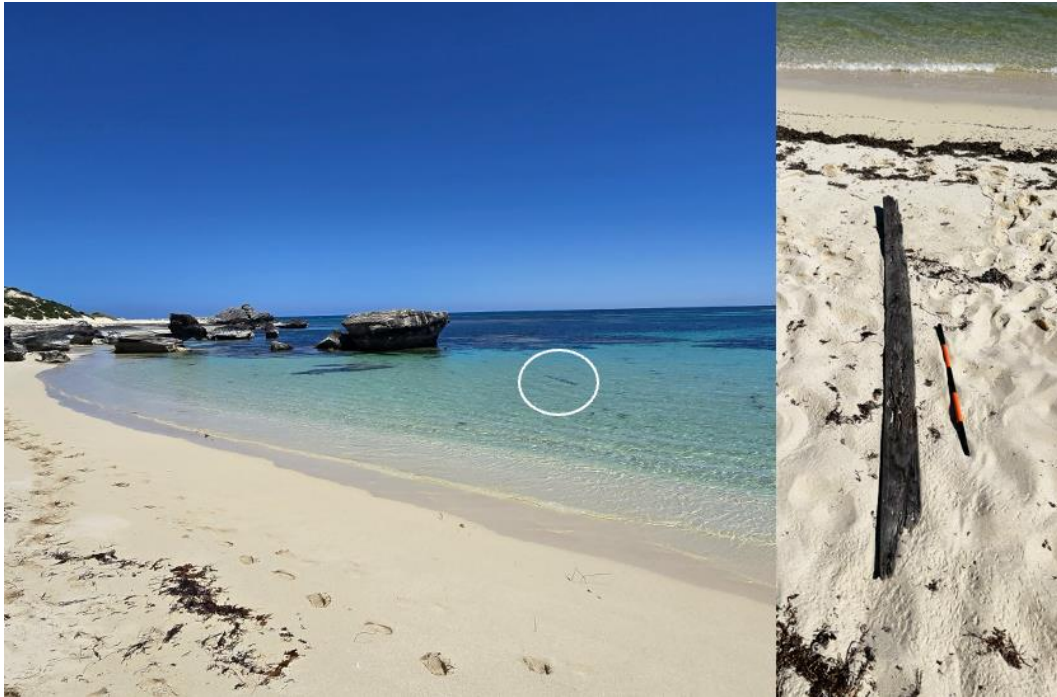
Following the first two timbers being removed from the wreck site in November 2024, another timber had washed ashore, and a second had been displaced from the wreck, submerged 15 m from the shore. When Maritime Heritage staff arrived at City of York Bay in February 2025, this timber had been removed from the water and dragged up the beach (Figure 6).

Figure 6 Timber 1 submerged in November 2024 (left) and after it had been dragged out of the water when it was recorded in February 2025 (right) (left: Rottnest Island Authority 2024, right: Patrick Morrison, WA Museum, 2025).

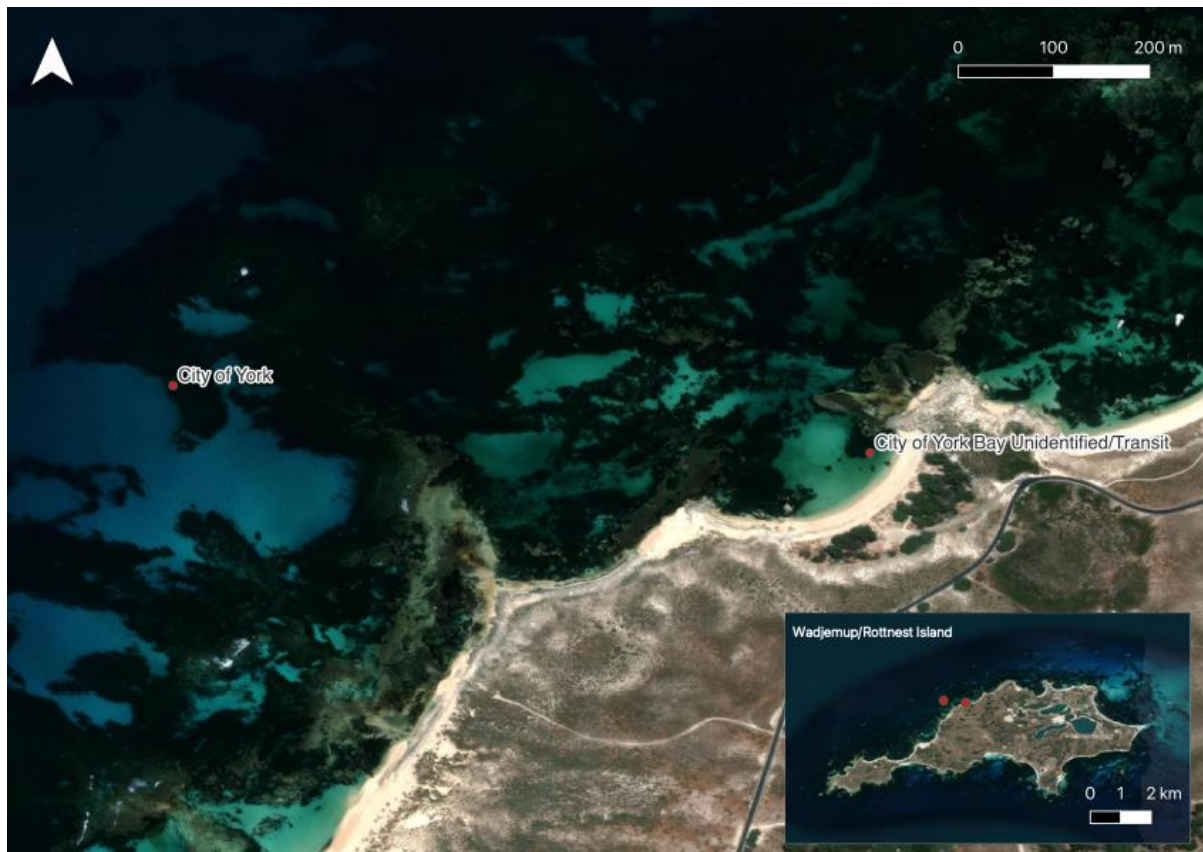
City of York lies approximately 740 m west-north-west of the City of York Bay Unidentified wreck, providing some important context for the site (Figure 7). One of the *City of York*'s crew - Michael Murphy, was at the wheel when the vessel struck on 12 July 1899, and gives an account of the wrecking, as summarised below (Australian Town and Country Journal 1899):

Figure 7. City of York in relation to City of York Bay Unidentified/Transit
