**THE SURVEY
of the
V.O.C. FLUIT RISDAM
1727
MALAYSIA**

**REPORT DEPARTMENT MARITIME ARCHAEOLOGY
WESTERN AUSTRALIAN MUSEUM : No. 25**

The Survey of the V.O.C. *fluit Risdam* (1727), Malaysia

GEOLOGICAL REPORT ON THE WRECKSITE OF THE DUTCH SHIP *RISDAM* (1727),
PENINSULAR MALAYSIA
E.V. Gangadharam

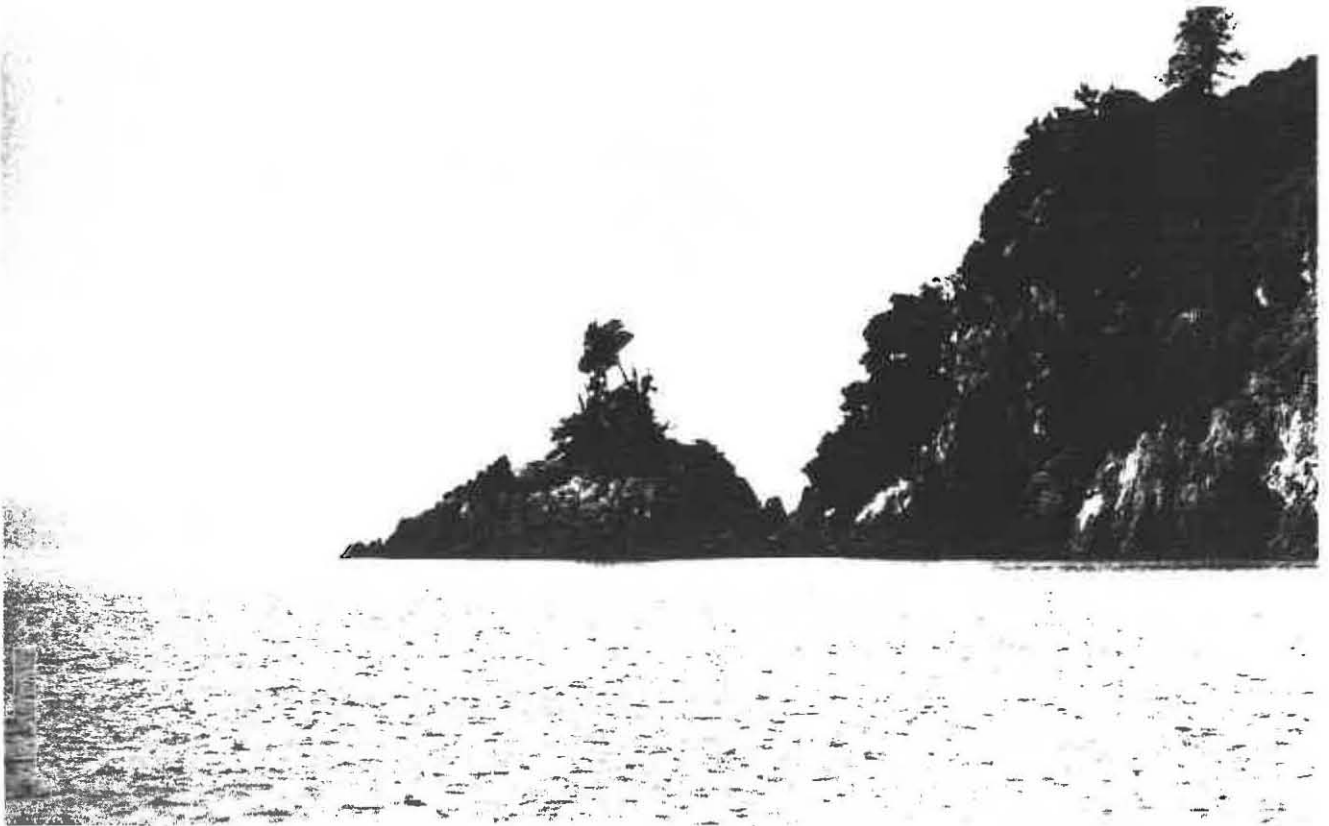
Fig. 4A Photo transit S end P. Batu Gajah

Compass bearings were made to five points A, B, C, D and E (see Fig. 4A & B)

Point	Location	Magnetic
A	E side of P.Batu Gajah	171°
B	W side of P.Batu Gajah	194°
C	NW side of P.Setindam	235°
D	SW side of Tg Selantai	291°
E	E side of Tg Selantai	325°

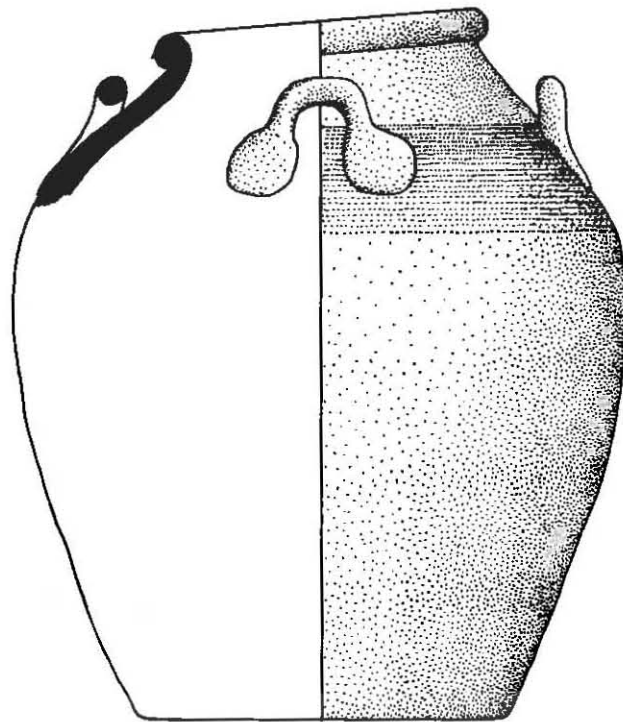
Fig. 9A Storage jars scale 1:4

1. Storage Jars (Fig. 9)

Two stoneware storage jars were recovered (Fig.9). Jar A was found near peg C (see Fig. 5 marked Pot 1) during the probe survey. The jar was extremely distorted with a collapsed neck and shoulders. The height of the jar was about 350 mm, body diameter 320 mm and base 172 mm. The body was Munsel colour 2.5 YR 5/2 with a glaze of Munsel colour 2.5 R4/1. The body had dark grits in it and was reasonably high fired stoneware. The second jar B (Pot 2 Fig. 5), had a slightly distorted neck, with a height of 373 mm, body diameter 325 mm, base 190 mm, neck external diameter 175 mm. The ceramic body was fine, low fired stoneware, with a Munsel colour 10YR 6/4. The slip or glaze was eroded, with a Munsel colour of 2.5 YR 5/4, it was poor quality, fine low fired stoneware with an eroded glazed slip.

These jars are commonly found in the Southeast Asian region and associated with kiln sites in north central Thailand. Originally, it was thought that this material came from the kilns around Sawankhalok and Sisatchanalai. However, recently it has been suggested that the material may have come from Bang Rachang (Harper, personal communication). There can be little doubt that these particular jars were used for a long period of time. They have been found on 16th century wreck sites in Thailand (Green & Harper, 1983), and have also been found on the 17th century sites of the VOC ships *Batavia* (1629) and *Vergulde Draeck* (1656), (Green, 1977). To date, this is the most modern site to have this type of material. Interestingly, the jars do not have the distinctive ridge associated with (although not certainly from) Sawankhalok. It is possibly a reflection of the poor quality of the material bought by the VOC in Ayutthaya. Possibly these were containers for *achar*, *kalk*? or part of the consignment of glazed pots mentioned in the records of goods loaded on board the *Risdam*.

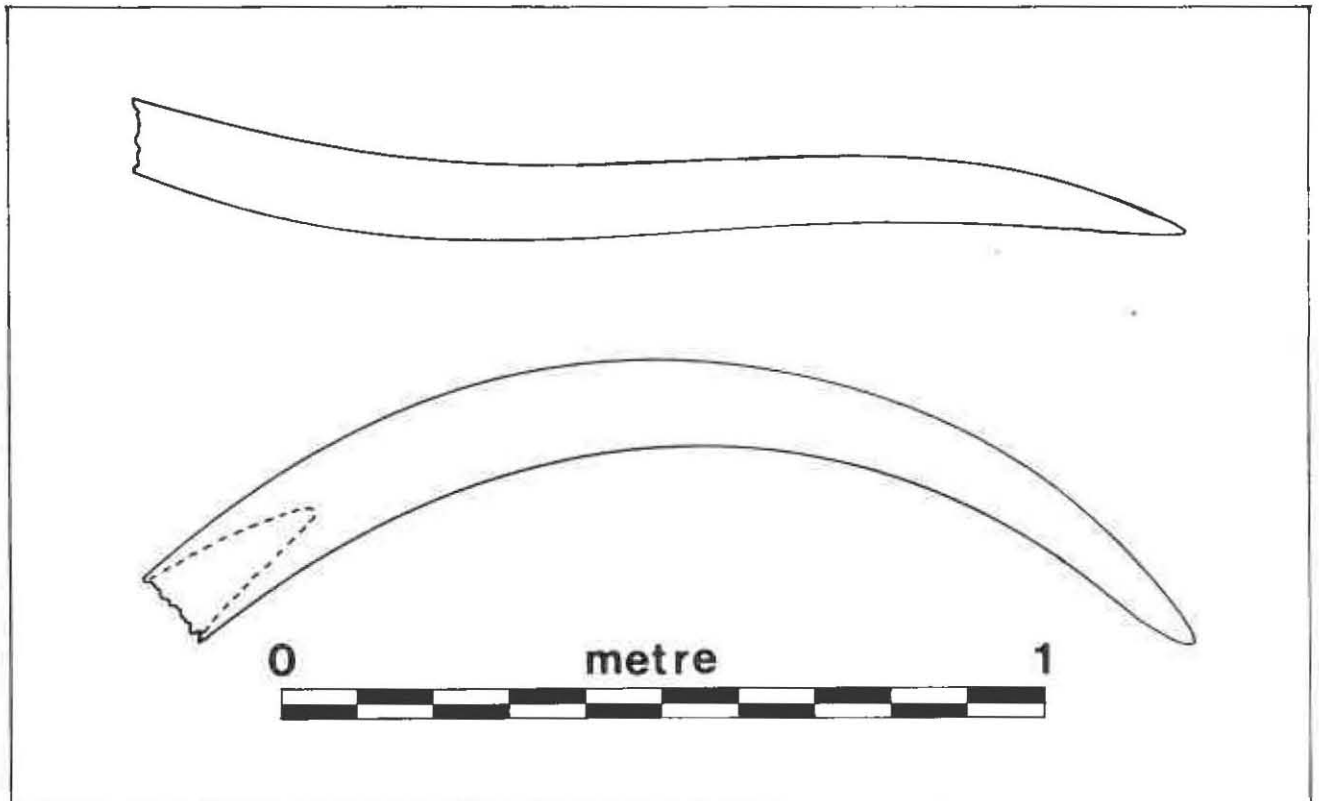
Fig. 11 Elephant tusk

3. Elephant Tusks (Fig. 11)

There were a number of tusks recovered by the original looters and by subsequent expeditions to the site (the Museum holds 90 tusks). Two loose tusks were recovered during the survey

and a large concretion was noted, in Area D (Fig. 5), containing a number of tusks. These were not possible to remove without damage, so were left in situ and covered up at the end of the expedition. A sample tusk was measured and photographed. It was one of the larger tusks, 1.3 m long with a root diameter of 123 mm and a bow of 256 mm at the mid point. The tusks have a noticeable skew or twist in their longitudinal axis. It is not certain if these are tusks from African or Southeast Asian elephants. Certainly some African elephant tusks are generally much larger, and have no twist, so it is possible they are from Southeast Asian elephants.
