REPORT

JAPANESE SUBMARINE 1 124

Mike McCarthy
Maritime Archaeology Department
WA Maritime Museum
Cliff Street, Fremantle, WA 6160
October 1990

Report—Department of Maritime Archaeology, Western Australian
Museum, No. 43

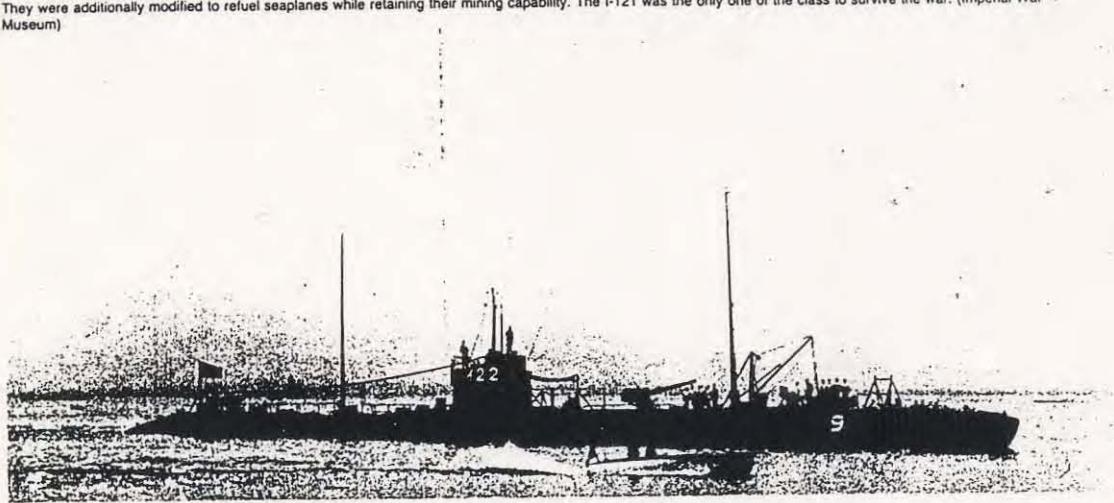
The I-21 (later I-121) was one of four specialized minelaying submarines built by Japan. Their design was based on a German U-boat acquired after World War I. They were additionally modified to refuel seaplanes while retaining their mining capability. The I-121 was the only one of the class to survive the war. (Imperial War Museum)

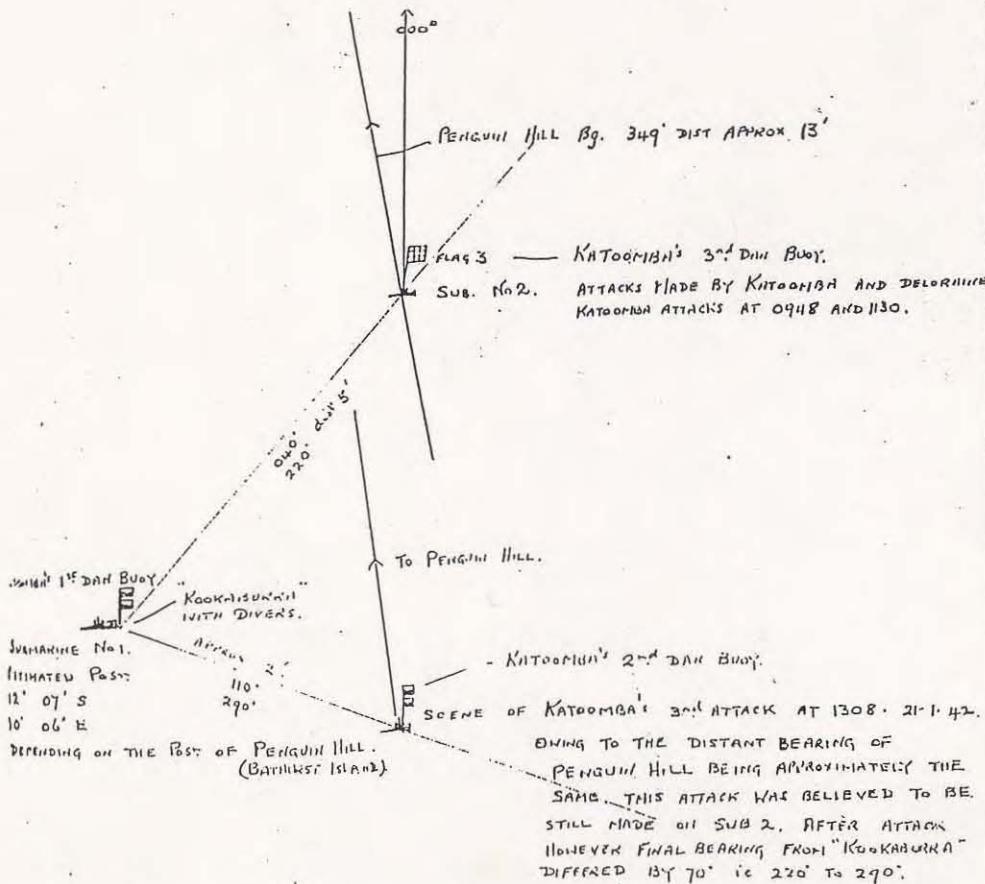
DIAGRAM OF ATTACKS ON SUBMARINES

20. 1. 42 and 21. 1. 42.

Katoomba then attempted to 'fix' the wreck of then stationary Submarine Number 1 or 1a accurately, and noted that it was lying on a bearing of approximately 020°-200°. The submarine was firmly hooked and another Dan Bouy laid. (See Figure) *Katoomba* then cruised around the wreck all night expending a further four charges 'in order to be sure he would remain there for all time'. To the attackers surprise, these 'did not split him asunder but only increased the flow of oil from the vessel'. She reported the wreck to lie at 12° 09'S. 130° 10'E and suggested that divers be sent to investigate.

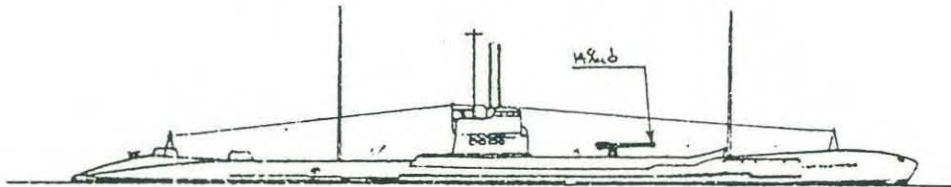
MINE LAYER TYPE.

NOTES: THEY ARE THE ONLY MINE-LAYING SUBMARINES IN THE JAPANESE NAVY. THEIR DESIGN WAS MODIFIED FROM THE GERMAN MINE LAYING SUBMARINE OF THE U-111 TYPE, OF WHICH ONE BOAT (U 125) WAS DELIVERED TO THE JAPANESE NAVY BY THE VERSAILLE CONFERENCE.

4 BOATS OF THIS TYPE (I 21 ~ 24) WERE BUILT BY KAWASAKI, COMPLETED BETWEEN 31/3/27 ~ 10/12/28.
THEY WERE RENAMED AS I 121 ~ 124 IN 1939.
