# DIRK HARTOG'S POST

A report on the site of the 1616 monument site  
at Cape Inscription, Dirk Hartog Island

An analysis of historical evidence of the posts  
erected there

Report - Department of Maritime Archaeology  
Western Australian Maritime Museum, No. 129

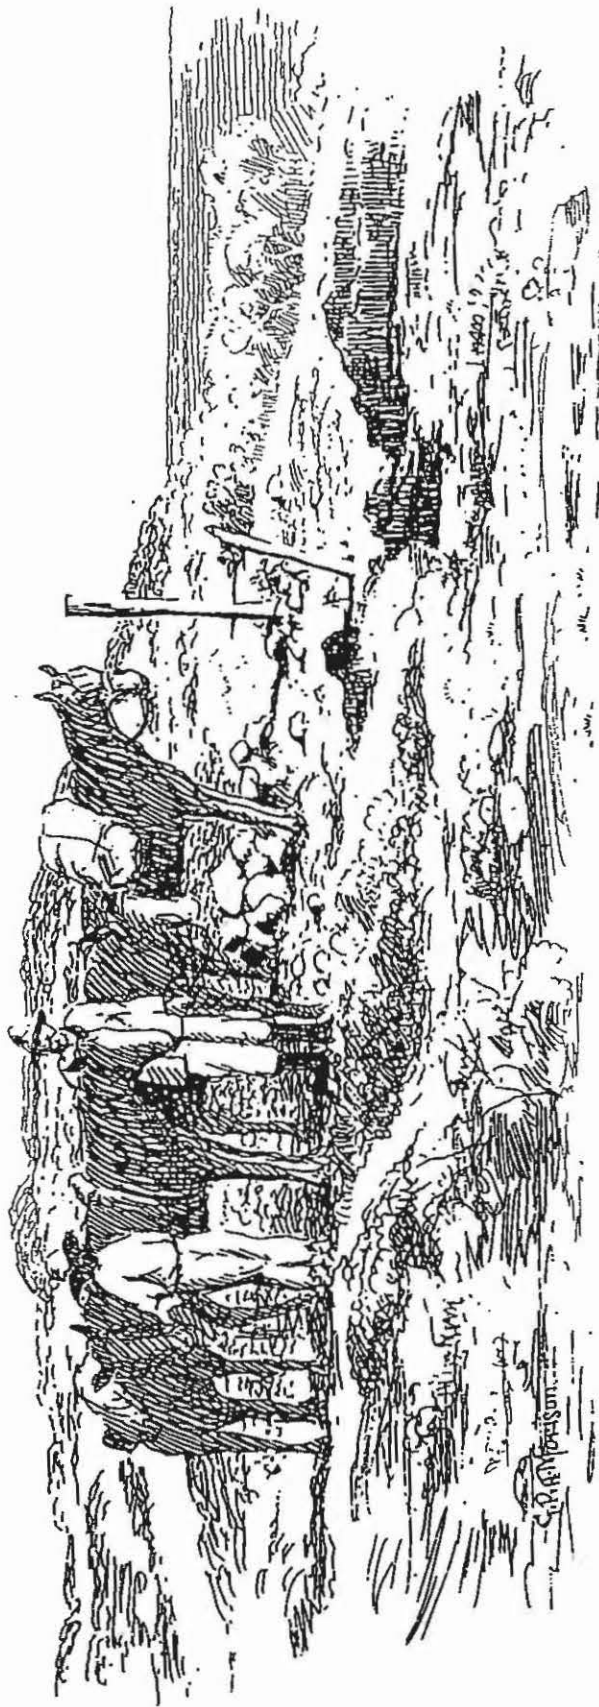
Cape Inscription, Dirk Harlògs Island; showing  
the "Vlaming" posts before removal.  
*Sketched from an illustration in the Western Mail, 1907.*

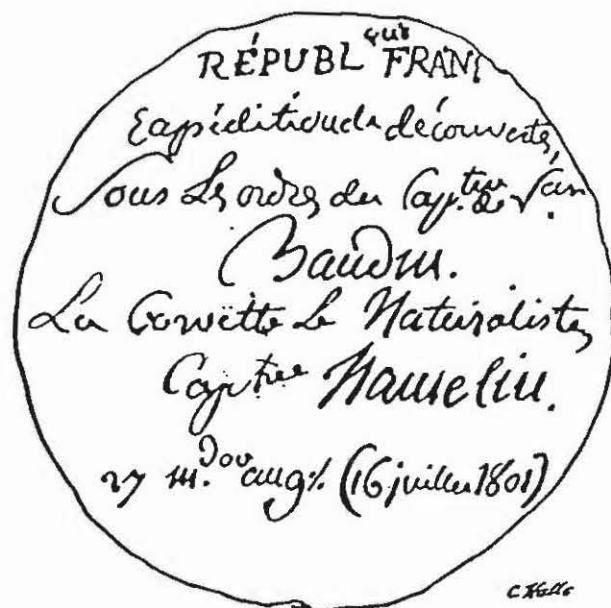
HALLS  
(1974)

*C. Hall*  
HAMELIN'S PLATE. The memorial, in translation, reads:  
"The French Republic  
Expedition of discovery  
under the orders of  
Captain  
Baudin  
The Corvette, the Naturaliste  
Captain Hamelin  
27 Thermidor (Revolutionary Calendar)  
16 July 1801."

There are at least two drawings recording the text of Hamelin's plate and suggesting its relative positioning. Halls (1974) provides a drawing of the plate (see Figure \*\*) but was unable to provide a source. The translation of Levillain's description (by Anne-Marie Caton BL 409A) has already been quoted in a previous section, although it should be noted that the Halls' (1974) translation records 27th Thermidor.
