Sri Lanka 2005—the search for HMAS *Vampire* (1942) and the VOC ship *Dolfijn* (1663)

Jeremy Green and Corioli Souter

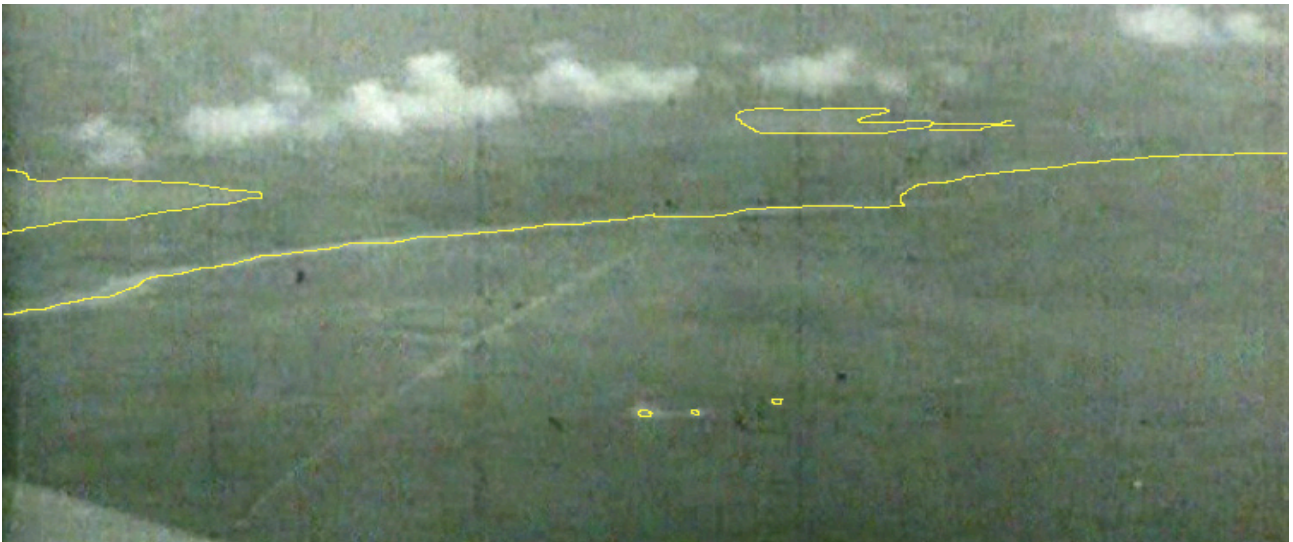
Figure 2. Screen grab from the film *The Most Dangerous Moment* showing *Hermes* and *Vampire* steaming south along coast.

1. The Admiralty chart shows the position of the *Hermes* about 9.5 nautical miles NE of Batticaloa lighthouse, see Figure 1, and the *West Coast of India Pilot* refers to this wreck as ‘...a 11,000 ton aircraft carrier, the position of which in 1966 was noted with numerous fishing boats operating over the site’. The position of the HMS *Hermes* needed to be confirmed in order to plan a search area for HMAS *Vampire*.
2. Film footage from a documentary called *The Most Dangerous Moment* based on the book by Michael Tomlinson, in which shows the Japanese surveillance aircraft during the attack on *Hermes* and *Vampire* Figures 2–5.

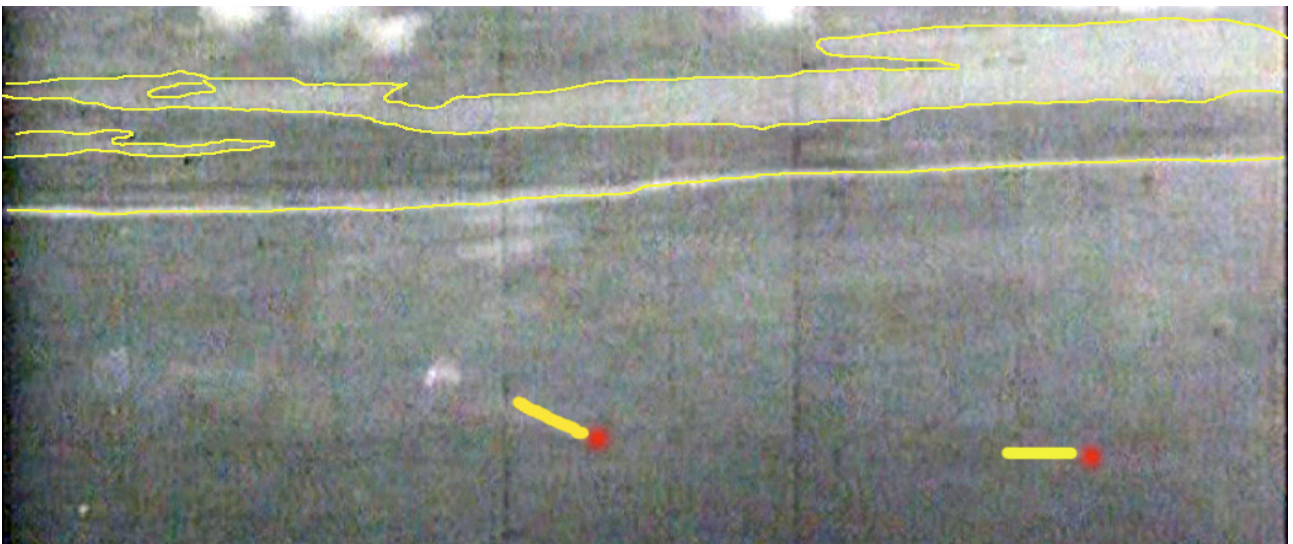
Figure 3. Screen grab from the film *The Most Dangerous Moment* showing *Hermes* and *Vampire* steaming in a roughly north-easterly direction. Note hills and lagoons in background.

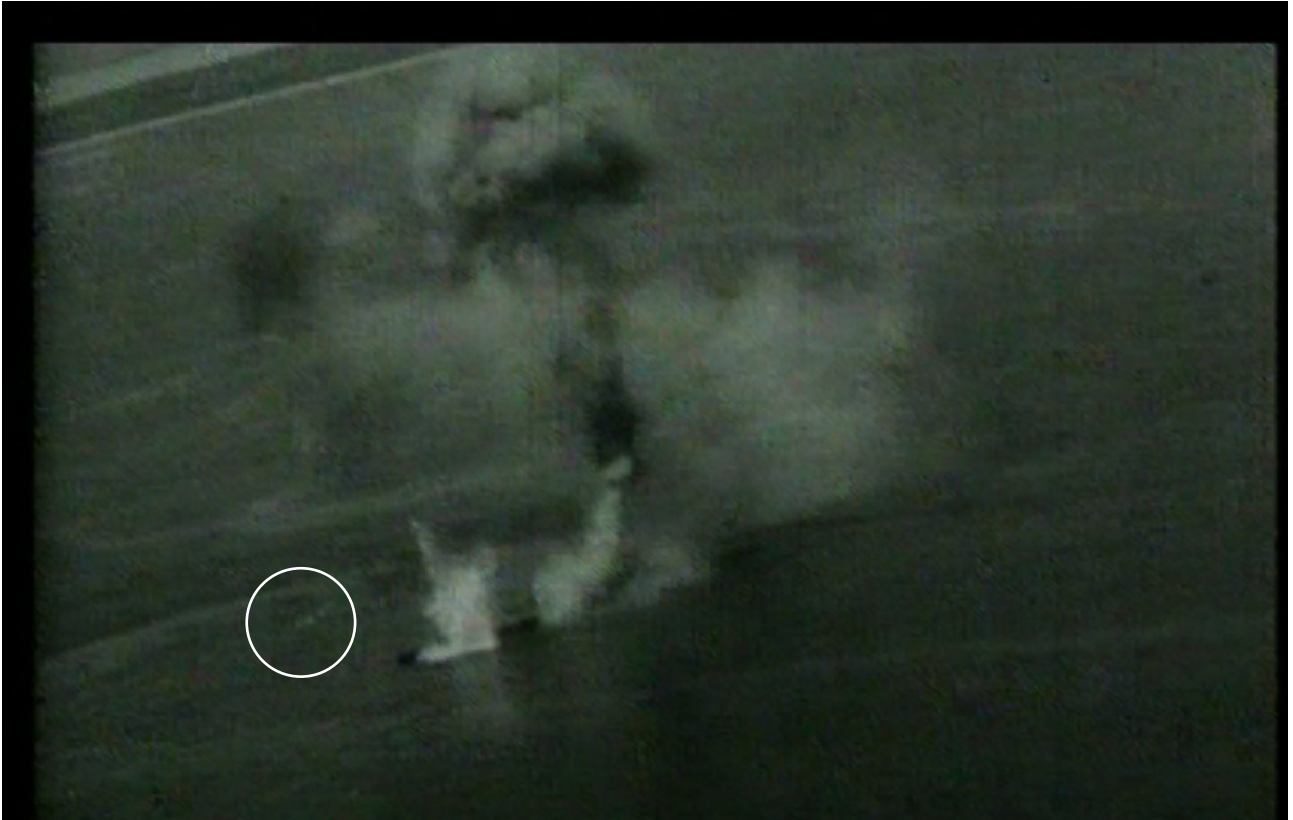
Figure 4. Screen grab from the film *The Most Dangerous Moment* showing *Vampire* under attack, note dive bomber in mid-left of picture.

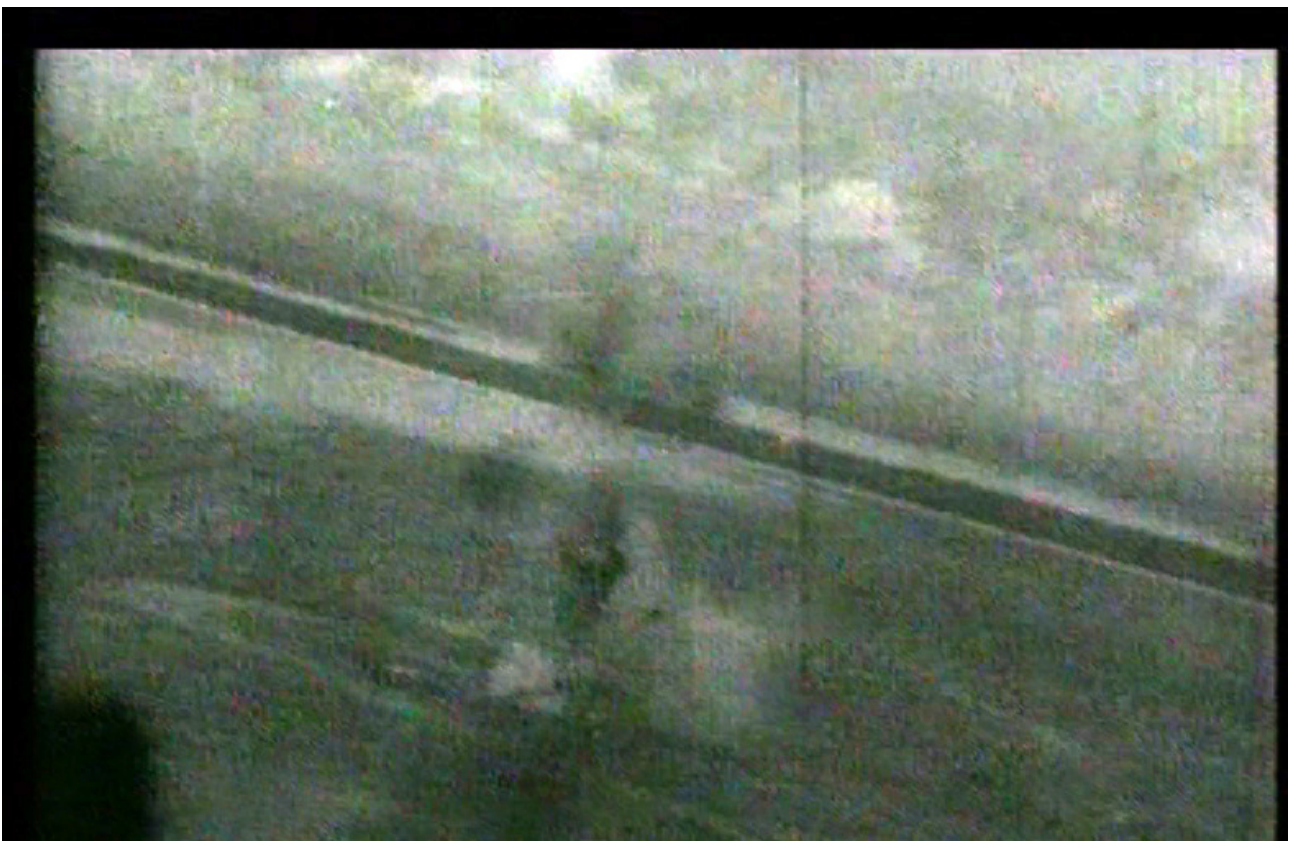
Figure 5. Screen grab from the film *The Most Dangerous Moment* showing final moments of *Vampire*. Note hills and lagoons in background.

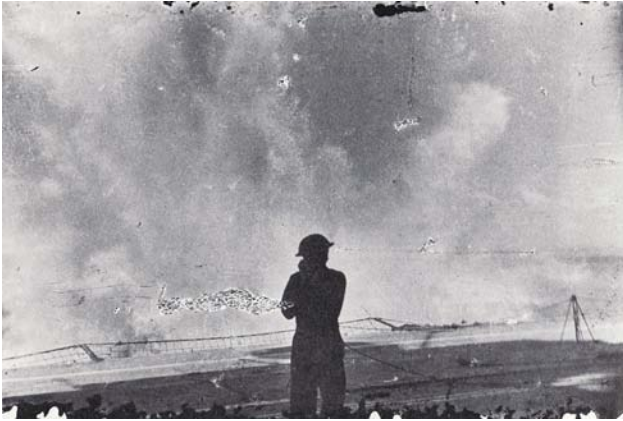
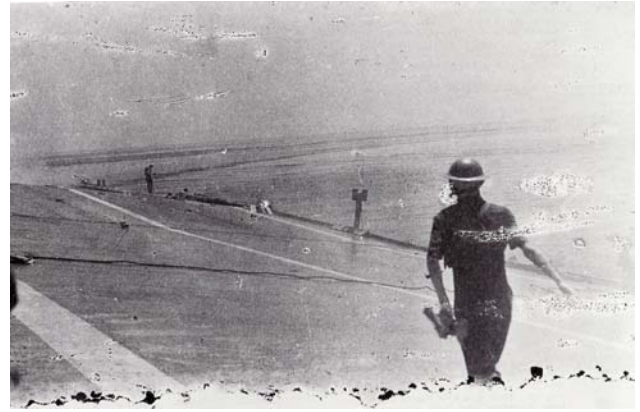
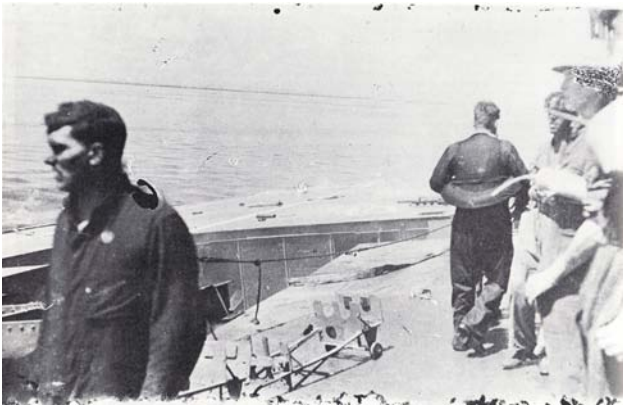
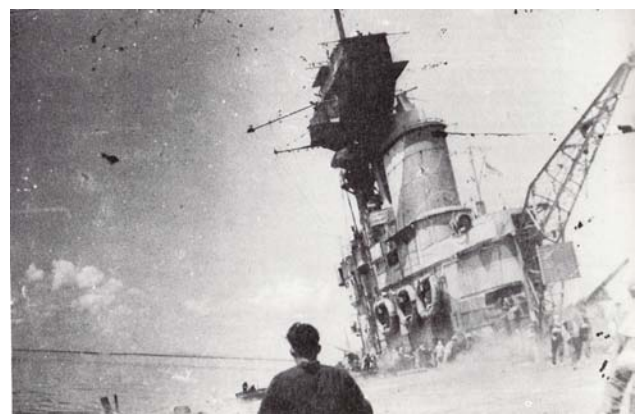
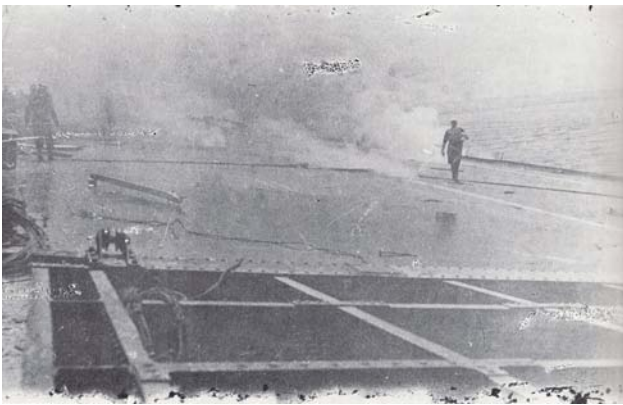
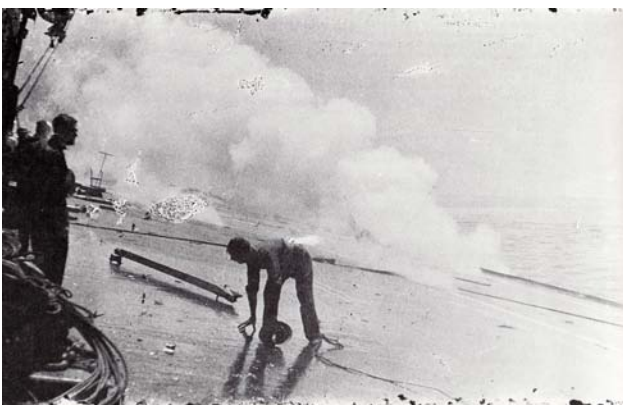
Figure 6. Photographs in *The Hermes Adventure* that were taken by Charles Morgan

3. Written and oral accounts of the survivors describing the relative positions of the two vessels during the attack, particularly the accounts in *The Hermes Adventure* by Rex Morgan.
4. Photographs in *The Hermes Adventure* that were taken by Charles Morgan who was an official photographer on board *Hermes* during the attack., Figure 6.

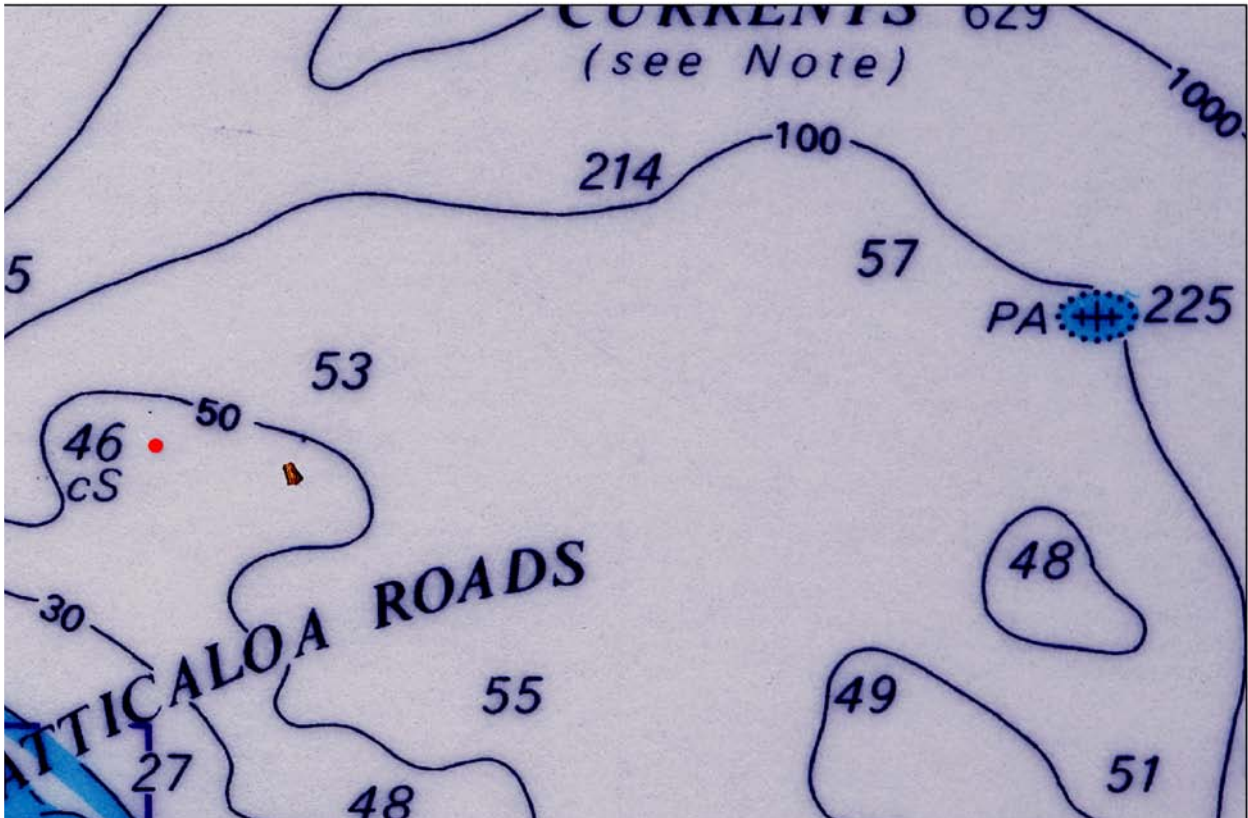
Figure 7. Search area showing deep water trench, false *Hermes* position, Morgan *Hermes* position and true position.

In May 2005, prior to the fieldwork, Corioli Souter travelled to Sydney to interview survivors from HMAS *Vampire*. The interviewees included Mr Lloyd Saltmarsh (Gunner), Mr Bill Price (Gunner) and Mr Vince Cesari (Stoker). All the survivors recollected that the *Vampire* was close to *Hermes* and in visual range (< 2 nautical miles) when it was sunk. They also corroborated the idea that *Vampire* was north of *Hermes* and heading back towards Trincomalee at the time of the raid. An opportunity during this trip was taken to meet with Mr Rex Morgan to discuss his expedition to find the *Hermes* in 1981. Morgan stated that the *Hermes*, by his reckoning, was 5 nautical miles NE of Batticaloa lighthouse, less than half the distance shown on the chart. Thus at the start of the operation we were aware that the *Hermes* was not in the position reported in the *Pilot* and the hydrographic chart No. ?? As it transpired, when the team was taken to the site by a local fisherman, the position (latitude 7.81487°N, longitude 81.732218°E) was slightly different from Morgan's position, see Figure 7.

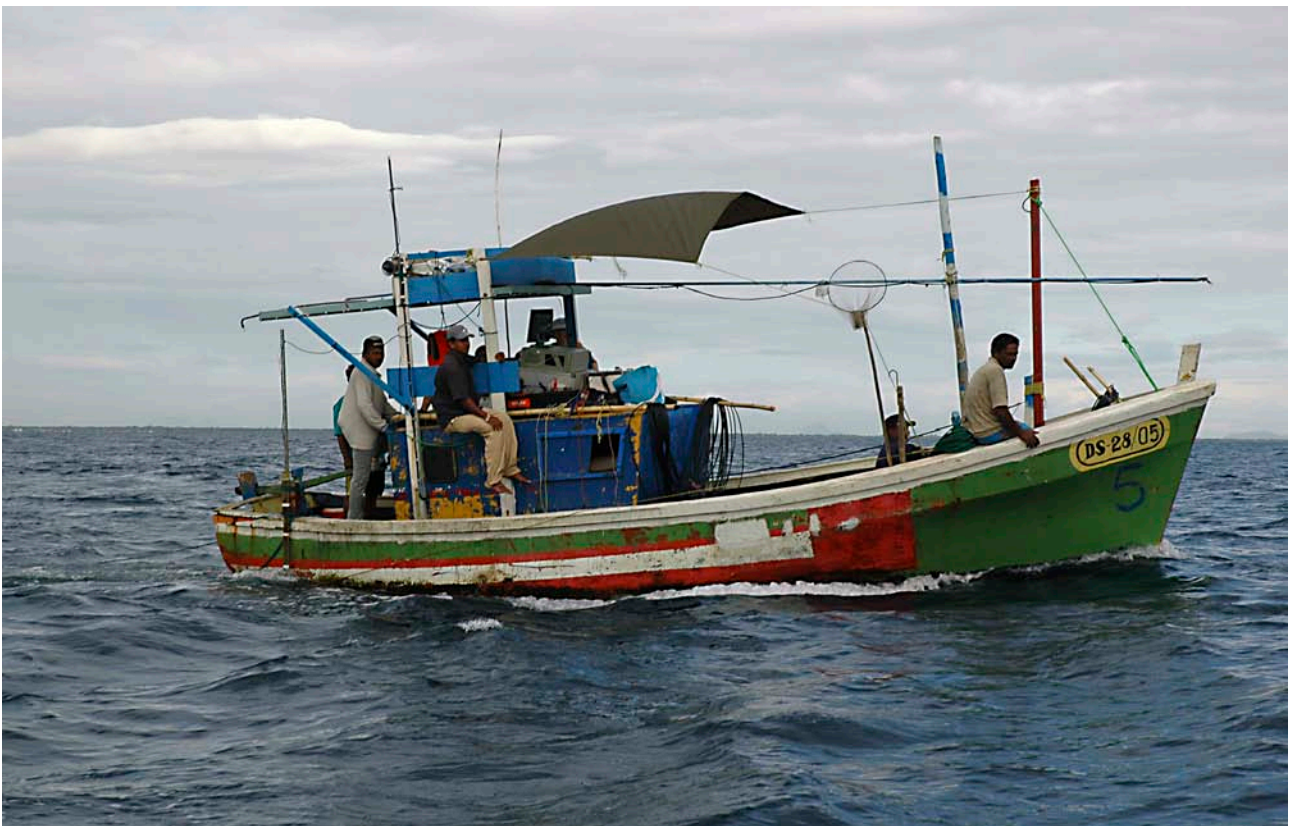
Figure 8. Survey vessel.

The survey was conducted using an ELSEC proton magnetometer and a MarineSonic dual frequency side scan sonar in conjunction with a GPS track plot (Fig. 8). The whole unit was integrated so that the sonar trace and the magnetometer data were recorded on the computer and displayed on the screen. An echo sounder was

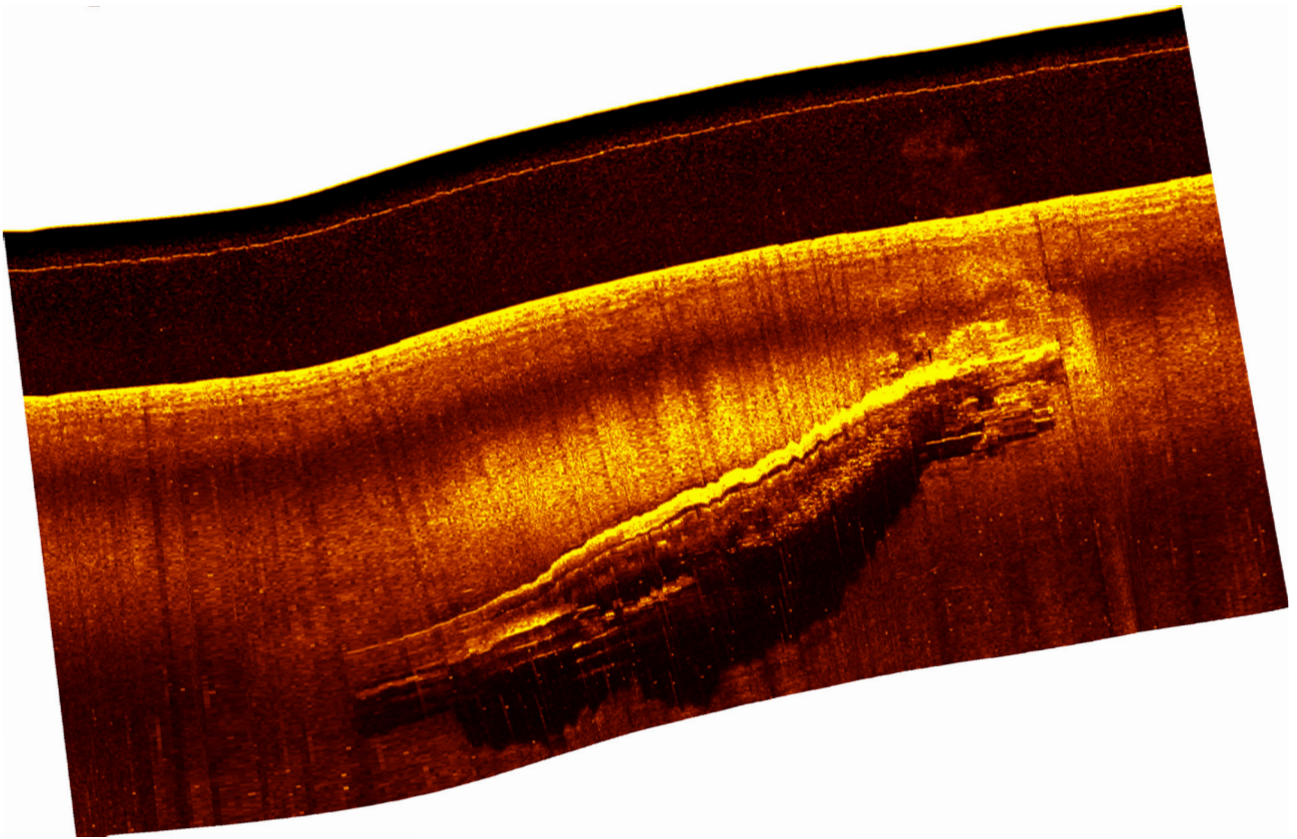
Figure 9. Side scan sonar image of *Hermes*.

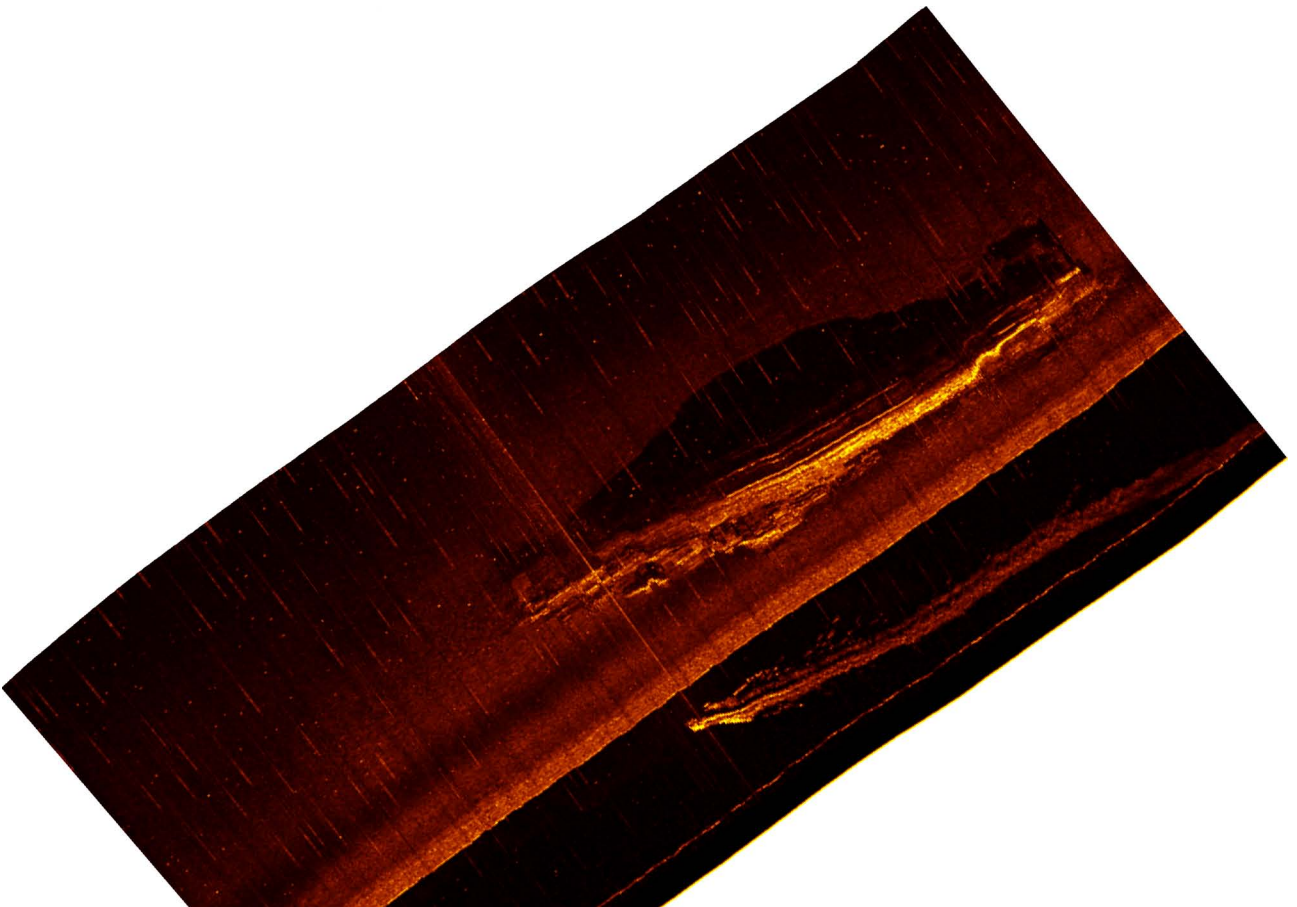
Figure 10. Side scan sonar image of *Hermes*.

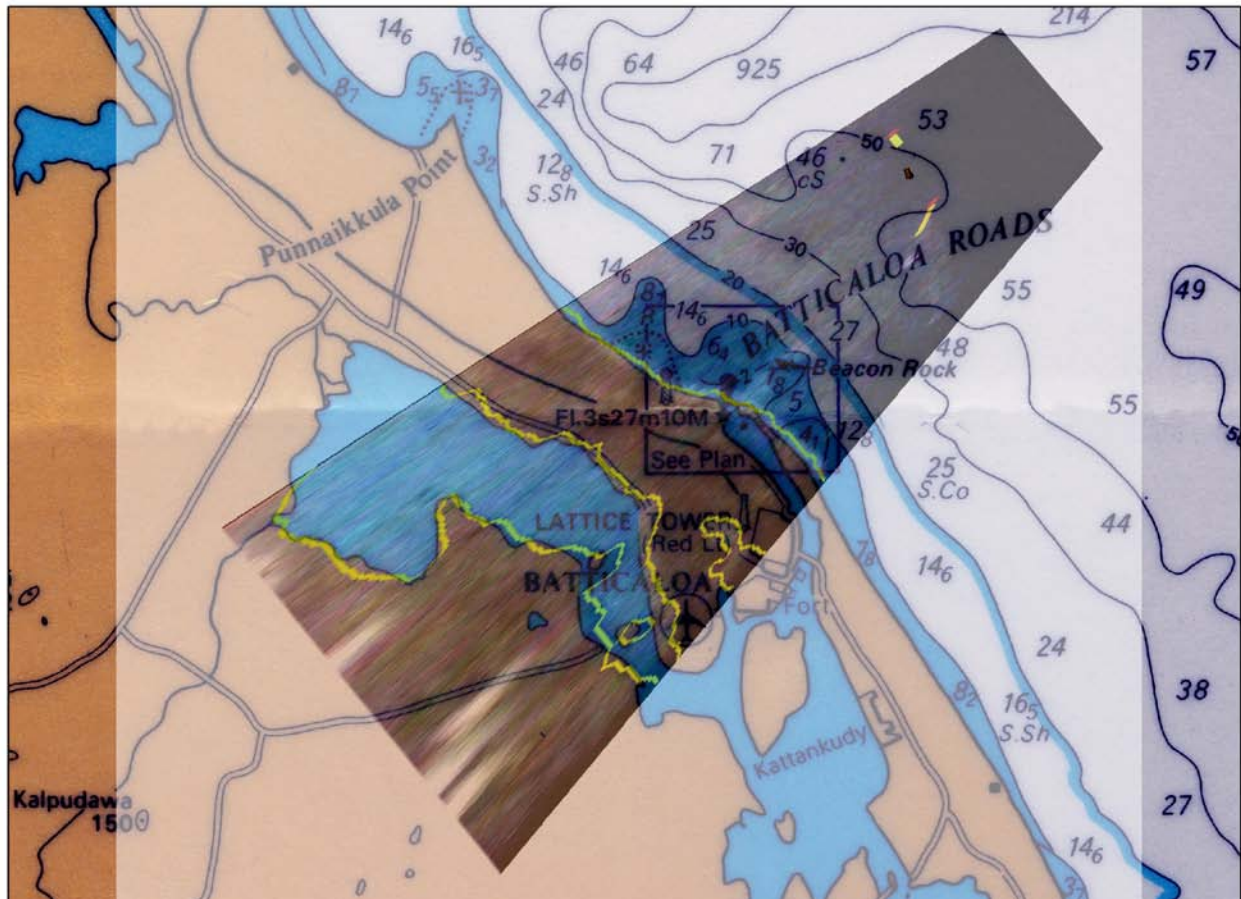
Figure 11. Image from Figure 3 superimposed on the chart of the area after stretching to make features fit the plan.

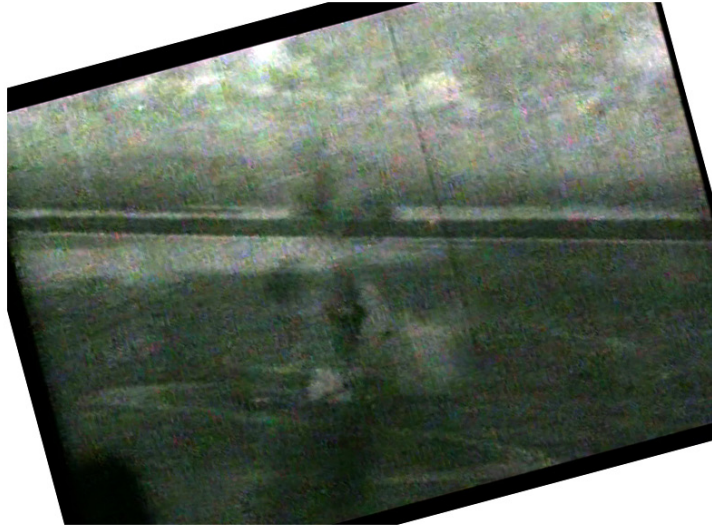
Figure 12. An attempt to make the image from Figure 5 fit chart. Top a coastal outline, middle the clip from the film showing the *Vampire* under attack, not the mountains in the background and the lagoons in foreground. Bottom, plan showing lagoons at Batticaloa.

and the final track is in curving back towards the foreground in the upper part of the 'S' (i.e. heading south). Attempts were made to identify the mountain range in the background, but this proved to be very difficult (Fig. 12). It was thought that the prominent peak that appears in the centre of the photograph, in among the smoke was Friars Hood (654 metres ASL) and that the small bay in the lagoon, slightly left of centre was the headland in the lagoon. Aligning the photograph with the map proved to be very difficult, but it did suggest that, if the mountain was Friars Hood, then the *Vampire* could be located to the north of the deep water trench. This 'northern solution' was investigated and a large area to the north of the trench was surveyed (see Fig. 13). The only substantial anomaly in this region appears to have been derived from a geomagnetic source possibly a magnetic high associated with magnetite.

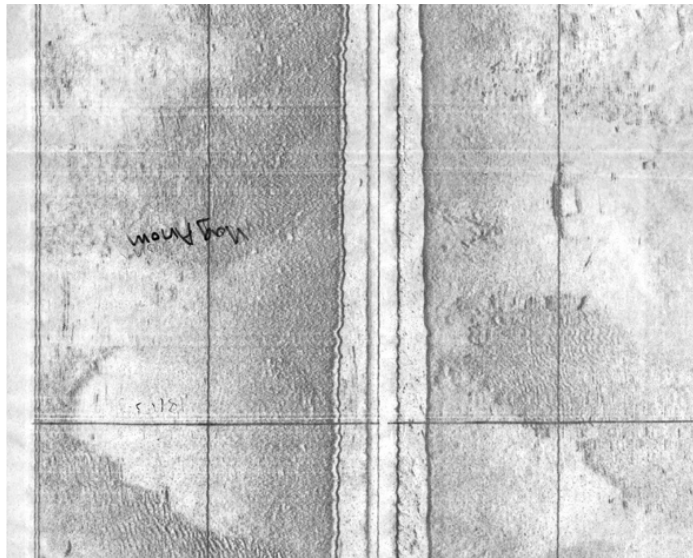
Figure 18. The 1997 sonar traces

After earlier attempts in 1993 to survey the area SE of the city, side scan sonar and magnetometer surveys were carried out in 1996 and 1997 (Fig. 17). A few sonar targets were found (Fig. 18 and 19), but at the time it was decided to delay the inspection to avoid the danger of looting.

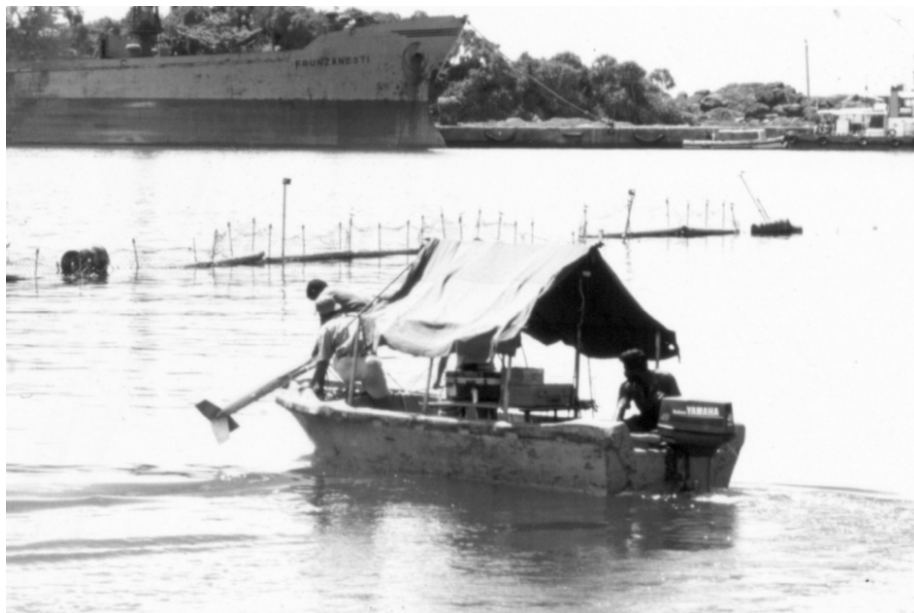
Figure 19. The 1997 survey boat.

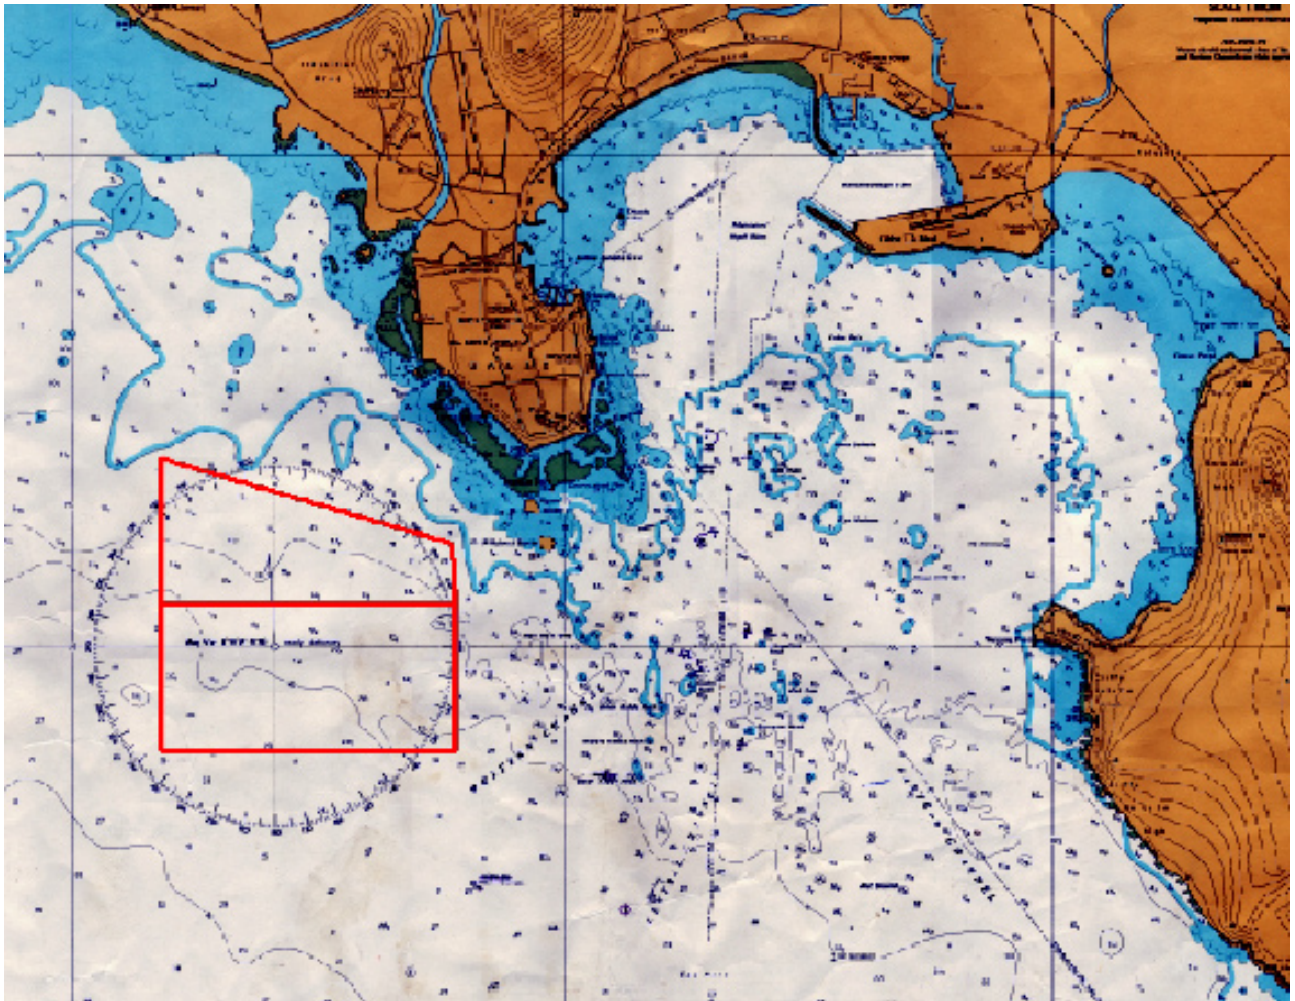
Figure 20. The 2005 proposed search area.

[As part of the *Vampire* project] we will have a sophisticated side scan sonar, magnetometer and fathometer. From the survey in 1997, we know the approximate search area. I propose that we survey a 2 square kilometre area SW of the lighthouse where the *Dolfijn* is thought to have sunk. As we know that the top of the masts were showing, so the depth is known and the search area is quite easy to define. We would complete a full three part survey (side scan, magnetometer and fathometer). This should not take more than two days provided the equipment is working, that there are not strong geo-magnetic anomalies in the area and that the site is visible above the sea bed. We would then do an assessment dive on the site to record what is there, make a preliminary plan of the site and recover any sensitive material. In regard to the latter, we are aware that the conservation facilities of the MAU are already committed to remedial work on the *Avondster* site, so any recovery would be confined to essential items. I would then like, with the help of the Prospero Team, to set up a video surveillance system to monitor the site on a 24 hour basis. I think we can get a quite cheap infra-red video camera that could be mounted on a high building from where the site can be seen and the image shown on a screen somewhere. The ideal situation may be the MAU building, if you can see the site from there. During the non-working hours, the camera could take time lapse images and record them on a VCR. So at night or at the weekend the camera would take a single frame say every half hour. When the team comes back to work, they can flick through 24 images to see if there was anyone diving on the site. This would work at night too. It may alternatively be better to involve the Navy or the

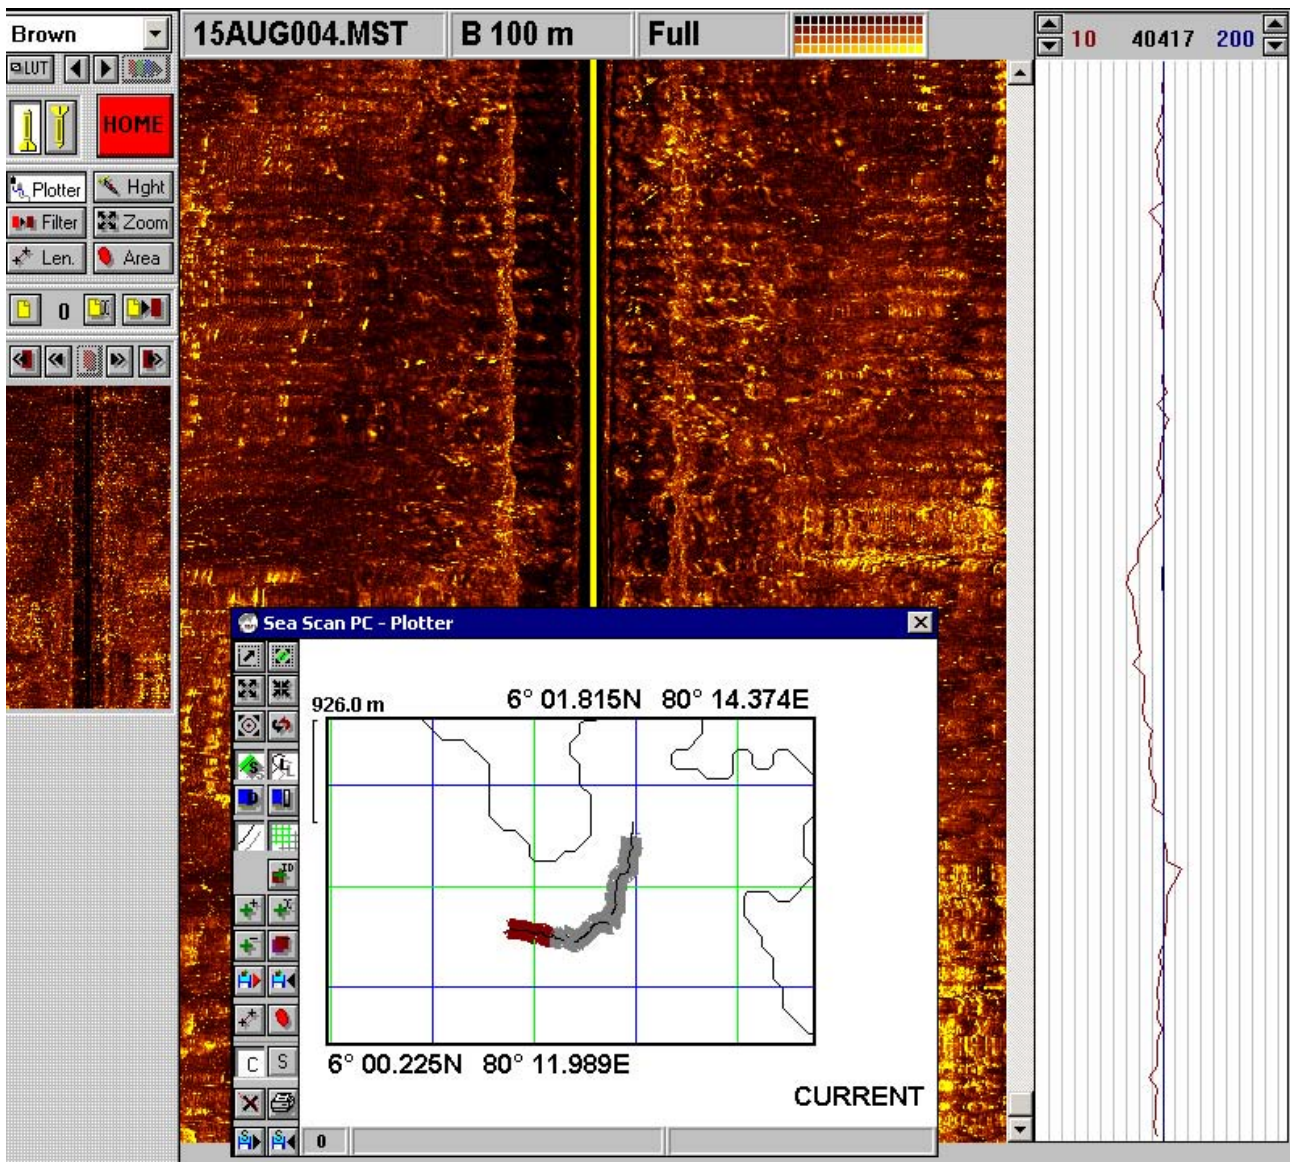
Figure 22. Typical sonar record showing the sonar trace (centre), the magnetometer trace (right) and the navigation screen (centre). Sonar trace shows typical surface noise from sea conditions.

As it transpired, our arrival in Galle on 30 July 2005 coincided with the middle of the SW Monsoons (fig. 24). Survey conditions were unsuitable for the side scan sonar because the surface disturbance of wind-borne waves causes interference on the side scan trace (Fig. 22). This is a design fault of this particular dual frequency fish, as the transducers are set vertical, rather than slightly depressed. As a result, the sonar tends to pick up the image of the surface as well as the sea bed. Ideally, the sea state should be absolutely flat calm, so that there is no surface interference, alternatively, the fish can be angled at about 10° from the vertical, and the system run on one channel only so as to avoid the surface interference. The magnetometer was run continuously during the survey, however only very minor anomalies were noted. Assuming that the *Dolfijn* had some salvage work done following its loss, one would expect that the iron cannon and anchors would have been left in place. The fact that both iron cannon and anchors were found on the *Avondster* site in the inner harbour in a few metres of water suggests that these items were not considered worth salvaging. Since the *Dolfijn* was a medium sized vessel, one would probably expect about fourteen iron cannon and probably at least four iron anchors. One would expect to be easily able to detect a group of iron cannon at about 30 m (Green, 2004), so that the indication is that the *Dolfijn* is not in the search area (Figs 20 & 21). However, in view of the difficulties operating the survey vessel in the rough seas, it is possible that the survey could have missed the site. The conditions were really quite unsuitable for a survey to find a historical shipwreck in this sort of area.

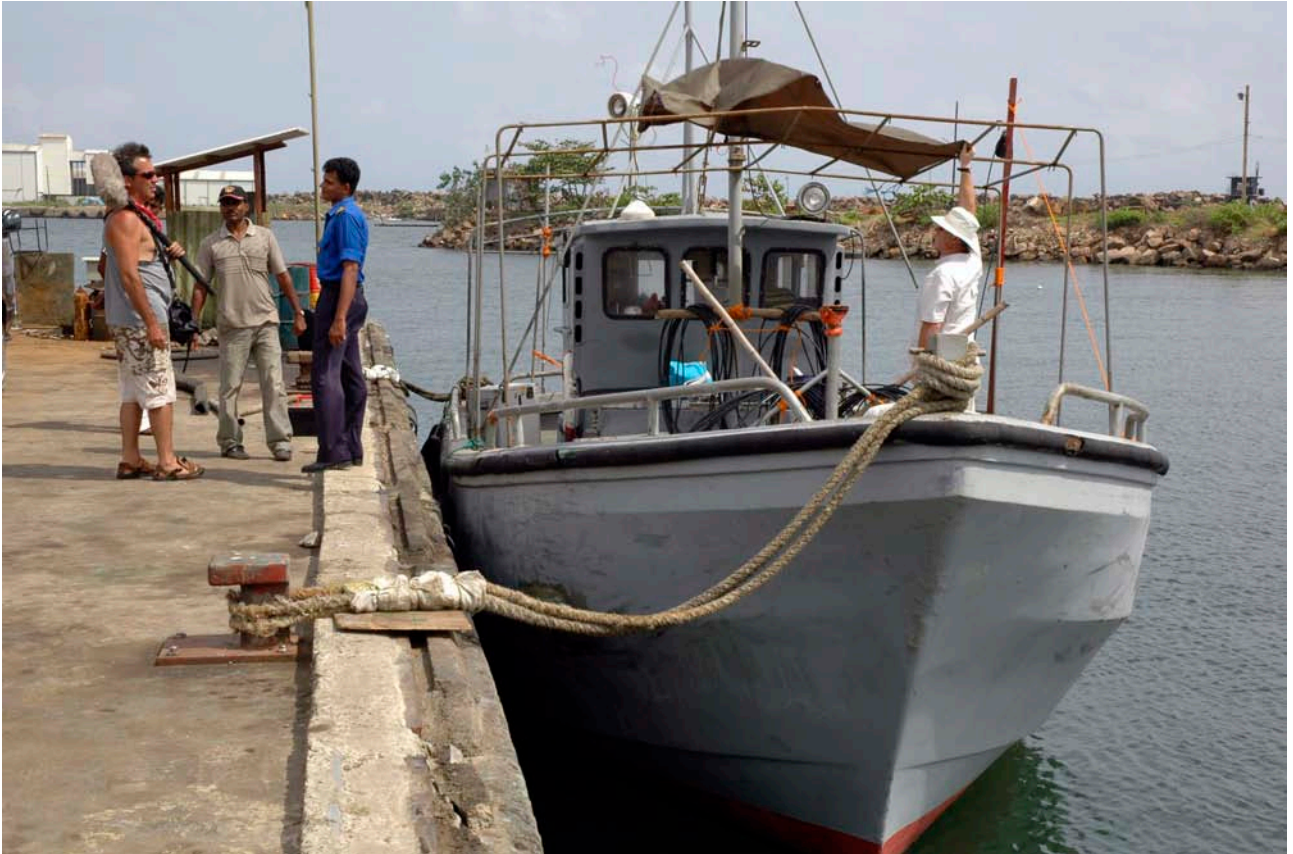
Figure 23. The Sri Lankan Navy vessel used for the Galle survey.

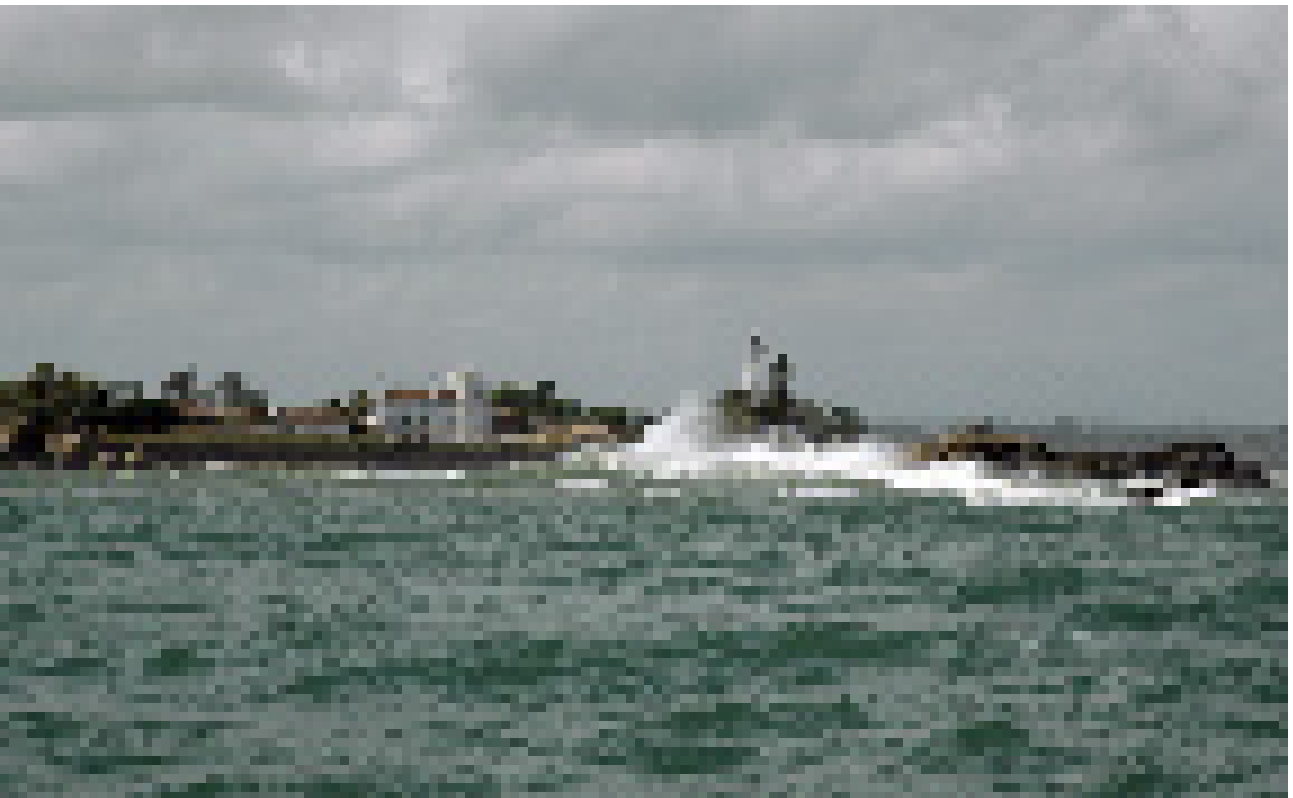
Figure 24. View from the survey vessel showing Galle Lighthouse and the Mosque and the typical sea conditions off Point de Galle.

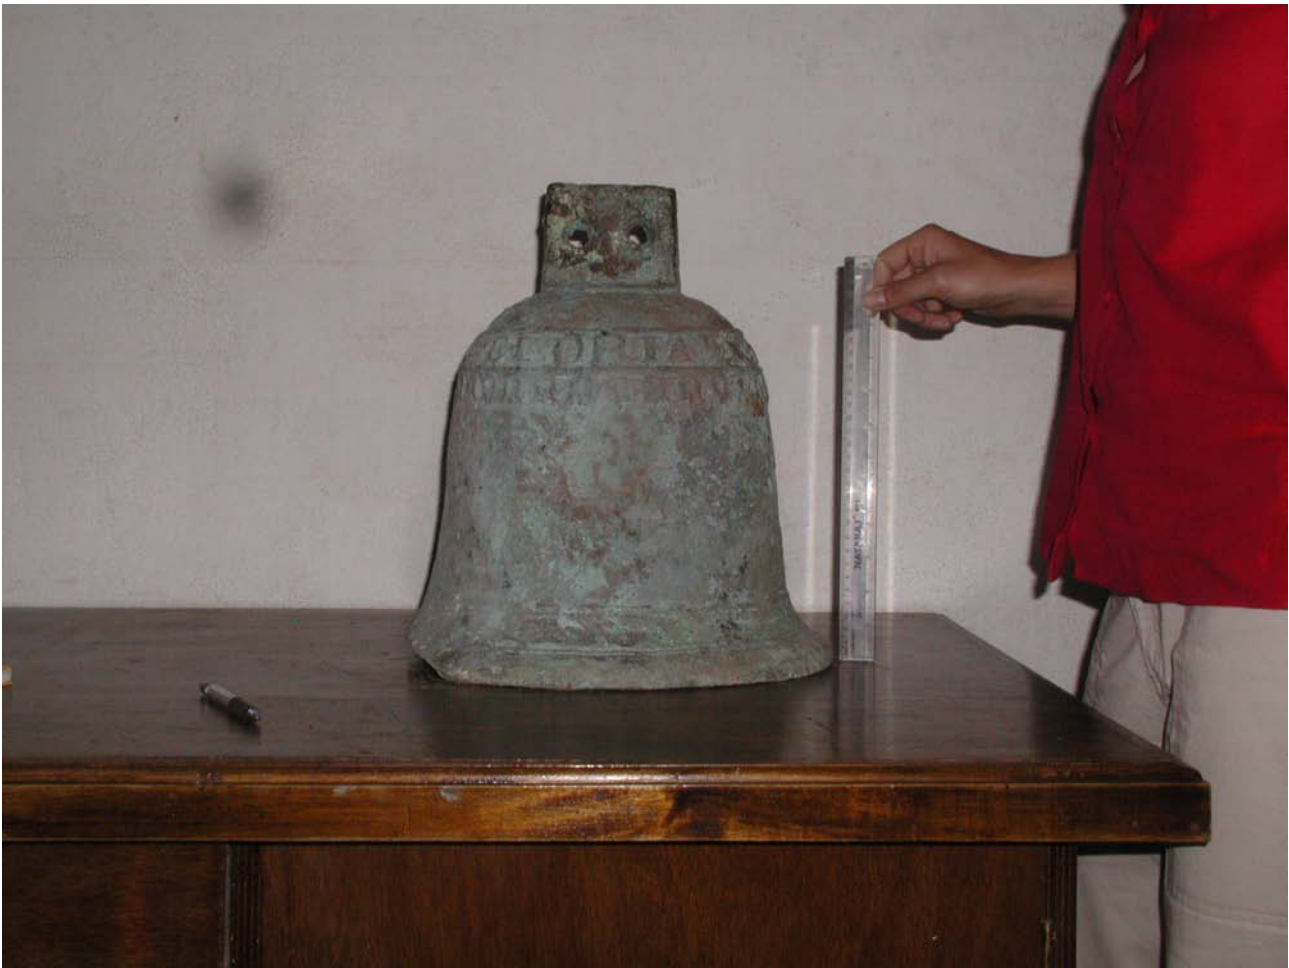
Figure 27. The bell from the Great Basses wreck site.

During one of our filming episodes for the *Shipwreck Detectives*, a visit was made to a local diving shop in Hikkadua, a few kilometres north west of Galle. The proprietor showed us a bronze bell that he had recovered from the Great Basses wreck site. The bell (Fig. 26) was 365 mm high with a mouth diameter of 357 mm. The bell was abraded on one side with a section where the metal had completely disappeared leaving a hole. There was an inscription around upper section of the bell with the letters ...O GLORIA ANNO 1... It is assumed that the Latin inscription was SOLI DEO GLORIA, it is so irritating that the year has been obliterated as this would have given some form of conformation of the dating of the site. We know that the coins from the site are Mogul and date 1113 (Arabic) or 1702 AD. There is much evidence that the vessel was European, possibly, but not necessarily Dutch. The report is given here for general interest and to supplement the information already published on the subject (Clark, 1974; Green & Devendra, 1993b).
