# THE “BARREL WRECK”: A PRELIMINARY ASSESSMENT OF ITS HULL REMAINS

By Wendy van Duivenvoorde

# **The Barrel Wreck: A Preliminary Assessment of its Hull Remains**

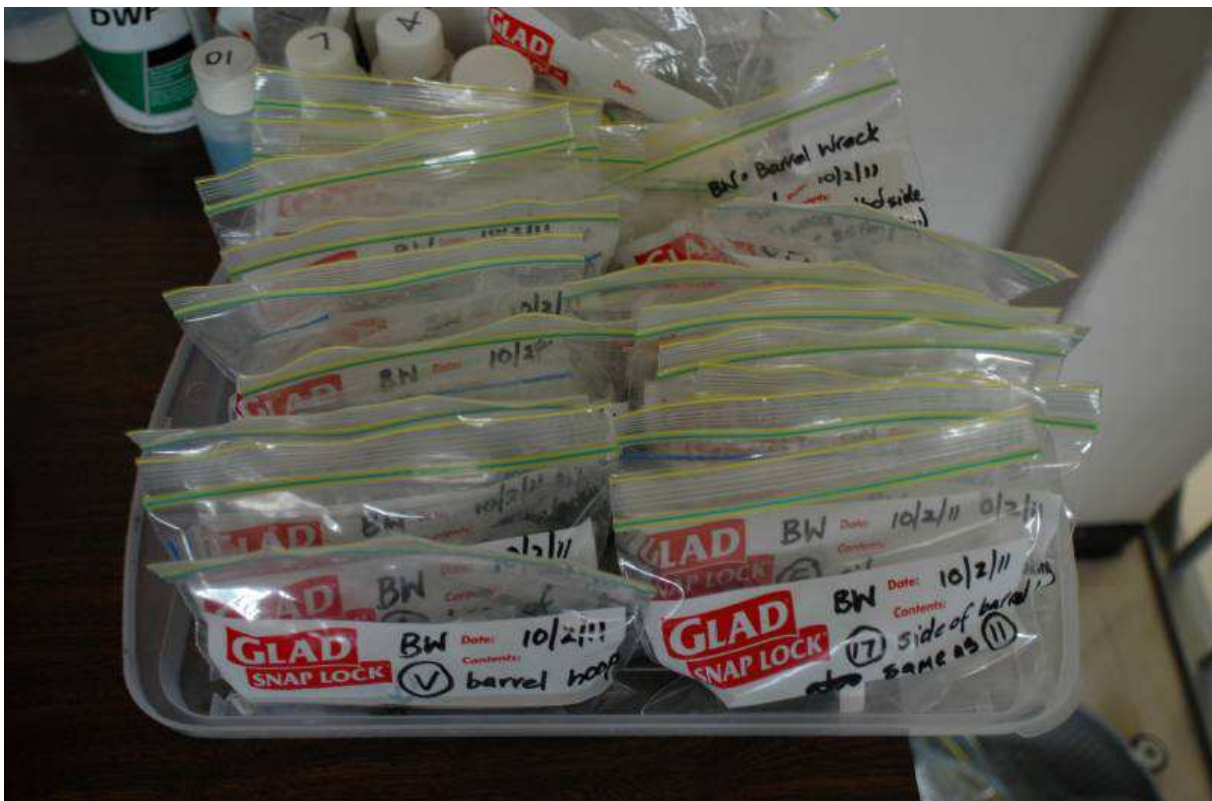
Fig. 1 Wood, resinous substance, and hair samples taken from the Barrel Wreck.  
Photograph: Jon Carpenter.

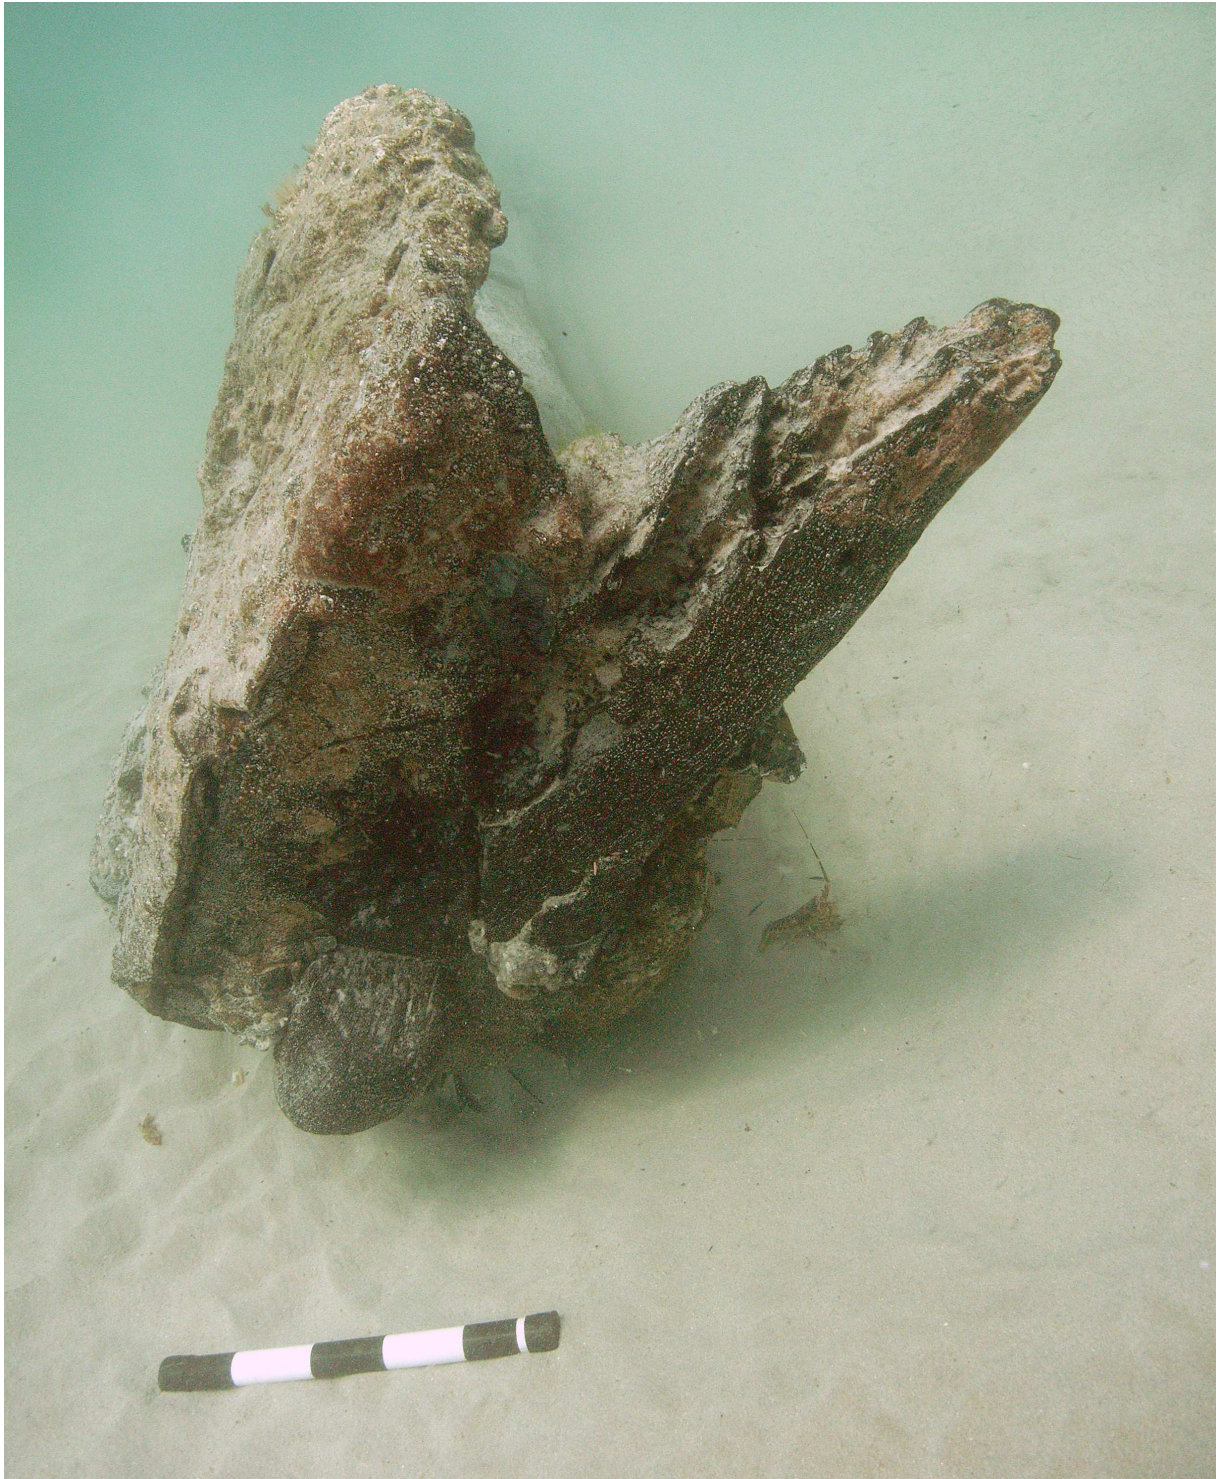
Fig. 7 Lead sheathing at aftermost end of the sternpost, Barrel Wreck. Photograph: Jon Carpenter.

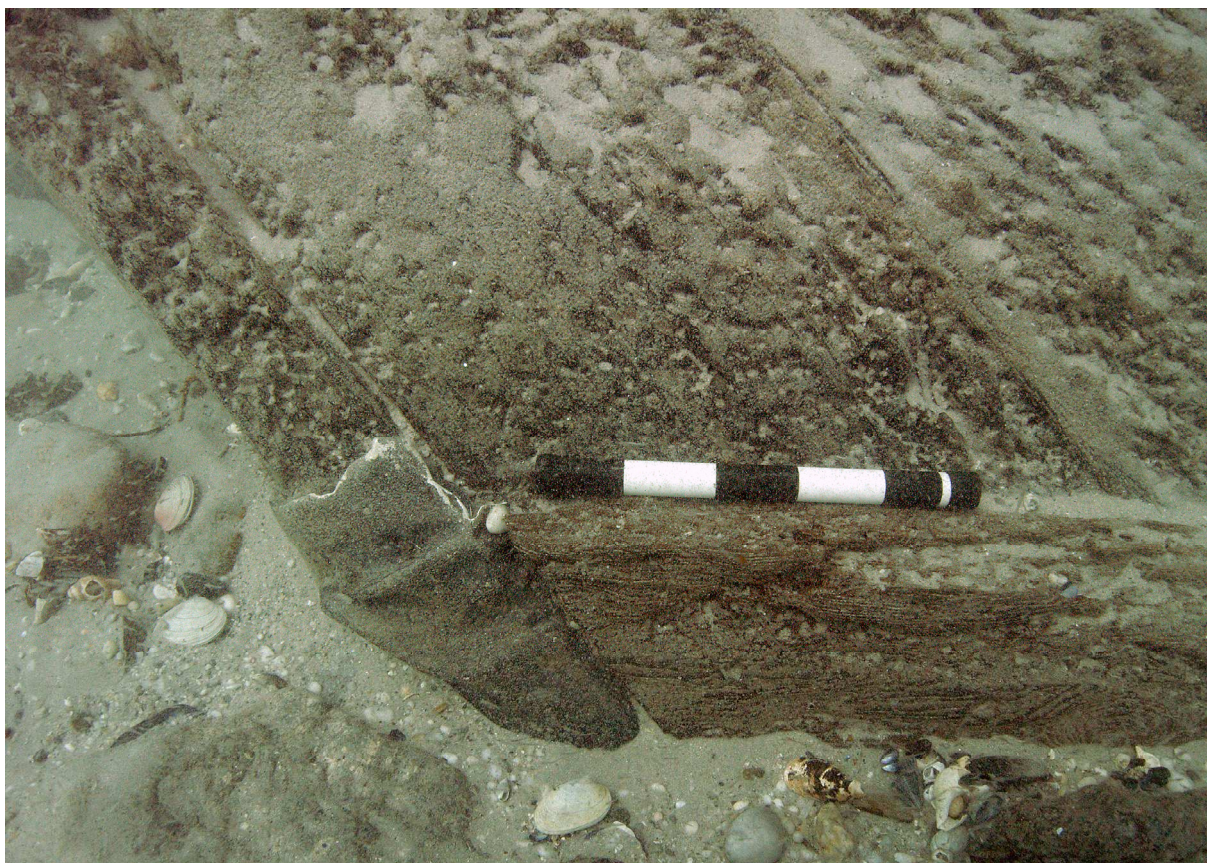
Fig. 8 Lead sheathing on the stem, Barrel Wreck. Photograph: Jon Carpenter.

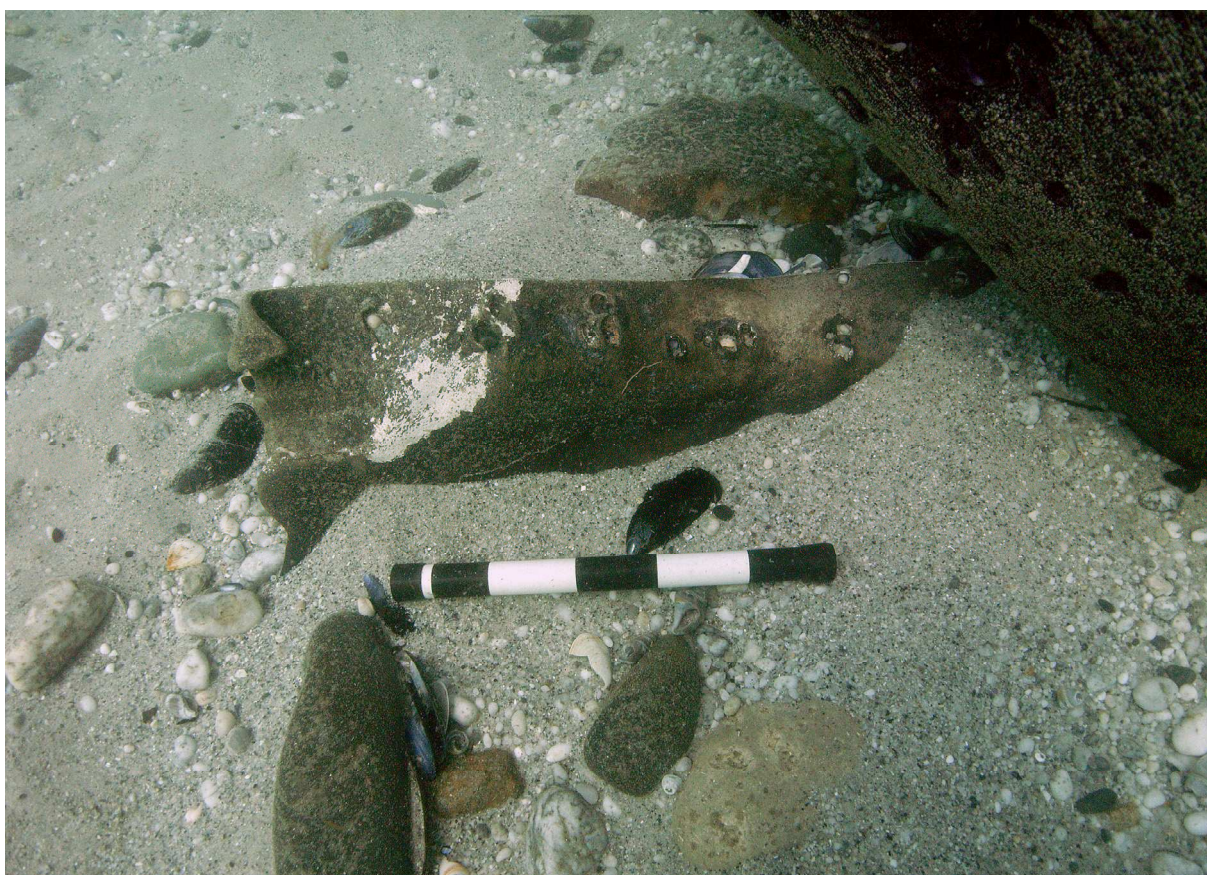
Fig. 9 Metal sheathing detached from the ship's hull, Barrel Wreck. Photograph: Jon Carpenter.

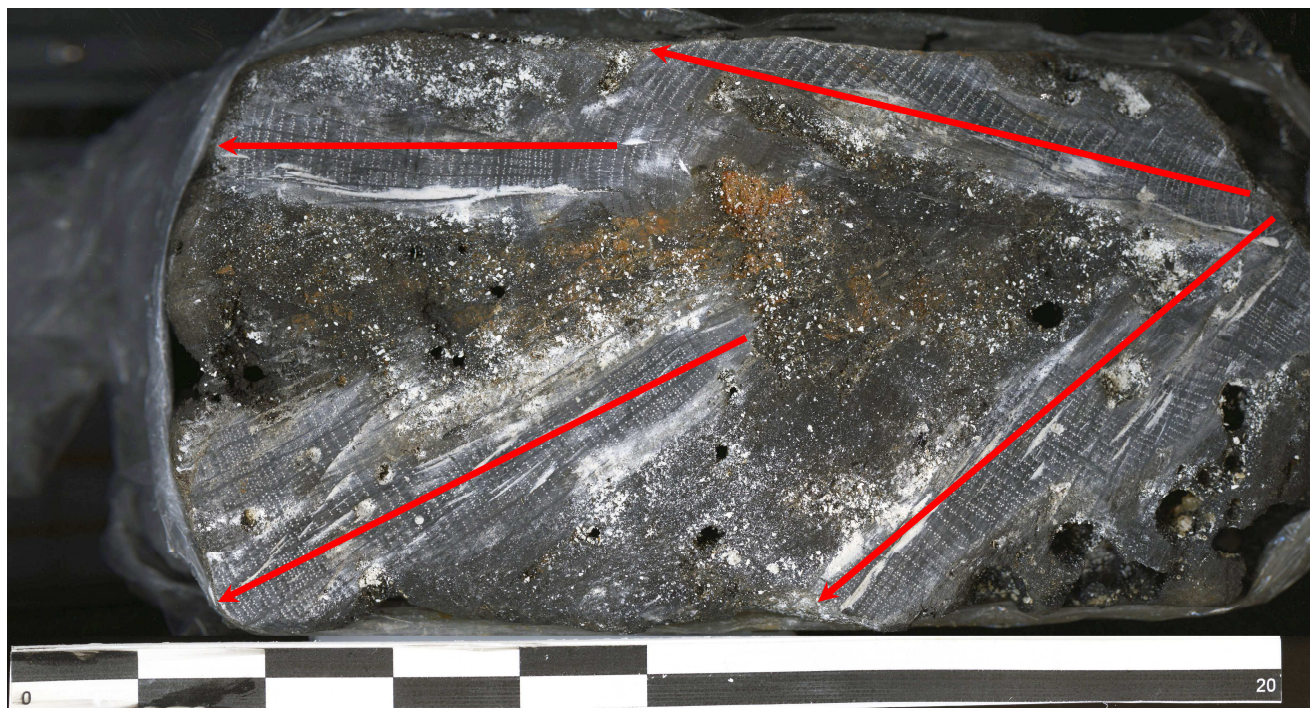
After cleaning several rays in the transversal surface of the sample (from the pith to the outermost visible ring as indicated in Figure 1, Appendix 1), we obtained a continuous tree-ring series containing 130 rings. The comparison of this tree-ring series with the master chronologies of oak available at the Ring Foundation (see <http://www.noaa.nl/content/hst03/h3.1.4.2.htm#143>) resulted in the absolute dating of the sample, with the most recent ring dating in AD 1742 (see Table 1 in Appendix 2, and Figure 2 in Appendix 3).

**Figure 1.** Transversal surface of the sample, showing the cleaned areas where the ring-widths have been measured. The red arrows point at the direction of the measurements, from the inner to the outer rings.
