WA
SHIPWRECKS
MUSEUM

DOLPHIN 60 AND COCKBURN SOUND'S WORLD WAR II ANTI- SUBMARINE BOOM NET - Site Inspection Report

June 2024

Compiled by Arabella McLeay, Aurora
Philpin and Ross Anderson
Department of Maritime Heritage
Report No. 352

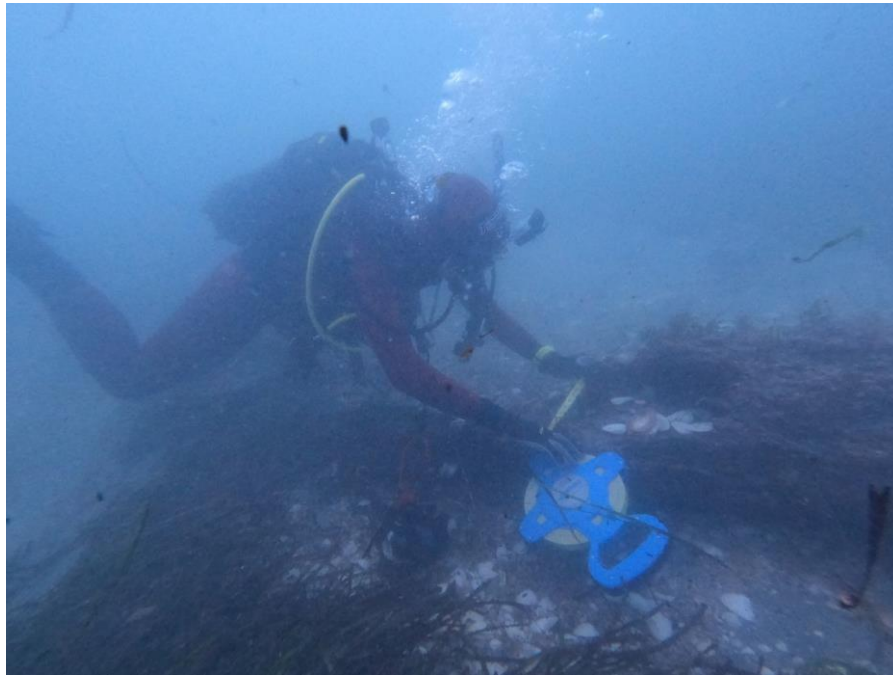
The exposed timber structure is significantly compromised, with evidence of further decay due to marine organisms. The jarrah timbers, once upright, now lie scattered on the sea floor. The observed presence of *Teredo Navalis* suggests ongoing biological degradation, which is impacting the structural integrity of the remaining timbers.

Figure 4: Diver (Aurora Philpin) measures Jarrah Timbers Diameter (Arabella McLeay / WA Museum)

Jarrah seafloor timbers measurements identified during the dive		
Pylon	Length	Diameter/Thickness
1	7.73m	27 - 34cm
2	6.62m	37cm
3	1.39m	26cm
4	9.50m	40cm
5	8.51m	45cm
6	10.73m	45cm

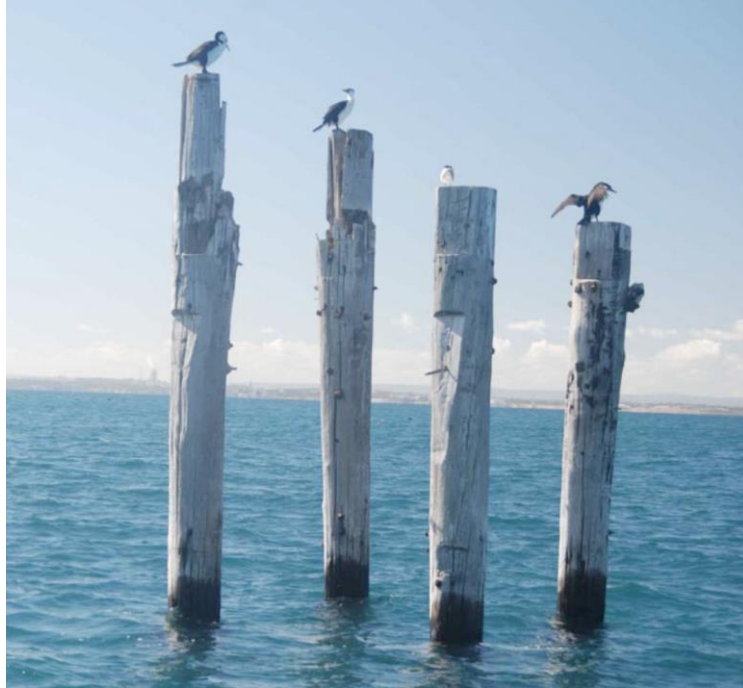
Figure 5: Timber pile structure off Garden Island since identified as Dolphin No. 60 in April 2007 after loss of timber platform bracing in a storm in 2006, view looking southeast. (Patrick Baker / WA Museum)

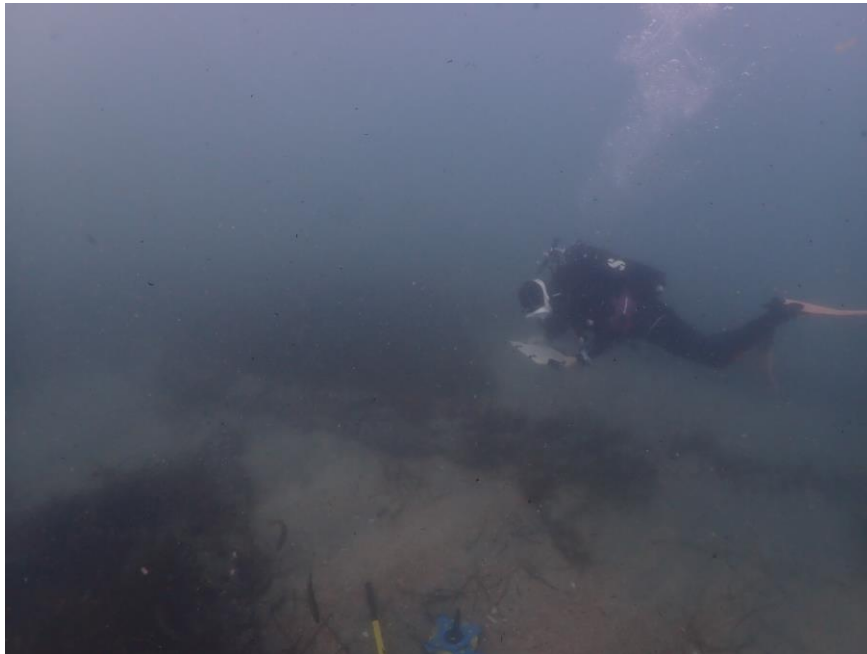
Figure 6: Diver (Arabella McLeay) measuring Dolphin No.60 timber pile structure (Aurora Philpin / WA Museum)

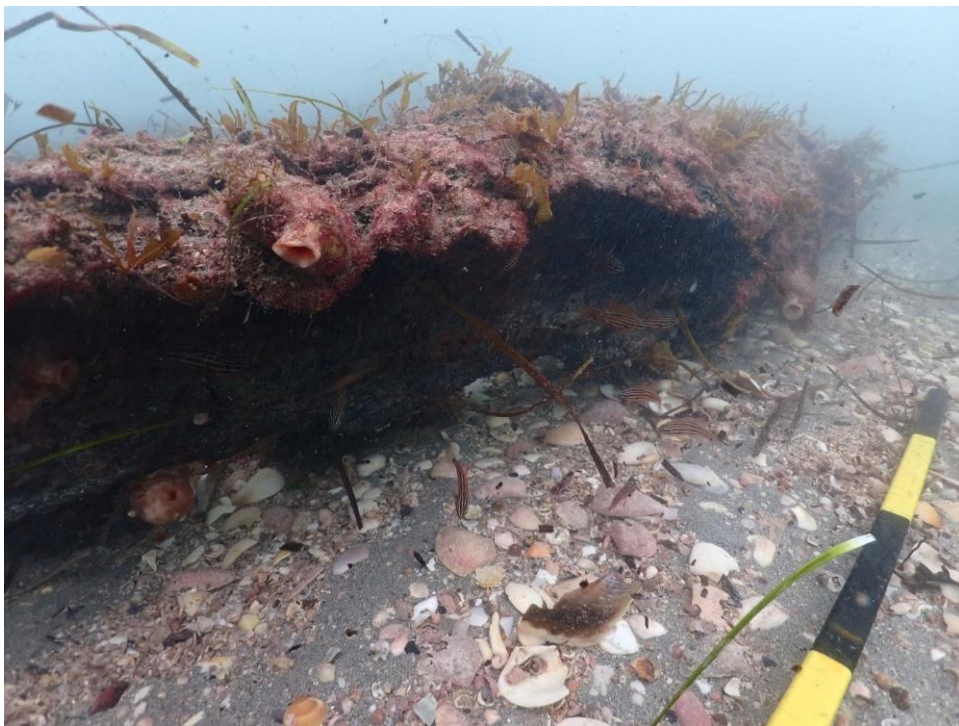
The timbers are heavily encrusted with marine growth, obscuring some details of the structure but also indicating its ecological role in the marine environment. The growth patterns were assessed to understand the potential for archaeological recovery and conservation interventions. The surrounding marine habitat of Dolphin 60 is characterized by extensive seagrass beds, which play a crucial role in supporting local marine biodiversity. These seagrass meadows provide nursery grounds for juvenile fish and act as natural filters, improving water quality and stabilizing sediment. During the inspection, the habitats were assessed, noting signs of resilience amidst environmental stressors. There is the presence of damaging organisms such as *Teredo Navalis*. Additionally, shifting sediment dynamics resulting from stronger currents and storm events may lead to increased scouring of the site. A comprehensive understanding of these climatic impacts is essential for developing effective conservation strategies that address both the archaeological and ecological dimensions of the site.

Figure 7: Marine growth on jarrah timbers (Arabella McLeay / WA Museum)

- Leave the site with minimal intervention rather than demolition and/or removal and monitor it over the long-term. Continue detailed photographic and video surveys to create a comprehensive record of the site's current condition. This will assist in future comparisons and highlight trends in degradation or preservation.
- Underwater interpretation could be provided along the section of the boom mesh net at Woodman Point and promoted as an underwater cultural heritage dive site to inform the local diving community of the significance of the site.

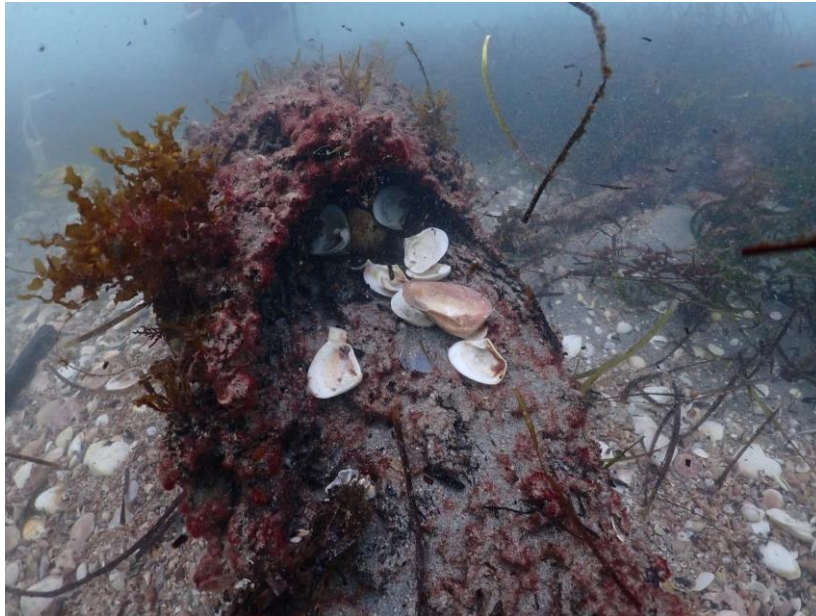
The debris scattered around Dolphin 60 includes fragmented timbers and sections of netting, suggesting a broader site of historical importance. Documentation through photographic surveys will facilitate comparisons with previous records from 2010, revealing changes in the site over the past years.

Figure 8: Marine growth on jarrah timbers along with surrounding debris (Arabella McLeay / WA Museum)

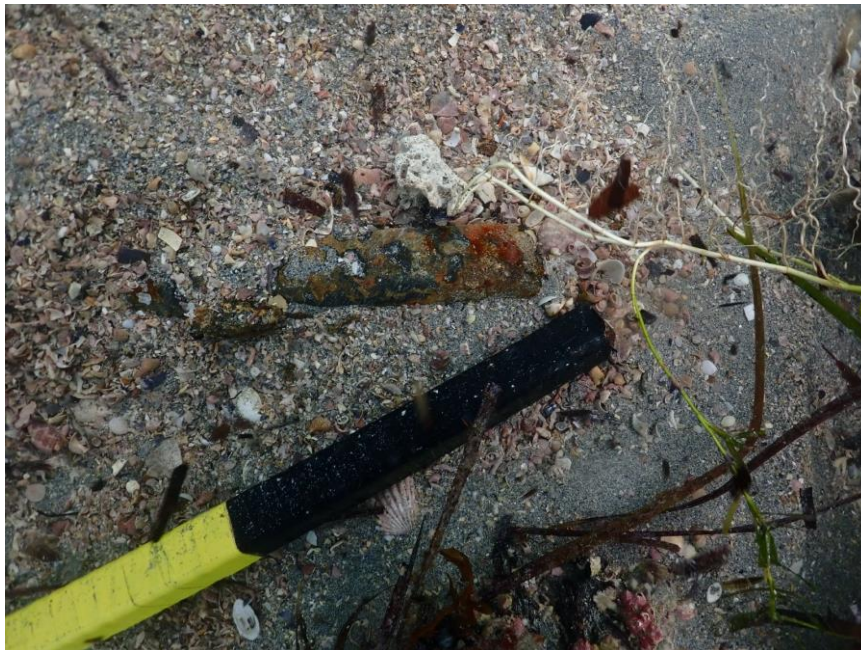
Figure 9: Surrounding Debris within Dolphin 60 radius (Aurora Philpin / WA Museum)
