Site Inspection Report

**Dyoondalup/ Point Walter Stone Barge
Dearden's flat (1882)**

**Report No. 340 — Western Australian Museum, Department of Maritime
Heritage**

February 2024

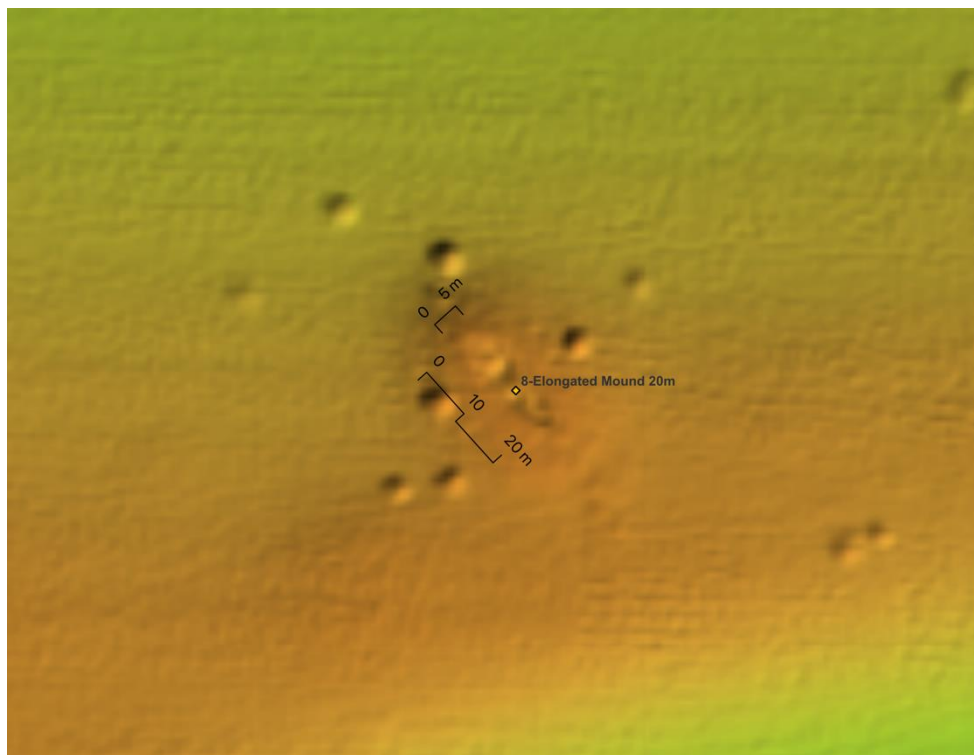
The site is located at a depth of 14 m on a flat seabed, in the deepest part of the main river channel at the eastern end of the narrow strait between Point Resolution on the north side, and Point Walter on the south side. Further east the waterway opens up into the wide expanse of Doontanboro/ Melville Water. The seabed consists of fine, easily disturbed silt. Diving on the site is difficult with typical bad visibility due to the silty bottom and suspended sediment, with visibility on this inspection ranging between nil to 1 m. Department of Transport multibeam echo sounder (MBES) data shows a number of impact and scour holes surrounding the wreck, likely caused by vessel anchoring (

Figure 2). However, no lost/ trapped anchors or chain were observed on the wreck on this inspection.

Figure 2. Point Walter stone barge wreck site environment as shown via the Department of Transport multibeam data. The wreck is in 14 m deep channel. It shows a raised oval mound surrounded by a scoured depression, and scattered scour/impact holes (Patrick Morrison 2024).

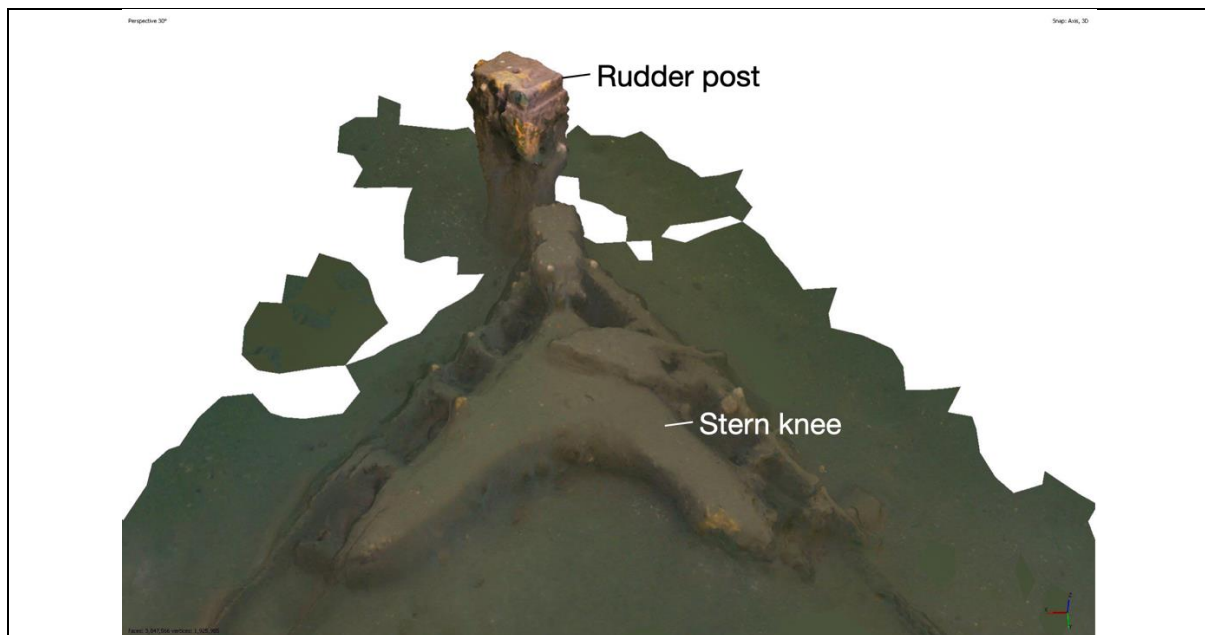
The stern area has some remaining intact hull structure including frames and planking, stern knee, and rudder post inclined to starboard at an angle of about 20° to the stern post (Figure 3).

Figure 3. Detail of 3D model of stern area showing stern knee and rudder post (Patrick Morrison and David Jackson 2023).

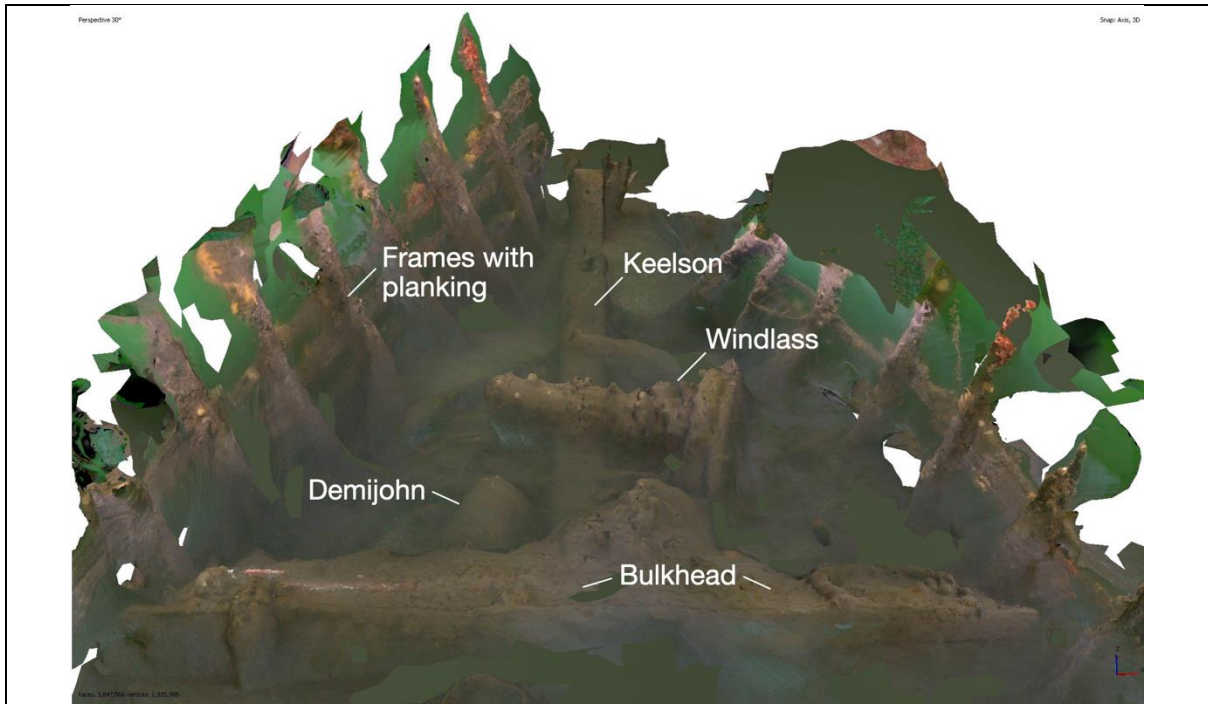
The bow area has has remains of hull frames with planking attached, although the stempost has broken and collapsed outward of the hull structure. It may have been damaged by the wrecking impact, or more likely impacted by subsequent fishing and anchoring activities over the site. The bow area also contains the remains of a windlass with pawls evident. A hard, concreted mass of pebbles that spans across the breadth of the hull appears most likely to have been permanent, cemented

ballast against a timber bulkhead. The keelson is also exposed in this area. One portable artefact was observed namely the ceramic demijohn. (Figure 4, Figure 5).

Figure 4. Detail of 3D model of bow area of wreck showing intact standing frames with attached planking, windlass, demijohn, keelson and cemented pebble ballast forming a bulkhead (Patrick Morrison and David Jackson 2023).

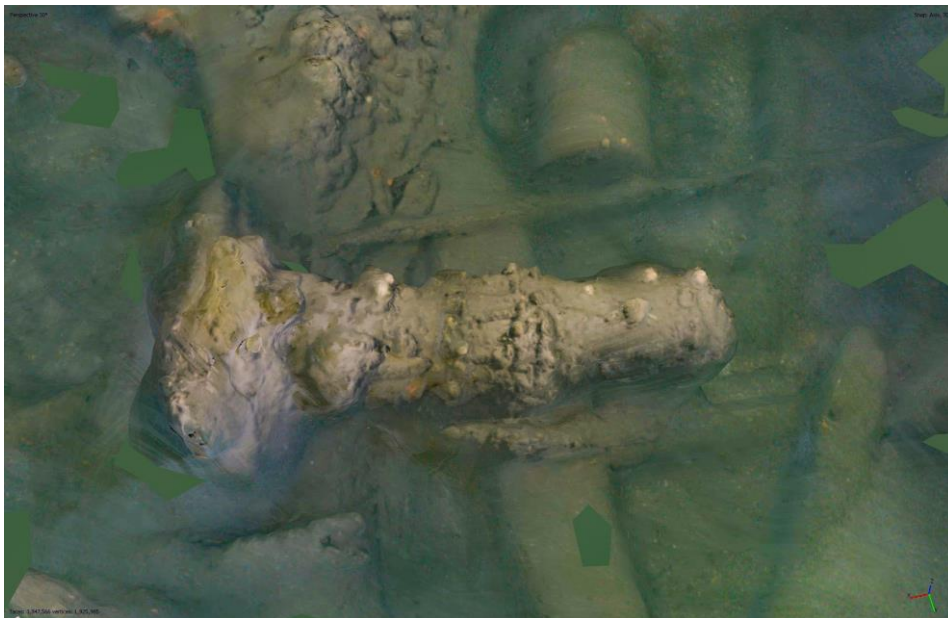
Figure 5. Detail of 3D model of windlass in bow area. Note pawls visible in centre of cylindrical part (Patrick Morrison and David Jackson 2023).

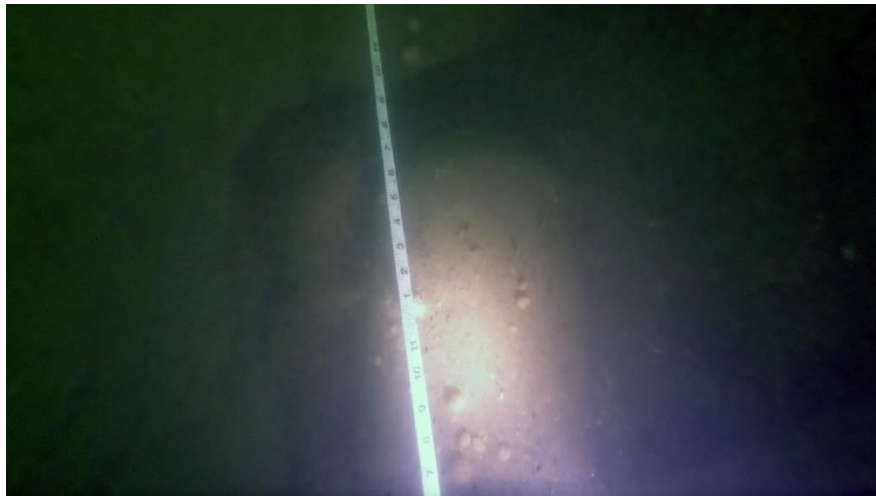
A large ceramic demijohn (registration number PWB6771) was raised to assist with dating the site, and for safekeeping. The demijohn was located lying on its side in the bow area of the wreck (Figure 6). It did not have any form of lid or closure attached, or evident nearby. On being raised and cleaned an owner's mark on the lip became visible 'J. & W. Bateman/ Wine and Spirit Merchants, Fremantle/ 5 [gallons]' (Figure 7, Figure 8). No manufacturer's mark is visible on the body of the demijohn, although one may possibly exist and be obscured by attached marine shells. The demijohn was most likely reused by the crew to contain drinking water. Following the recovery of the demijohn from the wreck site, it was taken to the WA Museum's Department of Materials Conservation Laboratory at the WA Shipwrecks Museum for conservation treatment (Figure 9).

Figure 6. Demijohn in-situ on the stone barge wreck site (Aurora Philpin, WA Museum 2023).

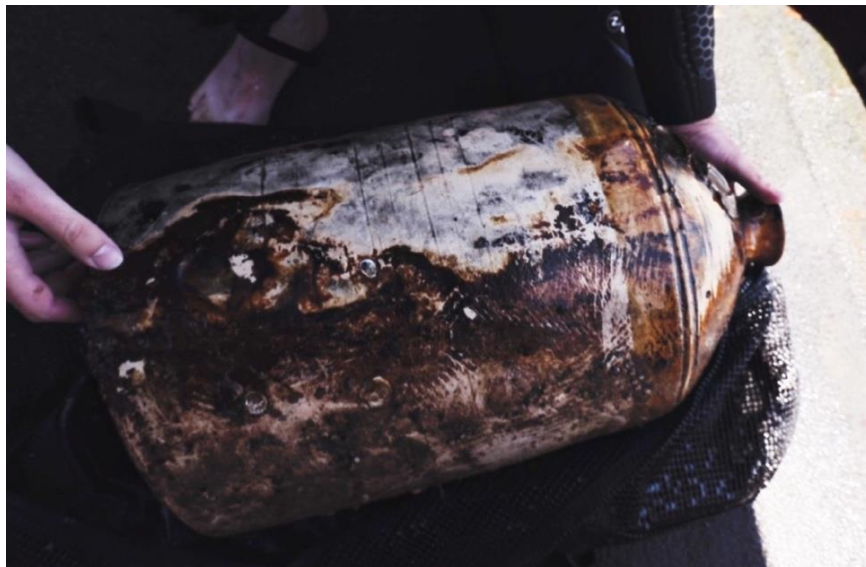
Figure 7. Demijohn following recovery from the wreck site (Ian McCann 2023).

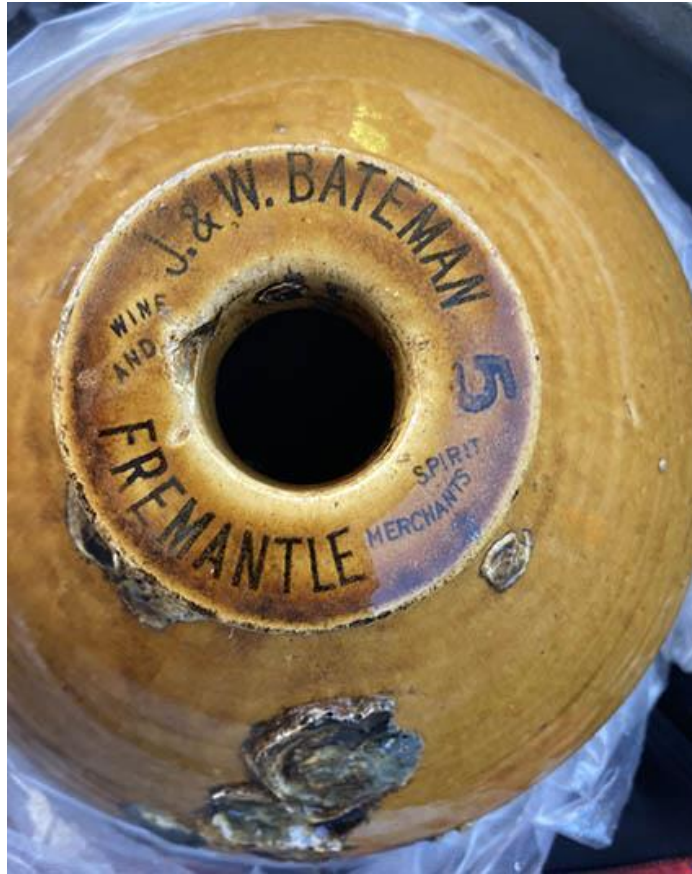
Figure 8. Detail of 'J. & W. Bateman/ Wine and Spirit Merchants/ 5 [gallon]' brand marking on lip of demijohn (Ross Anderson, WA Museum 2023)

Regarding the 'J. and W. Bateman' marking on the demijohn, J. & W. Bateman refers to the Bateman family, of whom there are four generations of similarly named men:

As the marking on the demijohn states 'J. & W. Bateman' and not 'J. and W. Bateman Ltd' or 'Pty Ltd' it could date from anywhere between 1857 and 1919.

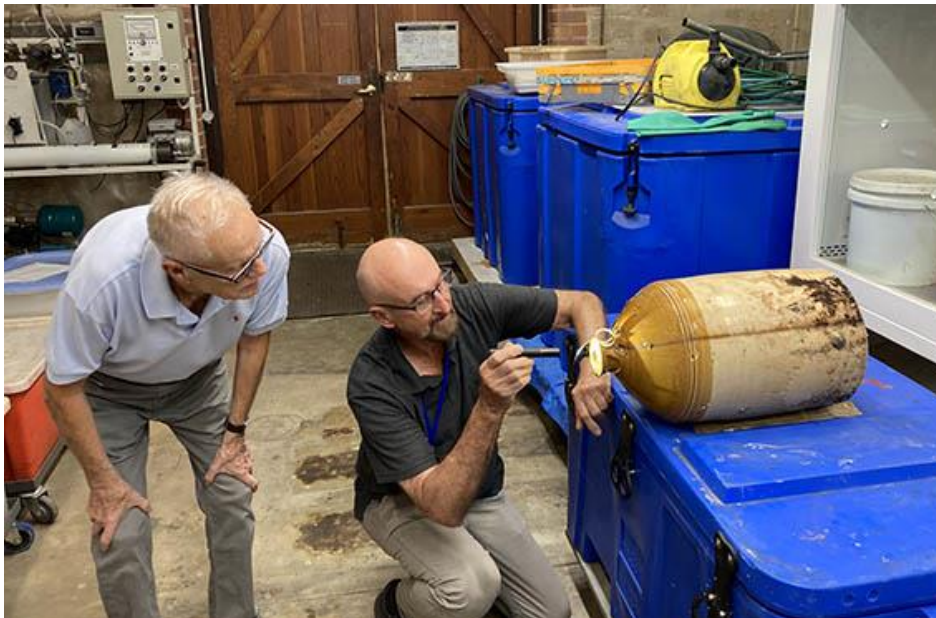
Figure 9. Conservator Jon Carpenter and volunteer Michael Mayers cleaning and inspecting the demijohn. Note the line of the staining along the side showing the level where it had been lying in the silt. (Ross Anderson, WA Museum 2024)

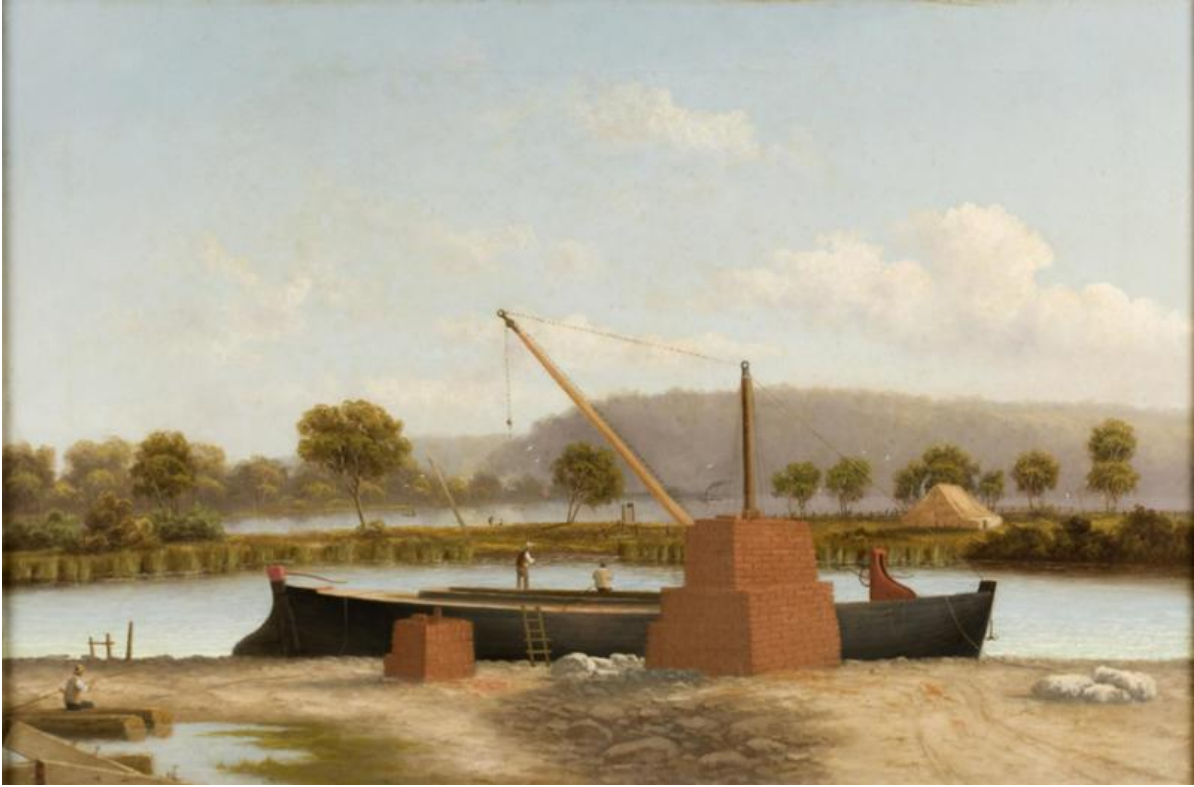
Figure 10. Swan River barge or flat shown in the oil painting 'Brick loading on the Swan River'. Note rudder, size of deck hatch coaming, crane derrick and mast, and windlass at bow. (Artist: Valentin Delawarr, Art Gallery of WA, 1975/0P17)

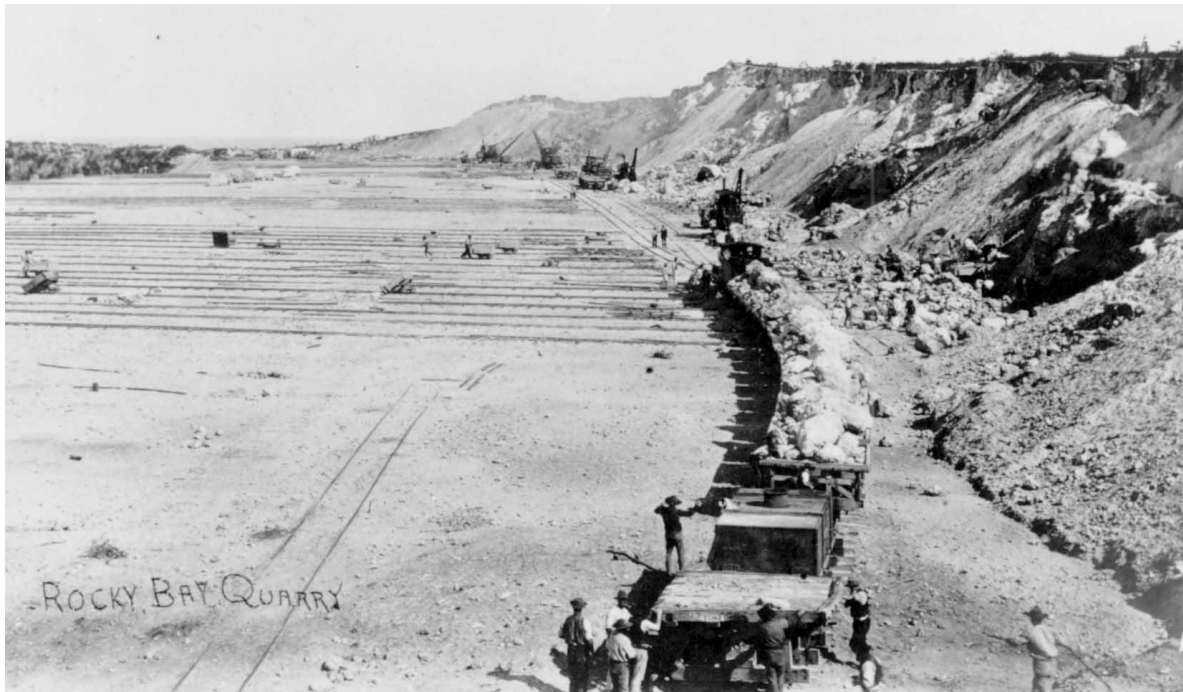
Figure 11. Rocky Bay stone quarries in 1893 (State Library of WA, B2163282_1g)

The "Fremantle quarries" refers to limestone quarries cut into the cliffs forming the riverbank in Rocky Bay and Freshwater Bay, which were conveniently sited to allow the direct loading of stone into flat-bottomed barges (also known as 'flats') suitable for navigating shallow waters of the Derbal Yerrigan/Swan River and transporting the stone throughout the Perth metropolitan area (Figure 10, Figure 11).

The Fremantle riverbank quarries operated from at least 1852 until the 1960s. From 1897, limestone quarried from Rocky Bay was used to construct the massive North and South Moles forming the entrance to Fremantle Inner Harbour. Extensive stone quarrying of Rocky Bay for over 100 years changed the Derbal Yerrigan/ Swan River landscape, resulting in the removal of six of the seven hills originally lining the riverbank, and severely impacting the seventh hill, leaving a terraced limestone cliff in their place (Cooper 2012: 30; *Perth Gazette and Independent Journal of Politics and News*, 27/2/1852 p.4) (Figure 11).
