Maritime archaeological analysis of two historic shipwrecks located during the MH370 aircraft search

Ross Anderson

April 2018

Report No. 322—-Department of Maritime Archaeology Western Australian Museum

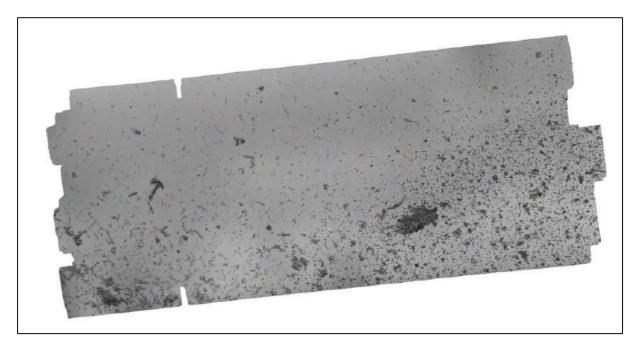
Figure 4 Orthographic projection of 3D mosaic showing part of IOS-001 site, with Anchor 1 and water tank visible along with coal and scattered fastenings (Australian Centre for Field Robotics, University of Sydney).

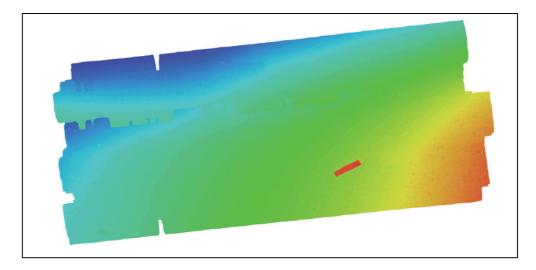
The site is lying widely scattered over a 630 by 460m area on a flat, sloping seabed with evidence of bioturbation. The photographs appear to show some light sedimentation occurring, possibly as a result of decaying organic matter falling from the upper ocean waters onto the seabed. This matter known as 'marine snow' is estimated to cover about three-quarters of the world's deep ocean floor, adding to bottom ooze and accumulating at a rate of as much as 6 metres every million years (Marine snow, n.d. 20/8/15). The bathymetric data appears to show the beginning of a large mound that may indicate the presence of buried lower hull remains, that may in turn be overlain by collapsed structure and cargo (Figure 6).

Figure 6 Bathymetry showing part of IOS-001 site with rectangular water tank visible, and possible circular edge of a wreck mound at lower right. Dark blue corresponds to -3791 m and red to 3784.2 m. An elevation offset visible in upper left of model is due to a lack of photographic matches in this area (Australian Centre for Field Robotics, University of Sydney).

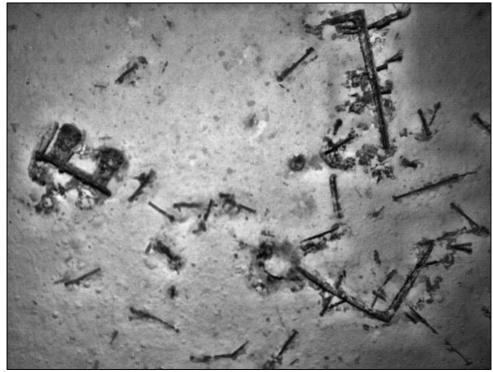
Figure 9 Detail of two right-angled iron knees with scattered fastenings and mooring bitts (Fugro/ATSB).

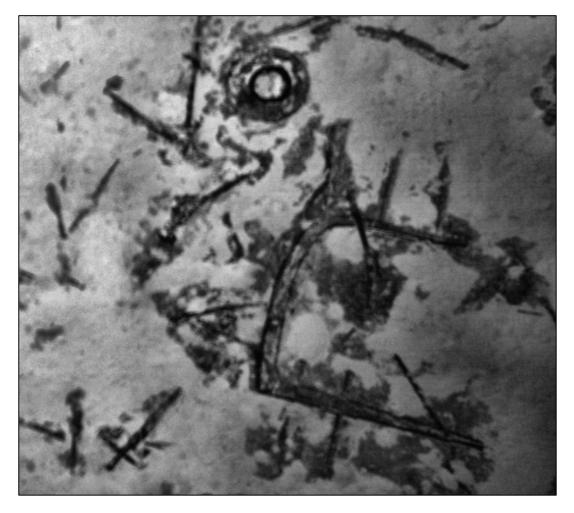
Figure 10 Detail of a smaller, curved between-deck staple knee (Fugro/ATSB).

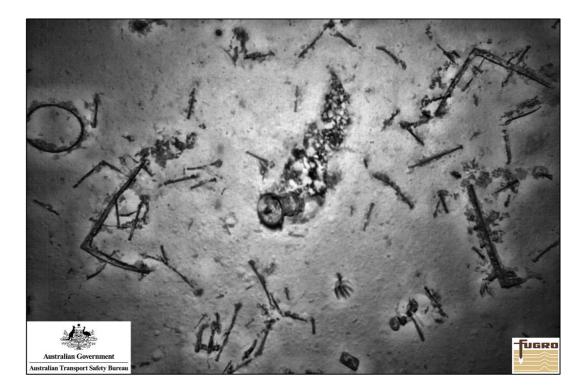
Figure 11 Concentration of three iron knees, fastenings, and an upside-down capstan in centre of image (Fugro/ATSB).

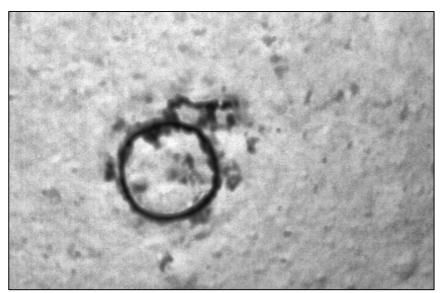
Although wooden materials exposed above the seabed have disappeared, wooden masts and yards would have included iron elements such as mast hoops (used to prevent splitting of the wooden mast and to attach rigging), truss hoops (to support yards), rigging chains and topmast caps (Figure 20). At least one possible truss hoop with chain attached is identified (Figure 21). There are other elements of rigging including mast bands present, indicating the ship sank with some of its standing rigging not having been detached.

Figure 21 Possible iron truss hoop with chain attached (Fugro Survey/ ATSB).

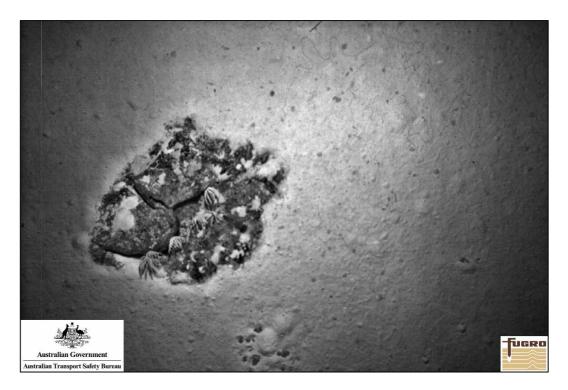
A small concentration of stone may be remains of ballast, or alternatively is a geological feature (Figure **24**).

Figure 24 Possible stone ballast (Fugro/ATSB).

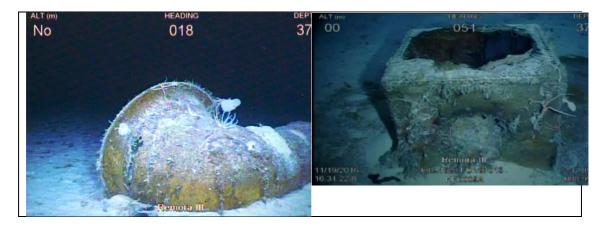
The vessel is lying upright on a flat or slightly undulating seabed, in 3732m depth. The sonar data exhibited some reflectivity from the environment surrounding the site that appears to be connected to the breaking up of the wreck and its contents, which the ROV survey subsequently confirmed to be remains of the coal cargo. The side scan sonar data showed two major areas, HH0009–identified as an iron sailing shipwreck–and HH0009A, which an ROV survey undertaken on 19 November 2016 confirmed to be a widely scattered (approximately 700 x 350m) area of coal, along with a ship's deck ventilator and an 4 ft cubic (1.22 m cubic) iron ship's water tank (Pearson 1992) (Figure 32). The two sites are clearly related to the same wrecking event.

Figure 32 Ship's ventilator and iron tank in Area HH0009A (ATSB)

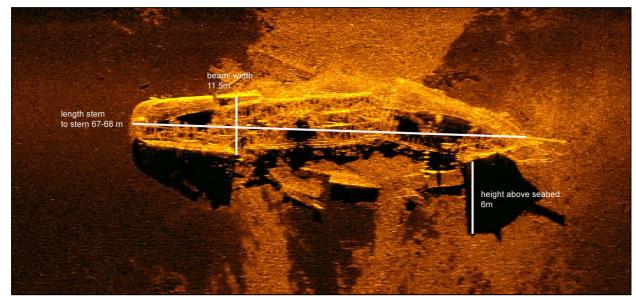
As the flying height of the AUV above the seabed is known, sonar geometry can be used to calculate measurements of the structure, that may in turn be correlated with historically known measurements for iron ships known to have been lost, or possibly lost, in the Indian Ocean (Figure **36**, Table 3).

Figure 36 Key measurements from sonar data (Fugro/ATSB/ WA Museum).

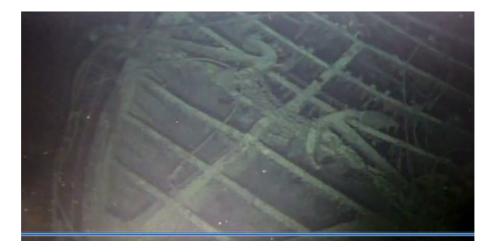
Figure 38 Two Admiralty anchors and chain stowed on the intact foc'sle deck (ATSB)

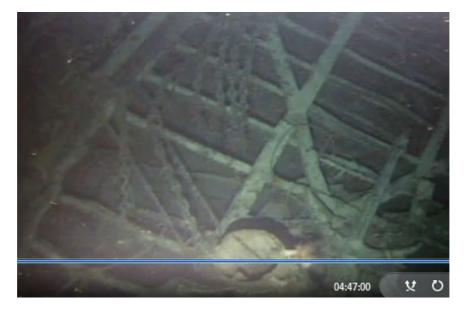
Figure 39 Spare folding stocked Admiralty anchor with chain on main deck, and foremast stump (ATSB)

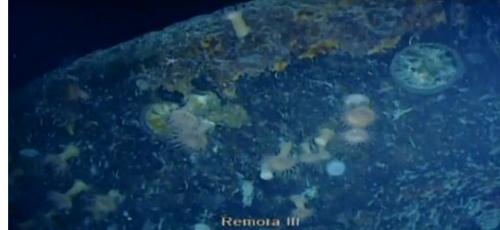
Figure 40 Intact counter stern with intact portholes and anenomes (ATSB)

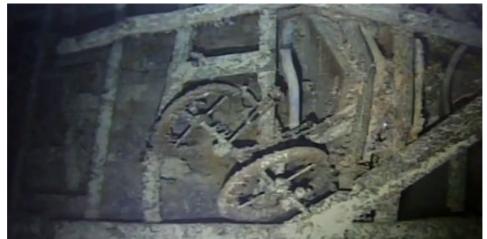
Figure 45 Manual bilge pump with lead piping visible (ATSB)

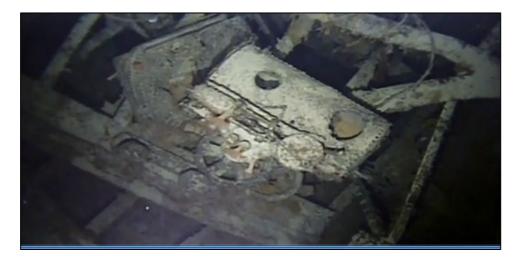
Figure 46 Donkey boiler and machinery (ATSB)

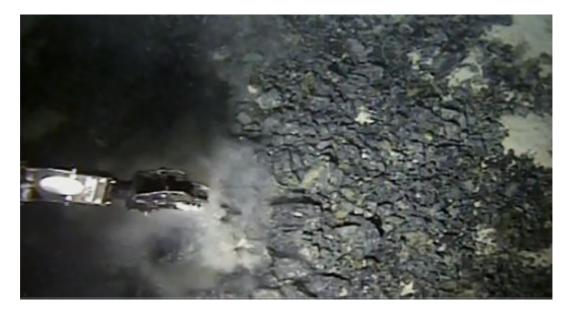
The Remora III ROV manipulator arm was used to obtain a sample of coal for analysis (Figure 49). The sample was sent to Geoscience Australia in Canberra with palynological analysis undertaken by Honorary Associate Professor Michael McPhail at the Australian National University's Department of Archaeology and Natural History. McPhail confirmed the coal to be Late Carboniferous [age limits 318-299 million (Ma) years] and probably British in origin, supporting a port of departure in the United Kingdom (McPhail 2017).

Figure 49 Remora III ROV manipulator arm recovering coal sample (ATSB)

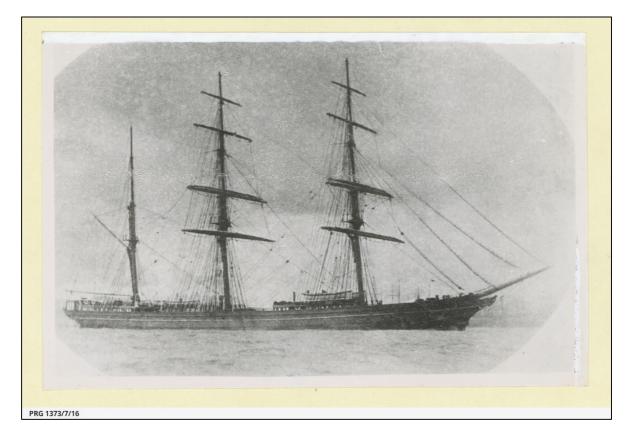
Figure 50 IOS-002 would have closely resembled the 3-masted iron barque *Kooringa*, which disappeared in the Indian Ocean in 1894 while on a voyage from London to Brisbane (A.D. Edwardes Collection/ State Library of South Australia, PRG 1373/7/16/).
