First port in the Northwest
A maritime archaeological survey of Cossack
25-30 June 2012

Report—Department of Maritime Archaeology,
Western Australian Museum— No. 297

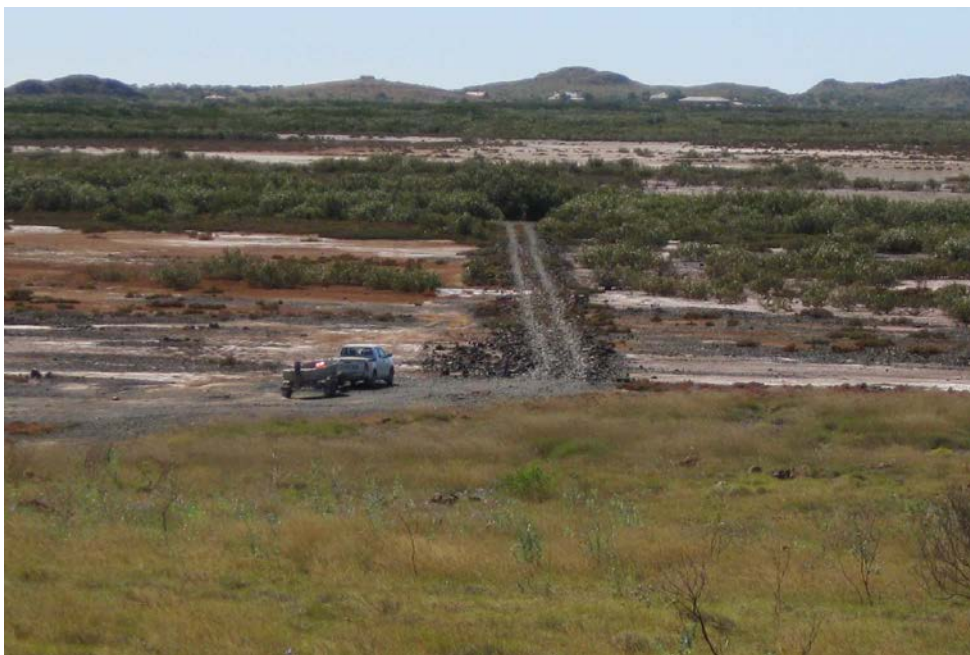
Figure 12. Upper Landing stone causeway, view looking north.

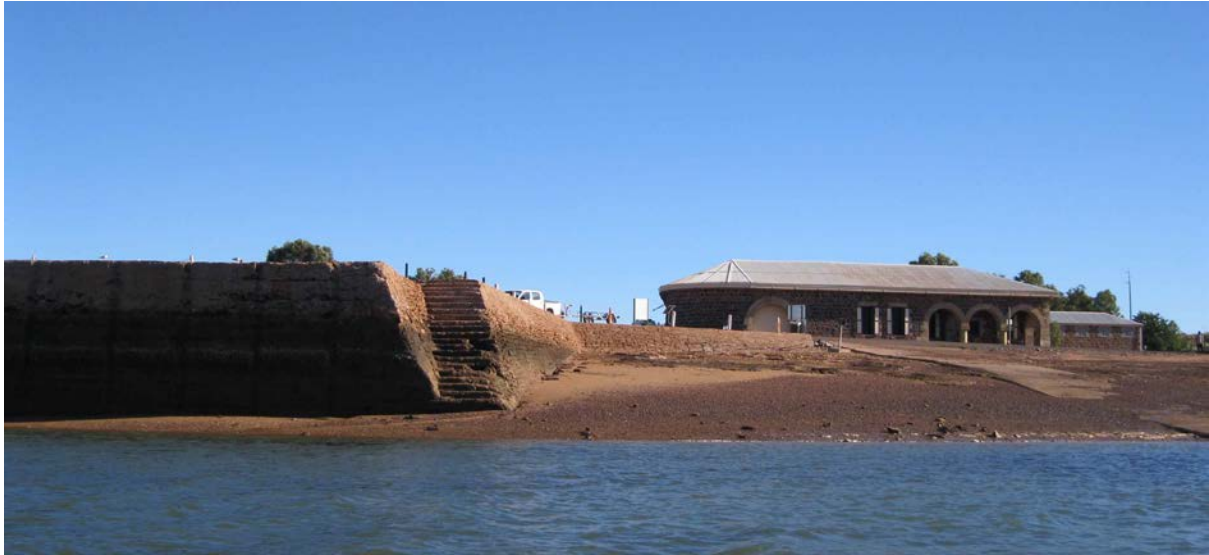
Figure 16. Cossack quay at low tide with Customs Bond Store in background and more recent concrete boat ramp. The turtle pen and swimming baths were in this area north of the quay, in front of the Customs Bond Store.

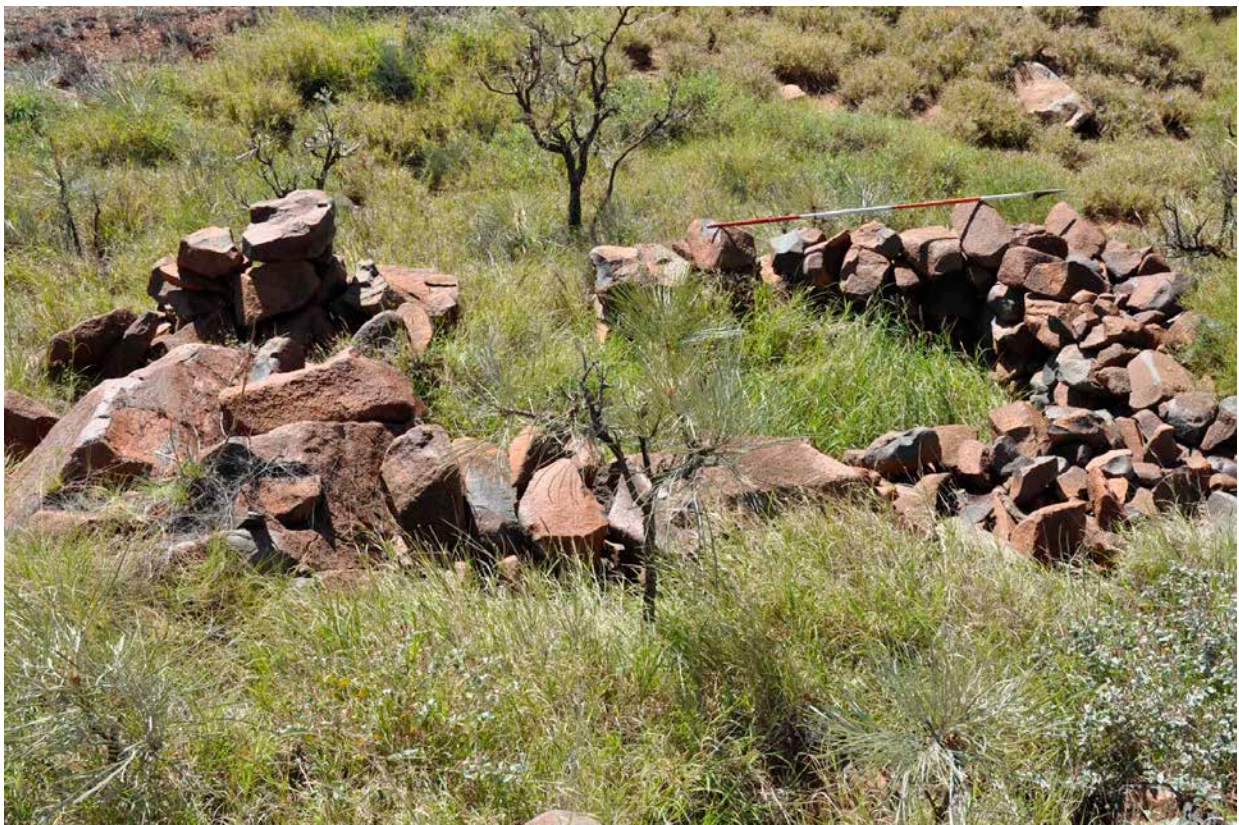
Figure 21. Explosives magazine structure (Feature CK65).

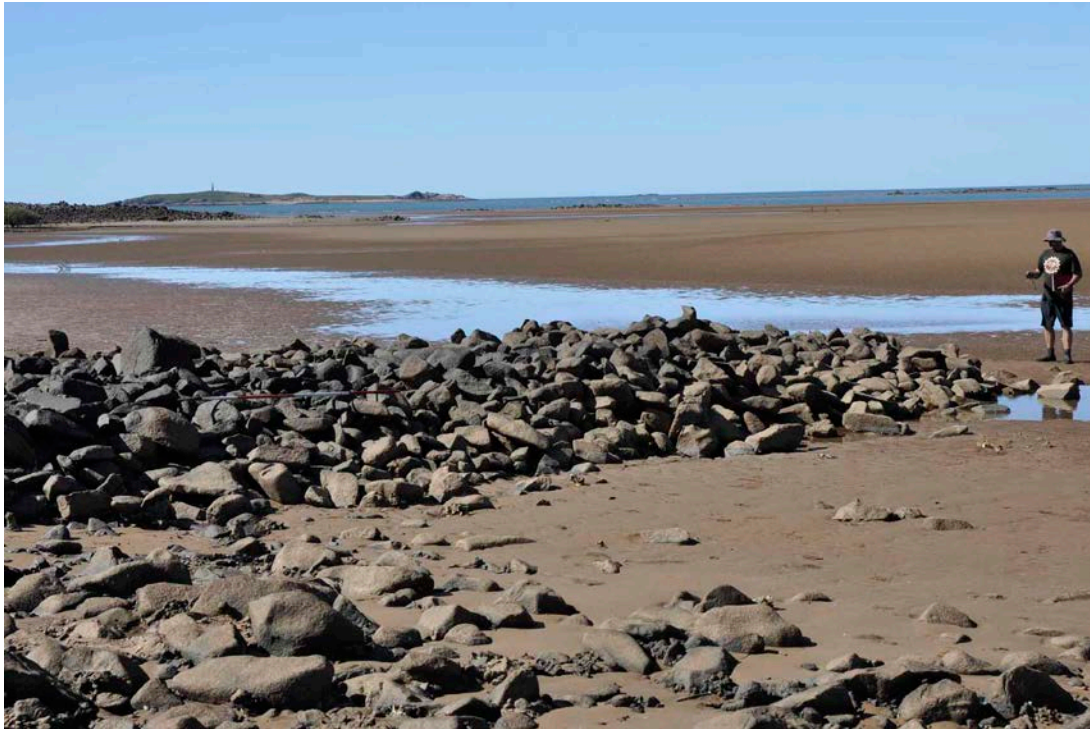
The explosives jetty (Feature CK67) is situated north of the Cossack town site on the western shore of Butcher Inlet. The construction date of the explosives jetty and magazine is unknown, but appears to have been constructed around the 1890s, being associated with the development of gold and copper mining in the Pilbara. The explosives magazine (Feature CK65) is a roughly made, thick-walled stone structure incorporating natural bedrock of the hill on its southwest corner (Figure 21). The remnant jetty structure consists of loose boulders that appear to have been collected from the beach immediately south, and piled up to form a stone groyne/ jetty (Figure 22, Figure 23). This has left a cleared area of sandy beach to the south of the jetty suitable for pulling up small boats at high tide. There is a concrete footing and three iron bolts in the intertidal zone just south of the jetty. The alignment for the a horse-drawn tramway cuts uphill through the foredune with a rock wall embankment, and further concrete and bolts indicating the track route are situated inland along the tramway route to the magazine. A modern vehicle track makes use of the tramway cutting alignment to access the area.

Figure 22. View of explosives jetty (Feature CK67) at low tide looking northeast.

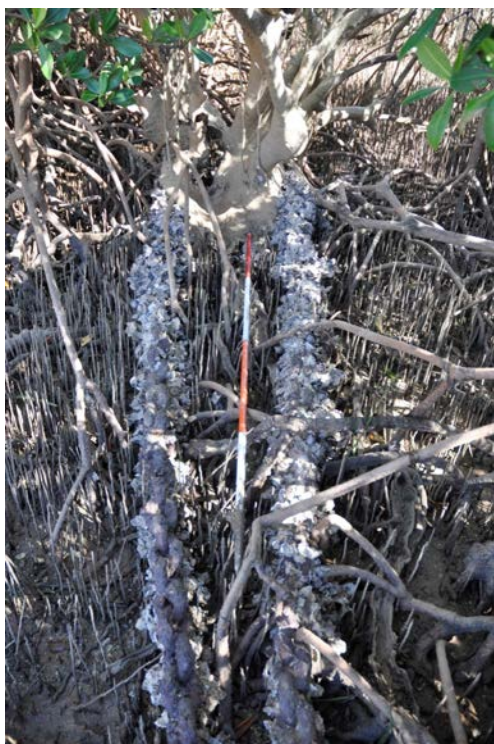
Figure 28. Mangrove tree with chain used as a mooring point in Butcher Inlet (Feature CK22).

Small cutters and luggers used anchor and chain moorings in Butcher Inlet, with multi-point moorings being used during cyclones. Foreshore surveys recorded numerous lengths and segments of corroded chain and two examples of large mooring chains secured to mangrove trees (Figure 28, Figure 29). The magnetometer survey recorded numerous anomalies on the south side of Vampire Island, which are interpreted as being evidence of chain and anchor moorings used by small craft that are known to have used this sheltered area.

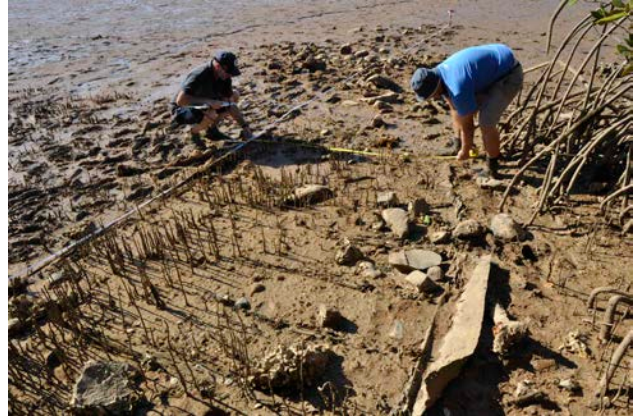
Figure 55. Timber frames and copper sheathing on Cossack UNID 3 site, wooden cutter or lugger wreck.

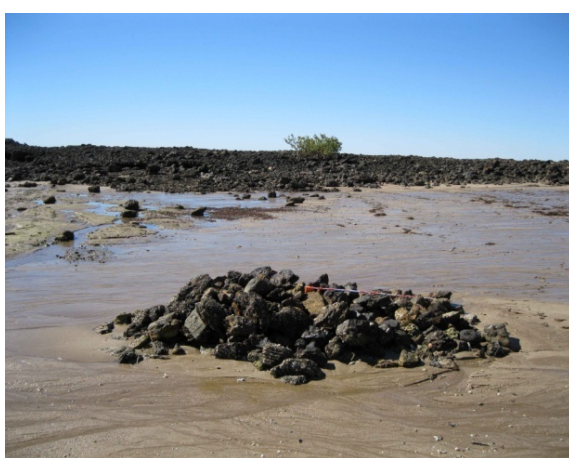
Another ballast mound was located at Point Samson that is probably associated with a wreck or stranding event.

Figure 67. Ballast mound at Point Samson.
