Flat Rock Unidentified site inspection and artefact analysis

**Report—Department of Maritime Archaeology,
Western Australian Museum—No. 294**

November 2015

Ross Anderson

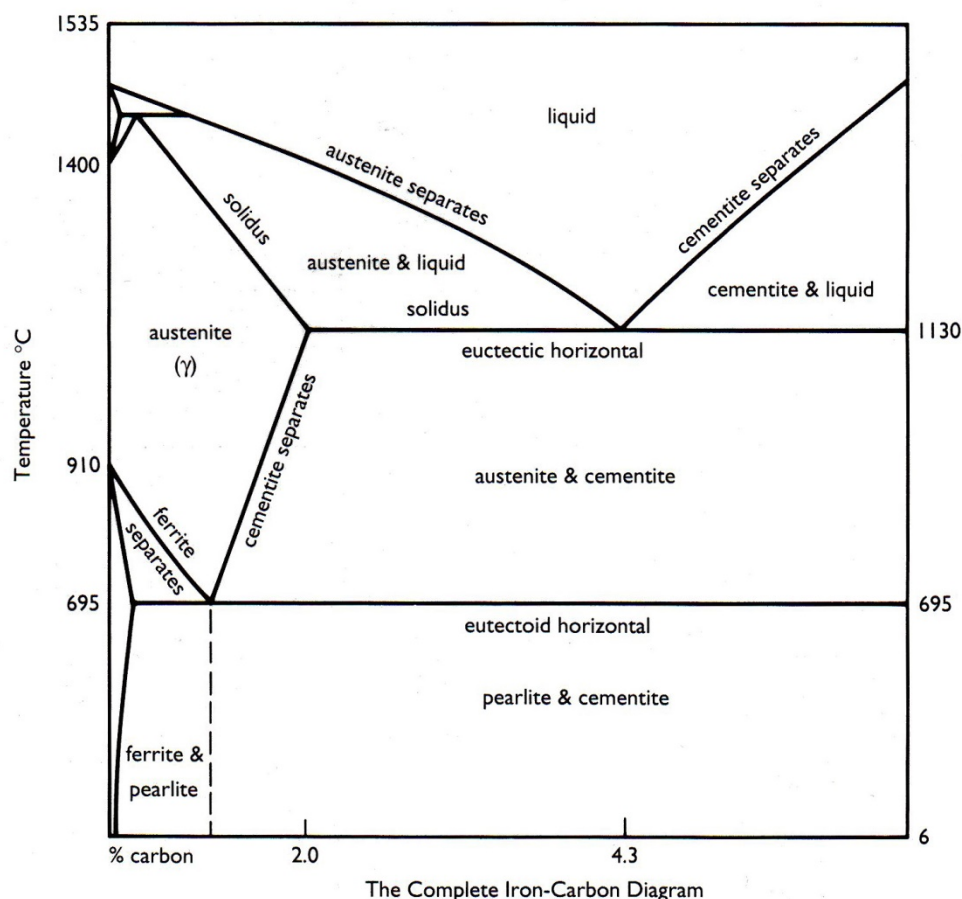
From the analysis totals for FLRK 6209 of 99.24% and the corrosion behaviour of the sample this material is likely to be a partially decarburized cast iron as the copper and nickel contents are low which indicates a relatively pure ore source. The high manganese content is typical of a cast iron and the low gap of possible carbon content in the analysis shows a maximum of 0.7% carbon which is hypo-eutectoid and as such the alloy would have significant amounts of the carbon tied up in residual pearlitic structures. This level of carbon is consistent with a cast iron fitting that may have been subject to being burnt (decarburized) at red heat associated with burning ships timbers and which was subsequently quenched. A full metallurgical analysis would confirm these observations but this is outside the resources of the conservation department to undertake at this point in time.

Sample FLRK 6171-1 gave a total analysis of 99.34% and the second sample had a total of 99.22% and the internal consistencies between the copper, nickel and manganese levels indicate that the samples came from the same batch of wrought iron. The high degree of corrosion observed in the samples is typical of the reactivity of a highly ferritic structure with slag (silicate) inclusions which are cathodic to the iron rich phases and so the latter are preferentially corroded in and along the lines of the inclusions. This material was typically used in the construction of chain plate in the 19th century sailing ships.
