Frontispiece: Aerial photograph of the excavation of the Elvie (photo P.Baker).

## ABSTRACT

The remains of at least three vessels are known to lie within Frenchman Bay, Albany. This bay, therefore, played a significant role in the history of the port of Albany. From previous Western Australian Maritime Museum surveys of these wrecks, and local knowledge, the identities of two of the vessels have been confirmed, with continuing debate over the number and identification of vessels lying along Vancouver Beach.

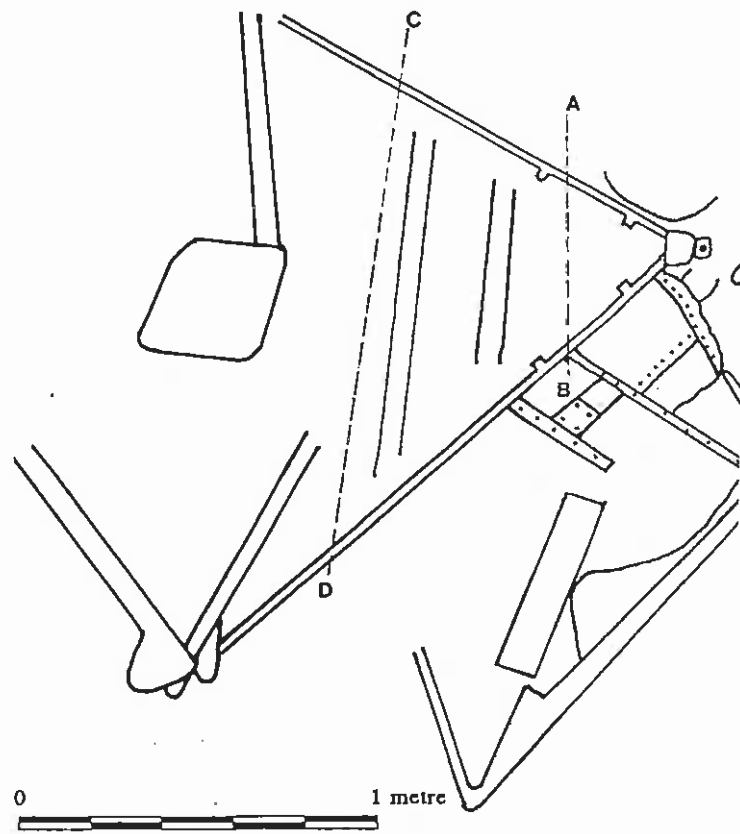
Internal profiles of the bow section were taken (Figure 4.3), using the probe to penetrate through the sediment down to the base of the vessel. A datum was established directly on top of the stempost and this was transferred along the vessel, using a system of starpickets and carpenter's level, to each station at which profiles were to be taken. This ensured that the heights from which the depth to base measurements were taken were constant. The distances from this established level above the vessel to the base were measured across the bow section; two profiles were taken at the bow (refer Figure 4.8), using this method in conjunction with the water probe. This system of transferring the datum was also used at the stern (Figure 4.4) where an alternative datum was established, as inaccuracies would have occurred in transferring the original datum over the entire length of the site.

Figure 4.3: Bow section of the Unidentified Lighter, indicating where profiles across the section were taken.

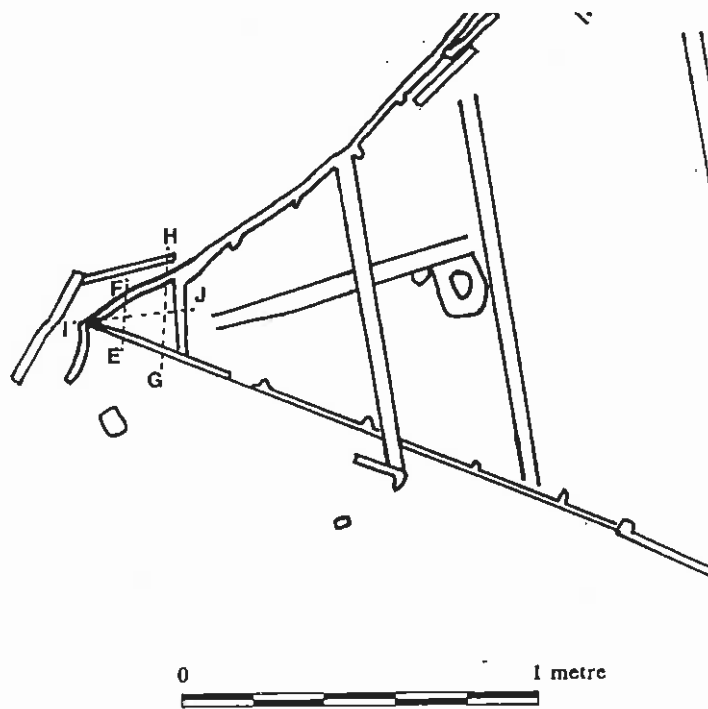
Figure 4.4: Stern section of the Unidentified Lighter, indicating where profiles across the section were taken.

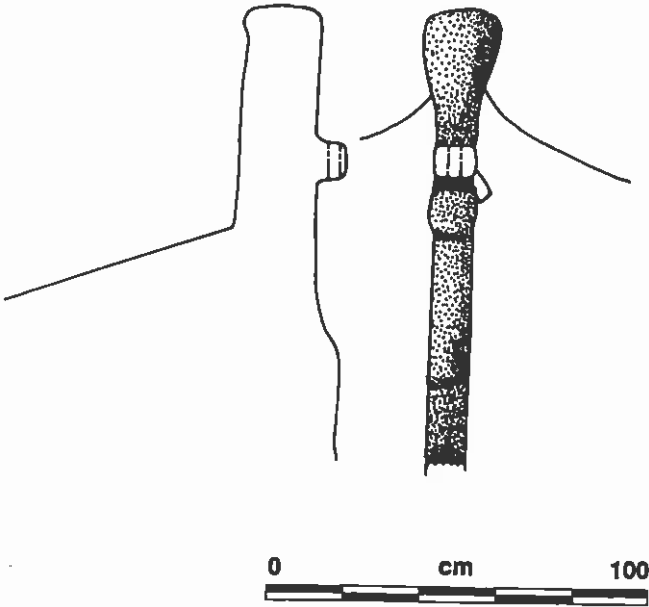
Figure 4.6: Profile of the stempost, Unidentified Lighter.

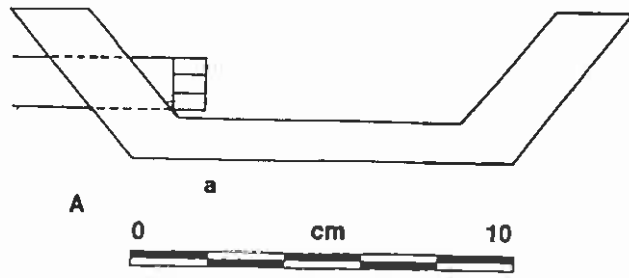
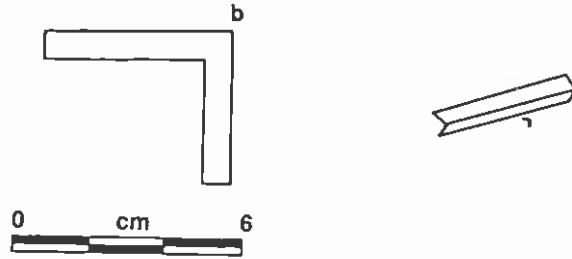
Figure 4.7a and b: Cross sections of the iron beams in the bow section

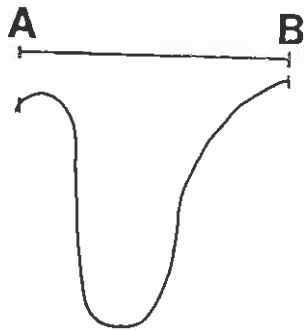
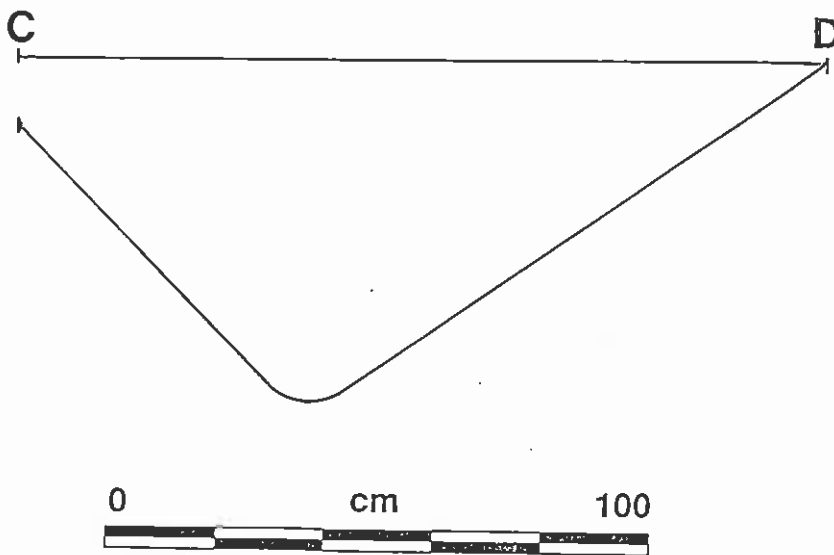
Sediment was removed from between the stempost and the first deck beam, which confirmed the bow profiles that had been taken earlier (Figures 4.3 and 4.8). The profiles indicate they were taken where the hull plates meet the stempost or the stemson. The keelson was not reached during the profiling. Had it been, the base of the profile would have flattened out in accordance with the perceived function of the vessel as a lighter. According to McKenna (1990:personal communication) and de Kerchove (1961:454), lighters are flat bottomed vessels; the profile, therefore, would have had a flatter base.

Figure 4.8: Bow profiles, Unidentified Lighter.

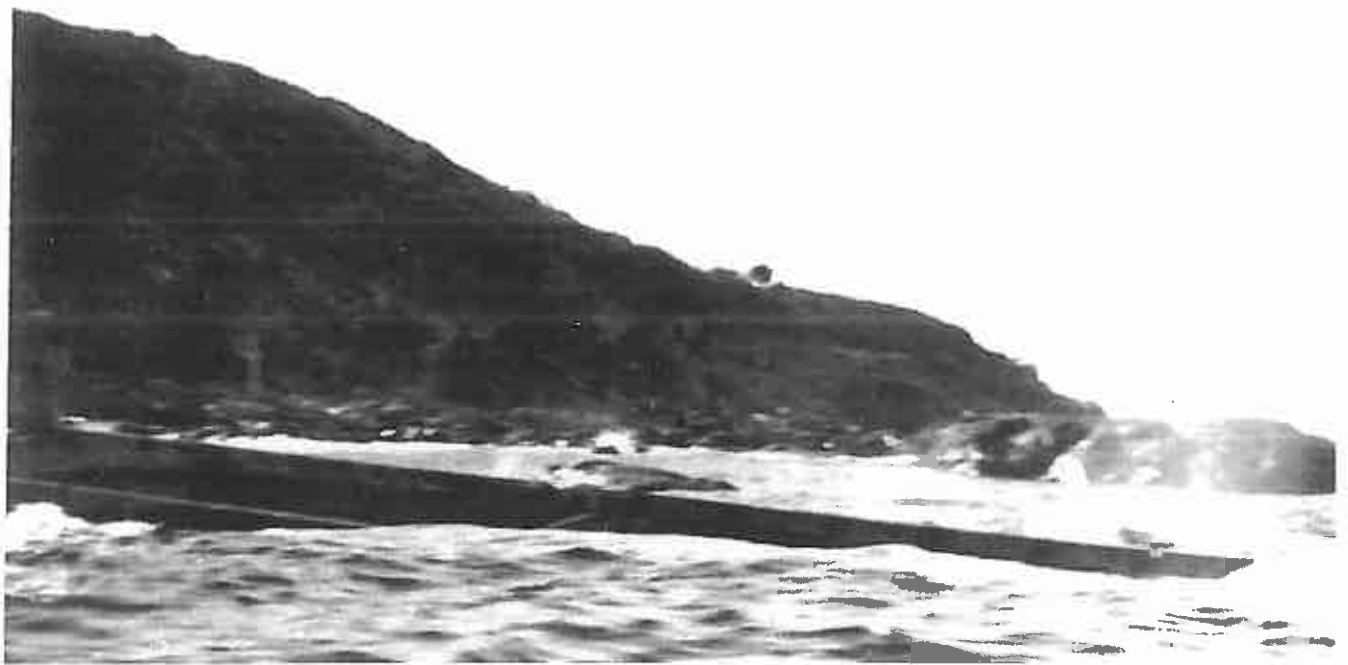
This section of wreckage has been interpreted as part of a raised fo'c'sle that formed a 'turtle-back' at the bow. 'Turtle-back' freeboard assists vessels to shed water in heavy seas. This would certainly be necessary for the waters around King George Sound, and to a vessel with a low freeboard such as a lighter. This 'turtleback' deck can be seen in Plate 4.6.

Plate 4.6: Lighter on beach, Whaler's Rock, Albany, showing the 'turtle-back' deck.

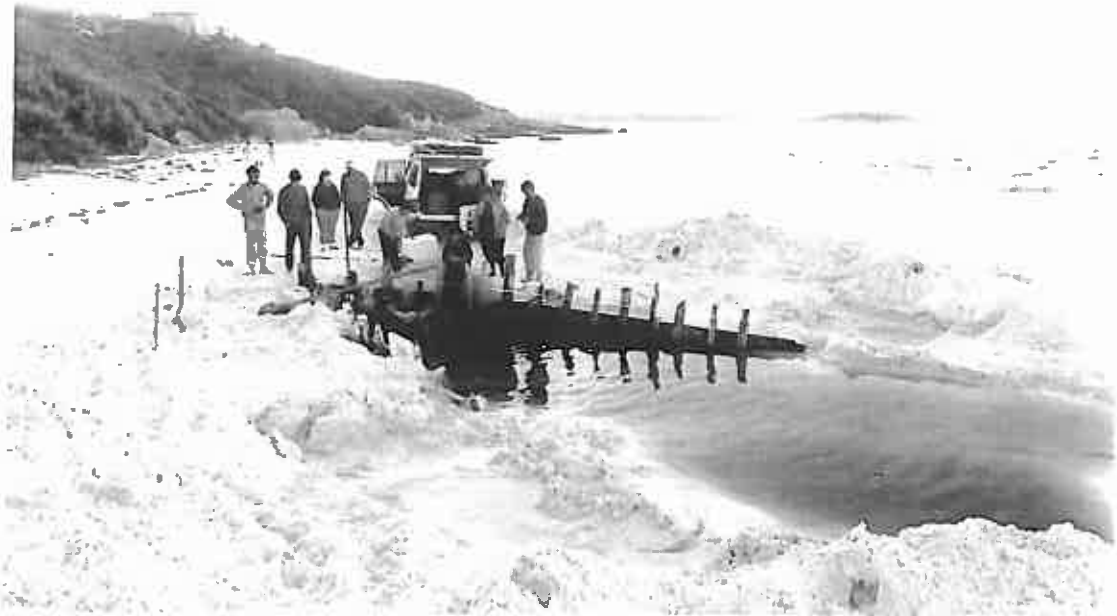
The tide was an additional source of difficulties during this procedure. The optimum time for backhoe excavation of the *Elvie* on this day was approximately 1 p.m. when the tide had receded sufficiently to expose approximately half of the site (Plate 5.4). The excavation took up to two hours, leaving little time for profiling before it became dark, and only one station was successfully completed. By the following morning the rising tide had completely refilled the hull with sand.

Plate 5.4: View of the *Elvie* showing the extent of the excavation.

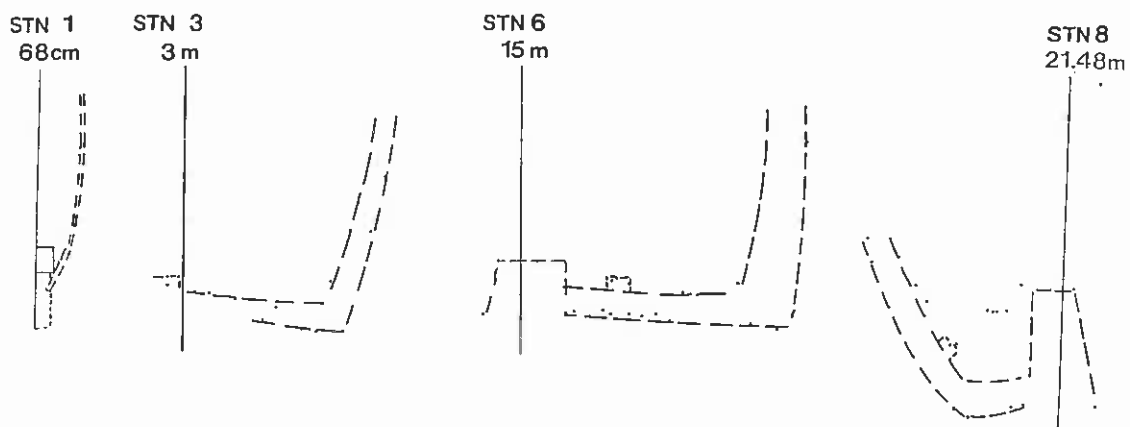
Finally, the method of profiling without being able to view what was being probed, hampered efforts at reconstruction, as it was difficult to determine the identity of individual features present in the profile (Figure 5.1). This became a critical issue when determining the difference between the floor and bottom planking of the body profile. There is therefore considerable supposition in the reconstruction.

Figure 5.1: Profiles at 68 cm, 3 m, 15 m, 21.50 m.

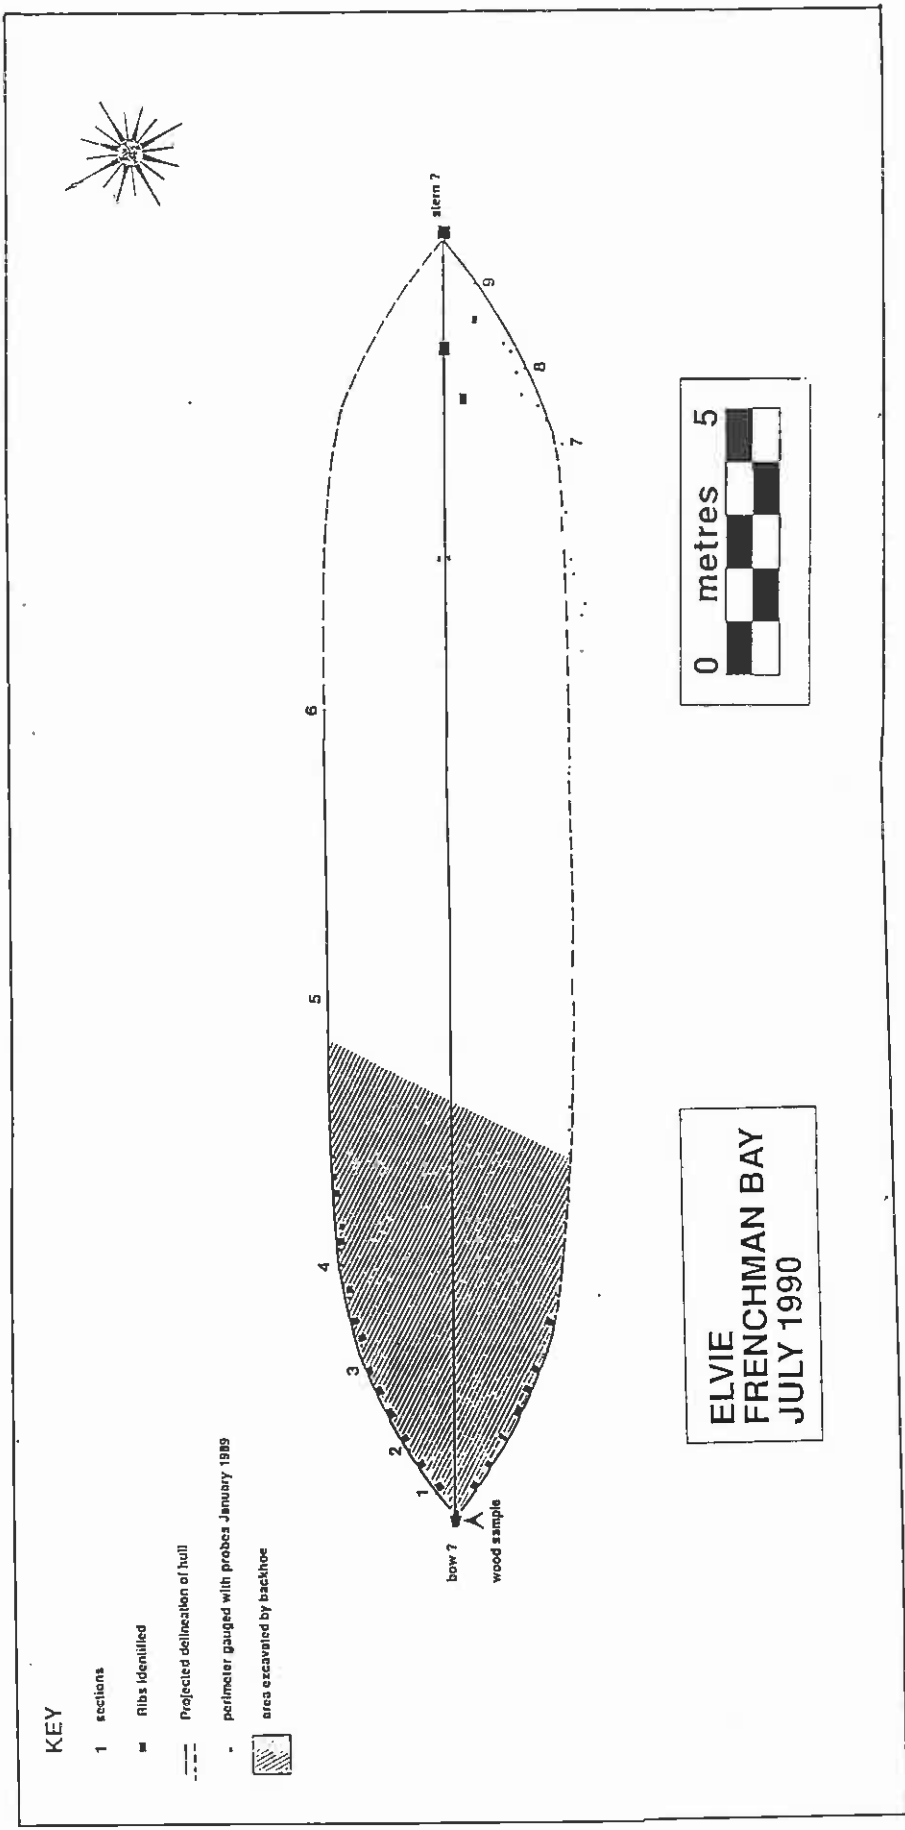
There is a discrepancy arising between the shape of the vessel proposed by the author and that by the previous survey (May and Richards 1989: unpublished). This arises because the previous survey failed to locate the sternpost. Thus the reconstruction of January, 1989, is more bluff ended, as the hypothetical reconstruction is shorter (Figure 5.2).

Figure 5.2: *Elvie* Site Plan

The estimated beam width according to the site plan is 4.50 m (Figure 5.2). The same distance on the lines plan is 4.08 m (Figure 5.3). The site plan was constructed with the assumption that the wreck was vertical in the sand, but examination of the profiles revealed the Elvie heeled to the port side. Given it was also difficult to differentiate between the floors, bottom planking and ceiling planking, the offsets of the assumed bottom planking were aligned along the baseline. This would therefore change the overall beam width, making it substantially smaller. The keel was not excavated, so its form remains unknown.

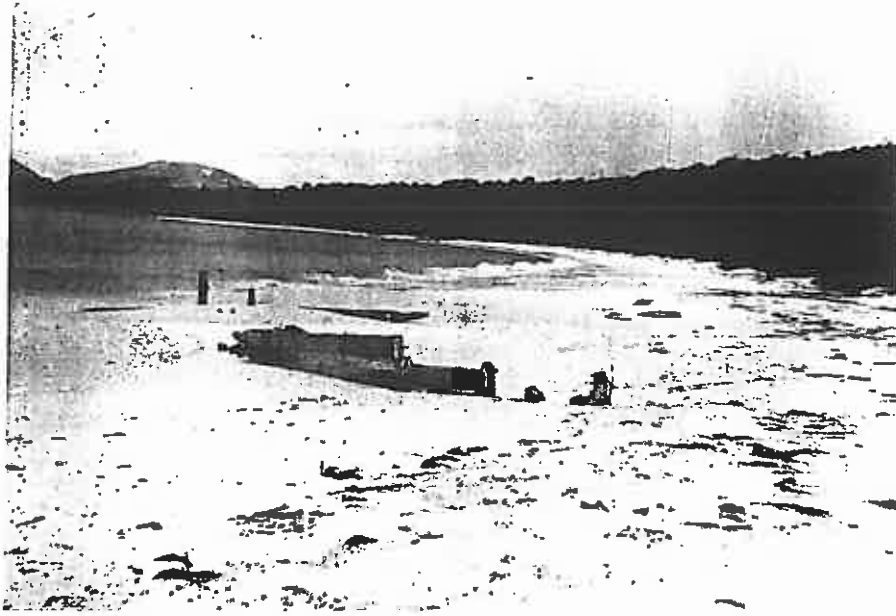
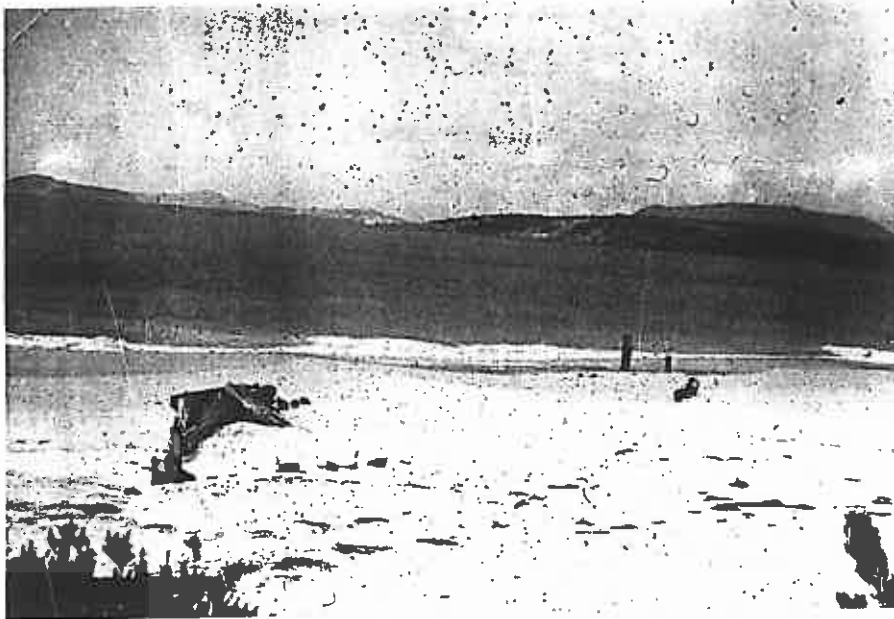
It was possible to estimate the original sheer line, through the comparison of a series of photographs. The earliest photograph, dated to the 1930s, shows the original extent of the vessel (This photograph was unavailable at time of writing). The second series of photographs (Plate 5.8), although undated, shows the Elvie in a disintegrated condition, not dissimilar to the condition in which she is at present. Plates 5.9 and 5.10 taken in 1989 and 1990 respectively, indicate the present state of preservation.

The width of the outside planking is already known (see 2.4), as is the approximate height of the vessel at ribs 6 and 8 (Compare Plates 5.8 and 5.9). In comparing the contemporary with the recent photographs, estimates were made as to the extent of the vessel lost. It has been estimated approximately three outside planks are missing at the bow of the vessel, whilst at 5 m, approximately rib 9, only one outside plank seems to have disappeared. By adding the widths of these planks onto the known highest points of the body profile, a hypothetical sheer line was faired (Figure 5.3). Thus the original height of the vessel at the bow was 1.61 m, and midships, 1.54 m.

Plate 5.8a: View of *Elvie* from the North.

Plate 5.8b: View of *Elvie* from the West.

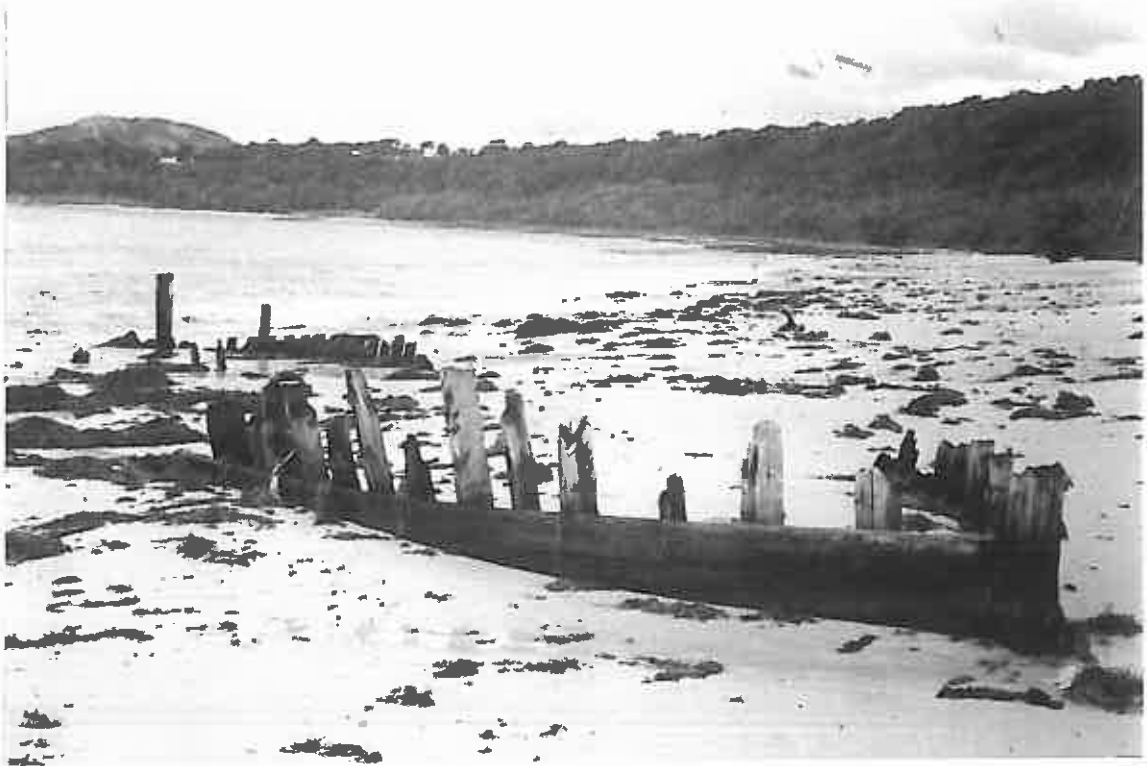
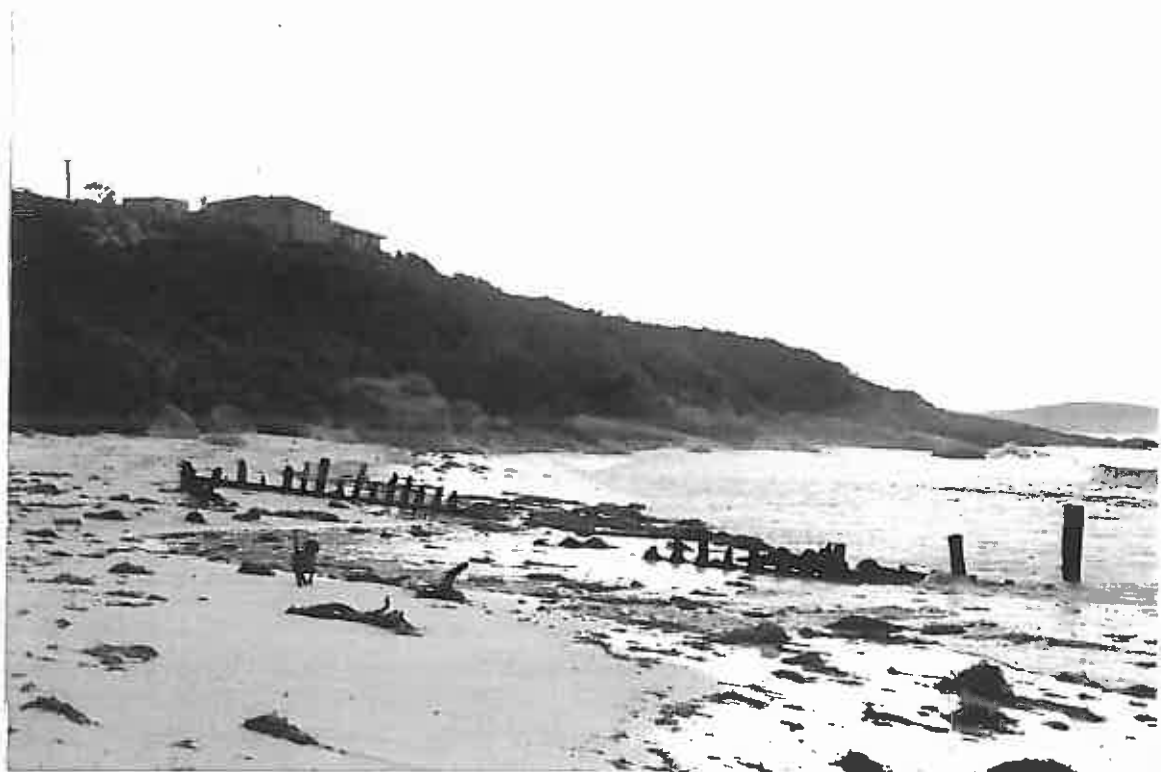
Plate 9a: View of *Elvie* from the North, August, 1989.

Plate 9b: View of *Elvie* from the South, August, 1989.

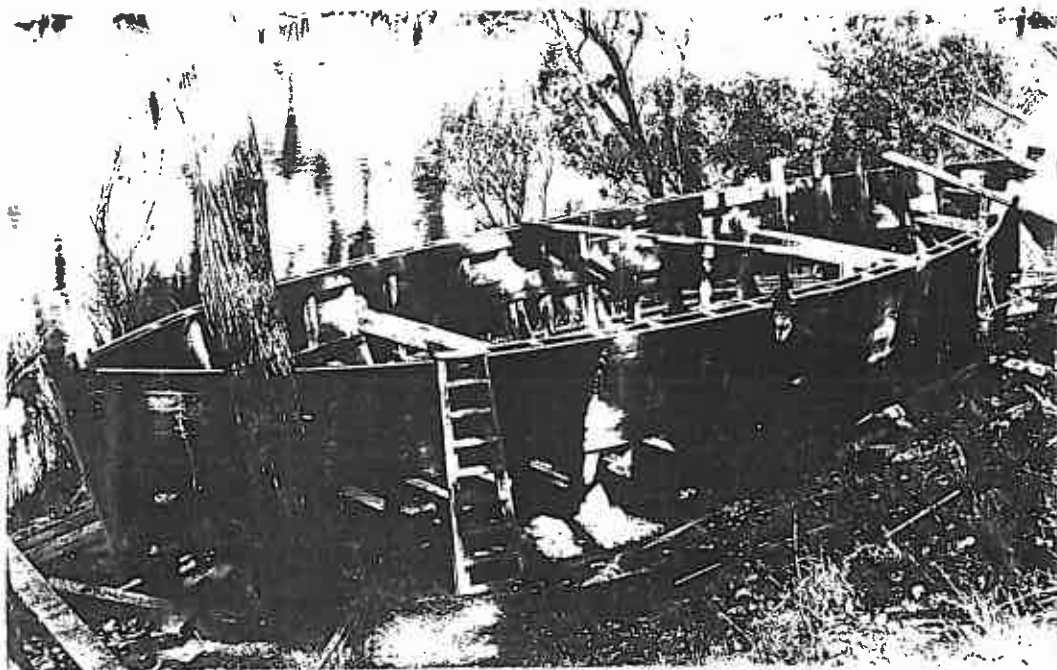
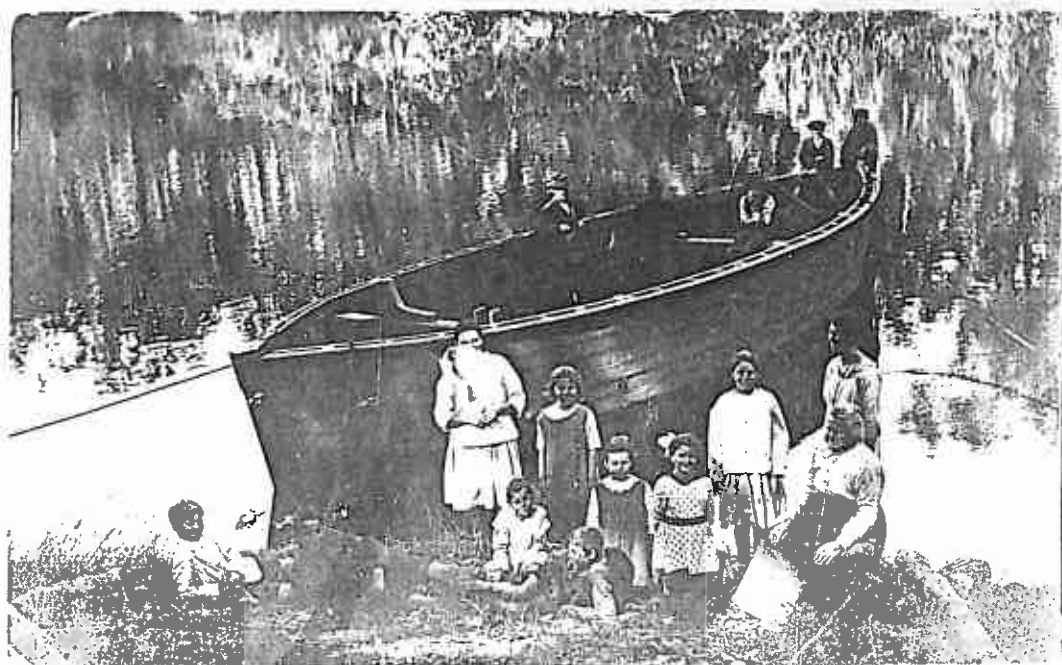
A lighter c.1925 (Plate 5.12), was constructed from Jarrah from the dismantled Frenchman Bay whaling station. Although smaller in dimensions, (40x12ft), the form of the vessel seems to be most likely that of the Elvie and perhaps a common shape for wooden lighters of this kind. The profiles and subsequent lines plan (Figure 5.3), confirmed the vessel as being flat bottomed. It also seems probable the vessel was double ended, although further investigation around the area of the sternpost will confirm this.

Plate 5.12: Lighter at Kalgan River, constructed from Whaling Station timbers from Frenchman Bay.
