JERVOISE BAY PROJECT REPORT

A survey of the shipwrecks Abemama and SS Alacrity

Report - Department of Maritime Archaeology, Western Australian Maritime Museum, No. 127.

June 1997

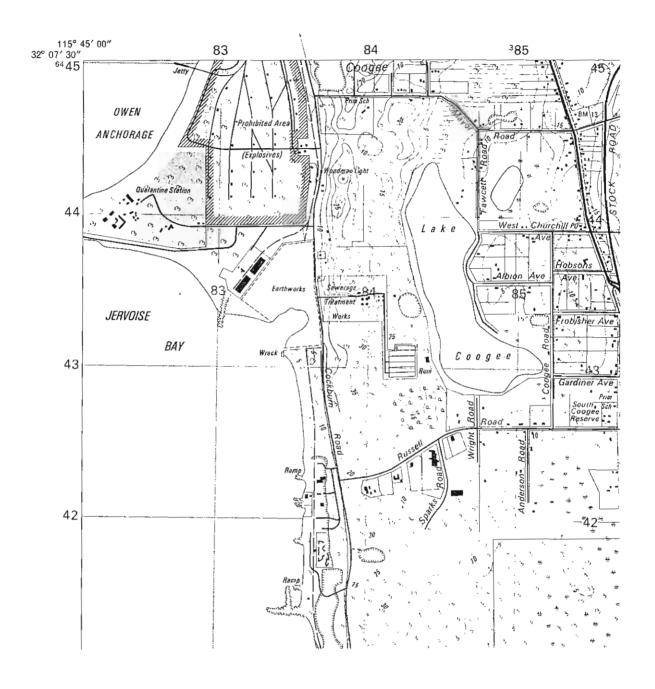
Figure 1. Australia 1: 25 000 Topographic Survey. Fremantle SW, Sheet 2033-1 SW (Edition 1), Series R 811, 1976. The wreck of the *Alacrity* is shown above. The *Abemama* lies under the beach to the east. Note the date.

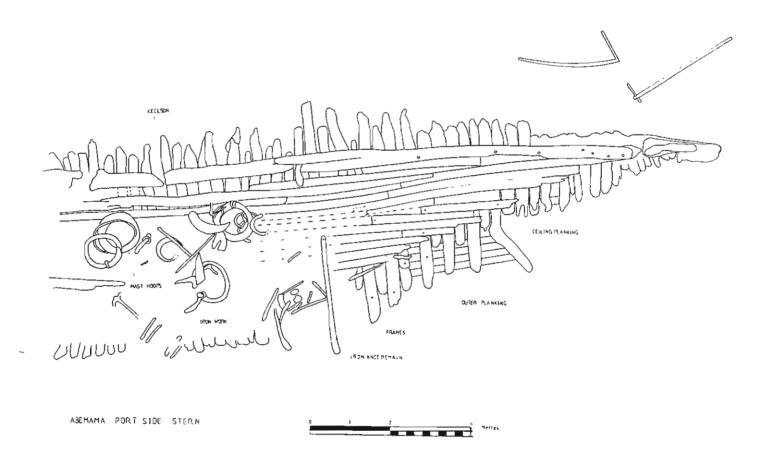
The Abemama lies on her port side on a north south axis with the bow to the south. The wreck lies parallel to the shore in a depth of 3.2 metres of water. The timbers are exposed due to recent shoreline changes, and the height of the wreckage above the seabed does not exceed one metre. Planking, frames and some iron fittings extend approximately 3 metres outwards from the keel, giving an overall breadth of six metres. The identifiable features around midships consist of iron knee riders, deck supports, mast rings and constructional fittings. The frames and planking on the starboard side have broken off near the keel and there is minimal hull structure remaining on this side. The wreck was stabilised under a layer of sand until the shoreline changes in 1975. The more exposed hardwood timbers of the Abemama were covered with sessile marine organisms while the exposed ends of the hardwood frames also exhibited damage caused by marine borers.

Figure 8. Site plan, Abemama. S Lester, WA Maritime Museum, 1981.

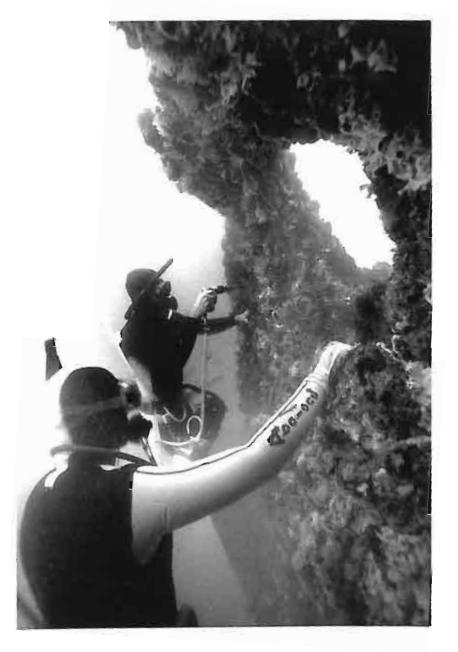
Figure 15. Conservator taking corrosion measurements on the *Alacrity* hull plates. Photo: P. Baker, WAMM 1997.

Eight pH and corrosion potential measurements were aquired. Four from the iron hull plates, near the stern post, which were drilled in upper and lower positions on the seaward and shoreward facing sides of the vessel. Two measurements one from either side of the hull mid site (approx). One measurement on a large iron shaft (prop shaft?) in the middle of the vessel lying (approx) between the latter two measurements positions. The final measurement was aquired from collapsed hull plating lying across the bow end of the vessel. Prior to drilling marine growth was stripped away from the concreted iron surface with a knife blade. In hindsight a smaller masonary drill bit should have been used to drill the relatively thin concretion layer (max 8 mm) as the optimum measurable closed volume of seawater was not attained for recording pH. The variance in the pH readings may reflect this.

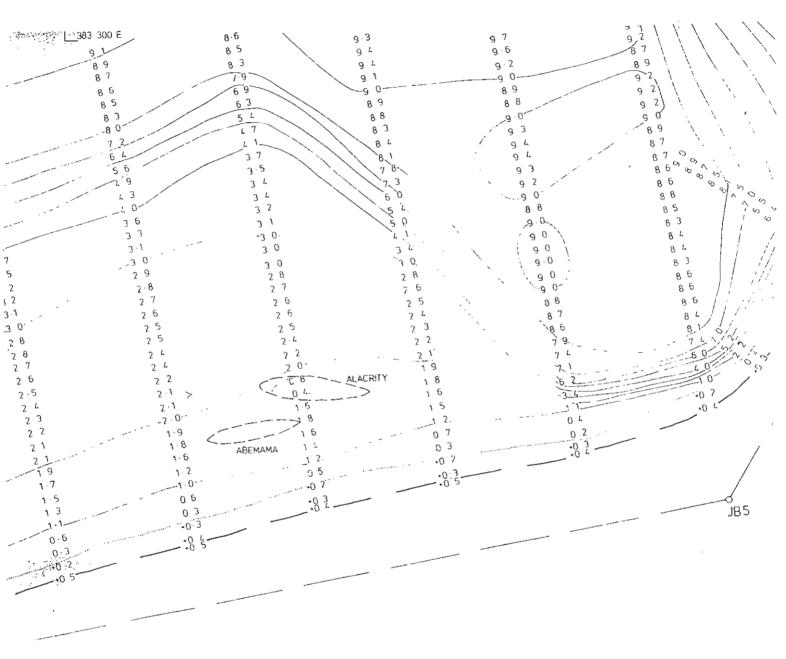
Figure 18. Public Works Department. Depth Soundings, Jervoise Bay, 1980, showing the depths after the dredging. See results for 1997 over.

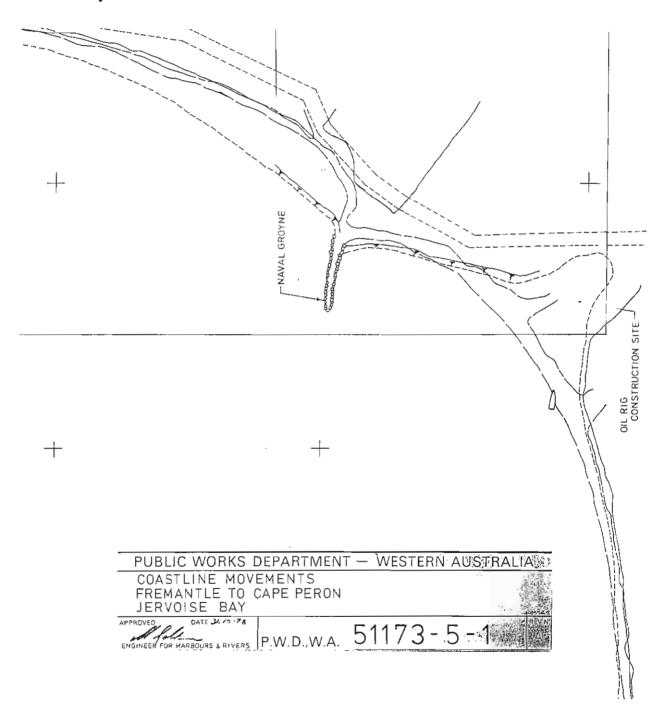
Figure 20. Public Works Department, Coastline Movements. Fremantle to Cape Peron, Jervoise Bay, 1976.

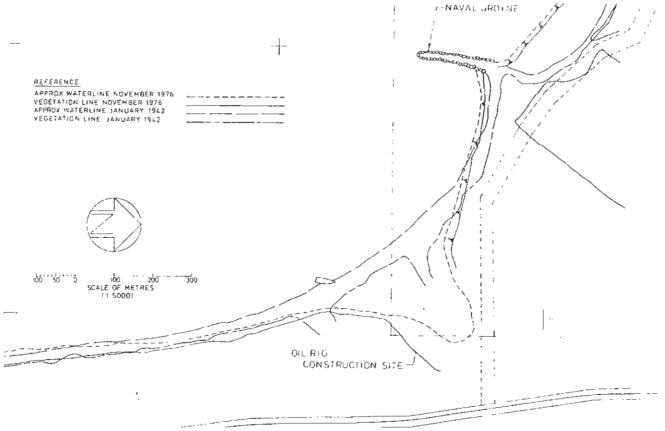
Jervoise Bay was one of several well known ships' graveyards and was utilised from 1890 to 1910. The *Abemama* broke away from her mooring in Jervoise Bay during a severe storm on the 27 June 1927 and was blown on to the shore where she lay for a few weeks before vandals burnt and totally destroyed the vessel. The wreck site was quite extensive and well preserved for many years by layers of sediment in approximately 2m of water and about 30m from the shoreline. The overall disturbance of this site is attributable to changes brought about by activities along and development of the foreshore. Most importantly, in 1975 dredging occurred to enable the newly completed construction of the oil rig, *Ocean Endeavour*, access to the open water of Jervoise Bay. As a consequence of this dredging, shoreline changes occurred and the *Abemama* was completely exposed (Figure 3) [McCarthy 1981; 1983].

Figure 3. Changes in the Jervosie Bay shoreline after dredging operations occurred in 1975 [Public Works Department Map 1978]

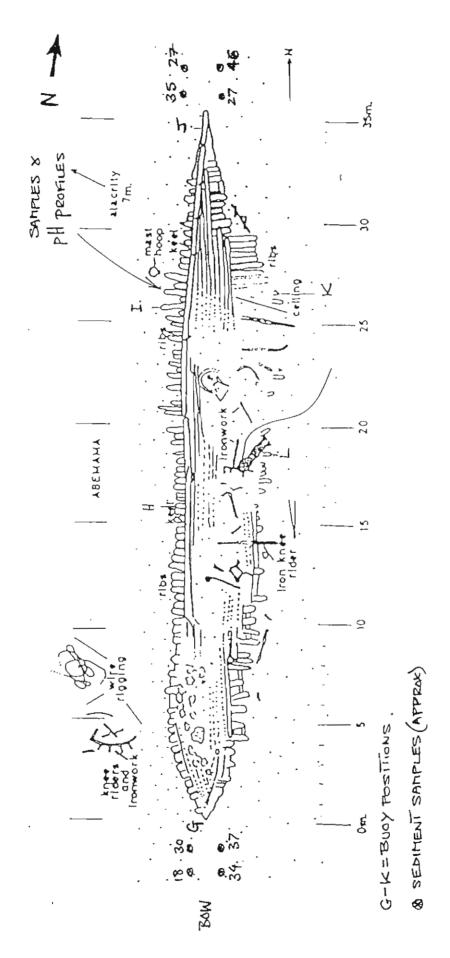
Figure 4. Site plan of the Abemama wreck site [McCarthy 1981; 1983].

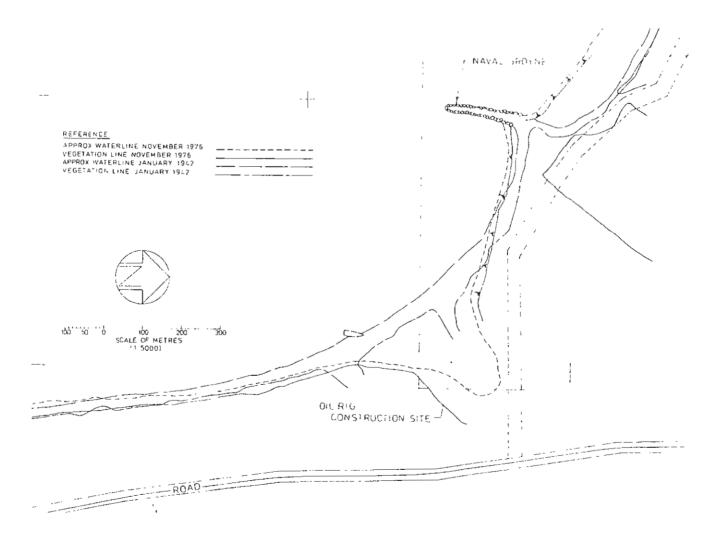
Jervoise Bay was one of several well known ships' graveyards and was utilised from 1890 to 1910. The *Alacrity* broke away from her mooring in Jervoise Bay in 1931 and drifted on to the shore where she lay in the intertidal zone for many years. The overall disturbance of this site is attributable to changes brought about by activities along and development of the foreshore. Most importantly, in 1975 dredging occurred to enable the newly completed construction of the oil rig, *Ocean Endeavour*, access to the open water of Jervoise Bay. As a consequence of this dredging, shoreline changes occurred and the *Alacrity* was undermined leaving the site under approximately 3m of water, about 50m from the shoreline (Figure 3) [McCarthy 1981; 1983].

Figure 3. Changes in the Jervosie Bay shoreline after dredging operations occurred in 1975 [Public Works Department Map 1978]

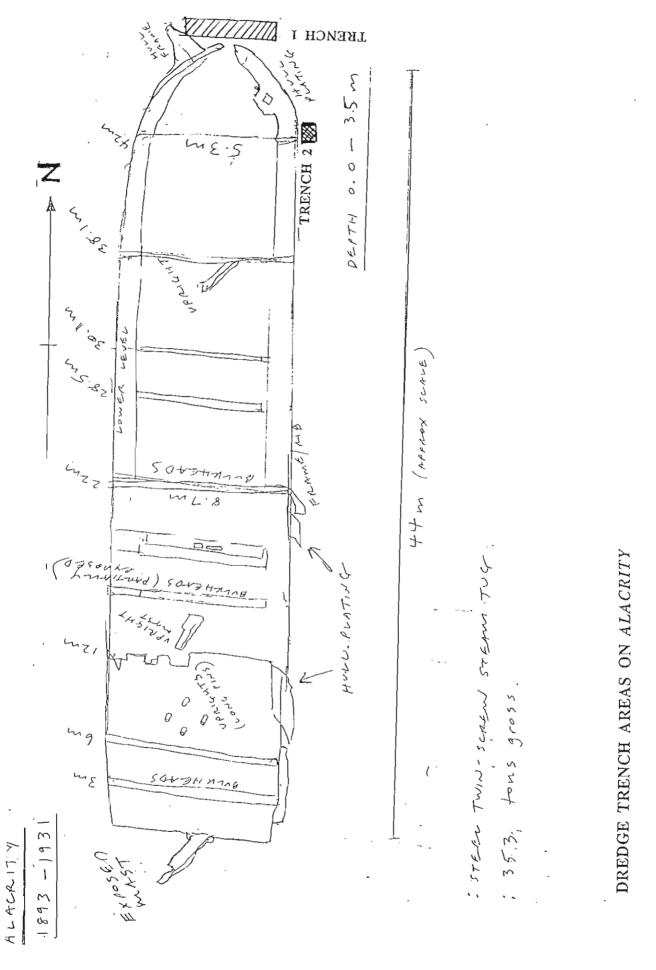
The highest part of the *Alacrity* is the stern post which extends approximately 1.5m above the sea water surface. In profile, hull structure at the stern and mid section rises approximately 2m above the surrounding seabed. The average height of the adjoining structure is about 1m above the sediment. There is a proportion of the wreck buried in the sediment up to about the turn of the bilge, however, the extent of this burial was not ascertained as the bottom of the vessel was not located during dredging operations (Figure 4).

Figure 4. Location of the dredged trench areas on the Alacrity site [Souter 1997].

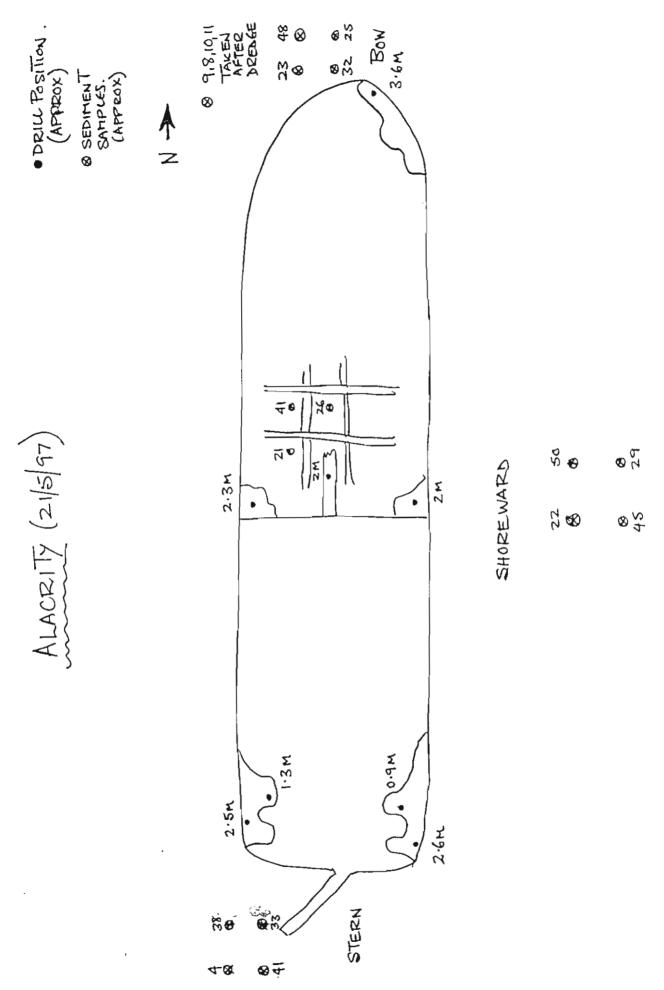
No shipboard artefacts were observed only collapsed hull structure was present around the site. Eight sets of corrosion potential and surface pH measurements were acquired and the results are presented in Table 1. The iron hull plates near the stern post, in upper and lower positions on the seaward and shoreward facing sides of the vessel, either side of the hull mid section, a large iron shaft, possibly a prop shaft located mid site and collapsed hull plating lying across the bow end of the vessel were measured (Figure 5). Marine growth was stripped away from the concreted iron surface with a knife blade prior to drilling. In hindsight a smaller masonry drill bit should have been used to drill the relatively thin concretion layer (maximum depth 8 mm) as the minimum closed volume of sea water was not attained for recording the surface pH. The variance in the pH readings may reflect this.

Figure 5. Position of corrosion potential and surface pH measurements and sediment sampling on the *Alacrity* site [Carpenter 1997].
