# ROTTNEST ISLAND: MARITIME CULTURAL HERITAGE ANALYSIS AND MANAGEMENT PLAN-2002

Edited by: Matthew Gainsford

Department of Maritime Archaeology, Western Australian Maritime Museum  
2002 Post Graduate Diploma of Maritime Archaeology

Report—Department of Maritime Archaeology  
Western Australian Maritime Museum No. 190.

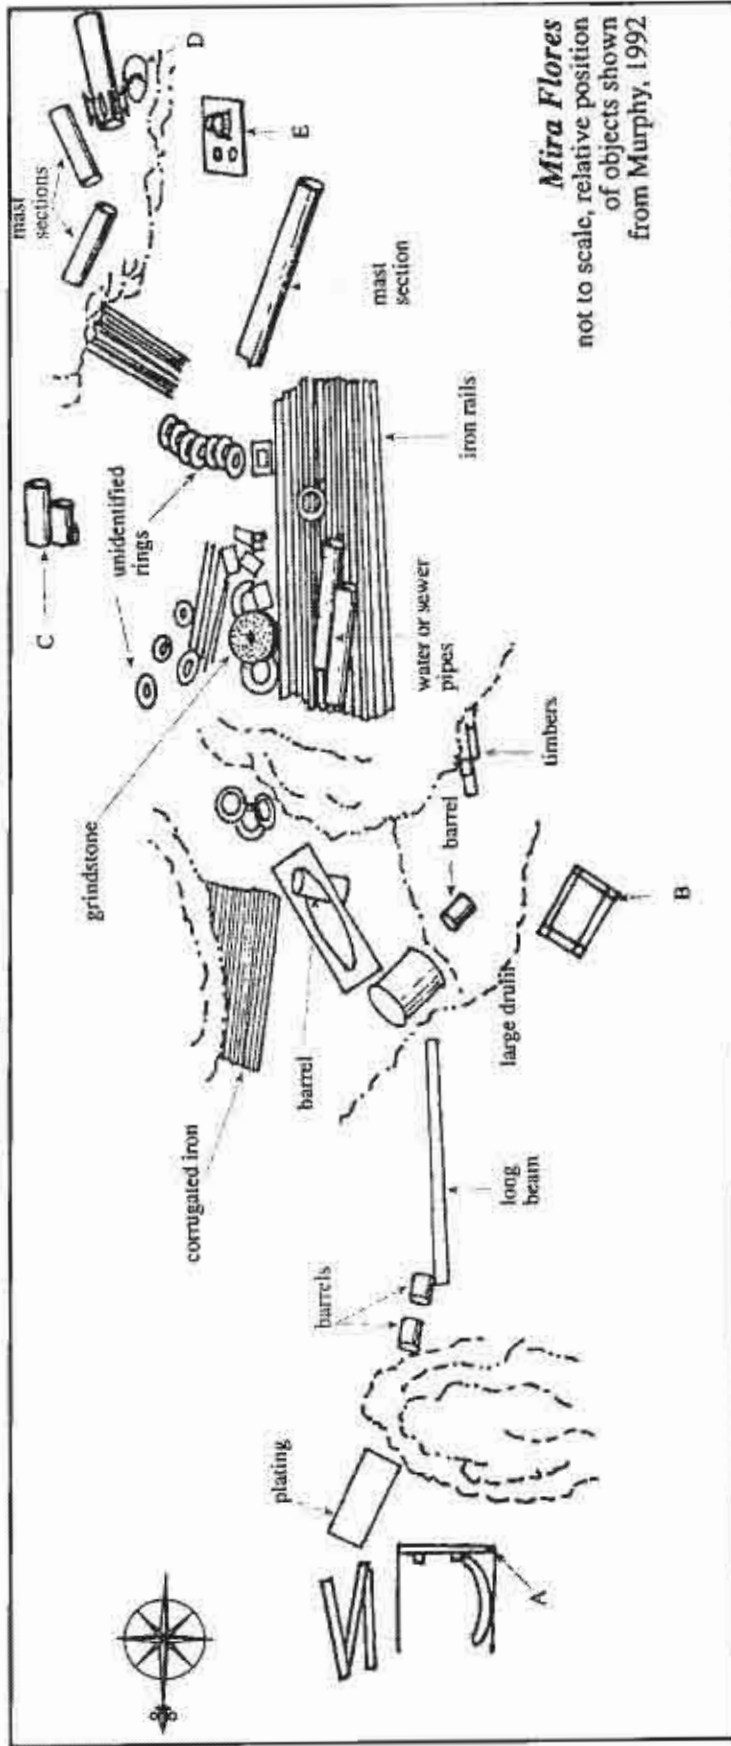
Figure 5. Plan of the *Mira Flores*

Sarah Kenderdines' site plan (see Figure 3) clearly delineates the sites' area. In light of the conditions experienced on this survey, the plan produced in Kenderdines' book remains the most informative. The *Mira Flores*' stern faces the shoreline, with the majority of the wreckage located on a kelp-covered reef top varying in depth from five to seven metres. Overall, the site measures 100 metres by 25 metres, with hull plating and frames spread throughout the wreckage. The wreckage located on the reef top is low relief and relatively hard to distinguish

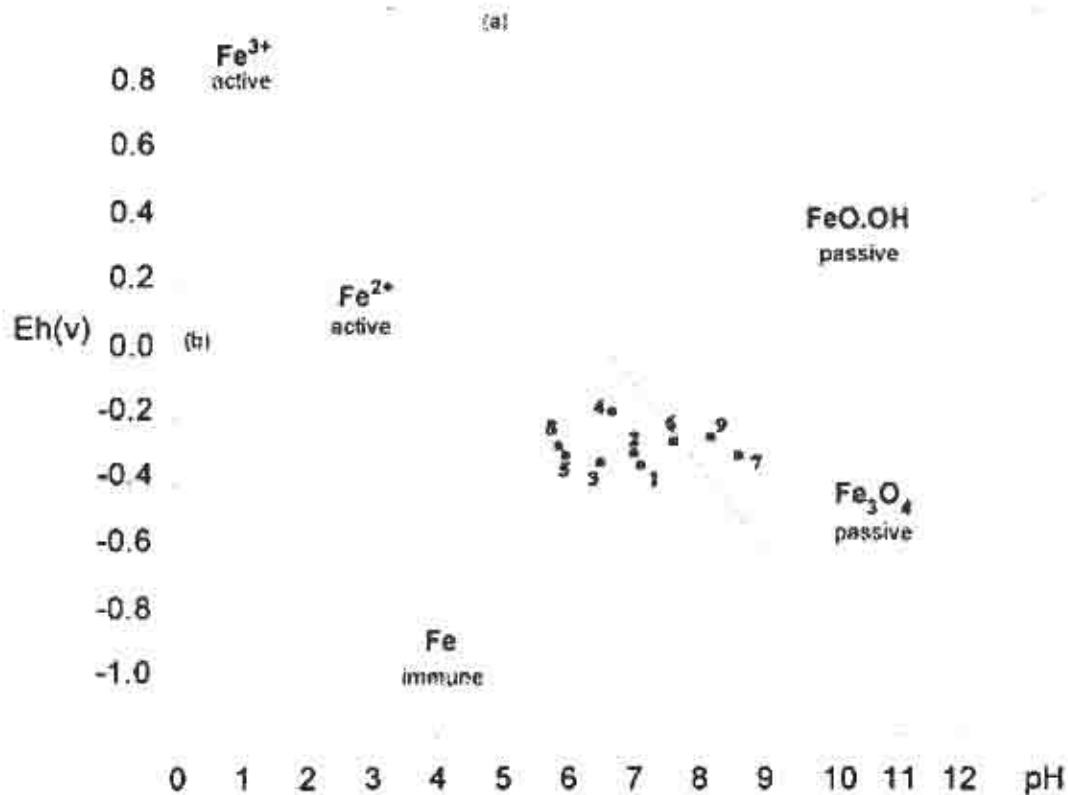
Figure 9. Pourbaix diagram for iron corrosion on the *Uribes*

Depth of graphitisation:  
3–6 millimetres

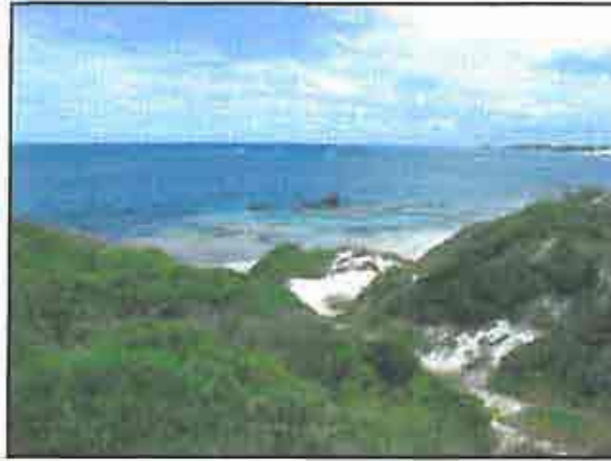
Figure 10. The *Shark* viewed from the road

As previously discussed, the site has remained relatively intact, and the structural components have remained easily identifiable. However, although it is a recent wreck it will continue to corrode rapidly. The site is corroding in the same pattern as that outlined by Riley in his model of iron ship disintegration (see Figure 12). The bow and stern will remain relatively intact, whilst the hull will collapse—evidenced on the port side—where not supported by the reef. The midship fittings have remained in a good state of preservation—not submerged—, and they are also vertical—not subject to problems caused by their weight—: in time, it is likely that these will collapse and become submerged.

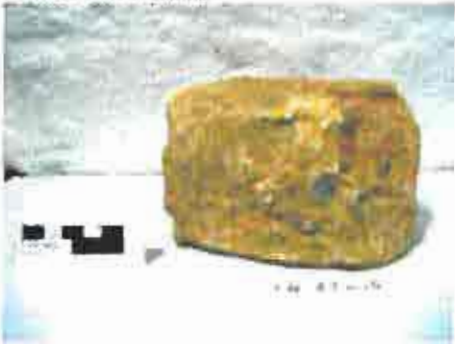
IND. NO.	
REG. NO.	CH75108 MC 75/108 (Museum Records)

VENUE	Rottnest Island Museum	DATE IN	
TITLE/TYPE OF OBJECT	Chunk of red lead oxide		
DIMENSIONS	12.7cm wide and 8 cm tall		
OWNER			
<b>Description of Object</b> Can see the pink oxide on the edges and it is heavily concreted.		<b>PHOTOGRAPH</b>

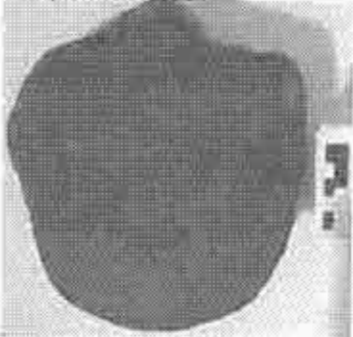
IND. NO.	
REG. NO.	CH75 109 MC 75/109 (Museum records)

VENUE	Rottnest Island Museum	DATE IN	
TITLE/TYPE OF OBJECT	Coal		
DIMENSIONS	210x180mm		
OWNER			
<b>Description of Object</b> Lump of coal, crumbling.		<b>PHOTOGRAPH</b>

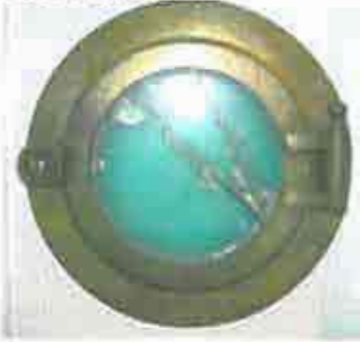
IND. NO.	
REG. NO.	CY3278

VENUE	Rottnest Island Museum	DATE IN	
TITLE/TYPE OF OBJECT	Porthole with glass		
DIMENSIONS			
OWNER			
<b>Description of Object</b> Brass porthole with glass. Glass cracked but still intact.		<b>PHOTOGRAPH</b>

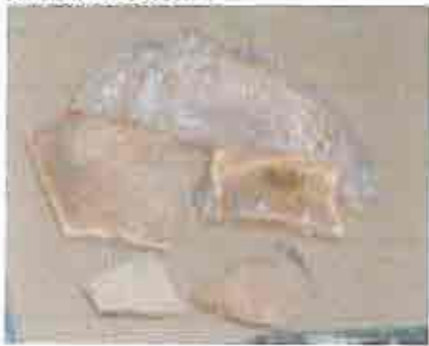
<b>IND. NO.</b>	
<b>REG. NO.</b>	MC2577

<b>VENUE</b>	Rottnest Island Museum	<b>DATE IN</b>	
<b>TITLE/TYPE OF OBJECT</b>	Stoneware sherds		
<b>DIMENSIONS</b>	Base was 13cm diameter		
<b>OWNER</b>			
<b>Description of Object</b> Had brown stenciling, and little brown cracks in the glaze. White concretion and salt coming out.		<b>PHOTOGRAPH</b>

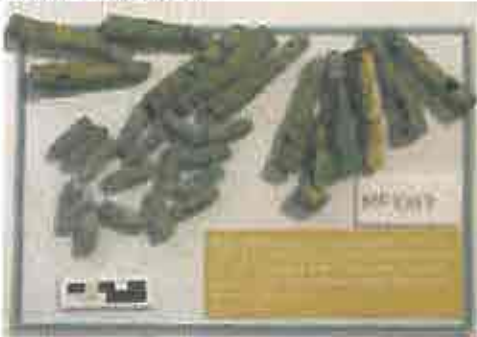
IND. NO.	
REG. NO.	MF1087

VENUE	Rottnest Island Museum	DATE IN	
TITLE/TYPE OF OBJECT	Lead bullets		
DIMENSIONS	Diameter is 1.12cm, length is 3.14 cm		
OWNER			
<b>Description of Object</b> Has concretion on some and white residue on the surface.		<b>PHOTOGRAPH</b>

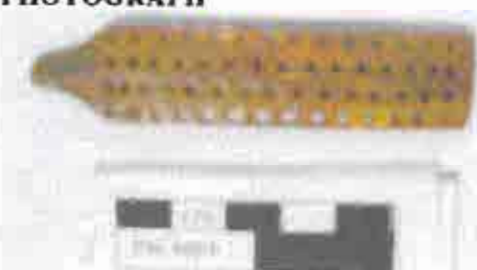
IND. NO.	
REG. NO.	ST503

VENUE	Rottnest Island Museum	DATE IN	
TITLE/TYPE OF OBJECT	Wood/ Bone base of comb/ Toothbrush		
DIMENSIONS	80x30mm		
OWNER			
Description of Object	PHOTOGRAPH		
Base of toothbrush/ comb with holes for bristles. Handle broken.
