WRECK INSPECTION REPORT

7 Mile Beach (Dongara) Unidentified¹

Department of Maritime Archaeology
Shipwreck Galleries
W. A. Museum
Cliff St. Fremantle
April 2018

Site Name: 7 Mile Beach (Dongara) Unidentified
Date lost: Post WWII

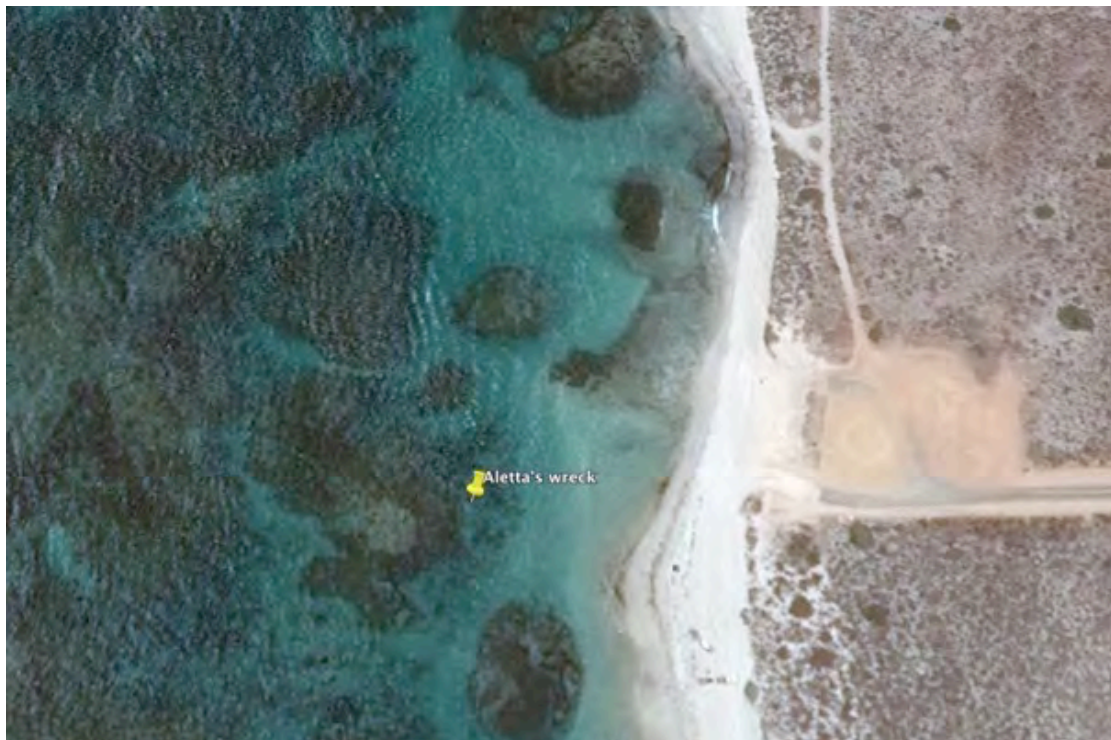
SITE LOCATION: Showing the 7 Mile Beach road, the carpark, makeshift ramp, the site and offshore reefs. (from Google Earth)

The site is sheltered from the prevailing winds and protected by an outlying reef structure to the west and south that also serves to form a natural boat haven. Fishing boat moorings (chain and in one case a close stowing anchor) are visible on sand to the north of the wreck. Though the area remains in use by large fishing vessels, those moorings close to the wreck appear to be abandoned and are too large for a vessel of this size. As such they are not part of the wreck, but do form part of the 7 Mile Beach boat haven's rudimentary infrastructure, comprising access road, ramp, moorings and an overnight unserviced caravan or camping area.

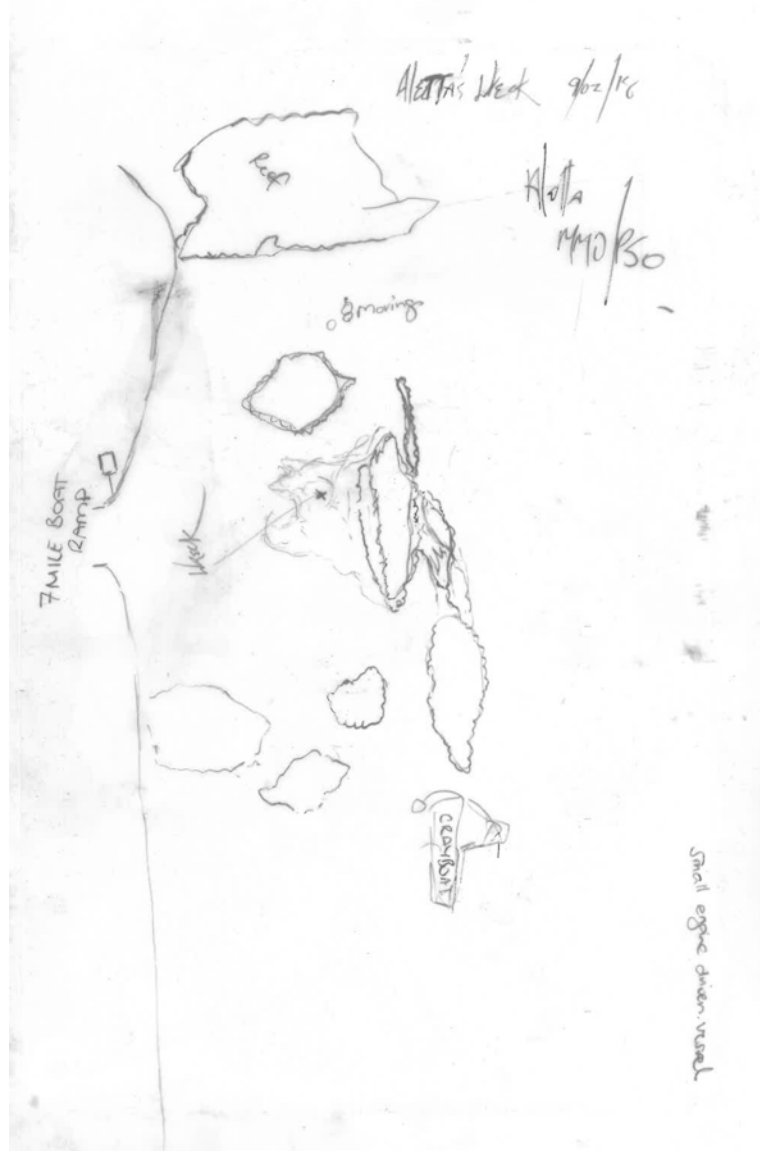
Sketch Map showing access to Site (North is down).¹

¹ Sketch by the finder. Explanation: The annotations MMO-PSO were added as an aide memoire by M.McCarthy and reflect the Finder's occupation Marine Mammal Observer- Protected Species Observer.
