INTRODUCTION

The purpose of this paper is to ascertain the possible and probable causes of the loss of H.M.A.S. SYDNEY.

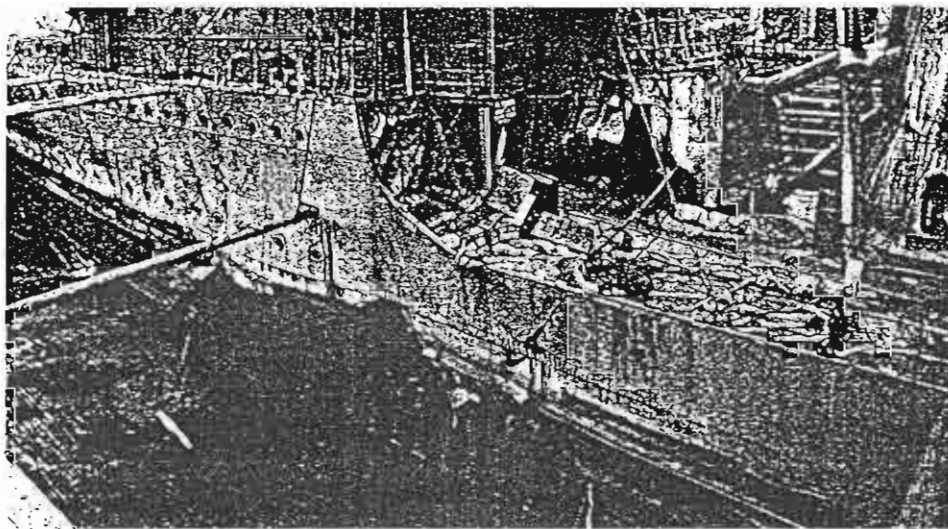
ANOTHER VIEW OF THE KELLY PRIOR TO REMOVAL
OF HER SUPERSTRUCTURE TO FACILITATE HER
REBUILDING.

the KELLY's sluggish movements and recognized the imminent danger of capsizing. He calculated that he needed to remove at least 10 tons of topweight to preserve stability.' But everything loose had already been ditched,'and all that remained was the ship's company who were all huddled on the upper deck.' As their aggregate weight was more than 10 tons, Mountbatten kept a skeleton crew and had the remainder transferred off the ship.

The KELLY was saved, and subsequent calculations by her designer revealed that if Mountbatten had not removed the bulk of his crew, the ship would have indeed capsized and sunk.(4)
