Maritime Archaeology in Sri Lanka

The Galle Harbour Project—1993

Interim Report

Report—Department of Maritime Archaeology
Western Australian Maritime Museum, No. 65
1993

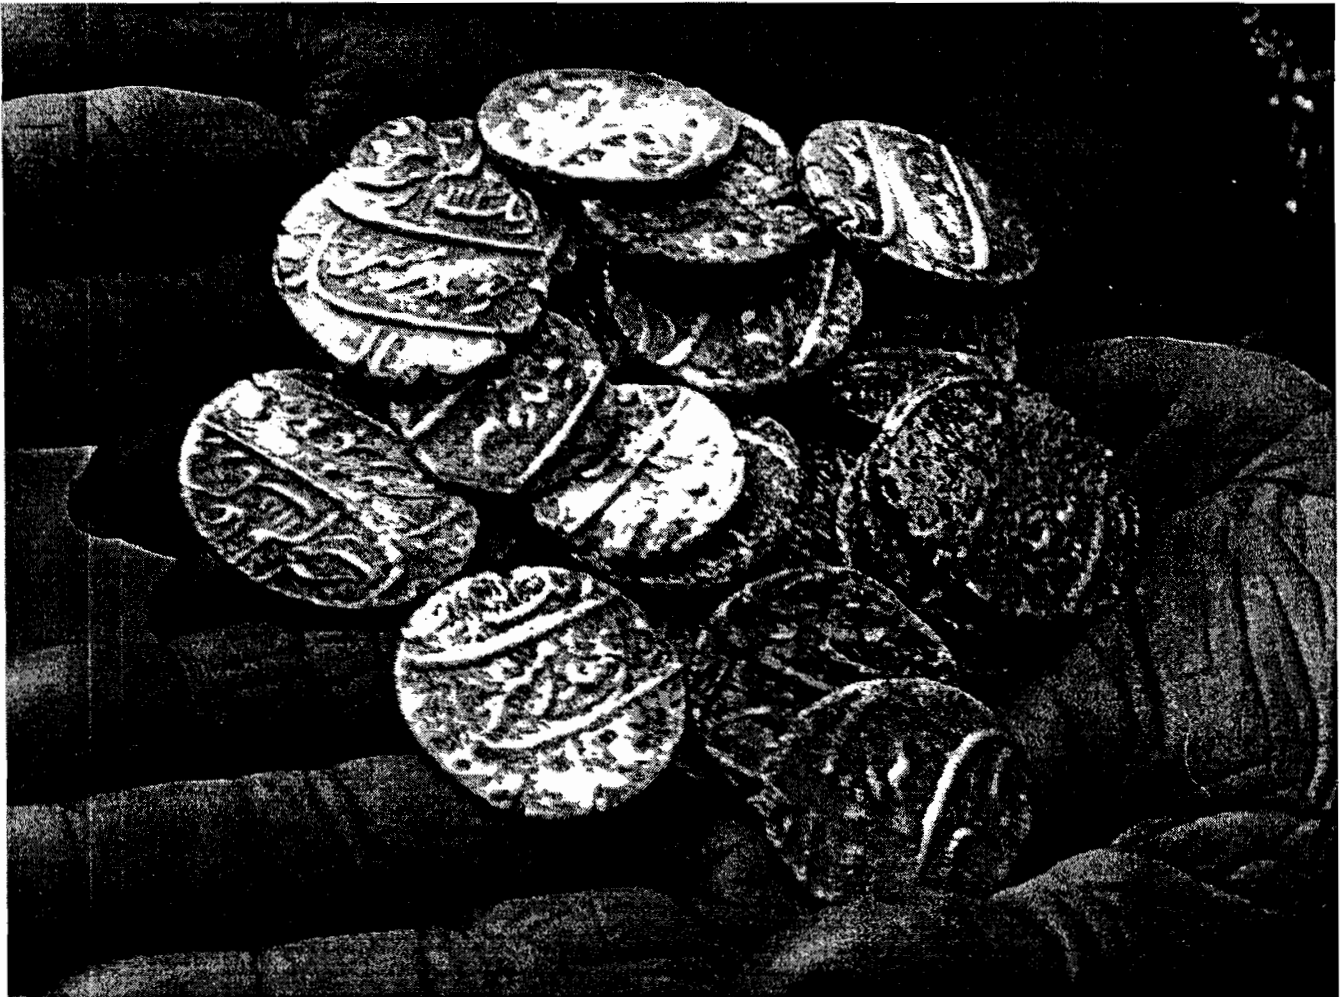
Figure 13. Coins from the Great Basses Site.

The silver coins exhibit varying degrees of corrosion. Some of the better preserved coins have iron corrosion deposits indicating that cathodic protection influenced their condition. The lead shot was found in an excellent state of preservation. With the exception of the beads, the
