# Town Jetty, Esperance

## Maritime Heritage Site Inspection Report

Compiler: Dena Garratt  
Consulting Maritime Archaeologist  
June 1994

Report - Dept. of Maritime Archaeology  
WA Maritime Museum, No 87.

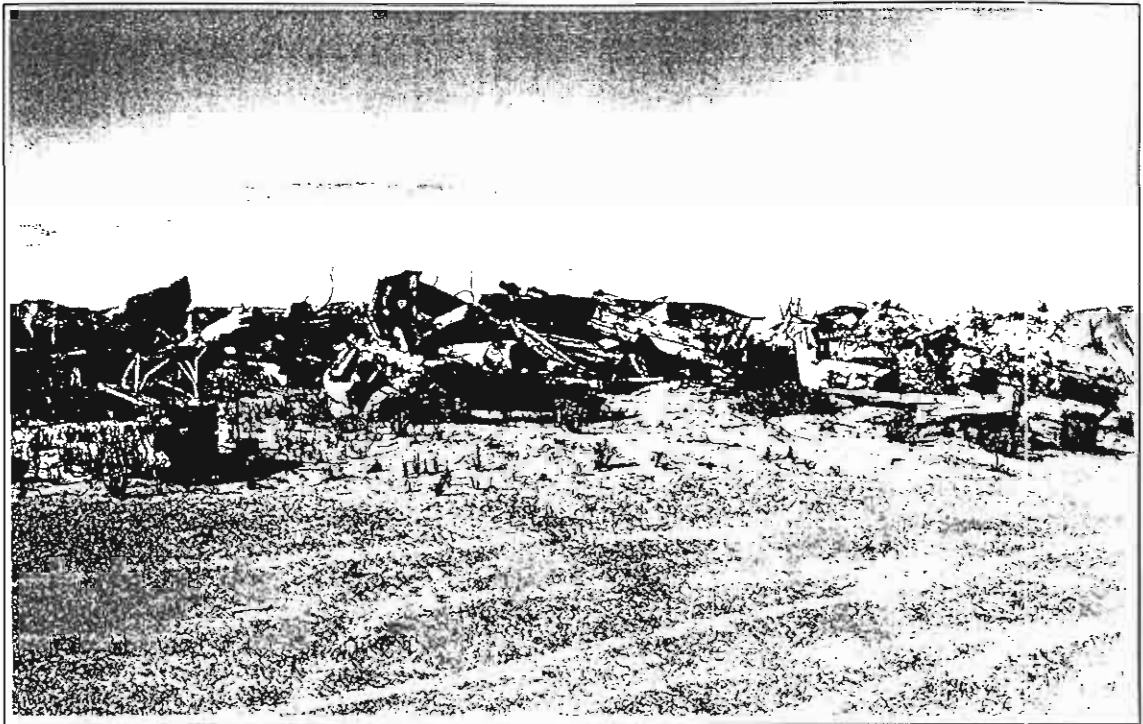
*Figure 8.* Material from Town Jetty dumped on the inner end of the Esperance harbour breakwater.  
(D. Cumming 1994.)

*Figure 9.* Material from Town Jetty dumped on the inner end of the Esperance harbour breakwater. (D. Cumming 1994)

*Figure 10.* Material from Town Jetty dumped on the inner end of the Esperance harbour breakwater. (D. Cumming 1994.)

*Figure 11.* Material from Town Jetty dumped on the inner end of the Esperance harbour breakwater. (D. Cumming 1994)
