THE V.O.C. SHIP "ZEEWIJK" 1727

REPORT ON THE 1976 SURVEY OF THE SITE

Catharine Ingelman-Sundberg  
Assistant Curator  
Department of Maritime Archaeology  
Western Australian Museum

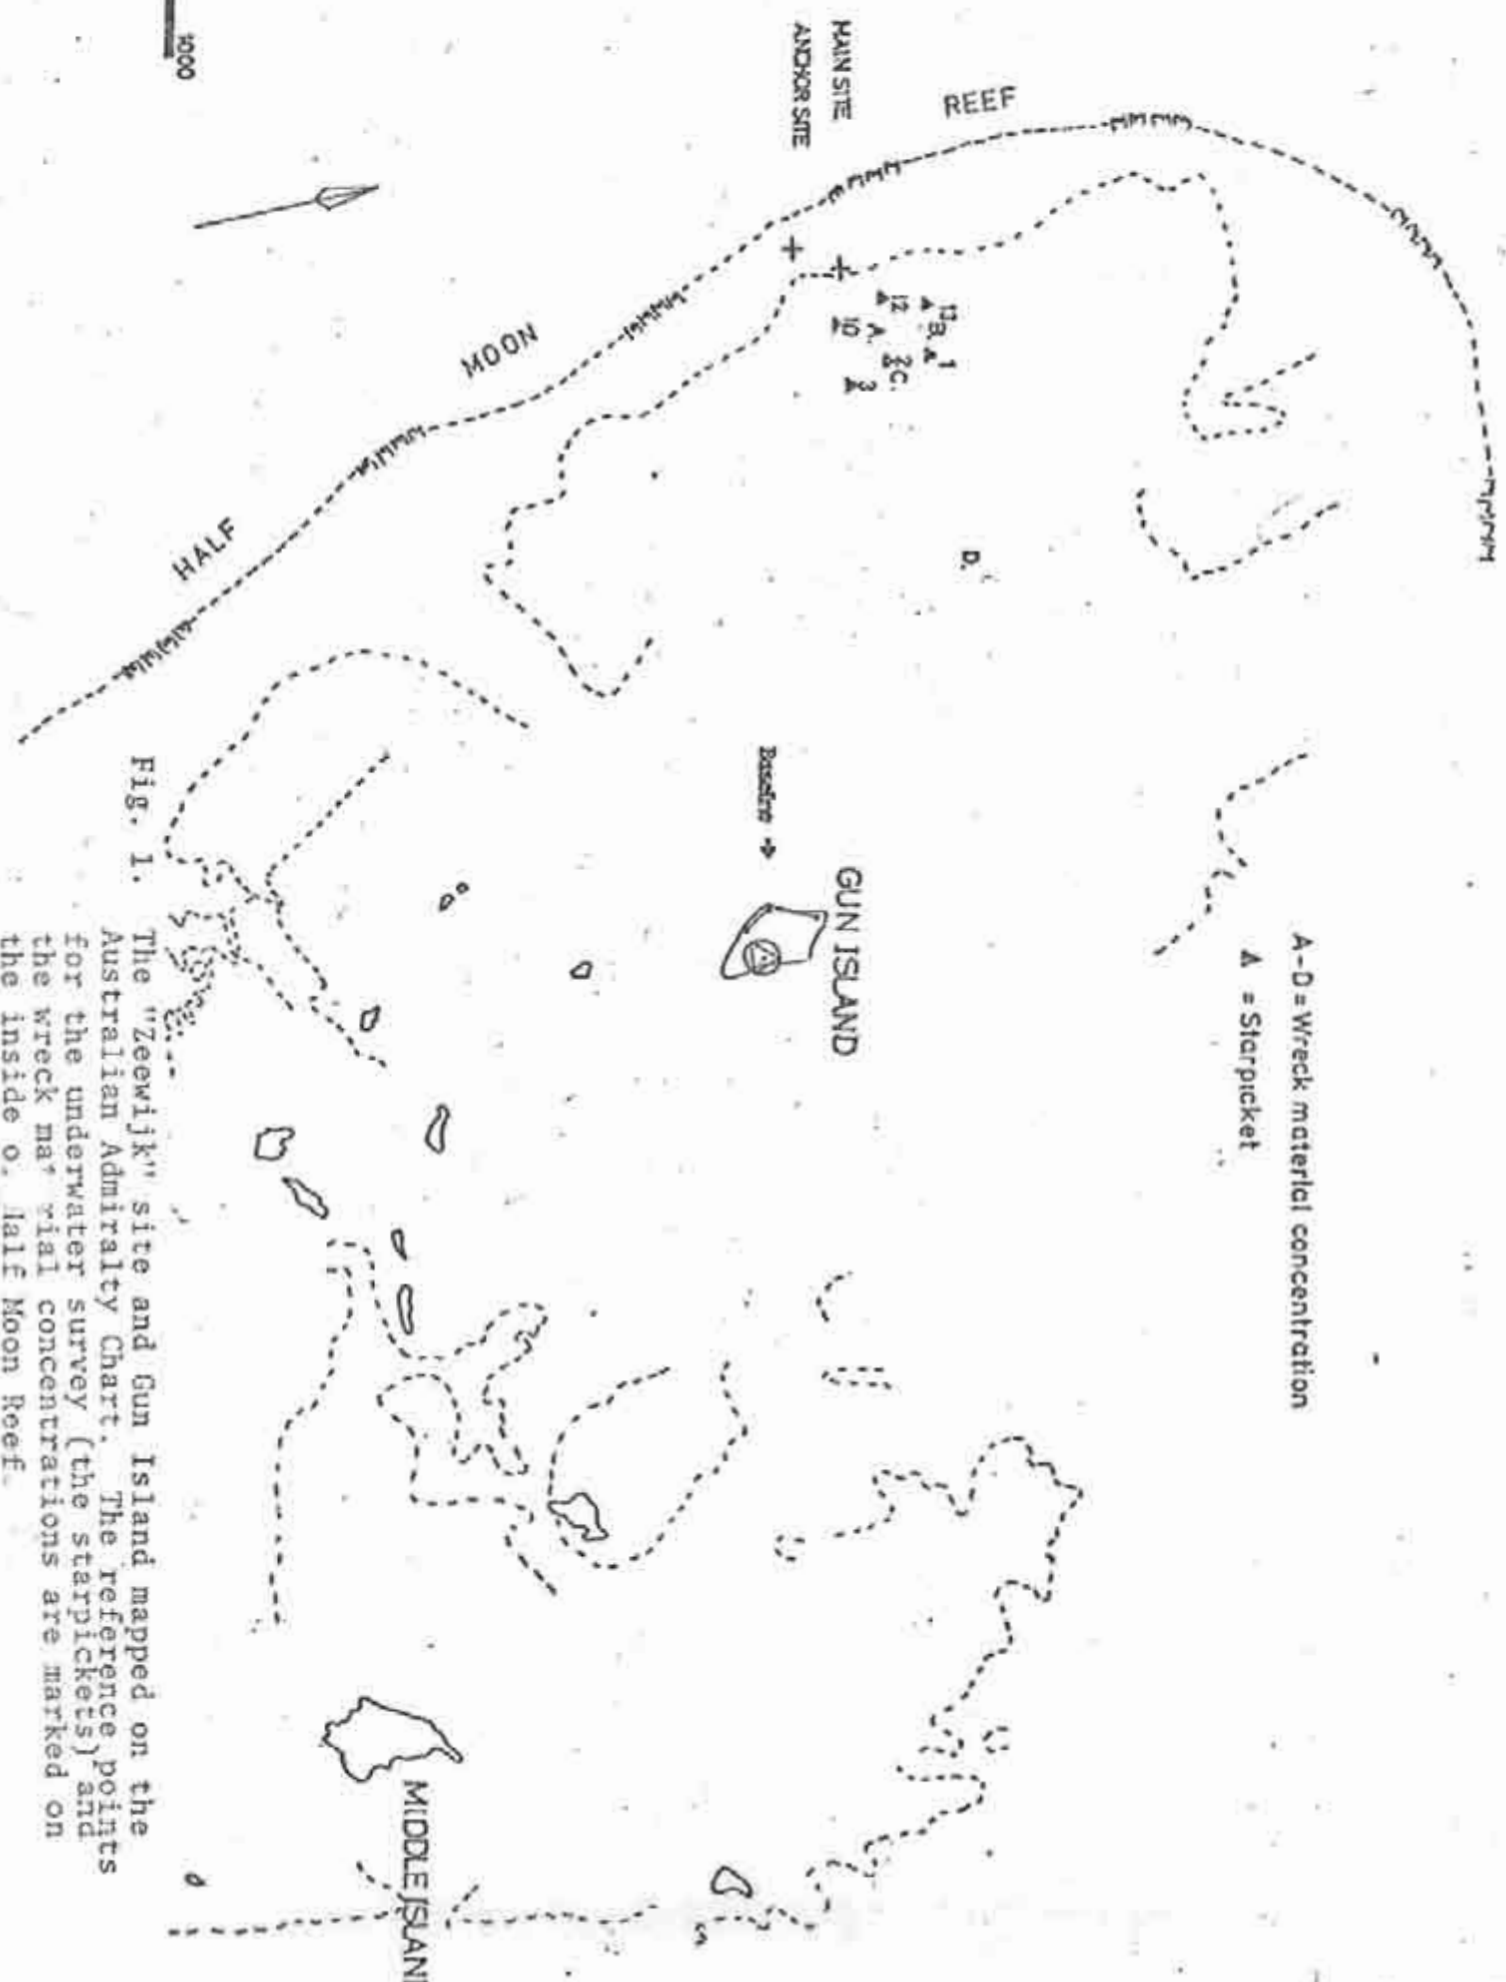
Fig. 1.

The "Zeewijk" site and Gun Island mapped on the Australian Admiralty Chart. The reference points for the underwater survey (the starpickets) and the wreck material concentrations are marked on the inside of Half Moon Reef.

A-D = Wreck material concentration  
A = Starpicket

The reference points consisted of six starpickets with flags on the end of bamboo canes attached to the pickets and were placed on the reef and in the shallows, fig. 1.

Three starpickets were hammered into the reef in a line at a distance of 280m apart, while the other three starpickets were placed 280 and 300m from each other in the shallow water inside the reef 350m and 90° east of the first line of markers. In this way the lines of starpickets formed a rectangle where each starpicket on the reef faced one in the shallows.

Wreck debris was found within the underwater survey area as well as between this area and Gun Island. So far, four major wreck material concentrations have been recorded on the inside reef. The areas are marked A to D, fig. 1.

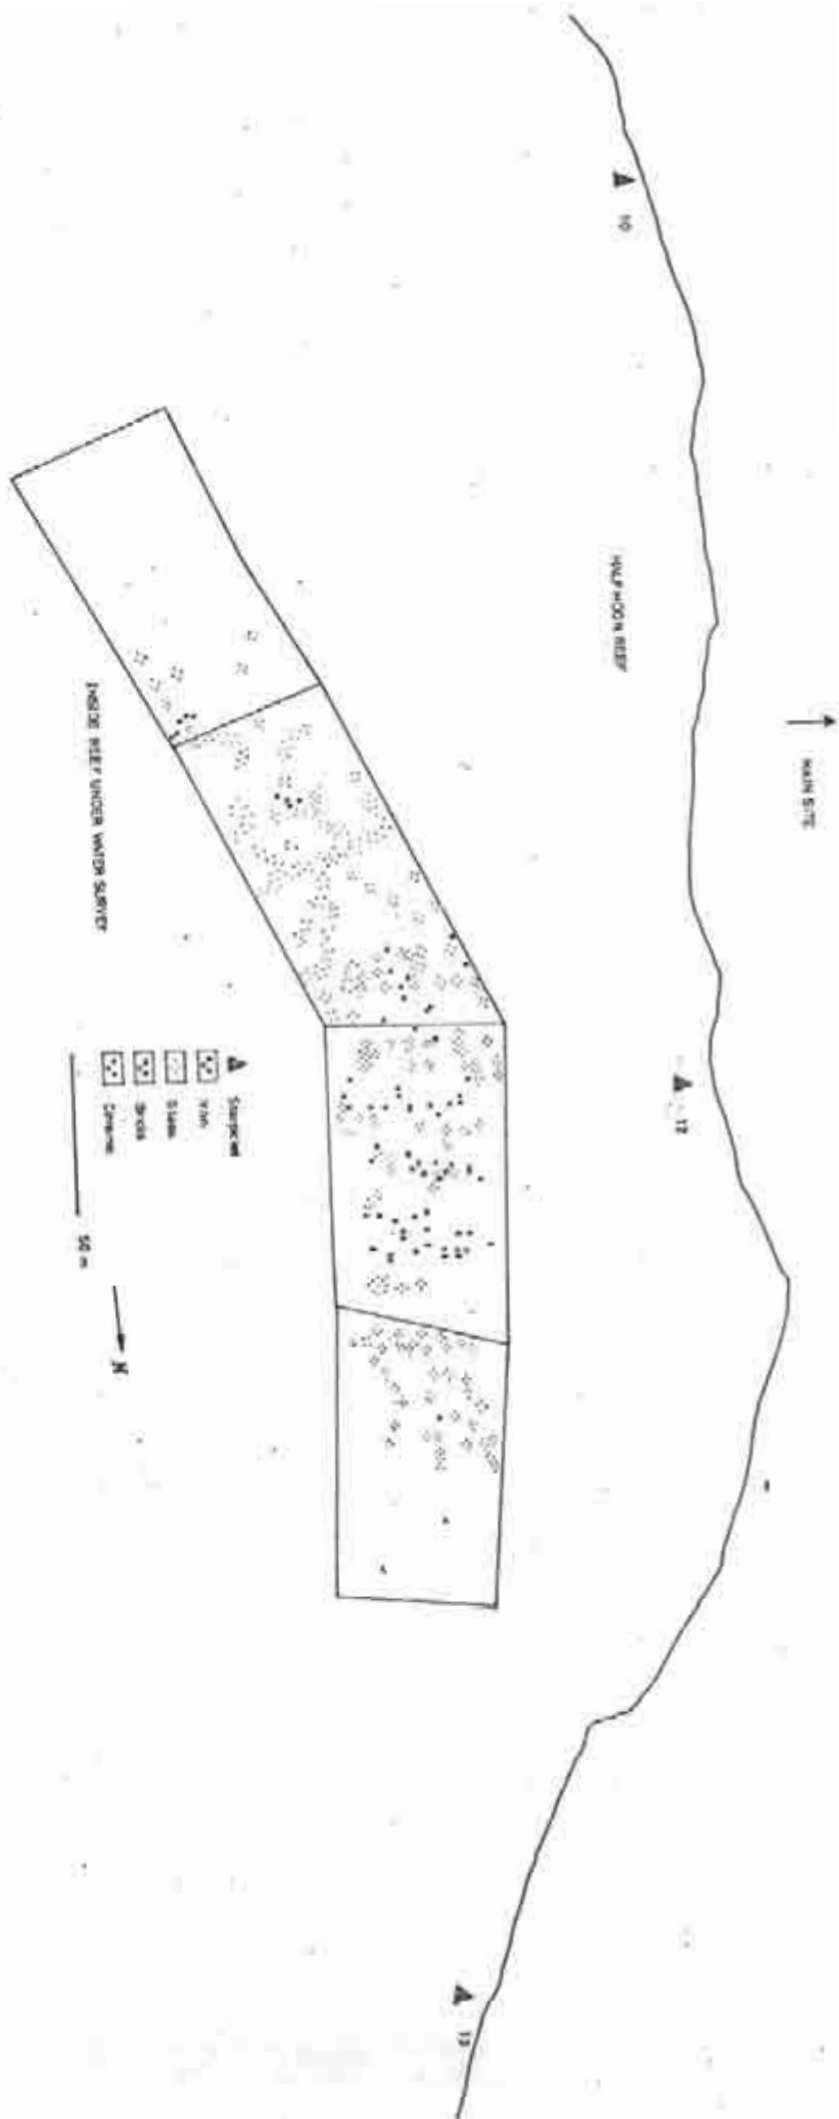
▲ Fig. 2. Distribution of artefacts recovered during the underwater survey.

As a result of the swimline search, it was possible to determine the extent of the area where wreck material had been washed over the reef. In the 50 x 400m area searched, the 300m wide area in the middle yielded 510 fragments of glass, pottery, bricks and metal.

The extent of different material varied in different areas, fig. 2A. At this stage of investigation, it is difficult to explain the reasons for this distribution. However, it is obvious that before any complete analysis can be done, the wreck site on the outside reef has to be fully investigated. Also, consideration has to be given to currents and the structure of the bottom in the area between the main site and in the underwater survey area. In addition, the shape and weight of the different wreck material involved has to be examined.

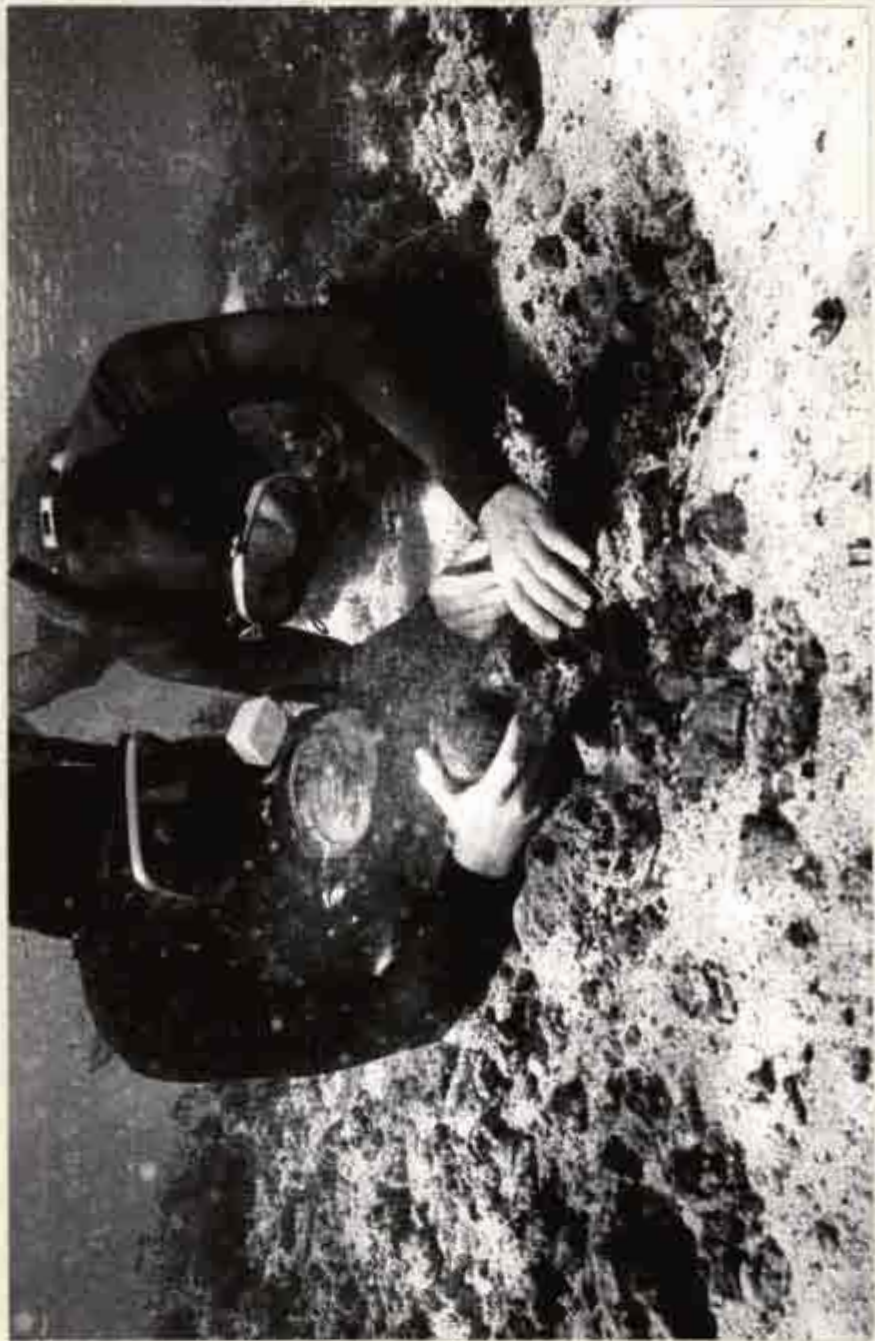
Divers recovering cannon balls in the underwater survey area.

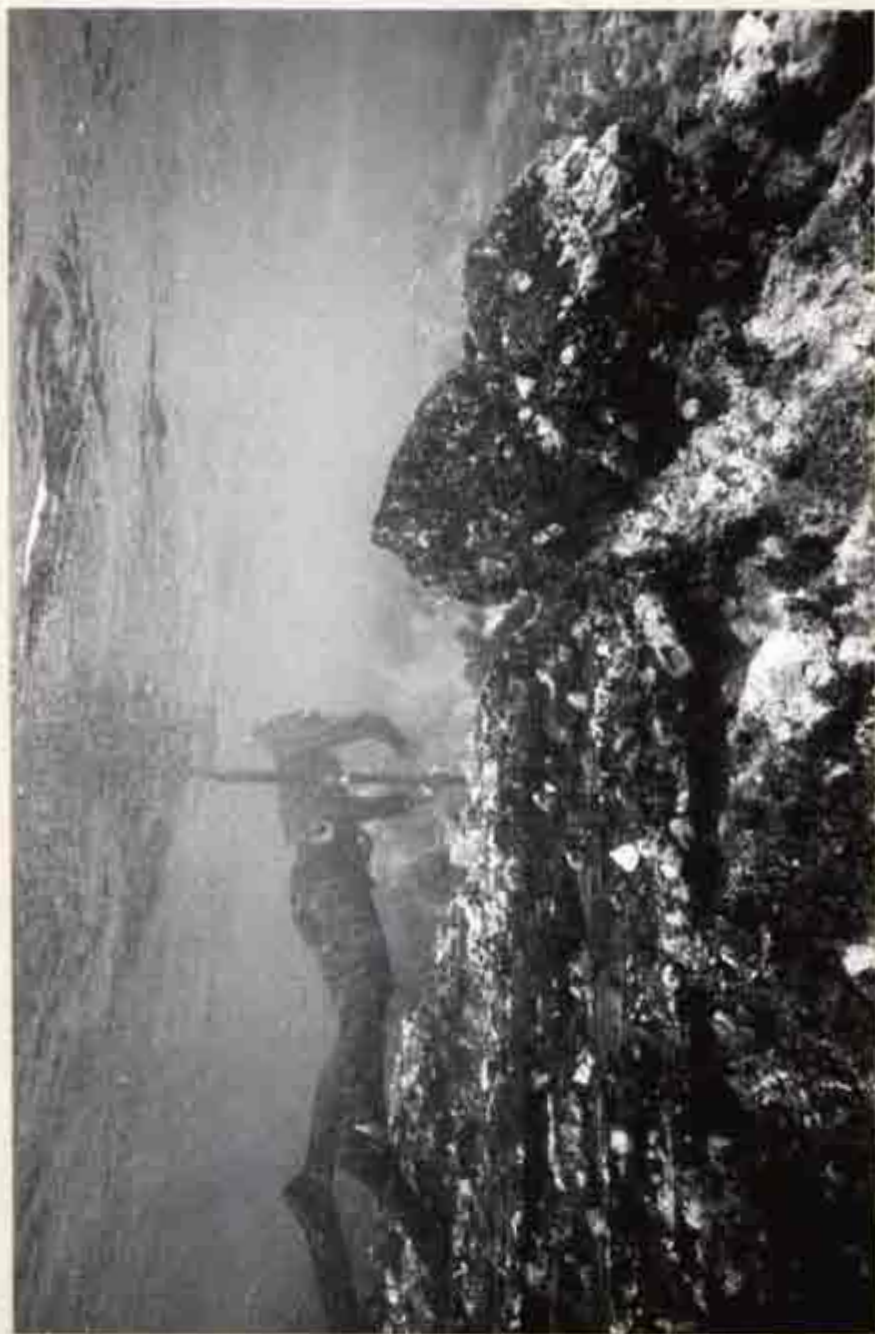
Fig. 2B. Iron bars and kegs of nails in Area B. In the background the starpicket base of marker 13.

In Area B, 1 iron cannon, 7 kegs of nails and 2 concentrations of iron bars have been located, fig. 2B. The wreck material is situated in about 1-1.5m of water on a hard limestone and coral bottom. The area was surveyed with an underwater theodolite. A test excavation in the area did not reveal any further finds.

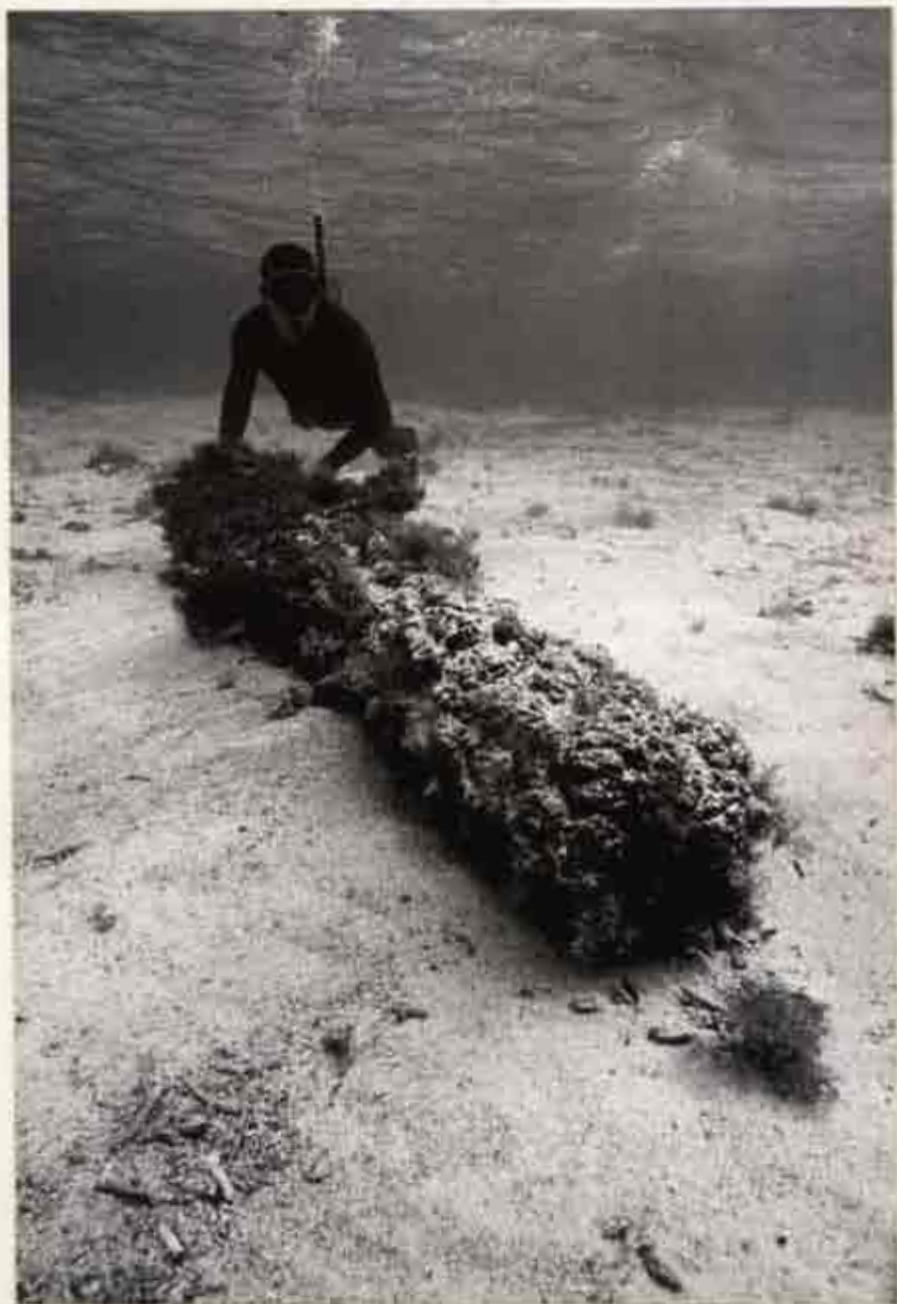
Fig. 3. A 2.60m long iron cannon found in Area C, 800m from the "Zeewijk" main site.

Area C located during the 1976 expedition contains another iron cannon, iron hooks, chain plates, part of a mast cap, and a lot of broken glass and ceramics, fig.3. The items lay

The iron hooks were found in the near vicinity of the cannon and might have been the hooks which once held the guncarriage in place on deck.

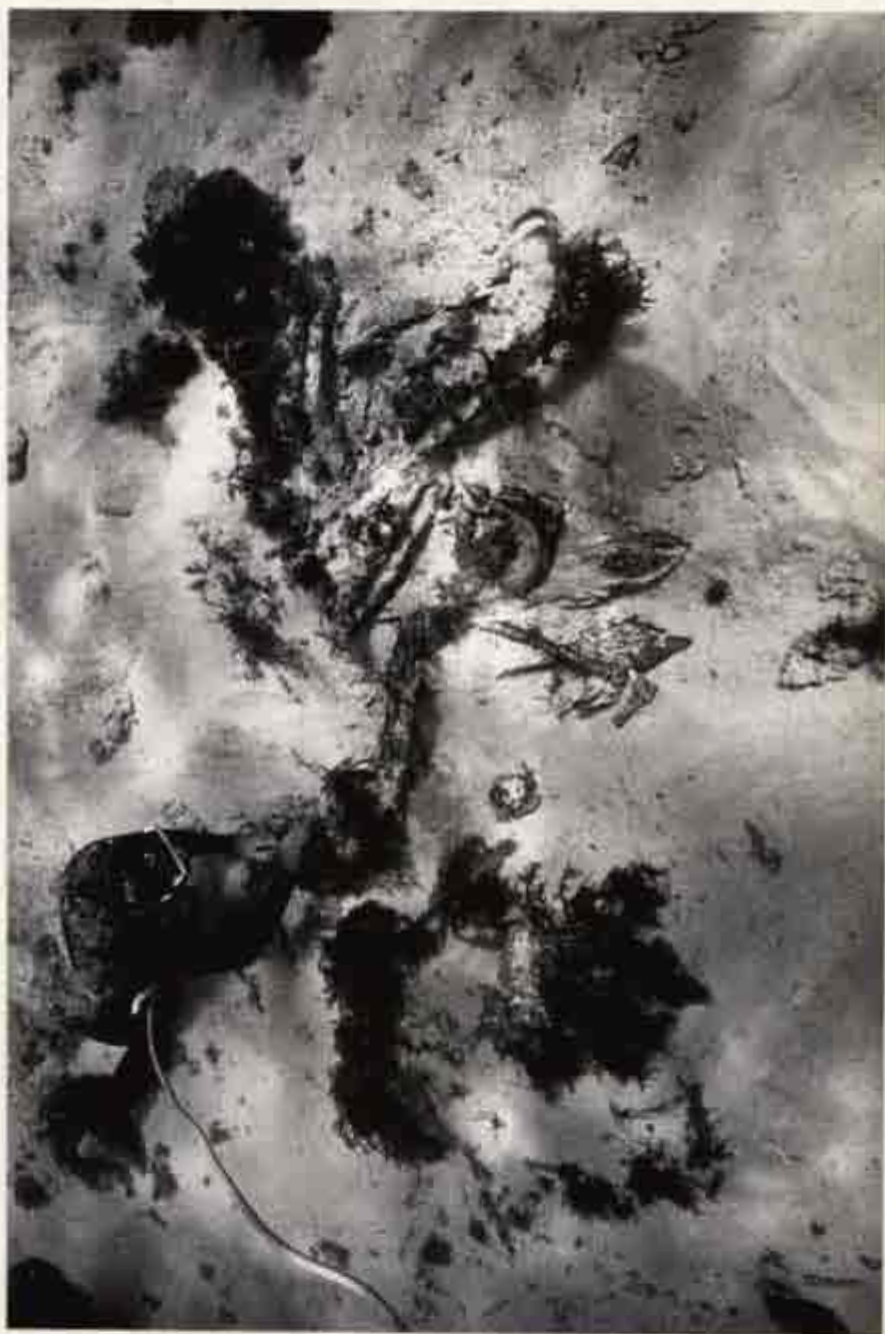
Fig. 4. Diver examining part of the "Zeewijk" rigging found 3.2km from the reef, in Area D.

Area D, fig. 4, lies in 2-4m of water on a sandy bottom surrounded by coral 3.2km from the reef. In this area, only parts from the rigging and timbers have been found. Visible, and partly buried in the sand, were 6 pieces of timber, chain plates and iron conglomerates. The area was mapped with triangulation and with the help of an underwater theodolite.

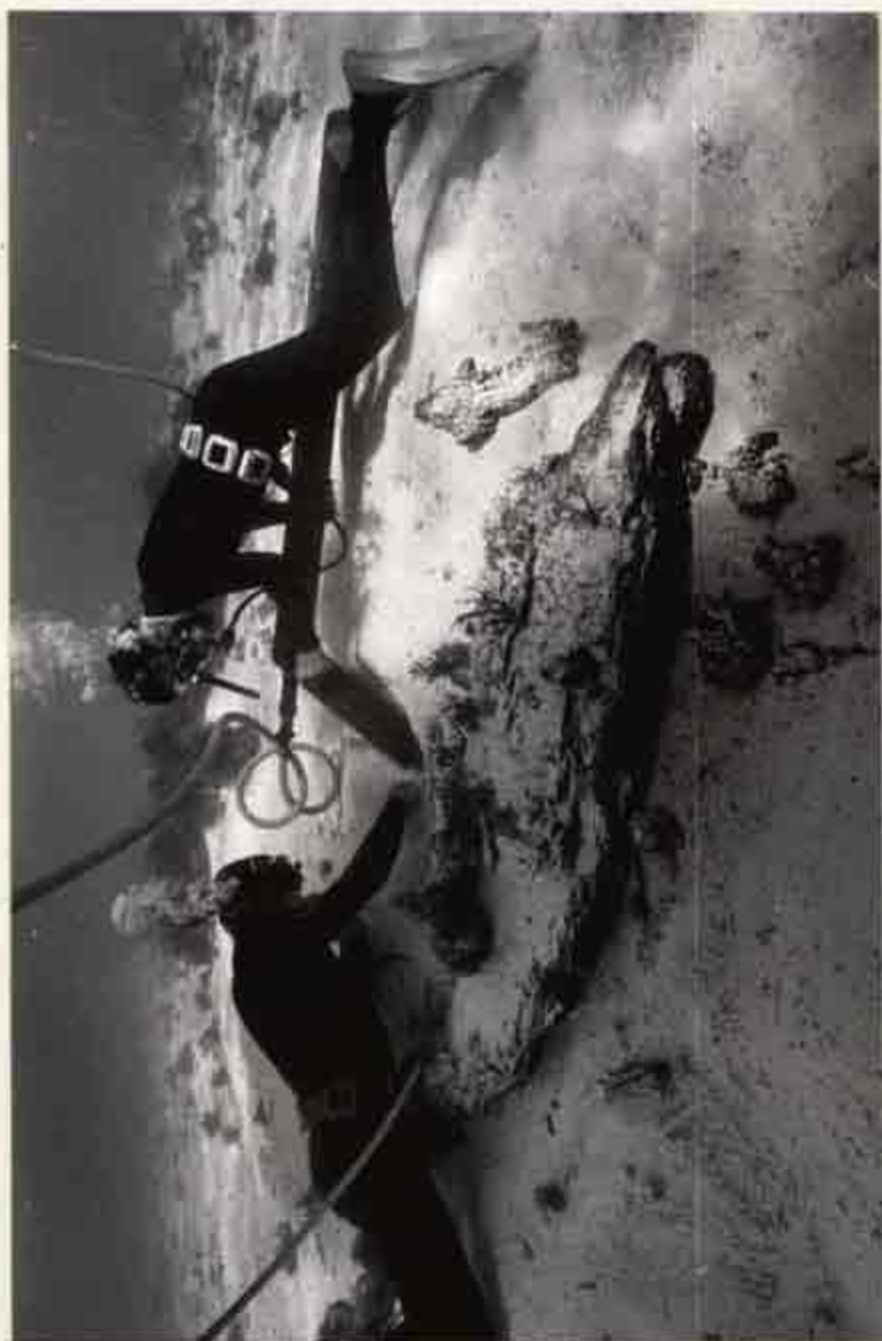
Divers uncovering "Zeewijk" timbers on the inside reef, Area D.

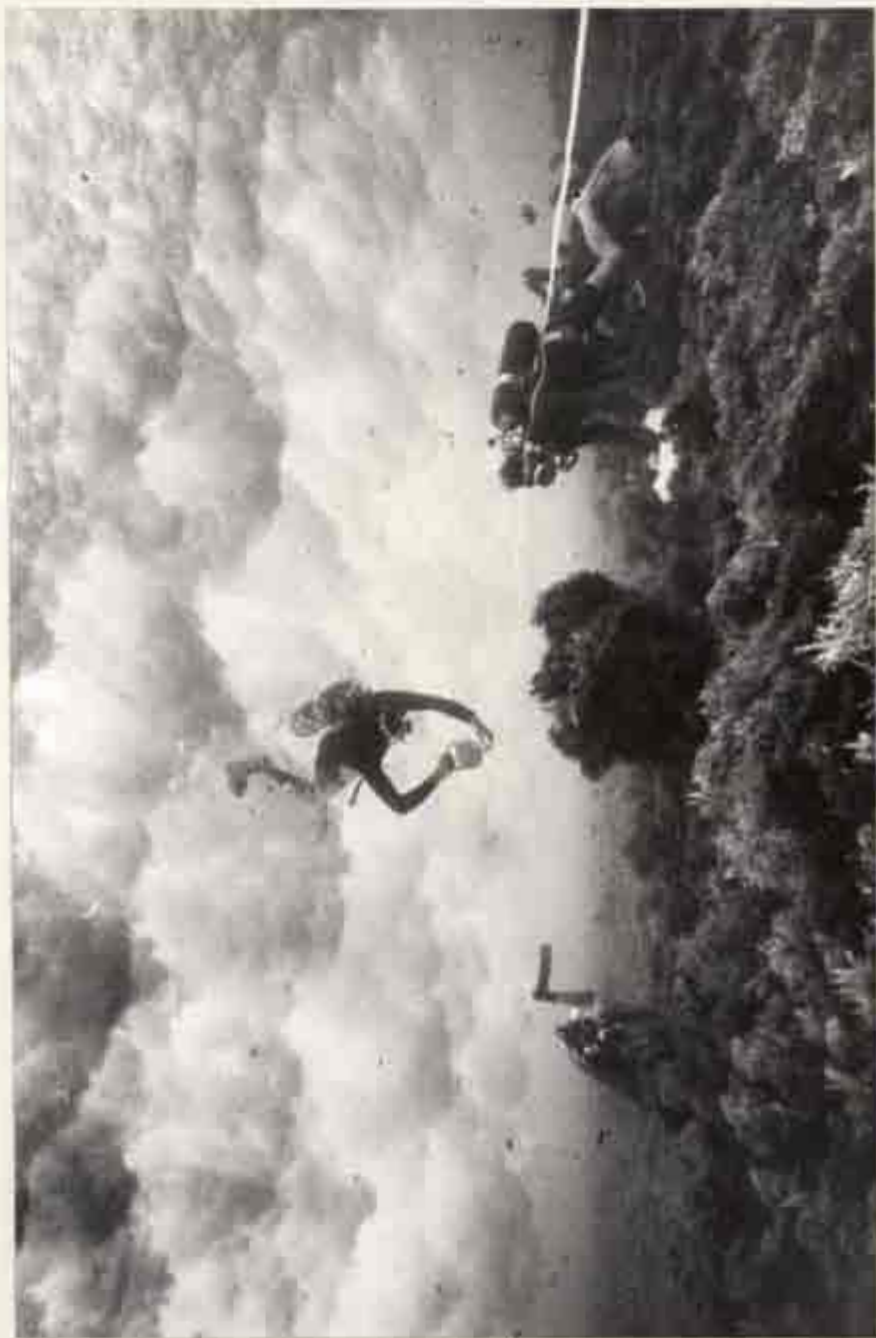
Fig. 5. The rough sea on the "Zeewijk" main site makes survey work a difficult task.

As has been pointed out before, the rough conditions of the "Zeewijk" site make any survey of the wreck an extremely difficult task, fig. 5.

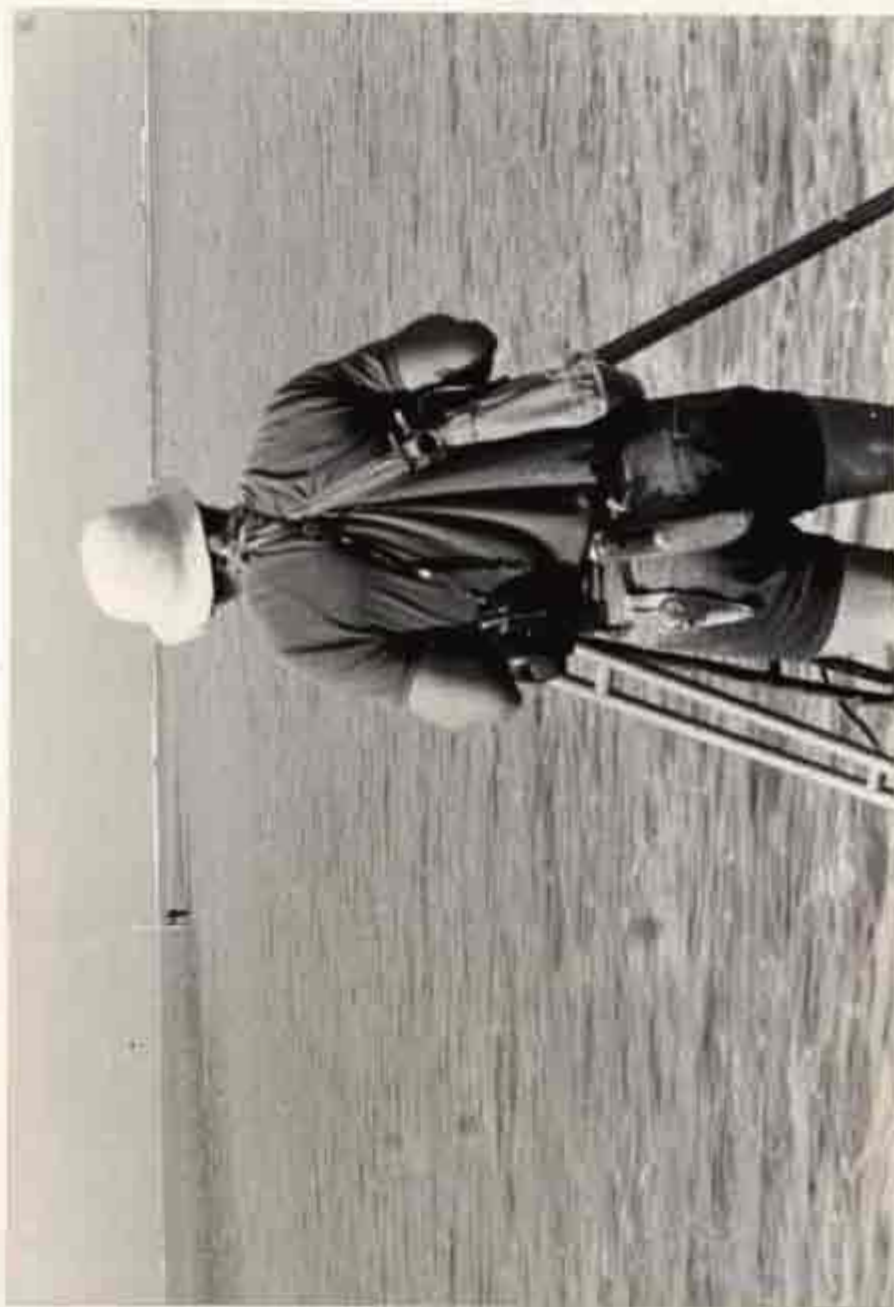
Fig. 6.      Setting up the theodolite on the reef to eventually take readings of the buoys on the wreck site.

The position of the buoys were taken with a theodolite placed on the reef. The theodolite was related to the survey control stations on the reef (the starpickets) fig. 6, which thence were related to the survey station on the island. In this way the wreck site could be accurately plotted in relation to the island, the wreck material concentrations and the underwater survey areas.

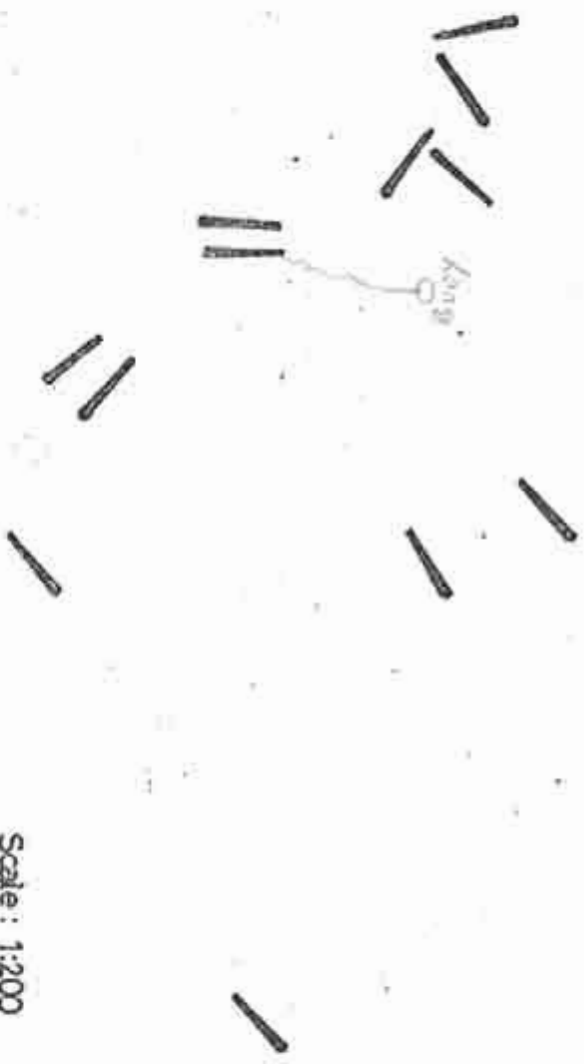
Fig. 7. A preliminary sketch of the "Zeewijk" main site area.

HALF MOON REEF  
ZEEWIJK MAIN SITE

Scale: 1:200

The triangulation of the main site resulted in a preliminary sketch of the area showing 12 cannon, fig. 7.
