*Maritime Archaeology in  
the People's Republic of  
China*

# Maritime Archaeology in the People's Republic of China

Interim Report for the Western Australian Department of Resources Development

**Part 1.**  
**The Song Dynast Shipwreck at Quanzhou**  
**Jeremy Green & Nick Burningham**

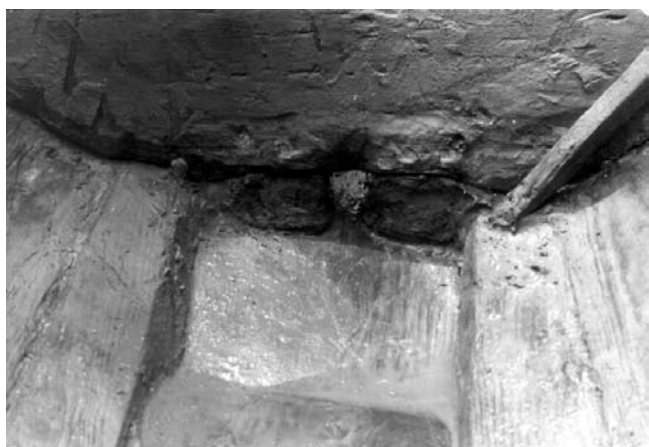
Figure 37. Fa Shi site showing the bulkhead and the waterway.

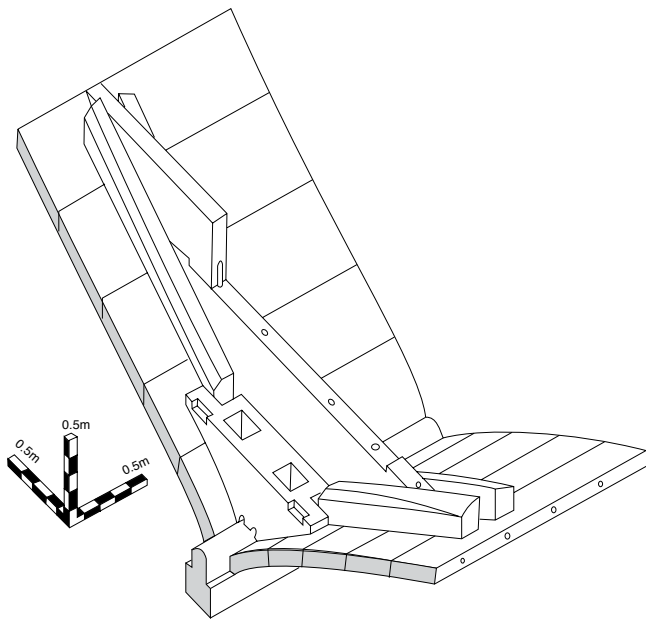
Figure 67. Cross-section of Bukit Jakas site showing the fore mast step and bulkhead frames.

Manguin (1983a) and Manguin and Nurhadi (1987) discussed a Southeast Asian vessel found in the Riau Archipelago at Bukit Jakas, Pulau Bintan, Indonesia (FIG). This vessel was edge joined with dowels (250 mm intervals) and had a keel length of about 25 m, planks are about 100 mm thick with a maximum width of 370 mm. The vessel had 17 bulkheads and the remains of (possibly) a fore mast step. The step had two rectangular holes for the tabernacles (100 x 150 mm by 100 mm deep). The separation of the holes was about 250 mm. The site is tentatively dated to 1445±80 (Manguin, 1983a).

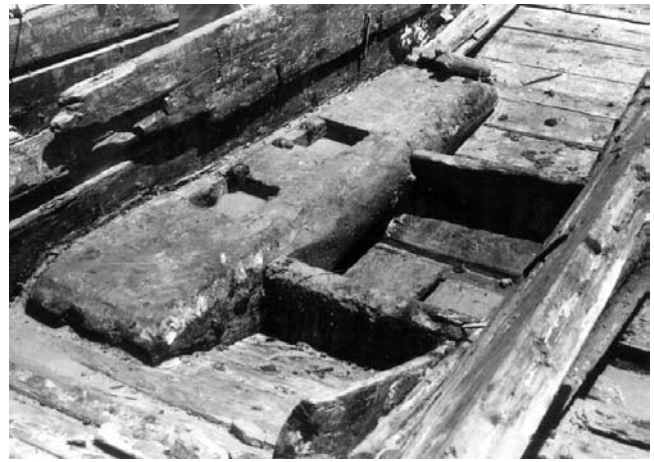
Figure 80. The main mast step at time of excavation, note longitudinal braces.

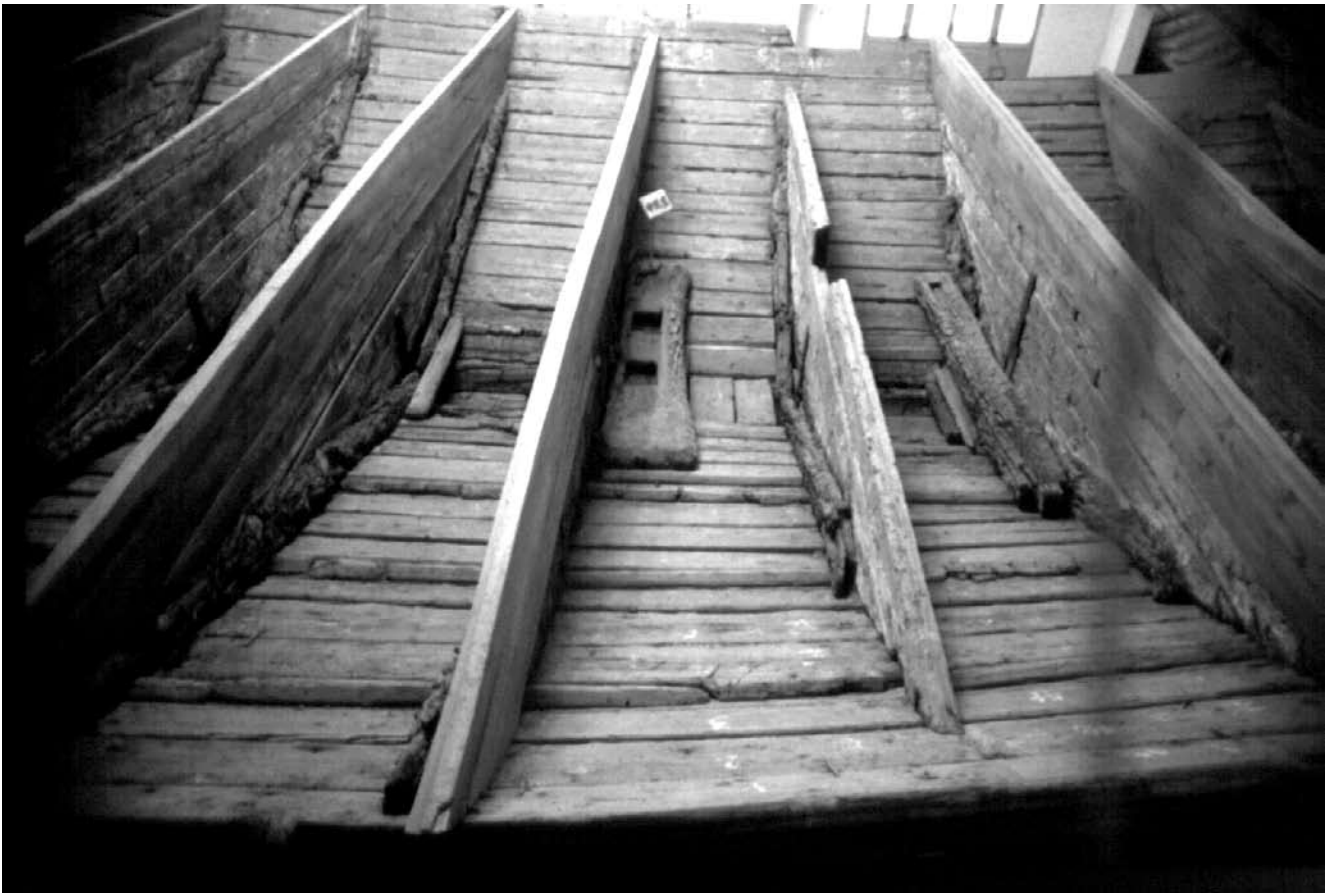
Figure 81. Photograph of the main mast step after reconstruction.

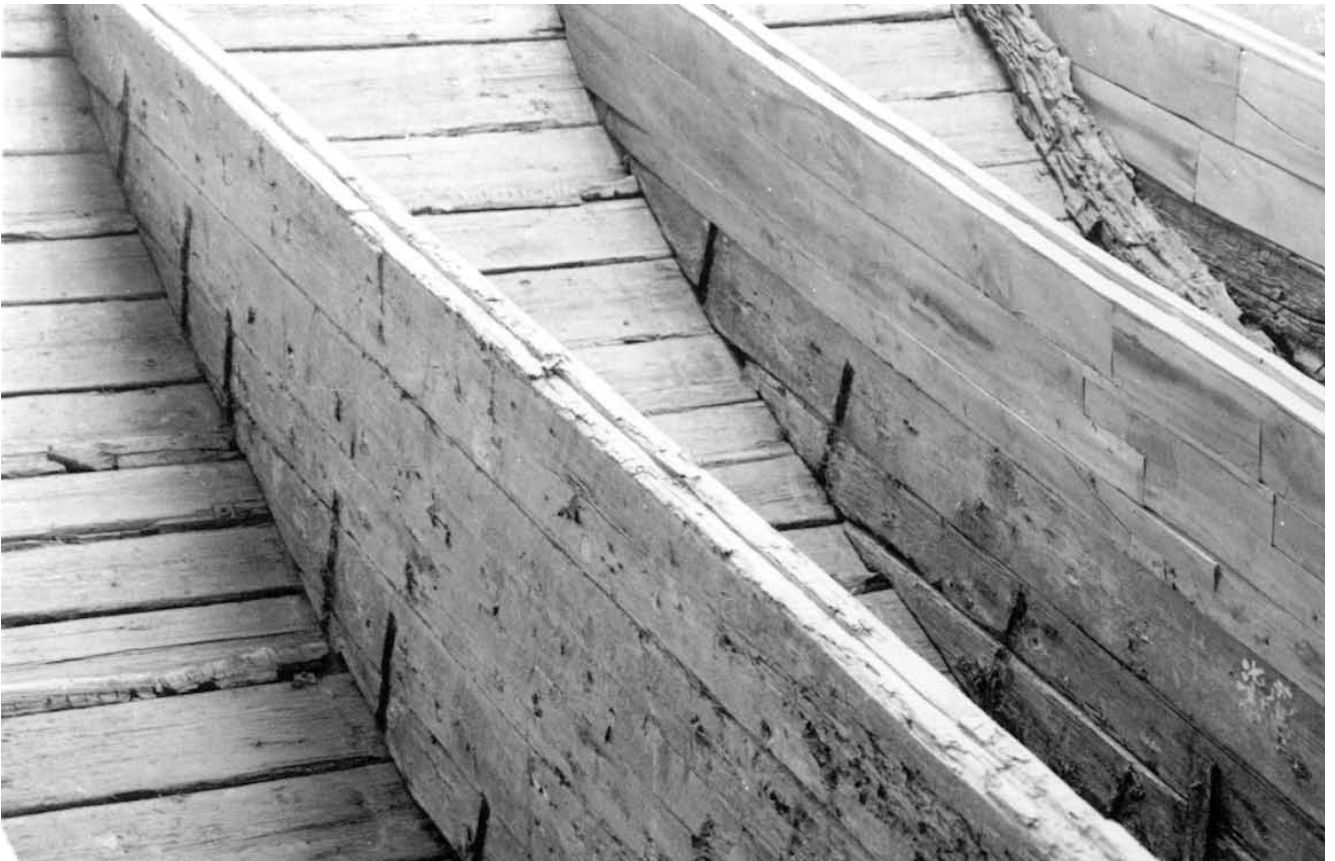
Figure 85. Photograph showing the bulkheads 4 to 9 (right to left) just aft of the mast step with the stiffeners (note to the right, the bulkhead with the frame on the aft side).

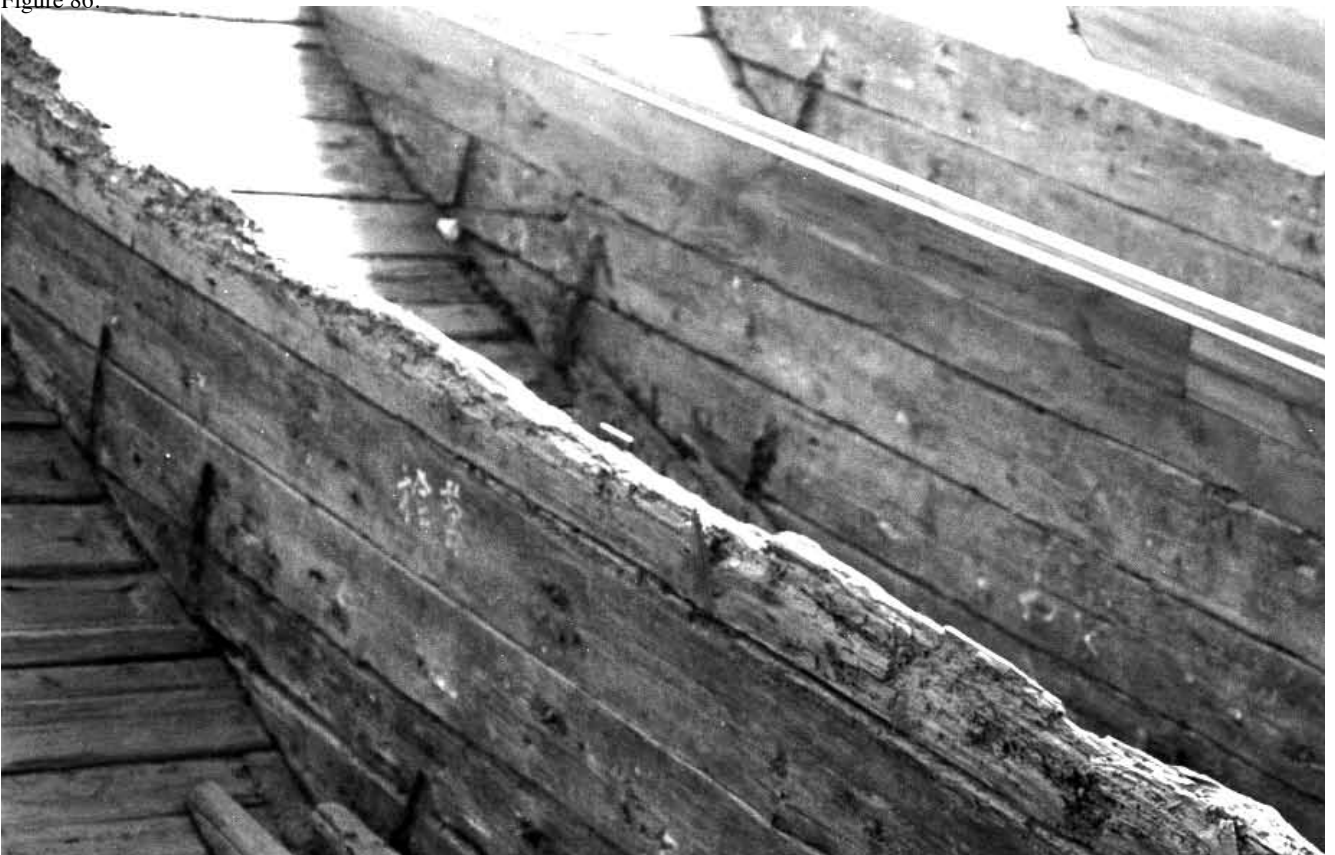
Figure 87. Bulkheads 7 to 10 (right to left).

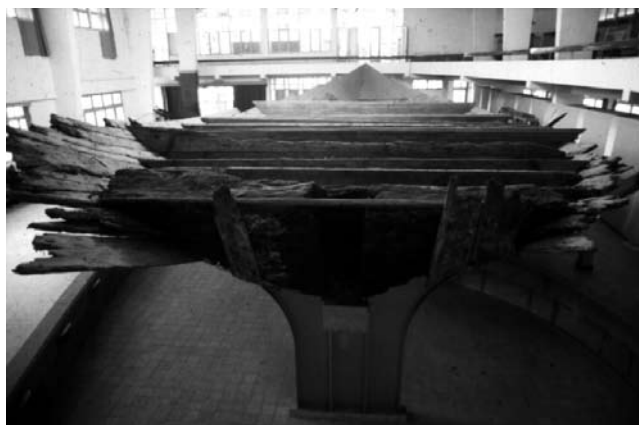
Figure 95. View of stern of vessel showing axial rudder slot.

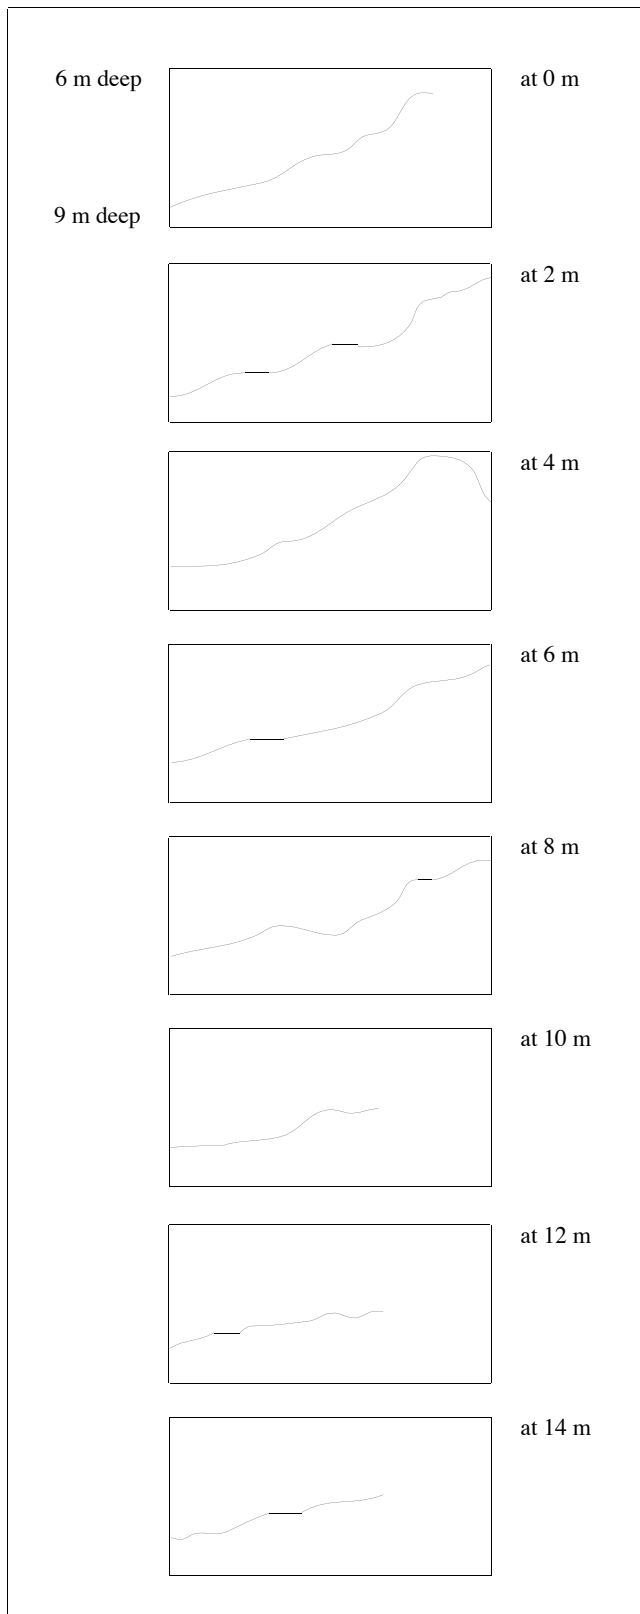
Figure 111. Profiles of the BJ1 site along the latitudinal axis.

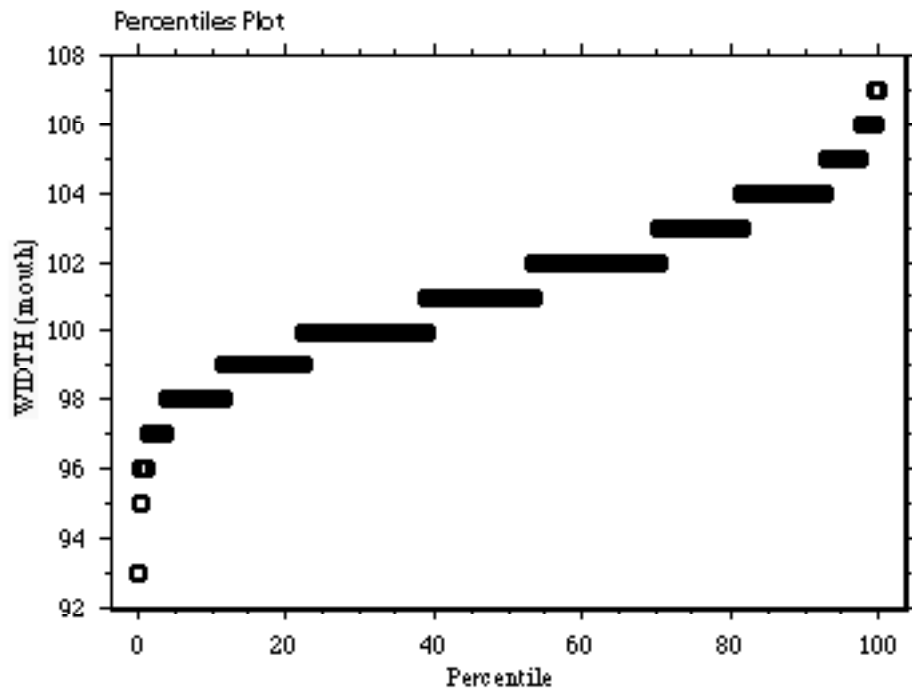
Figure 122. Variation in diameter of the mouth from a sample of black bowls.

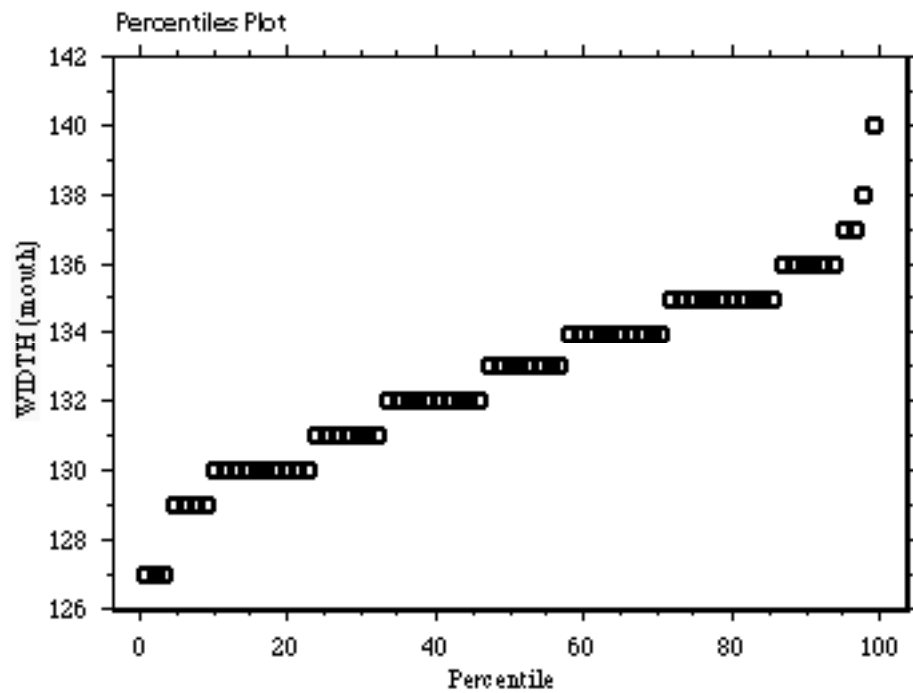
Figure 123. Variation in diameter of the mouth from a sample of celadon A bowls.
