First port in the Northwest
A maritime archaeological survey of Cossack
25-30 June 2012

Report—Department of Maritime Archaeology,
Western Australian Museum— No. 297

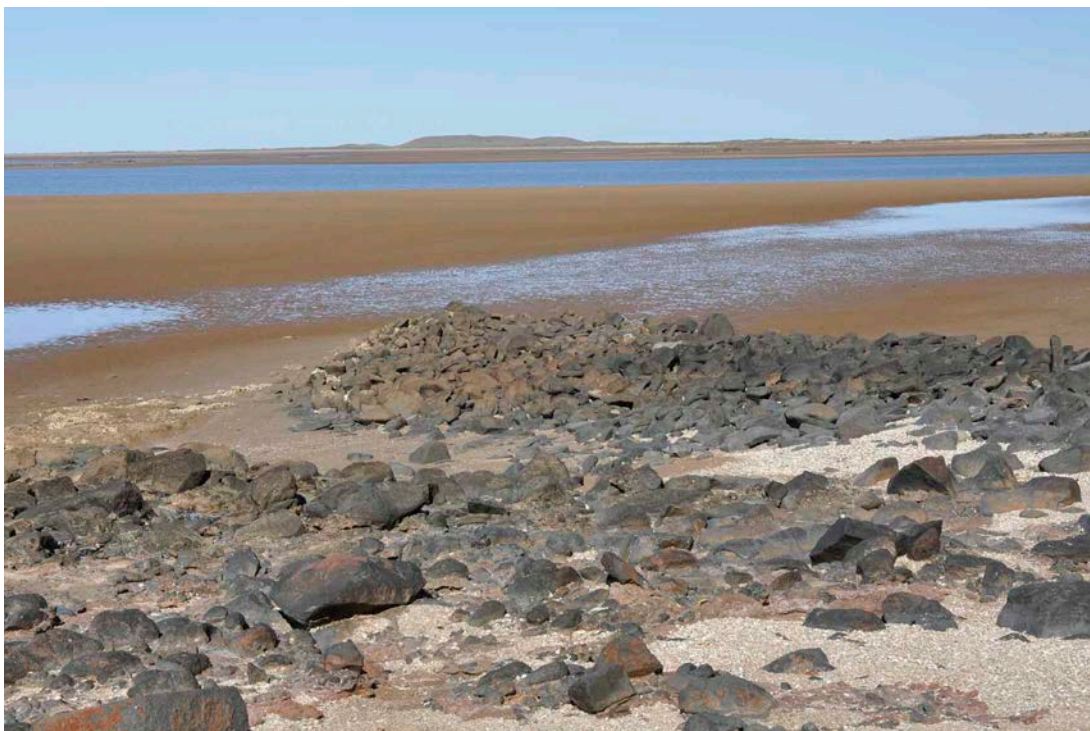
Figure 23. View of explosives jetty (Feature CK67) at low tide looking southeast.

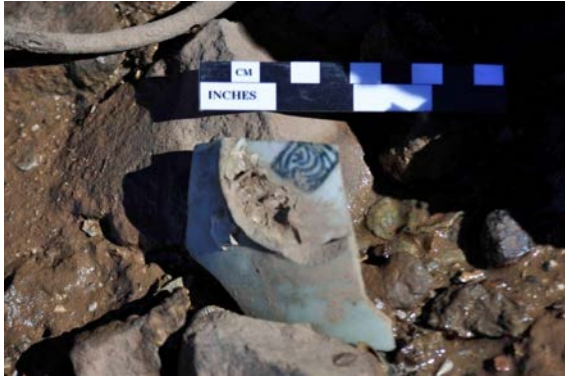
Figure 39. Base fragment of an Asian celadon ware ceramic bowl (Feature CK37).

shell fragments (Figure 40) were also found in this ship repair and lay up area (see Appendix B for GPS positions).

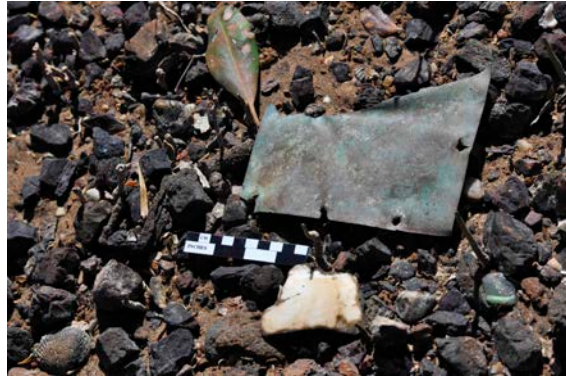
Figure 40. Fragments of copper alloy hull sheathing and baler shell (Feature CK48).

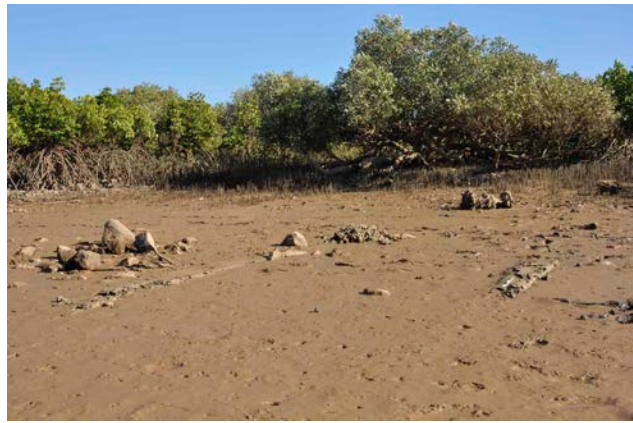
Figure 42. Two wooden ships' keels, piles of rock ballast, chain mound and a windlass mark at least one probable wreck site (Cossack UNID 6).

The Cossack foreshore shows evidence of having been a rich zone of maritime activity, with over fifty archaeological features located including maritime infrastructure (1890s stone wharf built over earlier jetties, concrete building foundations, Cossack sea wall), nine shipwrecks, ships' windlasses, a ship repair and lay up area south of the wharf, stone ballast mounds, corroded mooring chains, iron posts and mangrove moorings, and numerous artefacts (Figure 37, Figure 38, Figure 41, Figure 42). An Asian green celadon ceramic ware fragment (Figure 39), copper sheathing fragments and baler

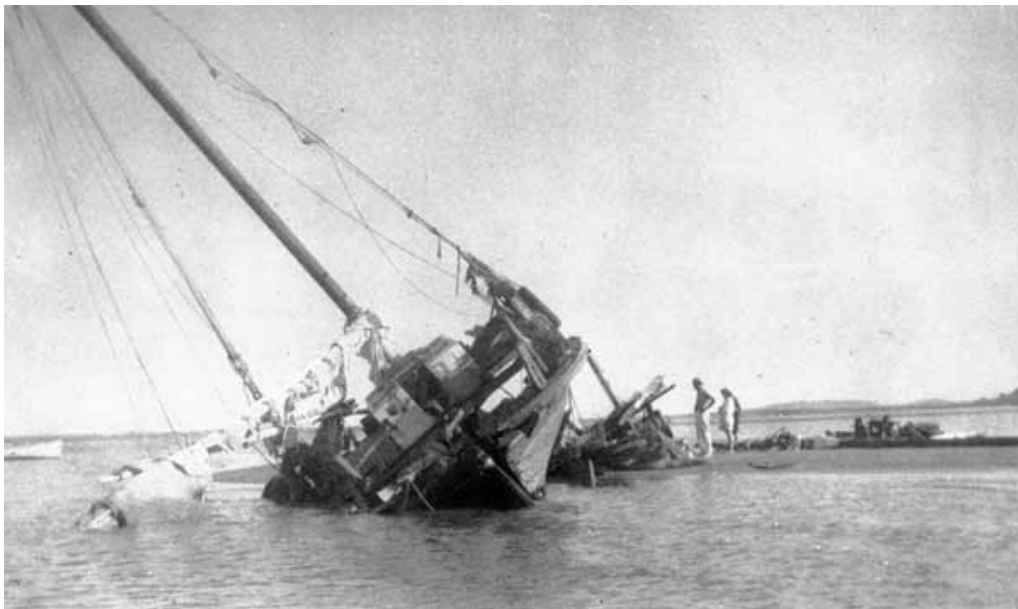
Figure 50. Wreck of *Eva* (1936) at entrance of Butcher Inlet (WA Museum, Department of Maritime History).

On 1 May 1936 the schooner *Eva*, described as having 'been used for some time as a lighter by the Cossack Lightering Co.' was transporting twelve tons of timber from the Point Samson jetty when it was wrecked at Reader Head in a strong easterly wind with high seas. No lives were lost (*West Australian* 5/5/1936 p.11). (Figure 50)

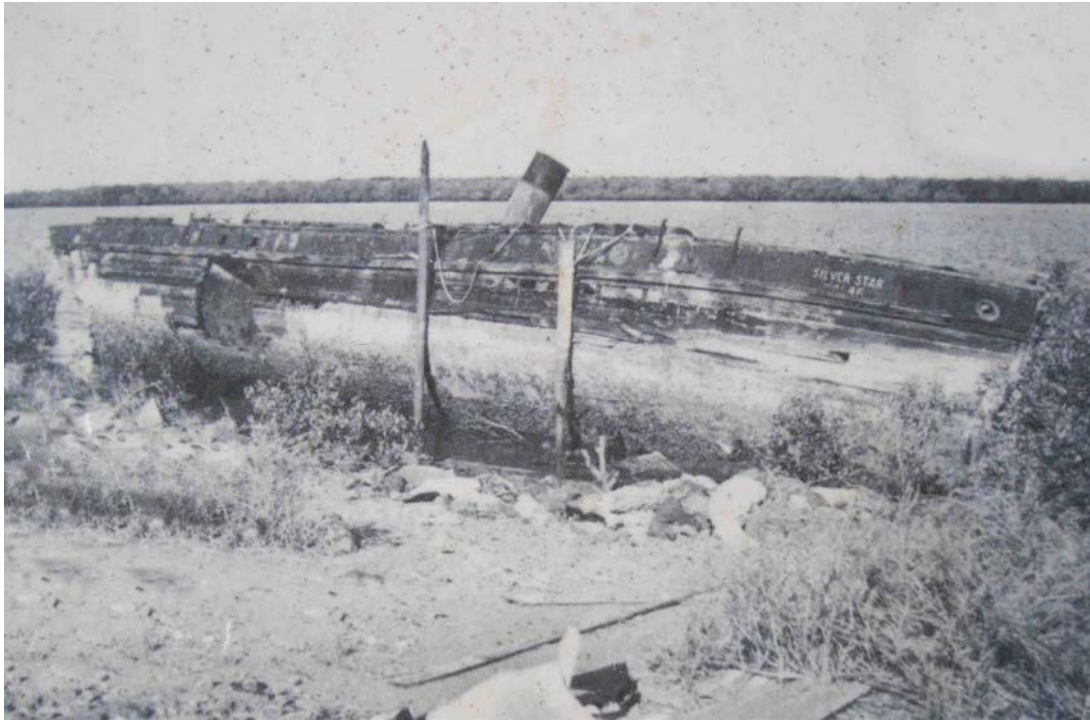
Figure 51. SS *Silver Star* wrecked on Cossack foreshore before being burnt (Battye Library 75079P).

The composite steam lighter *SS Silver Star* lying just south of Cossack wharf (Figure 51, Figure 52) is the most obvious and accessible shipwreck at Cossack, and was previously well known as an ex-Swan River ferry and Albany excursion steamer. Its flat-bottomed design made it ideal for lightering wool in shallow Butcher Inlet, where it spent its final years before colliding with the wharf in 1936, splitting its stempost. It was run ashore and later burnt to obtain its metal fittings for scrap.

In 1936 the ex-Perth river ferry and Albany excursion steamer SS *Silver Star* was owned by the Cossack Lightering and Trading Company when it rammed the Cossack wharf and split its stempost. It was beached just south of the wharf where it became a total wreck (De L. Marshall 2001: 239) (Figure 51).

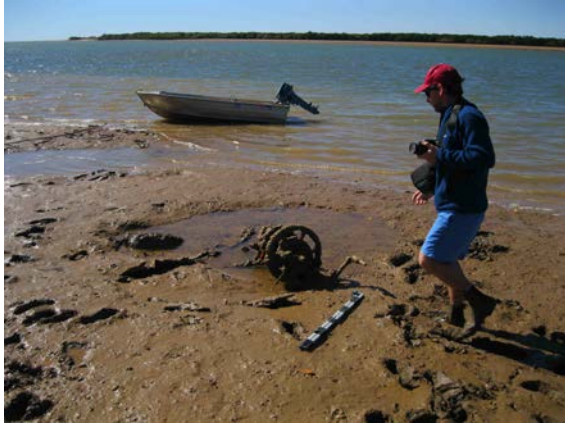
Figure 54. Windlass and copper alloy sheathing on Cossack UNID 1 site, wooden cutter or lugger wreck.

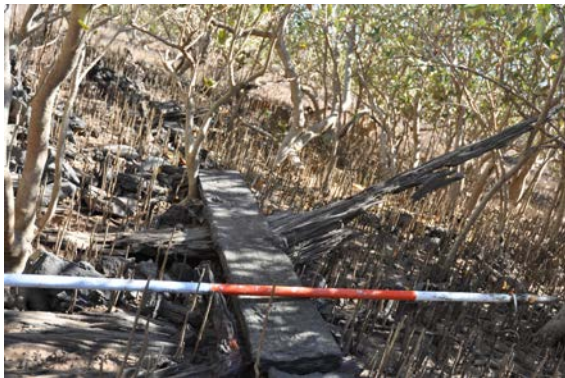
Figure 56. Cossack UNID 5 wooden lighter wreck in mangroves.

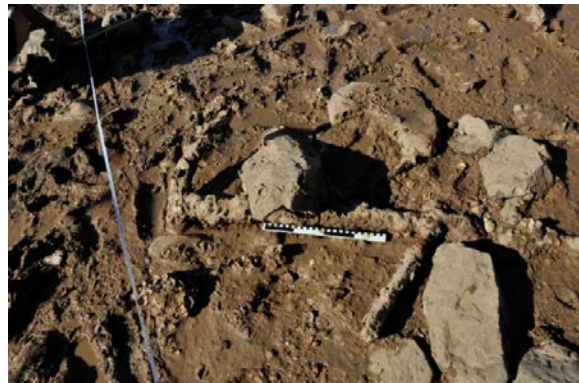
| Name | Description | GPS (GDA94) | position |
|---|---|---|---|
| Cossack UNID 3 | Wreck of a wooden cutter or lugger. Remains consist of rock ballast, timber frames, hull planking and two broken sections of keel, copper alloy sheathing, small anchor with corroded chain and iron hand winch. Frame spacing is 40-44cm and total length 22.4m. The anchor shank measured 1.06m. Hull plank width is 14cm. The winch measurements are 0.9m axle width and 40cm winch cog diameter. | S 20.68165 E 117.18563 | |

Figure 57. Small anchor on Cossack UNID 3 site.

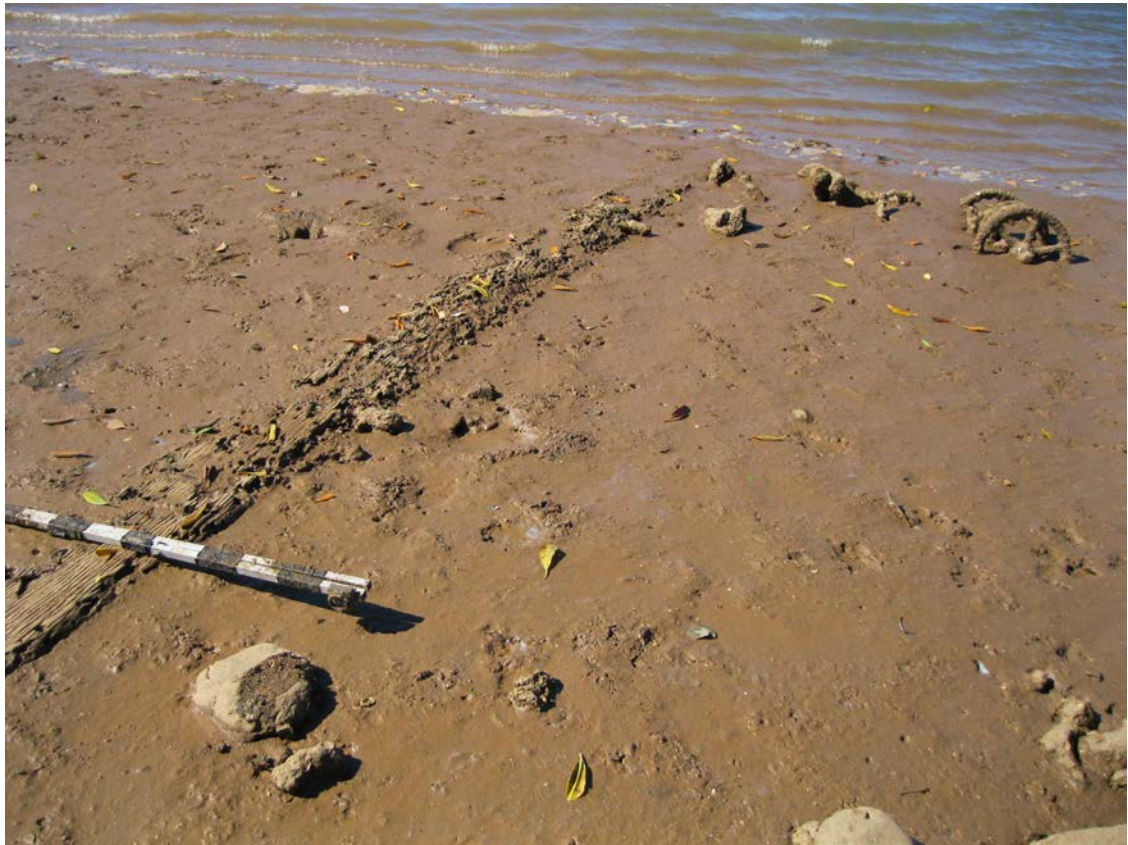
Figure 59. Wooden keel with windlass on Cossack Unidentified 6 site.

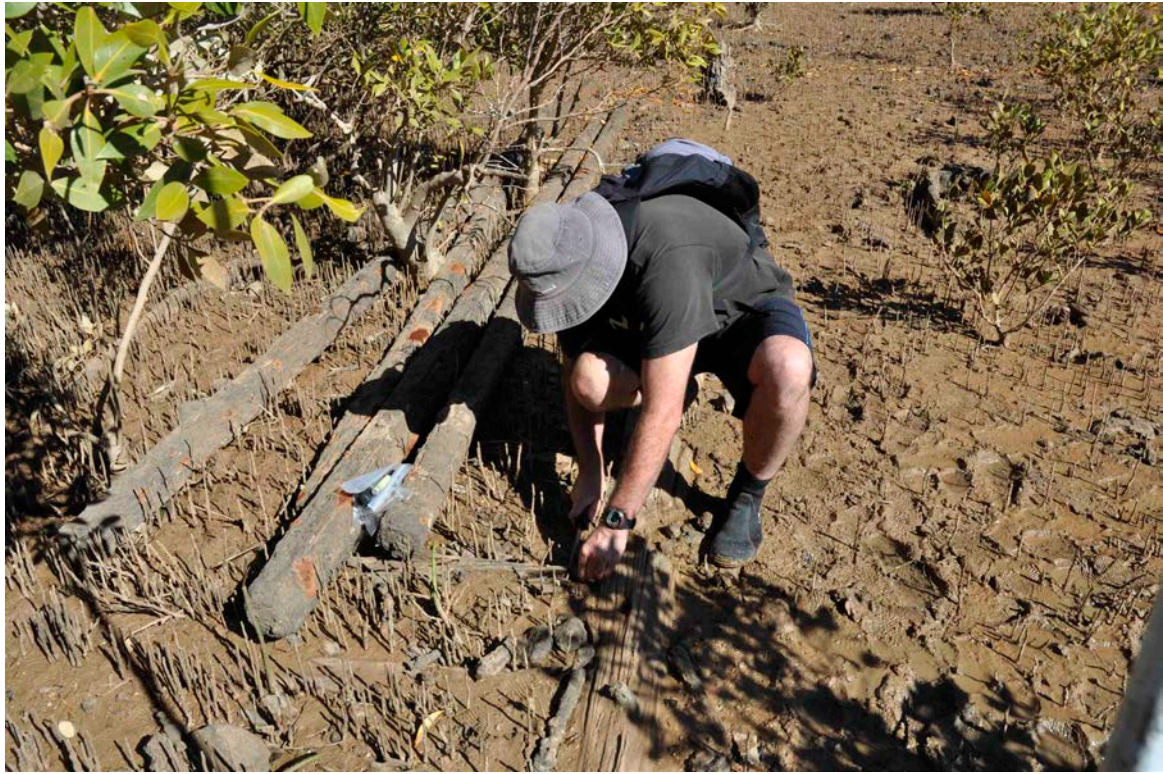
| Name | Description | GPS (GDA94) | position |
|---|---|---|---|
| Cossack UNID 4 | Wreck of a large wooden lighter. Remains consist of the bottom of the vessel with timber keel and frames, a wooden knee, two broken winches, a bollard/ bitt, iron fastenings, rock ballast, wooden sternpost, stacked iron beams (probably for laying across hatches to increase deck cargo carrying capacity) and hawse pipe. Possibly the <i>Amy</i> (1923), <i>Cossack</i> (1894) or <i>Derby</i> (1894). | S 20.68172 E 117.18537 | |

Figure 62 Keel, floor frames and stacked iron beams on Cossack Unidentified 4 shipwreck

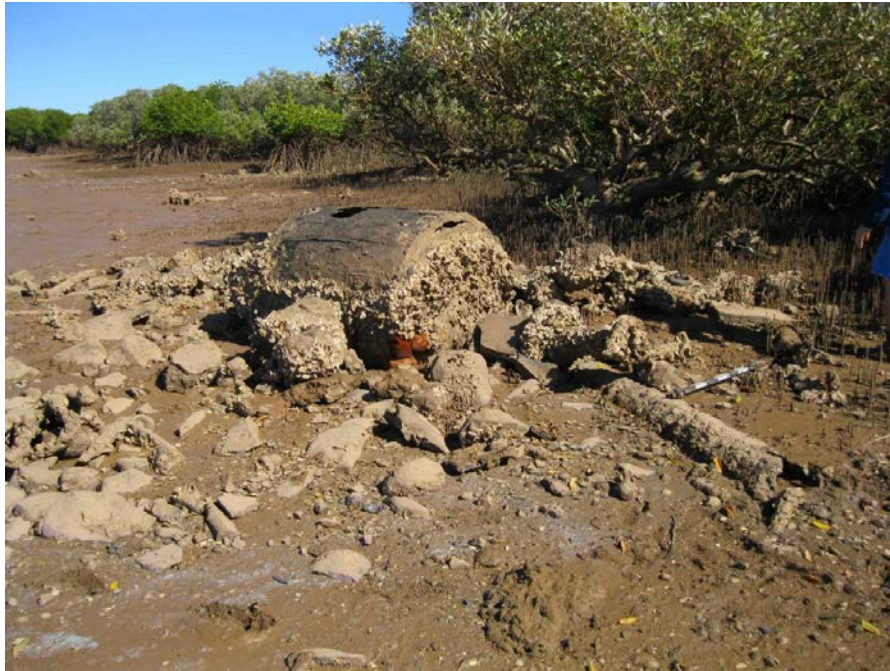
Figure 65. Cossack Unidentified 8 is tentatively identified as the wreck of the New Zealand-built wooden steam launch *SS Tui* (1894).

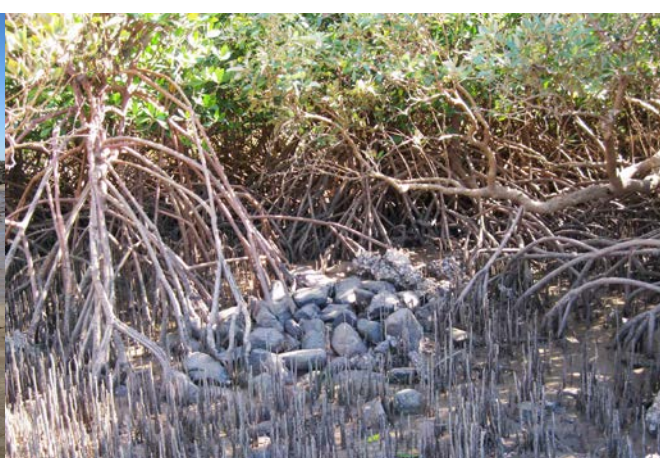
Figure 68. Ballast mound overgrown by mangroves on Cossack foreshore.
